September 17, 2021

RE: **Additional Information and Response to DNR Review of No Further Action (NFA) Request, 1818 W National Ave (now Cristo Rey Jesuit Highschool)  
1818 W. National Avenue, Milwaukee, Wisconsin  
BRRTs #02-41-583465 FID #241878450  
Regulatory Status: Open ERP**

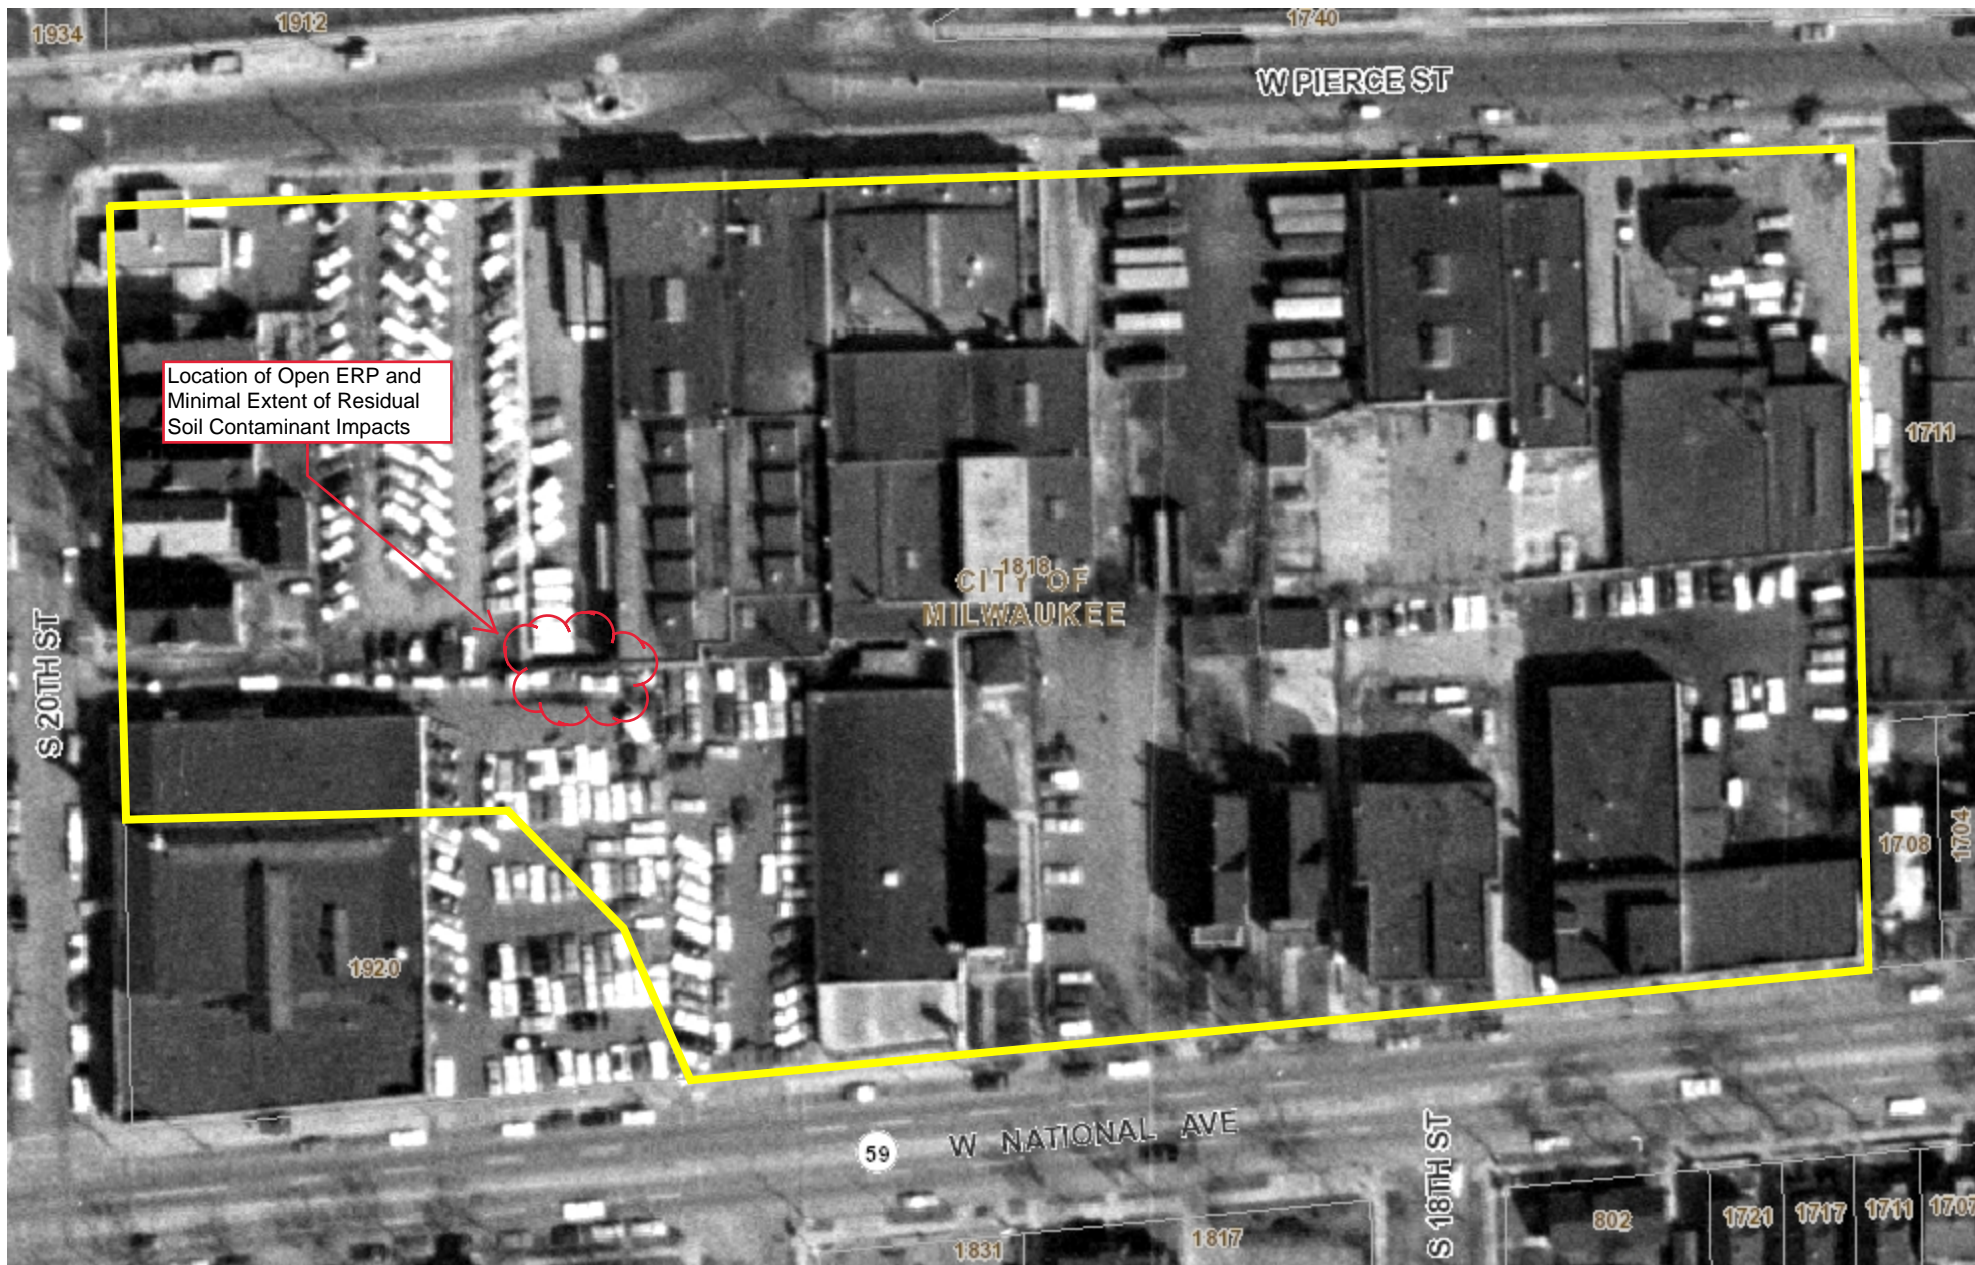
Location of Open ERP and Minimal Extent of Residual Soil Contaminant Impacts
