Re: NR 716 Site Investigation Work Plan
BMO HARRIS BANK BRANCH
900 E. Main Street
Merrill, Wisconsin
WDNR BRRTS No. 02-35-584409
PSI Project No.: 00541993

NR 716 SITE INVESTIGATION WORK PLAN

**BMO HARRIS BANK BRANCH
900 E. Main Street, Merrill
Lincoln County, Wisconsin
WDNR BRRTS No. 02-35-584409**

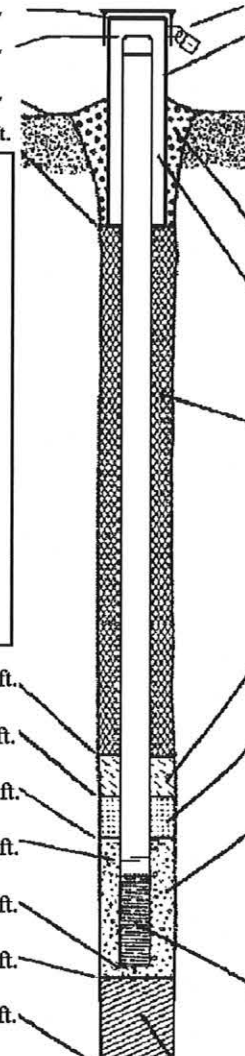
E. Bentonite seal, top _____ ft. MSL or 1.5 ft.	7. Fine sand material: Manufacturer, product name & mesh size a. Red Flint #15
F. Fine sand, top _____ ft. MSL or 4.5 ft.	b. Volume added 20# ft ³

G. Filter pack, top _____ ft. MSL or 5 ft.	8. Filter pack material: Manufacturer, product name & mesh size a. Red Flint #40
H. Screen joint, top _____ ft. MSL or 6 ft.	b. Volume added 275# ft ³

I. Well bottom _____ ft. MSL or 16 ft.	9. Well casing: Flush threaded PVC schedule 40 <input type="checkbox"/> 23 Flush threaded PVC schedule 80 <input type="checkbox"/> 24 Other <input type="checkbox"/>

J. Filter pack, bottom _____ ft. MSL or 16 ft.	10. Screen material: PVC SCH 40
K. Borehole, bottom _____ ft. MSL or 16 ft.	a. Screen type: Factory cut <input checked="" type="checkbox"/> 11 Continuous slot <input type="checkbox"/> 01 Other <input type="checkbox"/>

L. Borehole, diameter 8 in.	b. Manufacturer Johnson
M. O.D. well casing 2.35 in.	c. Slot size: 0.010 in.
N. I.D. well casing 2 in.	d. Slotted length: 10 ft.
