Professional Service Industries, Inc. (PSI) is pleased to submit herewith the Site Investigation Report (SIR) for the Subject Property as described above. The results of the SIR, including pertinent observations and a summary of the findings, can be found in the accompanying report. Hard copies of this report will be mailed at your request.

**SITE LOCATION MAP**  
**BMO HARRIS BANK BRANCH**  
900 East Main Street  
Merrill, Wisconsin 54452  
BRRTS No. 02-35-584409

**BMO Bank Branch**  
 900 East Main Street  
 Merrill, Wisconsin 54452

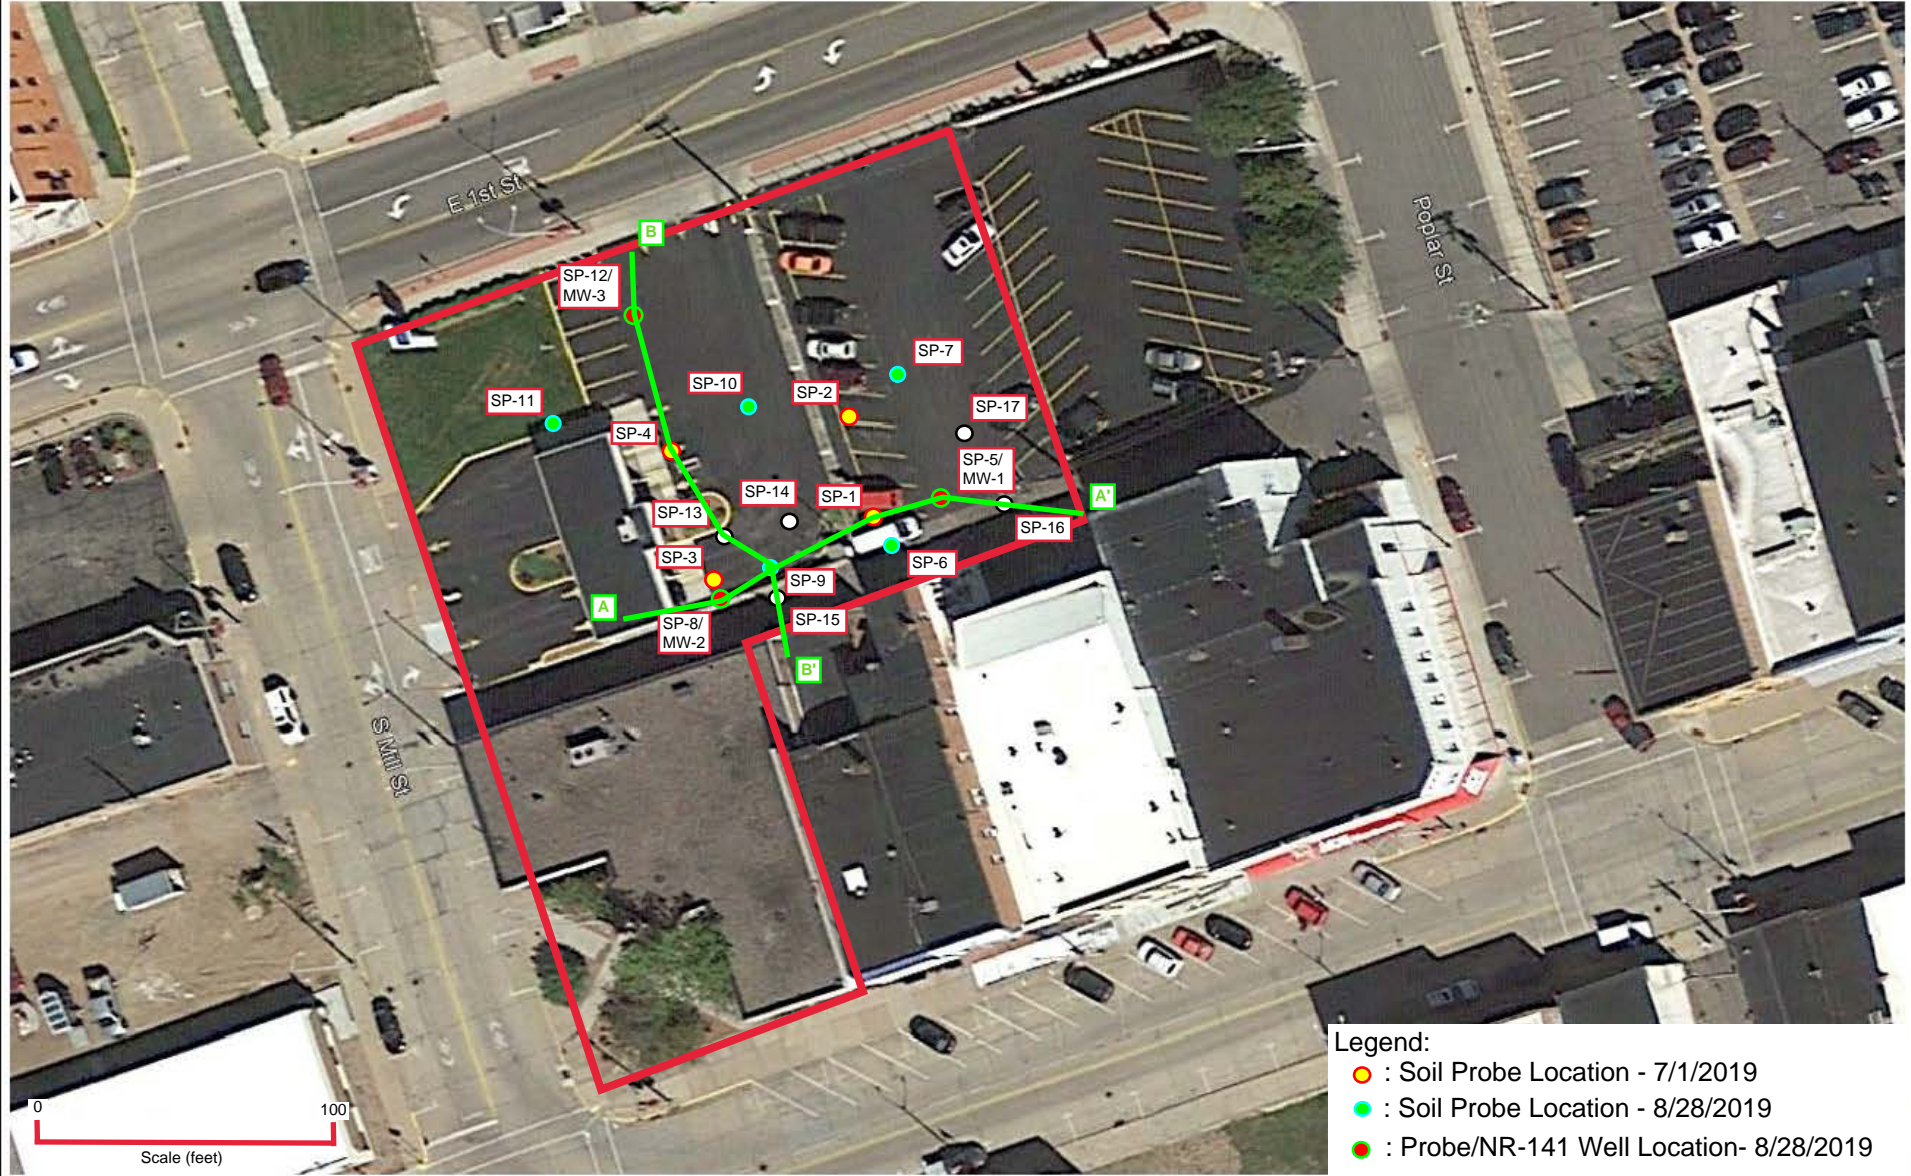
**SITE FEATURES DIAGRAM**  
**BRRTS No. 02-35-584409**

- Legend:**
- : Soil Probe Location - 7/1/2019
  - : Soil Probe Location - 8/28/2019
  - : Probe/NR-141 Well Location- 8/28/2019
  - : Soil Probe Location - 10/29/2019

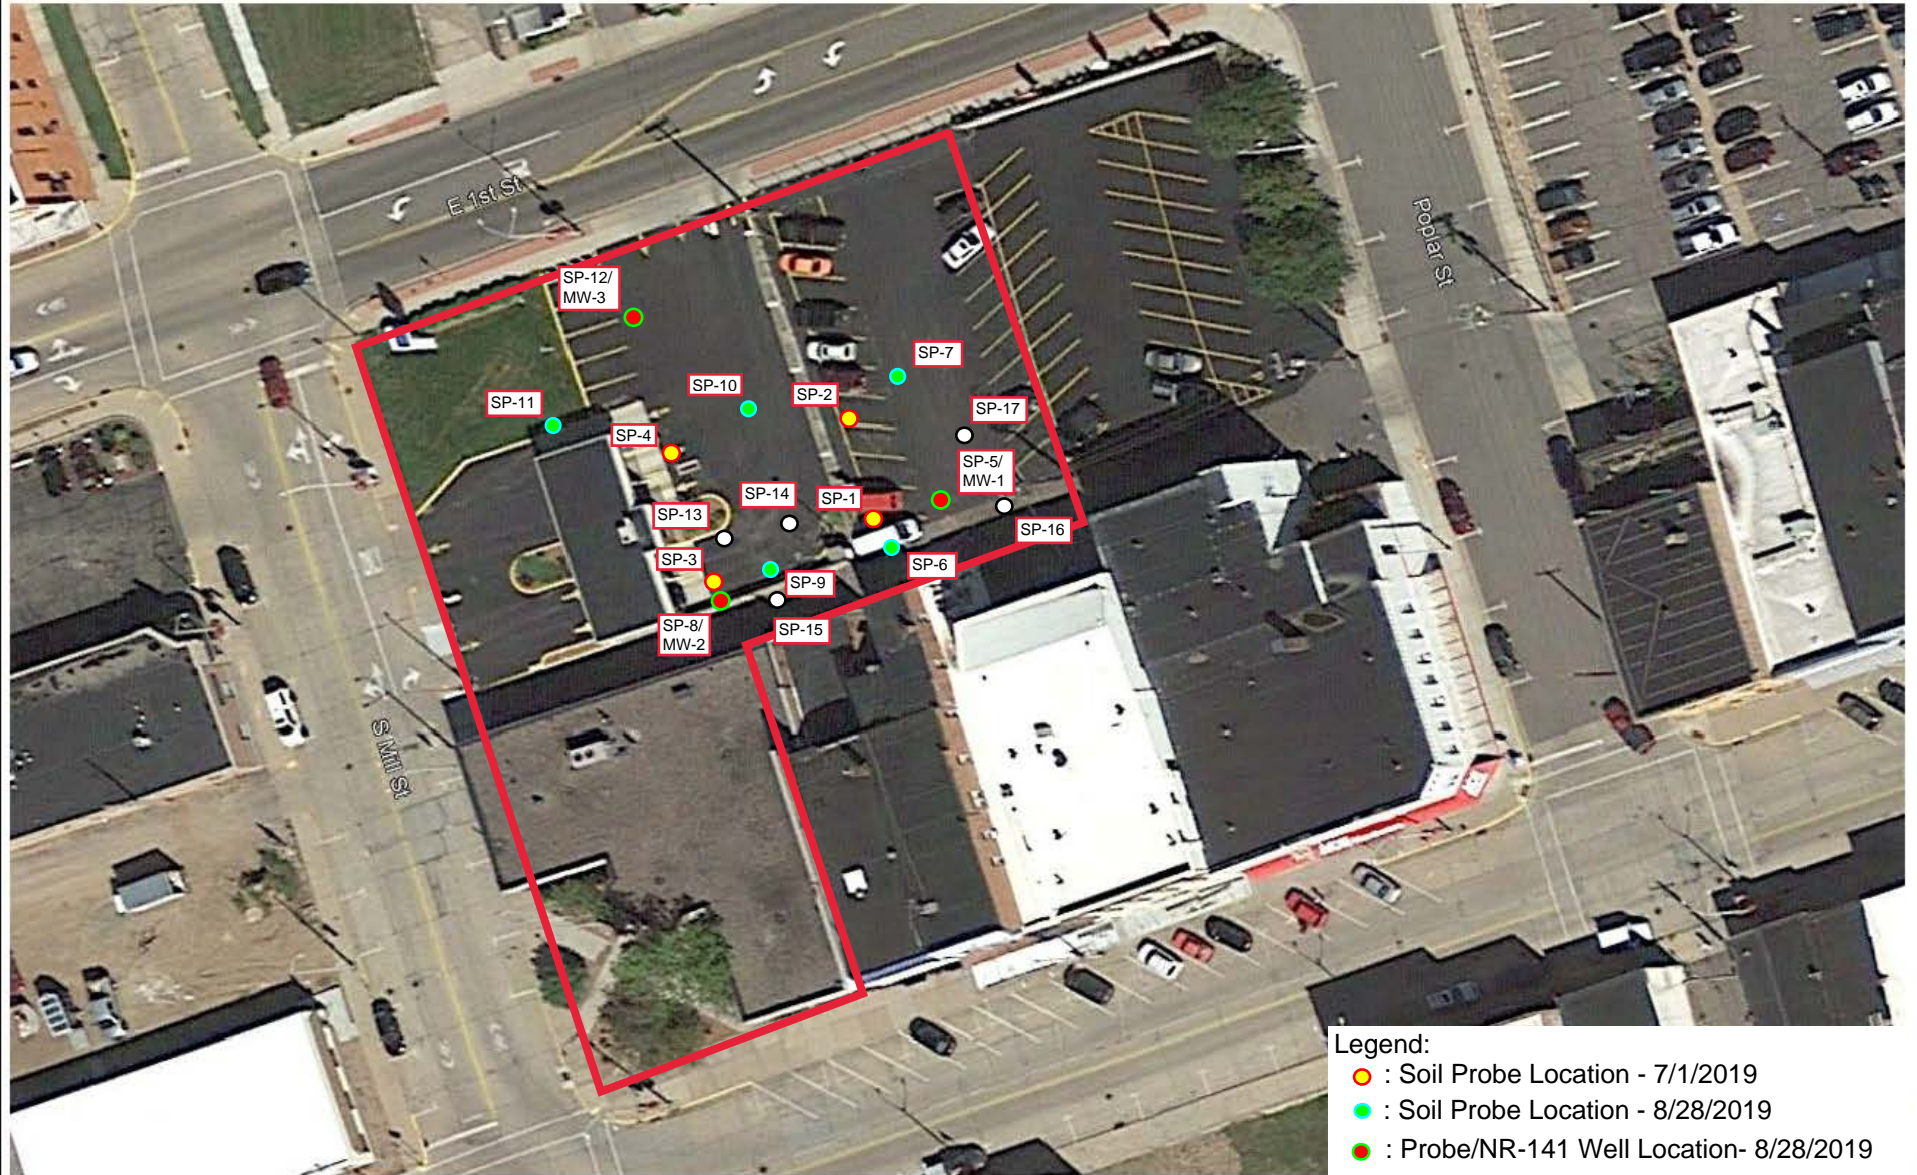
**WELL AND PROBE LOCATION DIAGRAM  
BRRTS No. 02-35-584409**

On October 29, 2019, five (5) additional soil probes (SP-13 through SP-17) were completed by a subcontracted probe contractor retained by PSI for this project. SP-13 through SP-15 were placed generally around the previous soil probe SP-9 while SP-16 and SP-17 were placed generally to the east of SP-5. They were placed in locations attempting to further define the PAH contamination detected in the shallow soils associated with SP-5 and SP-9. Based upon the previously encountered subsurface conditions, the probes were extended to a depth of about 5 feet below grade. The locations of these probes along with the previous soil probes and wells are shown on the probe and well location diagram

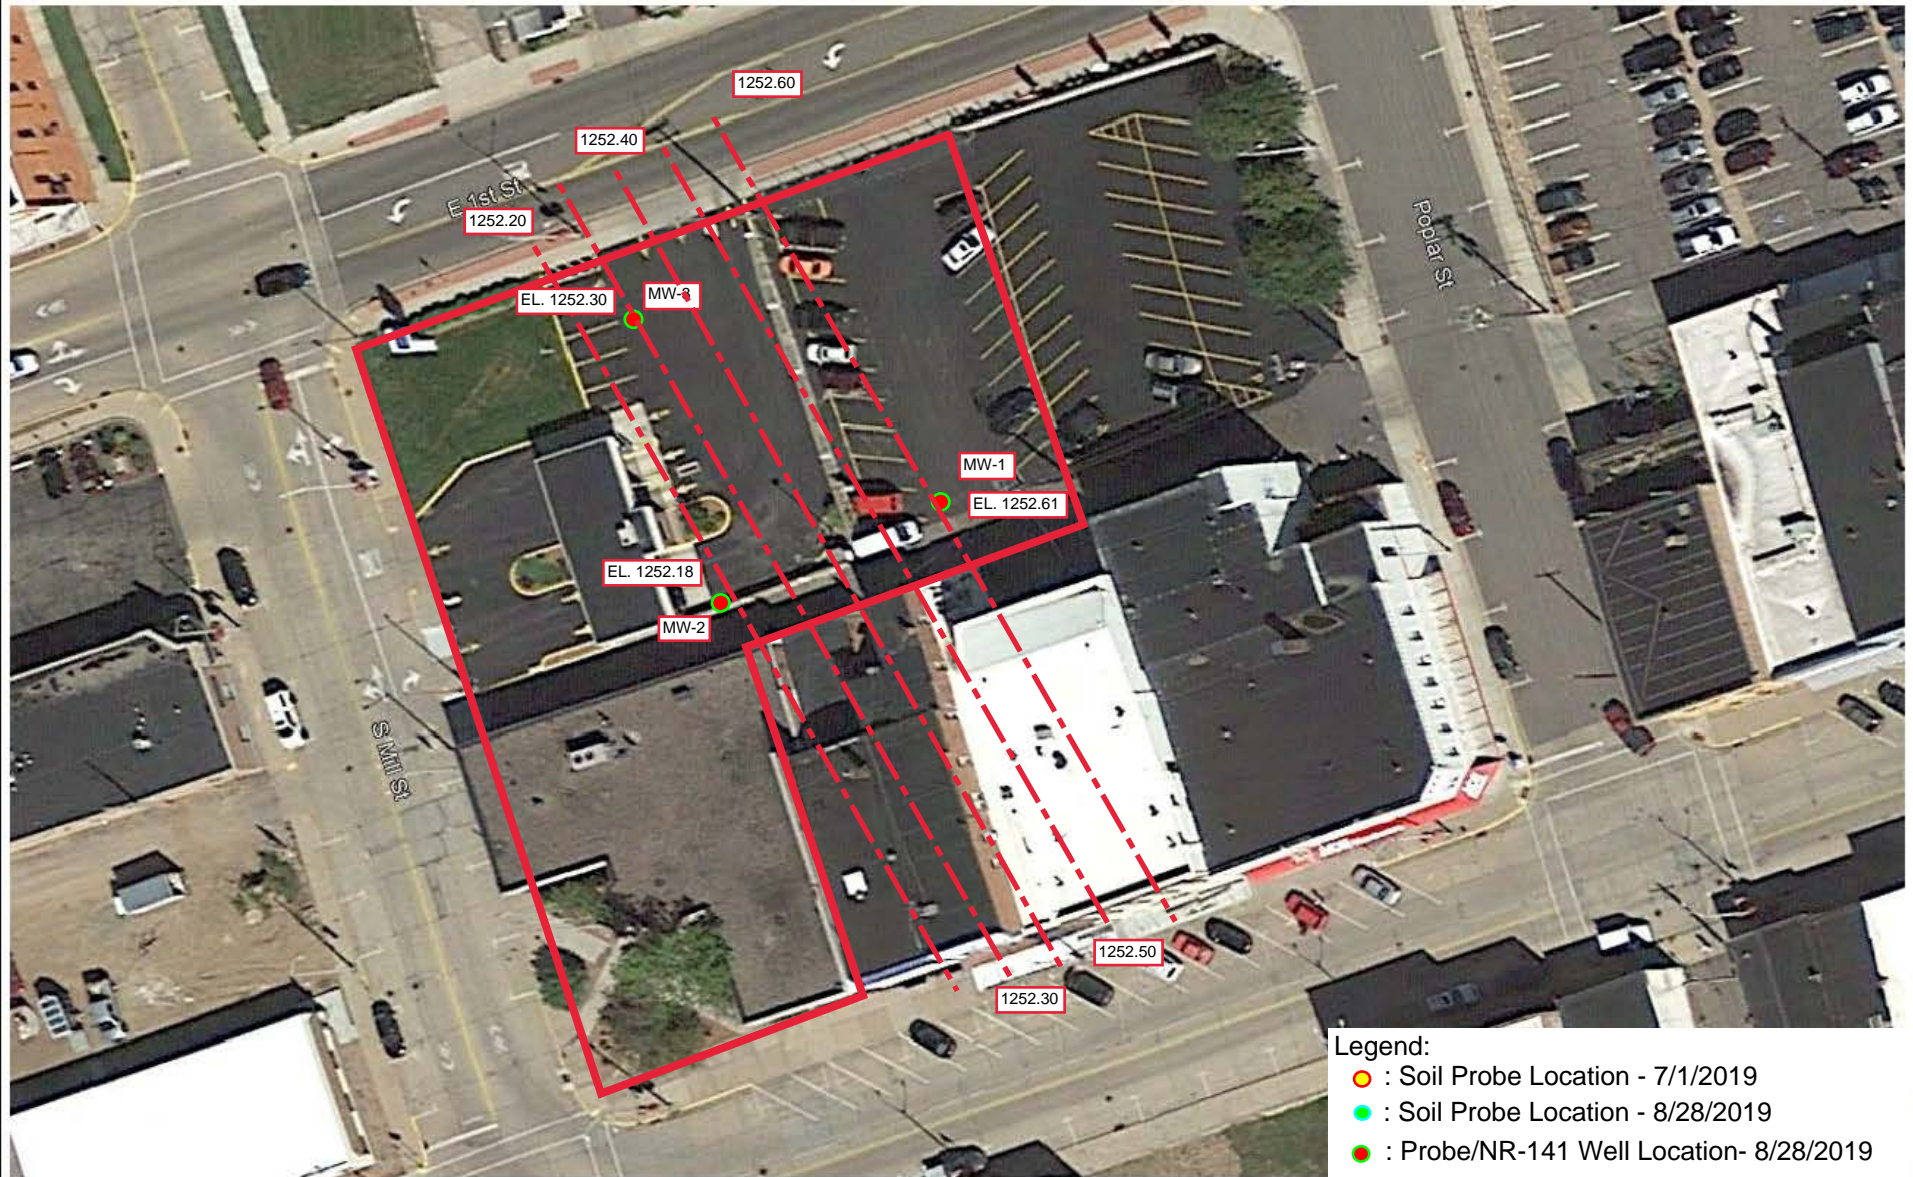
**GROUNDWATER FLOW DIRECTION DIAGRAM  
BRRTS No. 02-35-584409**

**Legend:**  
● : Soil Probe Location - 7/1/2019  
● : Soil Probe Location - 8/28/2019  
● : Probe/NR-141 Well Location- 8/28/2019  
 8-28-19 Groundwater Measurements

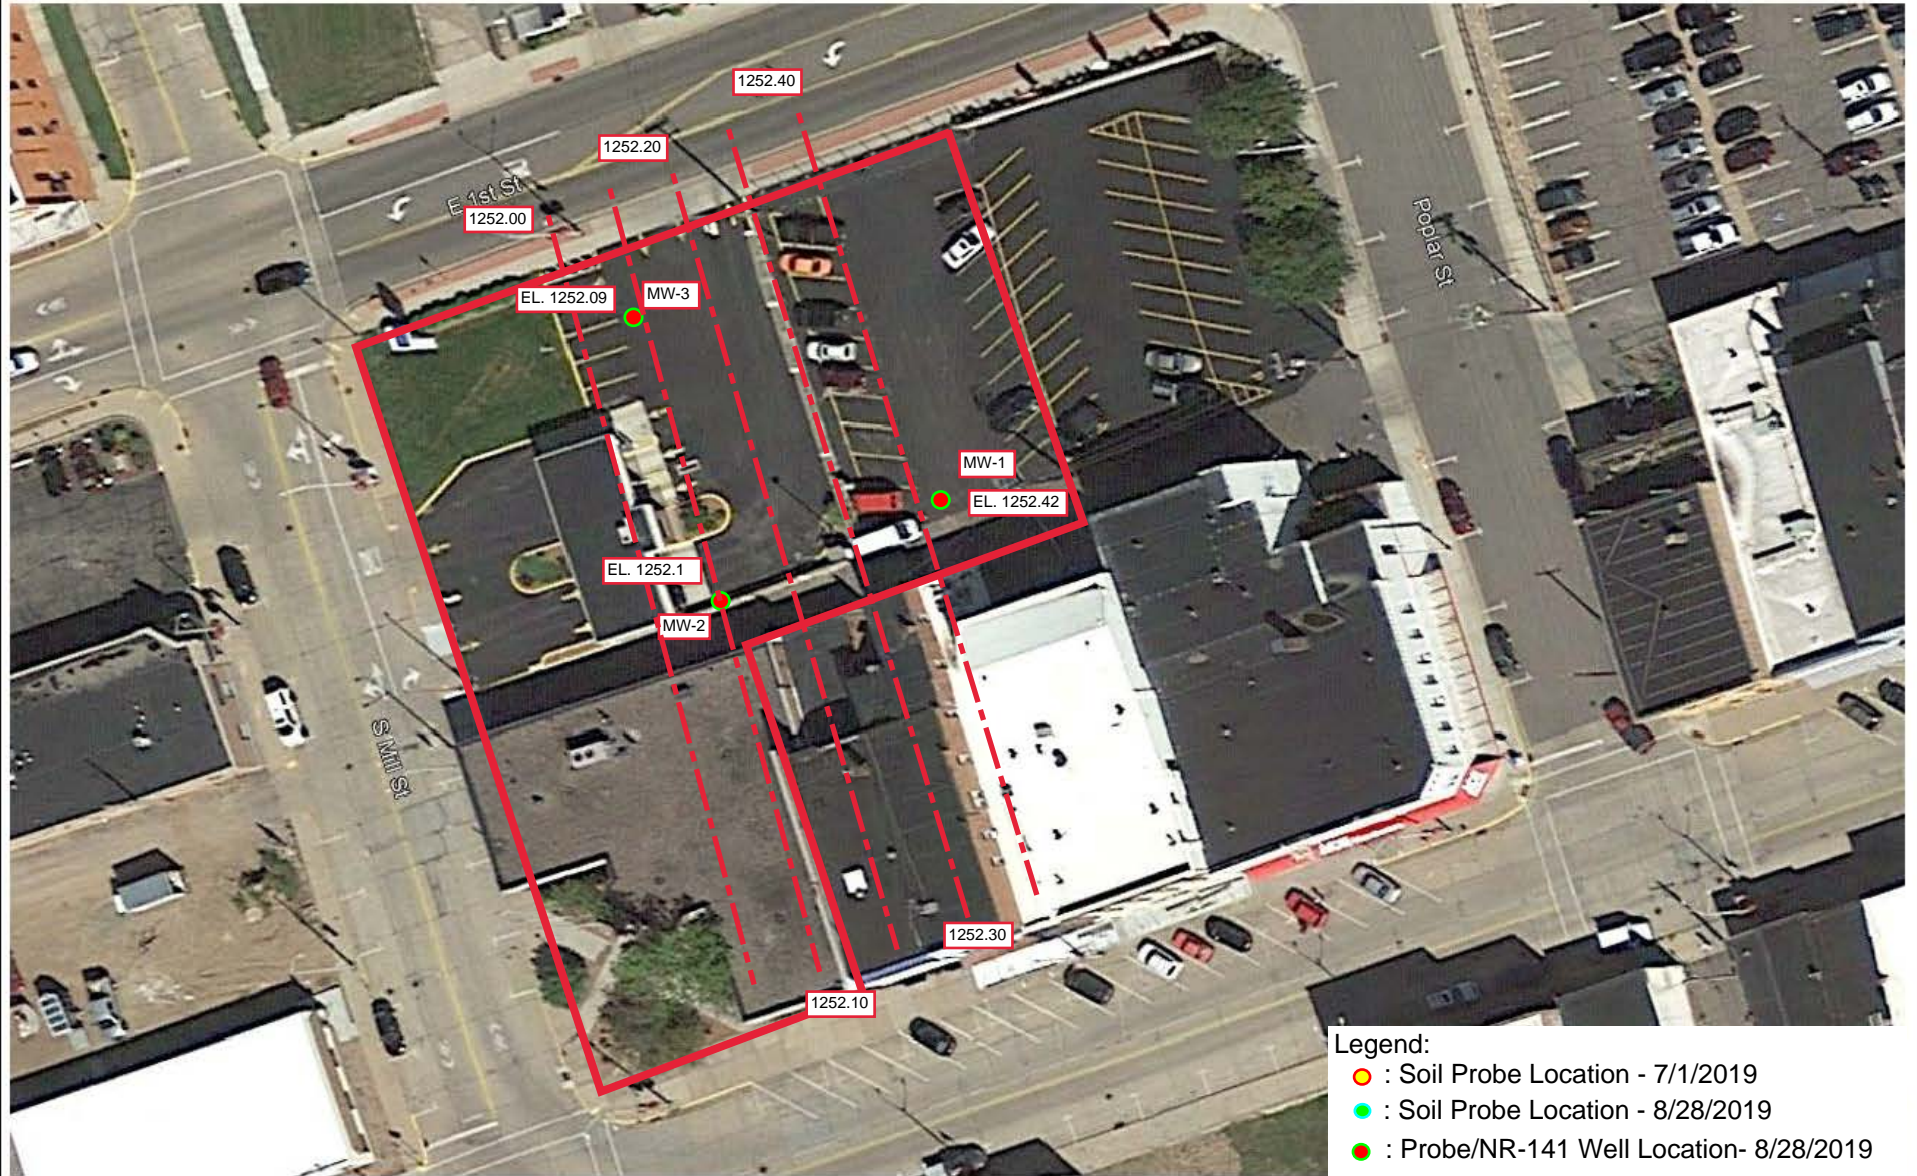
**GROUNDWATER FLOW DIRECTION DIAGRAM  
BRRTS No. 02-35-584409**

completed probes. The groundwater levels were measured within the monitoring wells on October 29, 2019 at depths ranging from 11.26 to 14.02 feet below top of casing (EL. 1252.09± to EL. 1252.42±). The groundwater flow is generally to the west/southwest towards the Prairie and Wisconsin Rivers. No obvious evidence of contamination was present within the collected water samples. Groundwater Flow Diagrams are included in Appendix A. It should be noted that groundwater levels and gradients can fluctuate with seasonal precipitation and changes in lateral drainage patterns.

**Legend:**  
 ● : Soil Probe Location - 7/1/2019  
 ● : Soil Probe Location - 8/28/2019  
 ● : Probe/NR-141 Well Location- 8/28/2019  
 10-29-19 Groundwater Measurements
