Subject: Supplemental Phase II Environmental Site Assessment
BMO Harris Bank Property
900 E. Main Street
Merrill, Wisconsin
PSI Project No. 00541937

SUPPLEMENTAL PHASE II ENVIRONMENTAL SITE ASSESSMENT

BMO Harris Bank Property
900 E. Main Street
Merrill, Wisconsin

PSI Report Number: 00541937

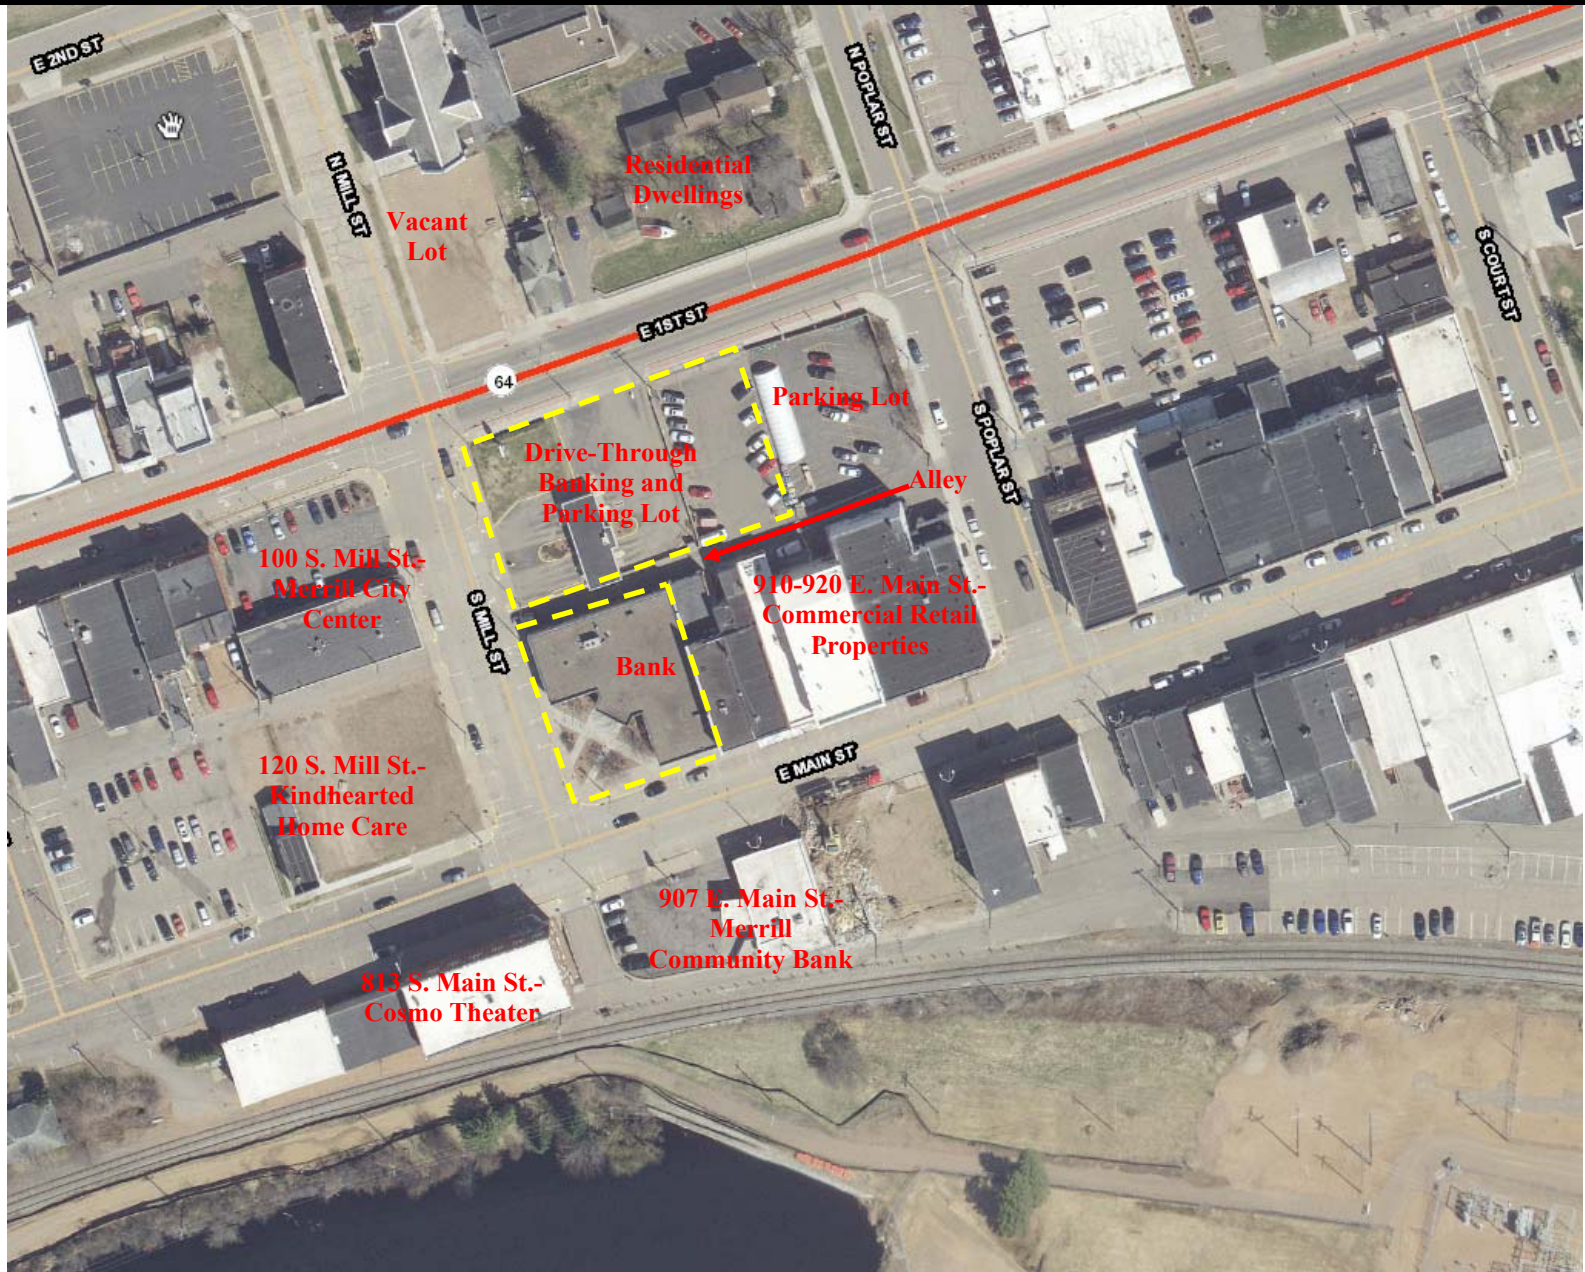
SITE FEATURES DIAGRAM

The Subject Property consists of an approximate 0.8-acre commercial property located at 900 E. Main Street in Merrill, Wisconsin. The Subject Property consists of two parcels and is situated within the Southwest 1/4 of Section 12, in Township 31 North, Range 6 East, in Lincoln County. A commercial structure is situated in the southwest portion of the parcel. A drive through structure is situated to the north of the building. Asphalt parking areas are generally located within the northern portion of the parcel. Landscaped areas are present in the southwest and northwest property corners.

The Subject Property is located to the north of E. Main Street, south of N. 1st Street, east of S. Mill Street, and west of several commercial properties and S. Poplar Street. The surrounding properties are generally occupied by commercial and residential properties and municipal facilities. The general location of the Subject Property is shown on the Site Location Map in the Appendix. A diagram showing the general site features is also included in the Appendix.

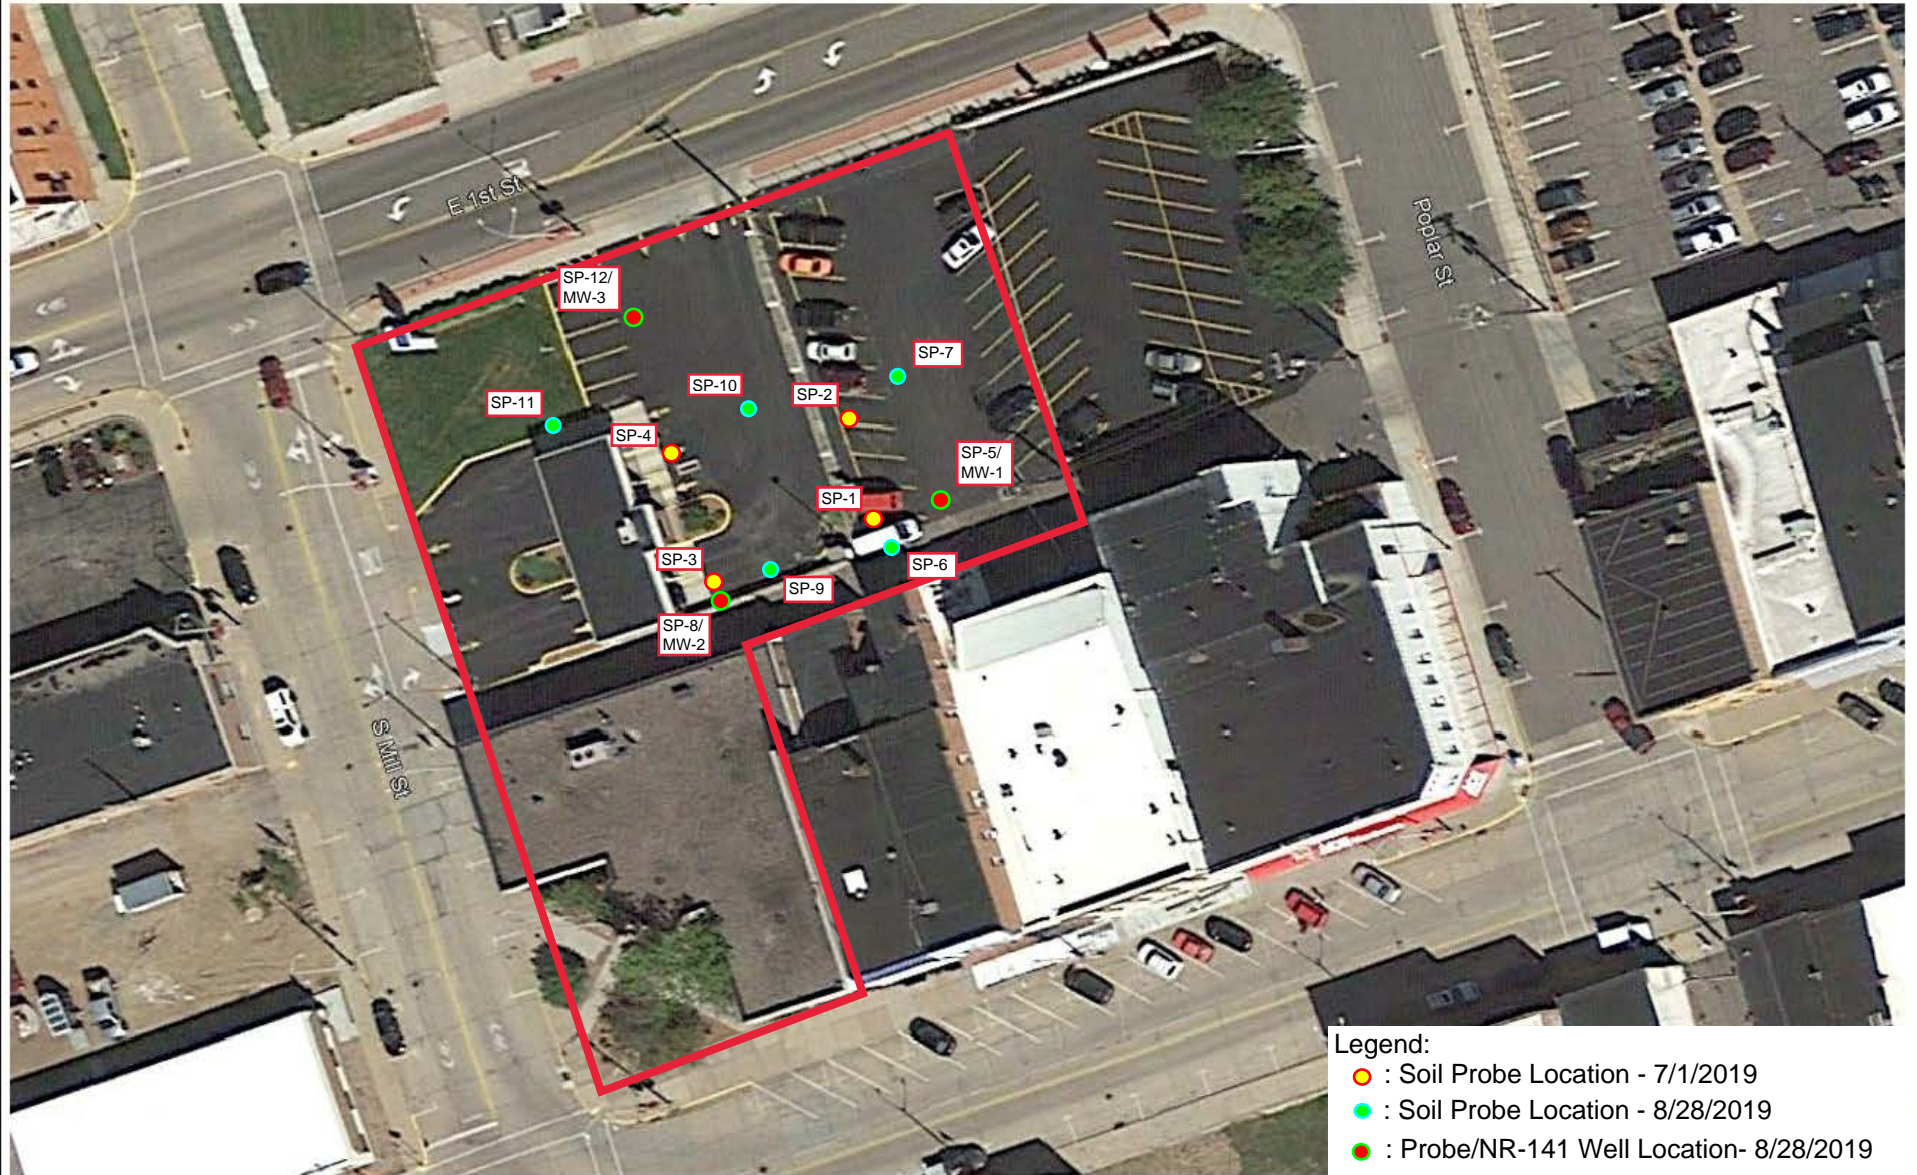
PROBE AND WELL LOCATION DIAGRAM
PSI PROJECT No. 00541937

On August 28, 2019, seven (8) soil probes (SP-5 through SP-12) were completed by a subcontracted probe contractor retained by PSI for this project. They were placed generally around the three previous soil probes (SP-1 through SP-3). Based upon the previously encountered subsurface conditions, the probes were extended to a depth of about 10 feet below grade, while the wells were extended to a depth of about 15 feet below grade. The locations of these probes and wells are shown on the soil probe location diagram included in the Appendix.

Upon completion of the field activities, five of the probes were backfilled with granular bentonite, in general accordance with WDNR guidelines. The general location of the probes was determined by conventional taping procedures based on existing site features and is shown on the soil probe location diagram included in the Appendix. Soil probe abandonment forms are also included in the Appendix.

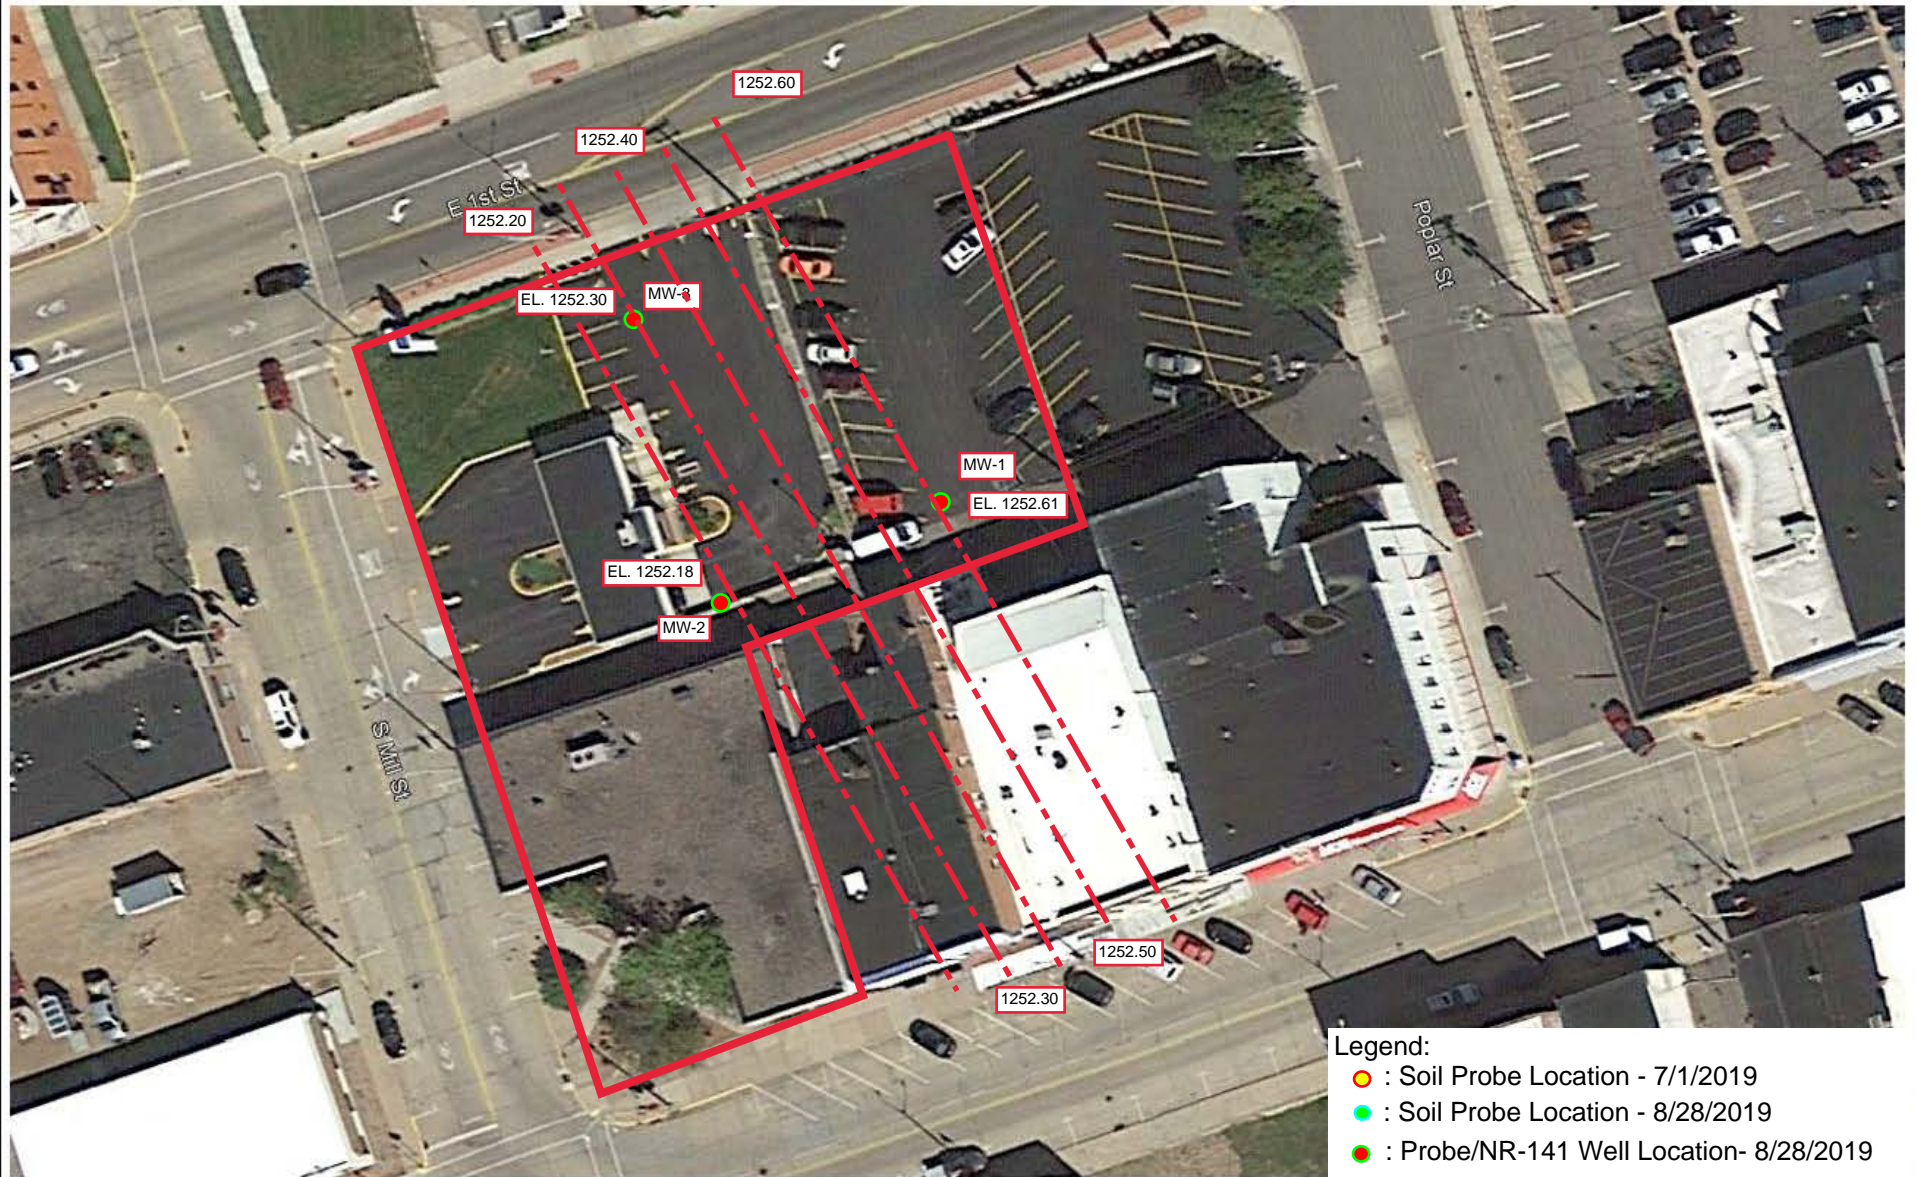
**GROUNDWATER FLOW DIRECTION DIAGRAM
PSI PROJECT No. 00541937**

Benchmark - fire hydrant on NW corner of First St and Mill St
(EL. 1265.3)

Legend:
● : Soil Probe Location - 7/1/2019
● : Soil Probe Location - 8/28/2019
● : Probe/NR-141 Well Location - 8/28/2019

The elevations of the top of the monitoring well PVC riser pipe of the wells were determined by PSI personnel using conventional leveling techniques. The elevations were referenced to the top of the right nut on the southeast corner of the square flange on the fire hydrant (H-035) located near the northwest corner of the intersection of E. First Street and Mill Street with an elevation of EL. 1265.38±, as provided by the City of Merrill. The groundwater levels were measured within the monitoring wells on August 28, 2019 at depths ranging from 3.23 to 5.66 feet below top of casing (EL. 1263.68± to EL. 1266.11±). These elevations are shown on the Groundwater Elevation Table included in the Appendix. No obvious odors or sheen were observed in the collected water samples.

Saturated soils were encountered at depths of about 11 to 12 feet below grade during probing activities. The groundwater levels were measured within the monitoring wells on August 28, 2019 at depths ranging from 11.07 to 13.81 feet below top of casing (EL. 1252.18± to EL. 1252.61±). No obvious evidence of contamination was present within the collected water samples. It should be noted that groundwater levels and gradients can fluctuate with seasonal precipitation and changes in lateral drainage patterns.

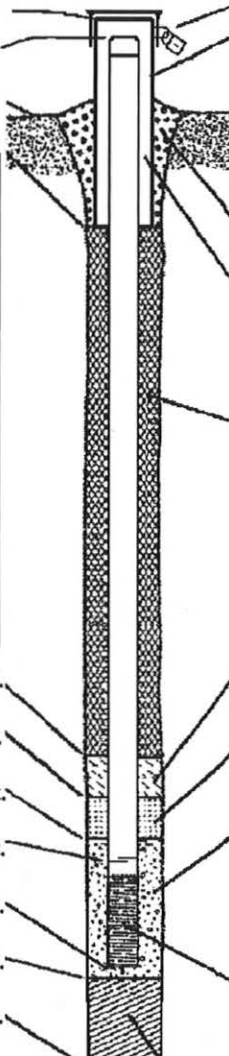
J. Filter pack, bottom _____ ft. MSL or 16 ft.	b. Manufacturer Johnson
K. Borehole, bottom _____ ft. MSL or 16 ft.	c. Slot size: 0.010 in.
L. Borehole, diameter 8 in.	d. Slotted length: 10 ft.

M. O.D. well casing 2.35 in.	11. Backfill material (below filter pack): None <input checked="" type="checkbox"/> 14 Other <input type="checkbox"/>
N. I.D. well casing 2 in.

On August 28, 2019, three groundwater monitoring wells were installed at three of the soil probe locations in general accordance with WDNR procedures set forth in Chapter NR141. The well construction consisted of a 10-foot section of 2-inch diameter, Schedule 40 PVC screen with 0.010 inch factory cut slots and 2-inch diameter Schedule 40 PVC flush threaded riser pipe extending to about 6 inches below the ground surface. A steel protective flush mount cover was placed over the top of each PVC riser pipe. Clean sand backfill was utilized as a filter medium around the screened PVC to a level about two feet above the top of the screened section. The sand backfill was placed into the annular space between the auger and PVC during progressive withdrawal of the auger. Bentonite chips filled the annular space above the sand filter. The well construction and other related details are shown on the Monitoring Well Construction Forms (Form 4400-113A), included in the Appendix.

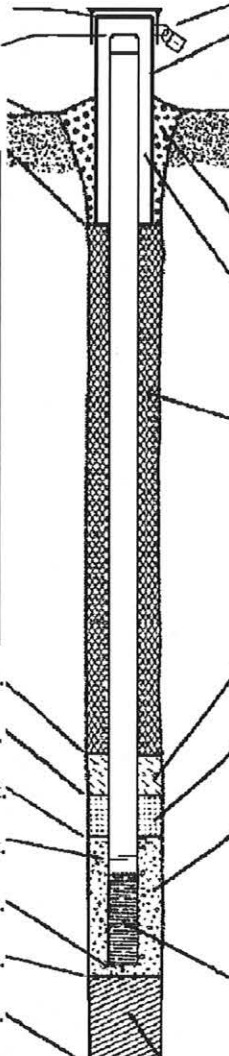
J. Filter pack, bottom _____ ft. MSL or _____ 16 ft.	
K. Borehole, bottom _____ ft. MSL or _____ 16 ft.	
L. Borehole, diameter _____ 8 in.	
M. O.D. well casing _____ 2.35 in.

N. I.D. well casing _____ 2 in.
