SUBJECT: Final Case Closure with Continuing Obligations  
BMO Harris Bank Branch Property  
900 East Main Street, Merrill, Wisconsin  
DNR BRRTS Activity #02-35-584409

**BMO Harris Bank Branch  
900 E. Main Street  
Merrill, Wisconsin 54452**

**(Maps, Figures, and Photos)**

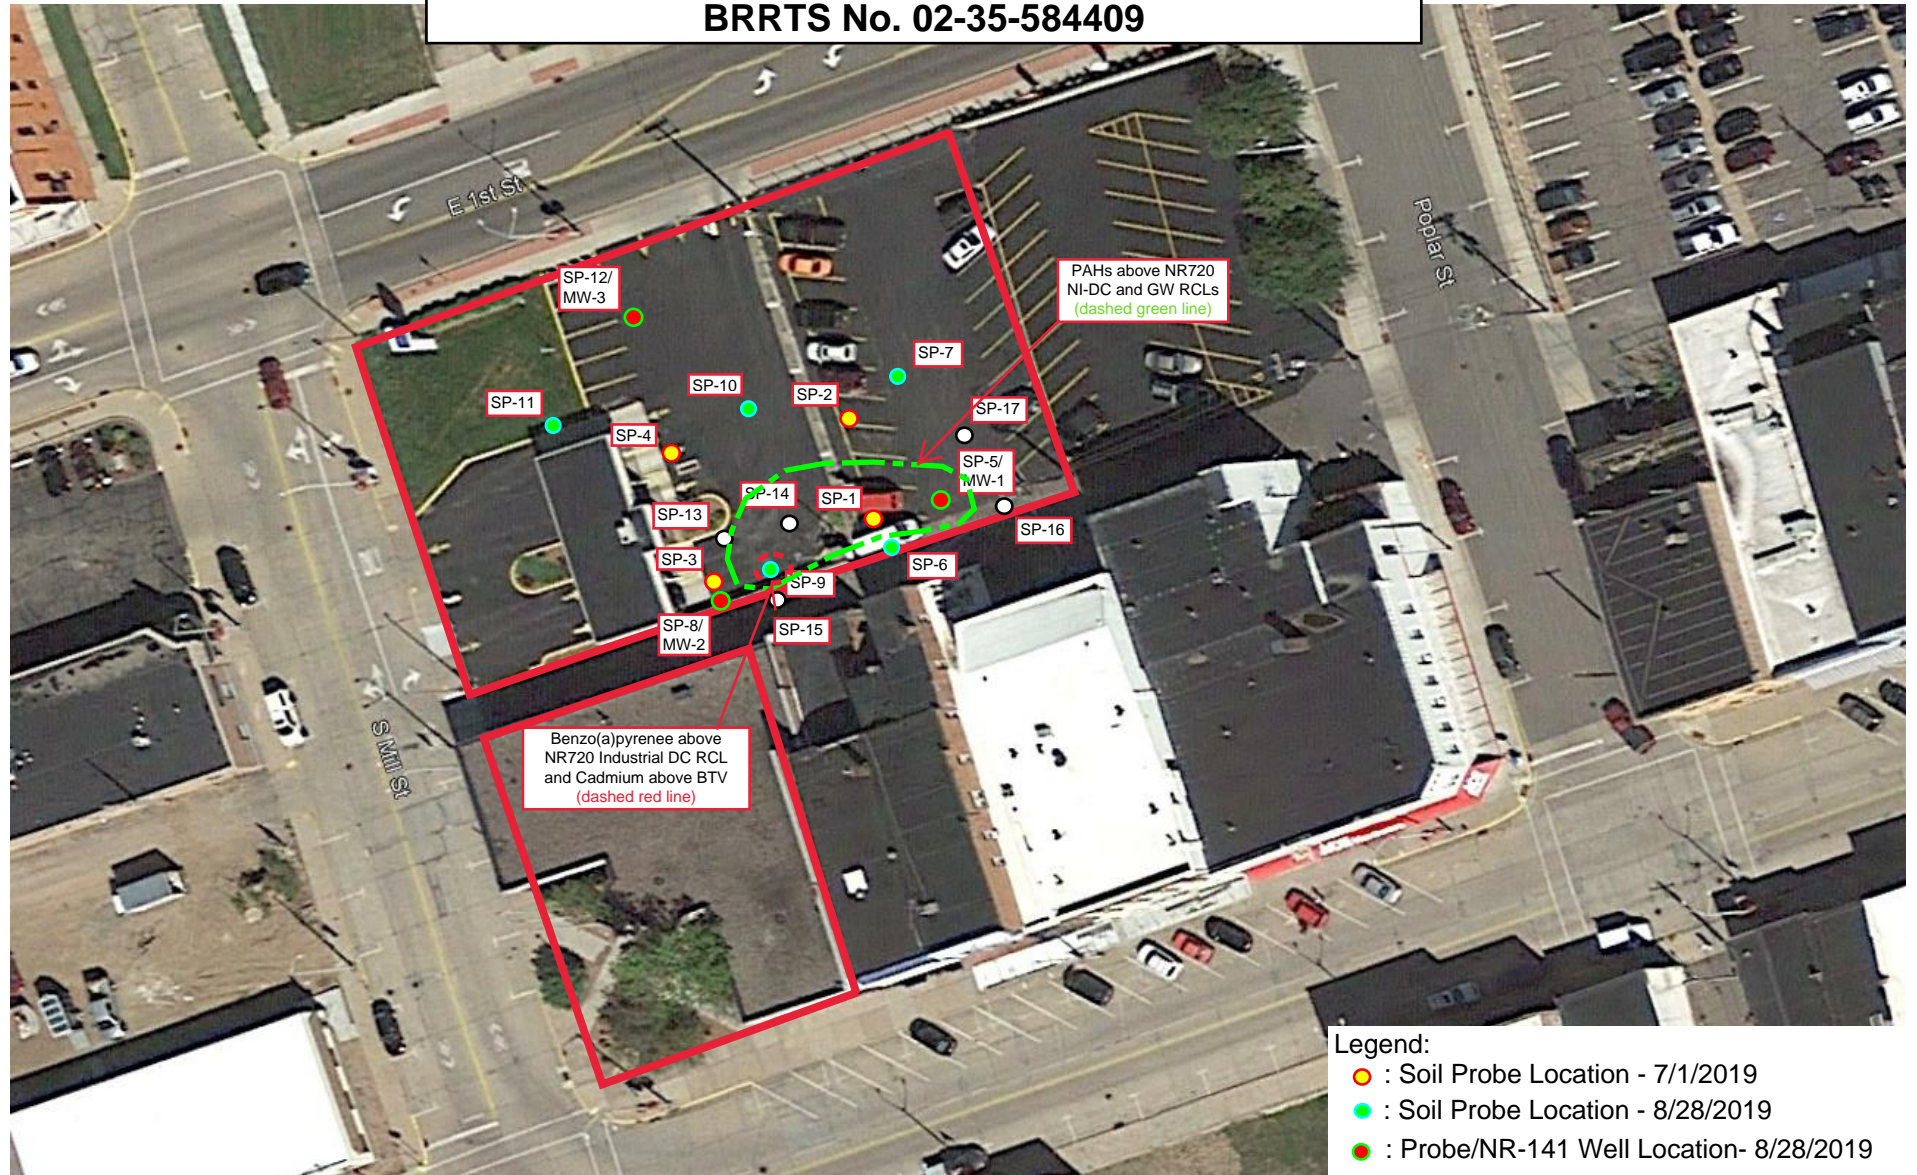
**B.2.a. SOIL CONTAMINATION  
BRRTS No. 02-35-584409**

Four (4) selected soil samples collected from the August 2019 soil probes (SP-1 through SP-4) were submitted for analytical testing. The selected samples collected from SP-1 and SP-2 (placed near the former auto repair facility) were tested for the presence of VOCs, PAHs and RCRA Metals. The selected samples collected from SP-3 and SP-4 (placed near the former dry cleaners/gasoline UST) were tested for the presence of VOCs. These samples were collected at intervals of 2 to 4 feet or 6 to 8 feet. Several RCRA Metals were detected in the selected soil samples collected from SP-1 and SP-2, but none of the detected concentrations were above current NR720 standards. The exception is a Cadmium concentration of 1.12 milligrams per kilograms (mg/kg), which is above its NR720 BTV of 1.0 mg/kg.

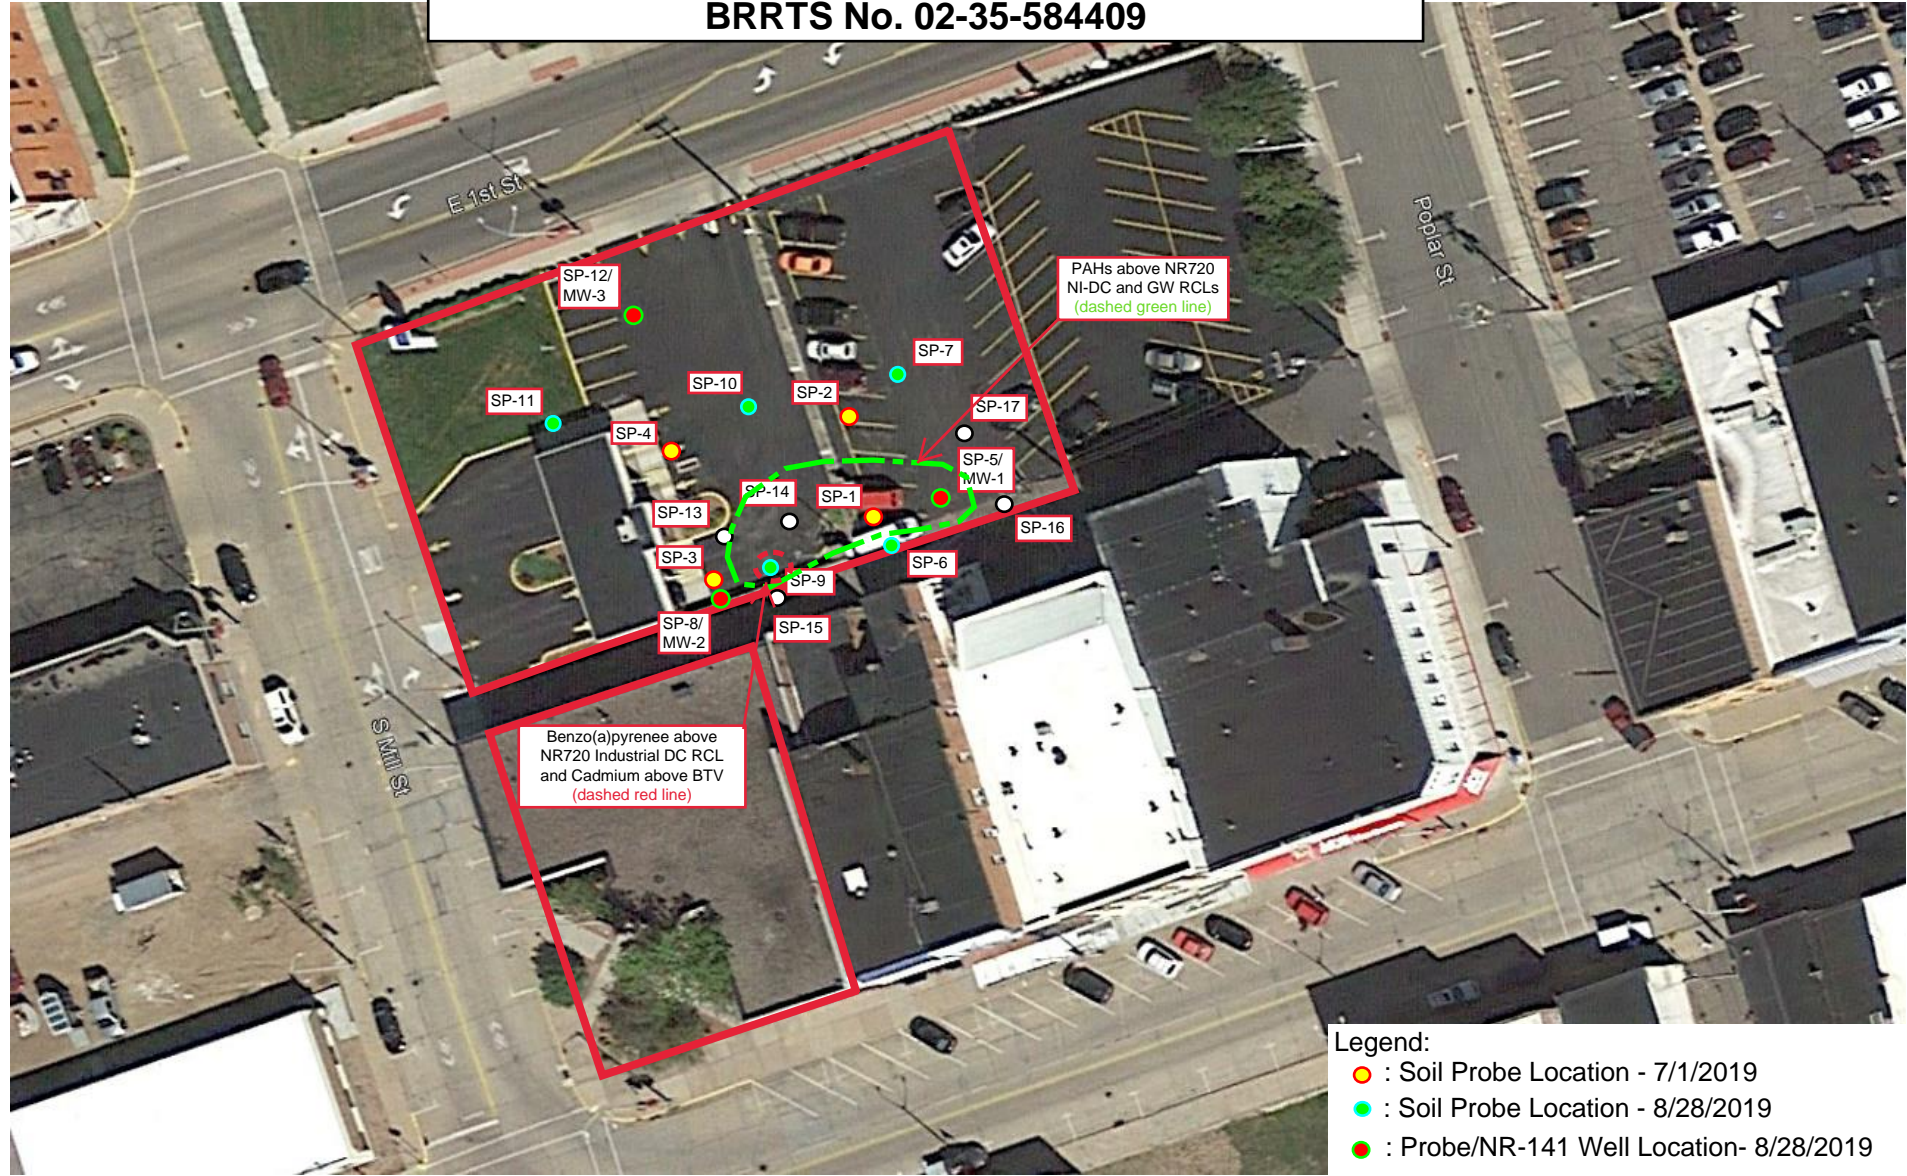
**B.2.B. RESIDUAL SOIL CONTAMINATION  
BRRTS No. 02-35-584409**

Benzo(a)pyrene above NR720 Industrial DC RCL and Cadmium above BTV (dashed red line)

PAHs above NR720 NI-DC and GW RCLs (dashed green line)

Soil contamination remains as indicated on the attached Figure B.2.B. Residual Soil Contamination, prepared by PSI and dated February 7, 2019. If soil in the specific locations described above is excavated in the future, the property owner or right-of-way holder at the time of excavation must sample and analyze the excavated soil to determine if contamination remains. If sampling confirms that contamination is present, the property owner or right-of-way holder at the time of excavation will need to determine whether the material is considered solid or hazardous waste and ensure that any storage, treatment or disposal is in compliance with applicable standards and rules. Contaminated soil may be managed in accordance with ch. NR 718, Wis. Admin. Code, with prior DNR approval.

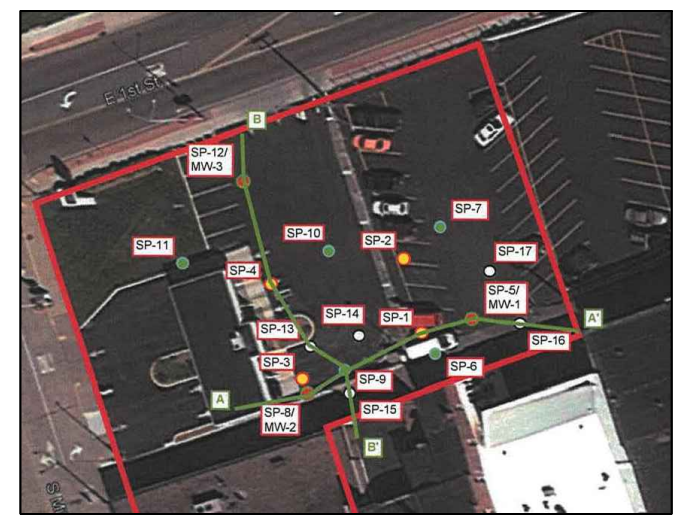
<b>Environmental Services</b> 821 Corporate Court Waukesha, Wisconsin 53189 (262) 521-2125 (262) 521-2471 fax	<b>Geologic Cross-Section B-B'</b> BMO Harris Bank 900 E. Main Street Merrill, Wisconsin 54452	Checked: P. Patterson	Scale: See Figure	Date: Dec 9, 2019	Figure: <b>2</b>
			Drawn: C. Moran <small>00541993-1 x-sect.dwg</small>	Project Number: <b>00541993</b>

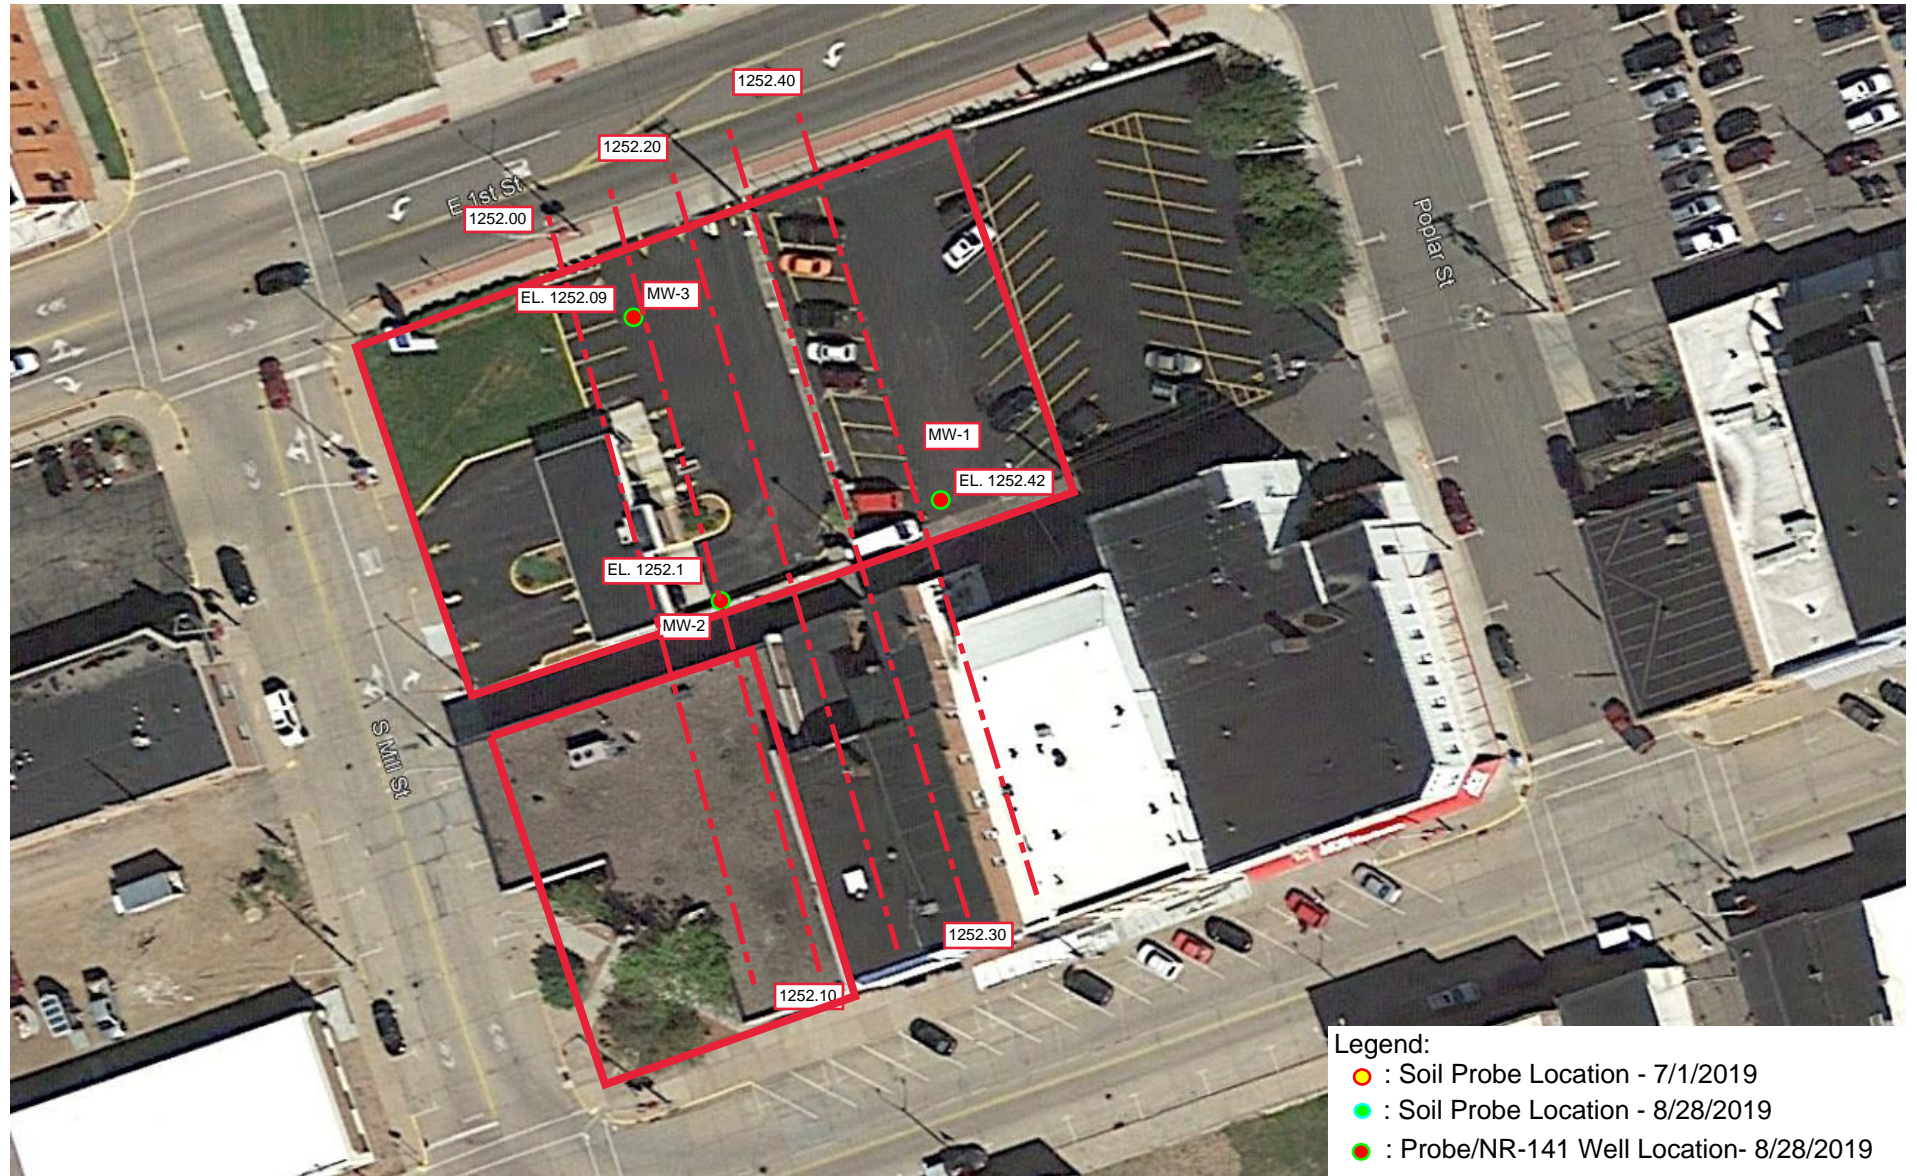
**GROUNDWATER FLOW DIRECTION DIAGRAM  
BRRTS No. 02-35-584409**

- ii. Discuss groundwater flow direction(s), shallow and deep. Describe and explain flow variations, including fracture flow if present.  
The shallow groundwater flow is generally to the west/southwest towards the Prairie and Wisconsin Rivers. The piezometric groundwater flow direction was not determined as part of these investigative activities.

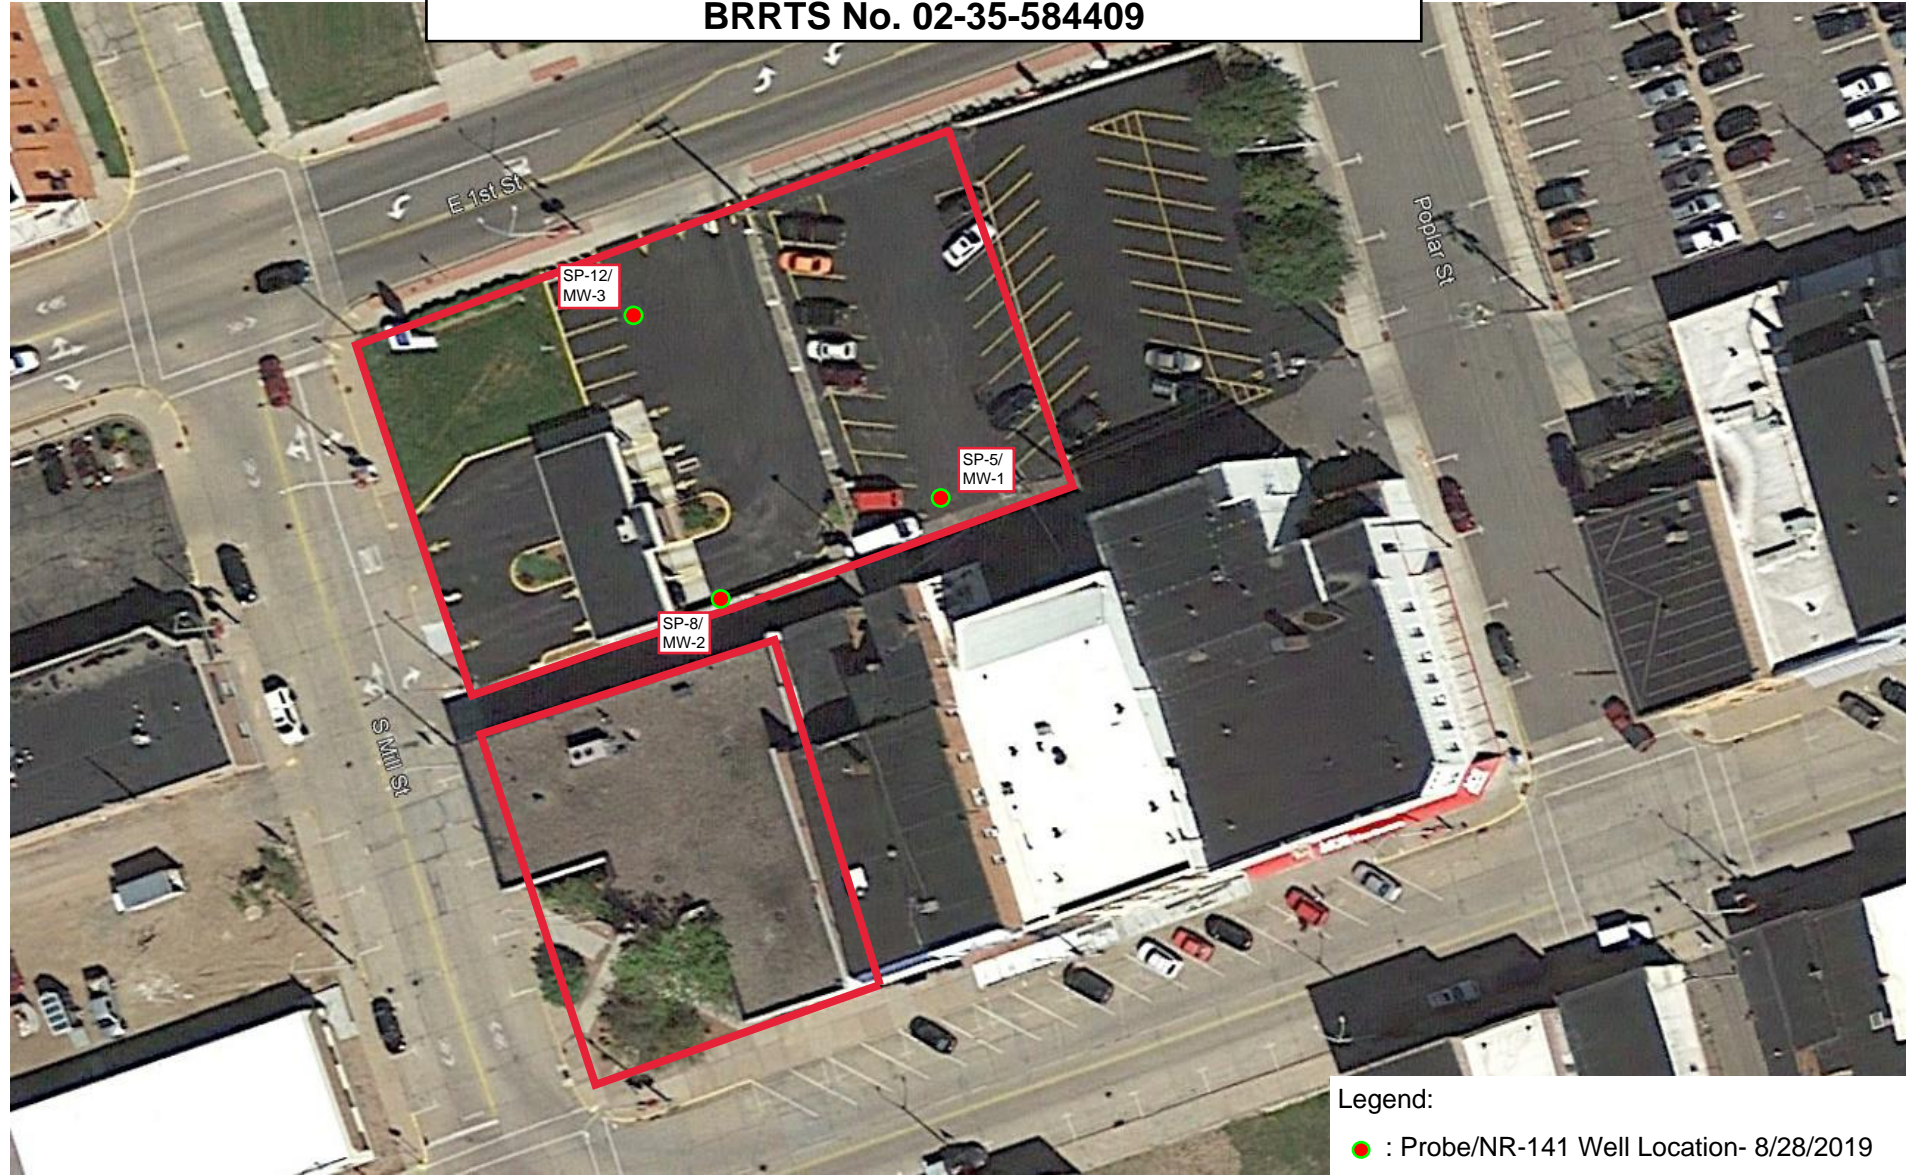
**B.2.d. MONITORING WELLS  
BRRTS No. 02-35-584409**

**Legend:**  
● : Probe/NR-141 Well Location- 8/28/2019  
 : Wells proposed to be abandoned

- No monitoring wells were installed as part of this response action.
- All monitoring wells have been located and will be properly abandoned upon the DNR granting conditional closure to the site

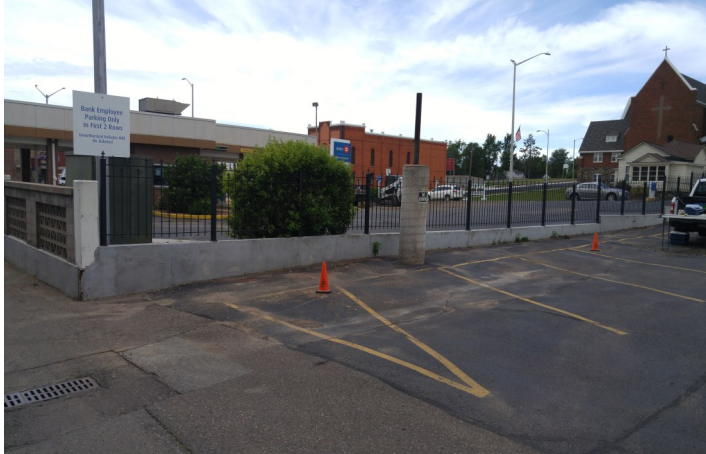
1. Photograph shows highway cones placed at the locations of SP-1 (left) and SP-2 (right) and the surrounding asphalt pavement and small retaining walls associated with the Subject Property. The photograph is taken facing to the west from the alleyway.

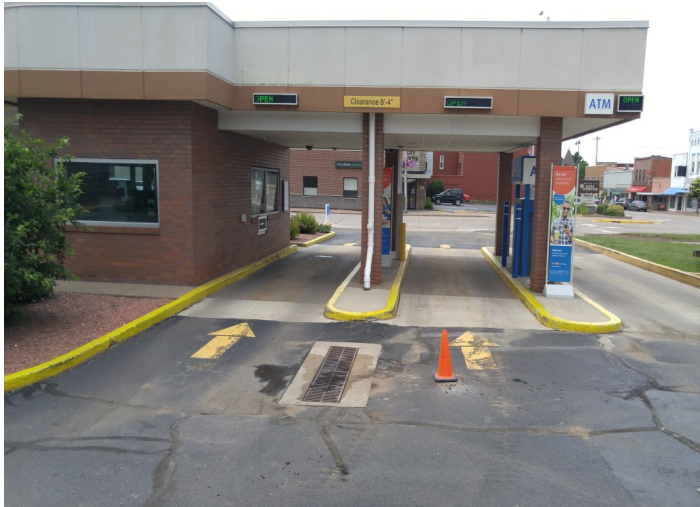
2. Photograph shows the northern drive-thru lines of the service window building associated with the BMO Harris Bank parcel. The highway cone shows the location of SP-4. A stormwater drain is located south of SP-4. SP-11 was placed in the grass area shown on the right side of the photograph. Photograph taken facing to the west.

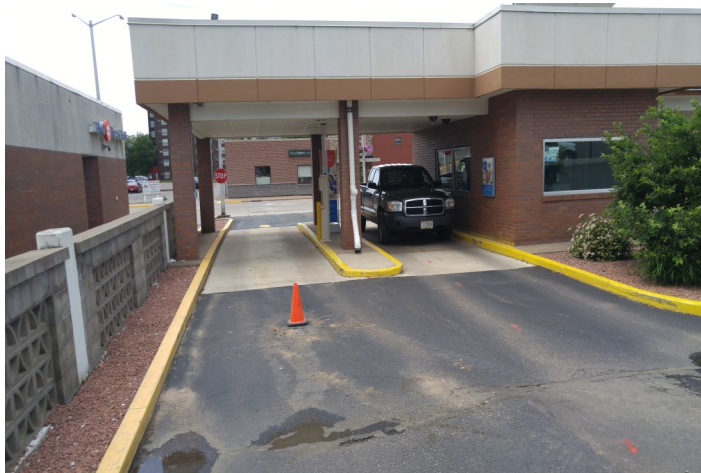
3. Photograph shows the southern drive-thru lines of the service window building and the highway cone is placed over SP-3. The photograph also shows the retaining wall along the alleyway and the asphalt and concrete pavement associated with the bank parcel.

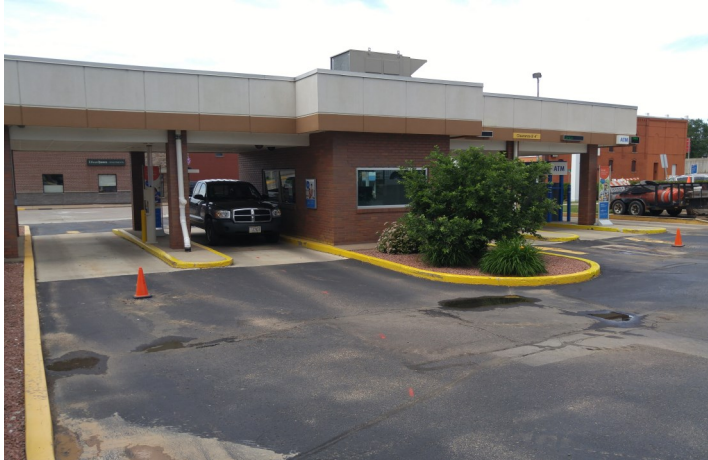
4. Photograph shows the drive-thru window building and SP-3 (left) and SP-4 (right).

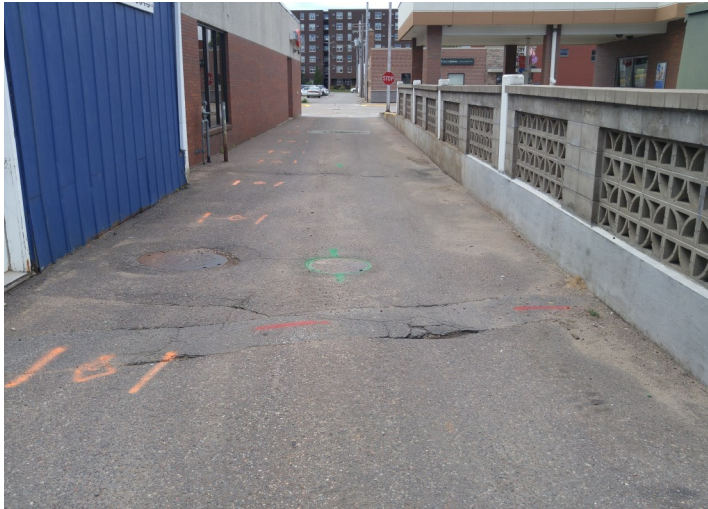
5. Photograph shows the alleyway and is taken facing to the west.

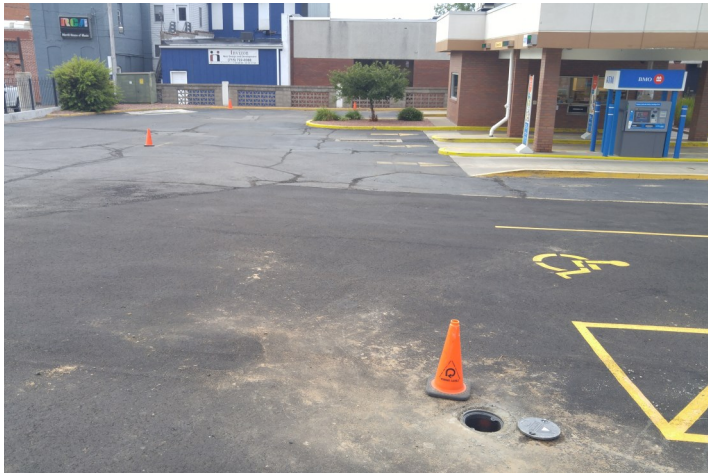
6. Photograph taken for near the northern property line and facing to the south. The photograph shows SP-12/MW-3 (in foreground), SP-10 (in the near background), and SP-9 (background left) and SP-8/MW-2 (background right). The photograph also shows the asphalt and concrete pavement associated with the bank parcel.

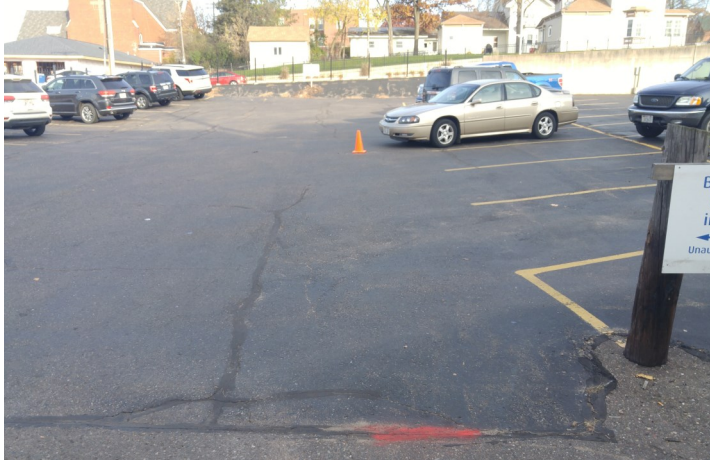
7. Photograph taken from the alleyway and facing to the north and shows the northeastern portion of the asphalt parking lot area. The highway cone is over SP-17 and SP-7 would be to the northwest of SP-17.

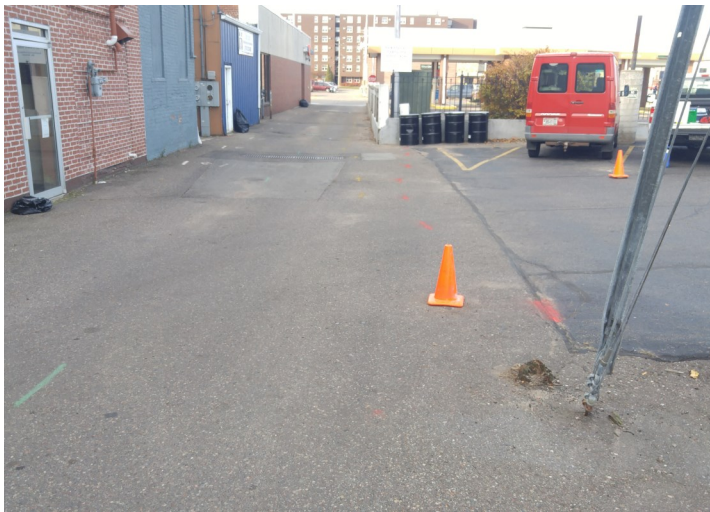
8. Photograph shows the alleyway from east to west. The near highway cone is over SP-16, while the farther cone is near SP-5/MW-1. The drums are associated with the installation and sampling of the wells.

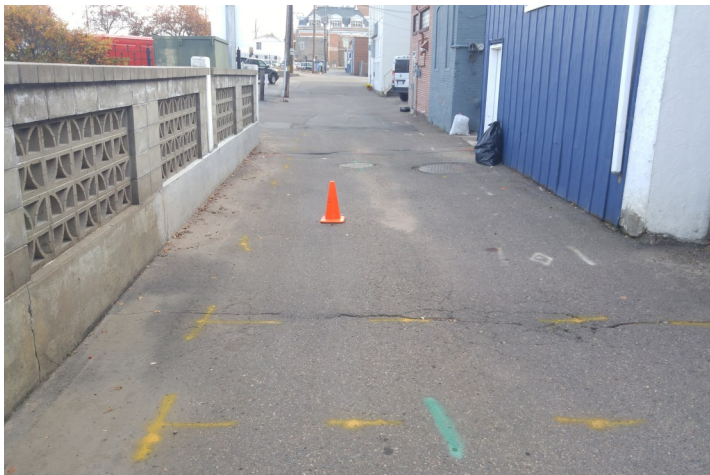
9. Photograph shows the alleyway facing to the east from near the west end and the retaining wall present along the north side of the alley. The highway cone is over SP-9.

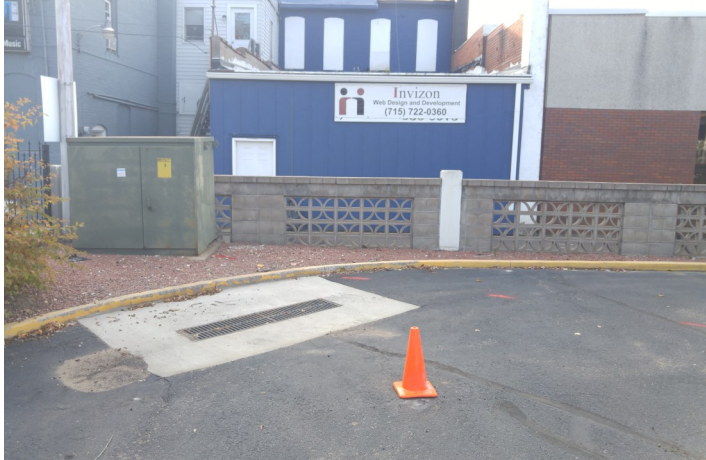
10. Photograph shows a highway cone over SP-14 and a stormwater drain.

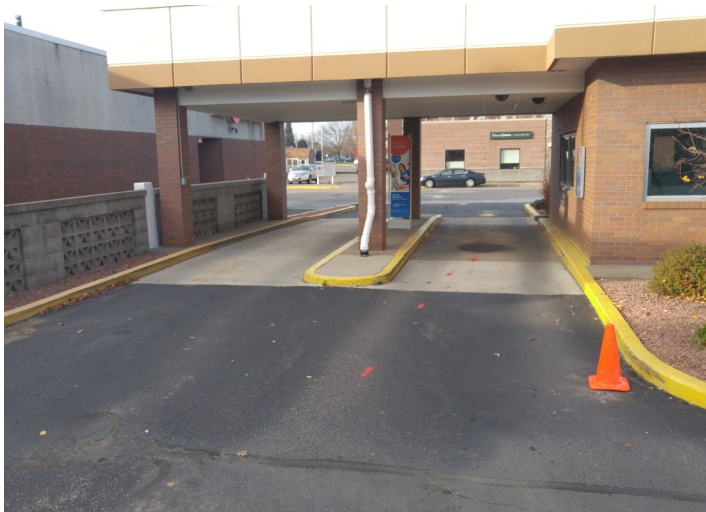
11. Photograph shows a highway cone over SP-13.

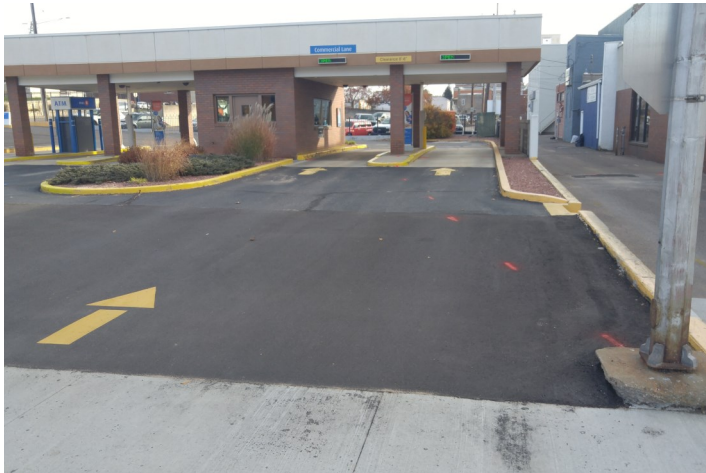
12. Photograph shows the western side of the drive-thru window building and the alleyway (right side of photo). Photograph also shows asphalt and concrete pavement associated with the bank parcel.

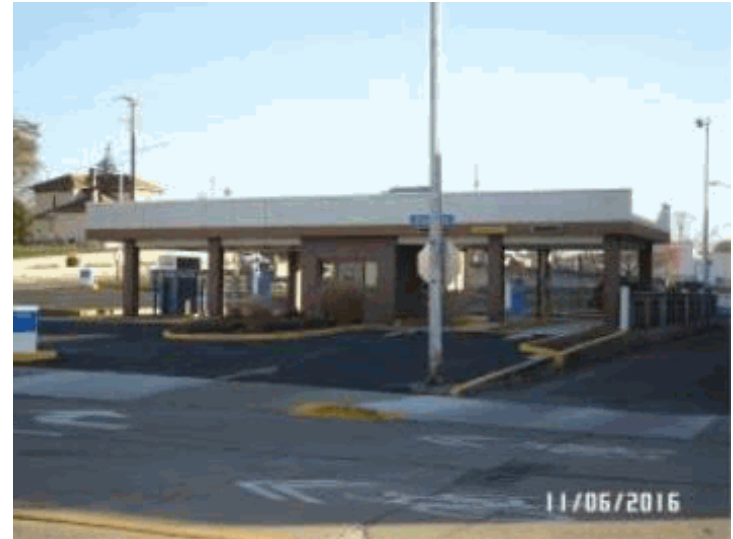
Commercial Building (BMO Harris Bank - Drive-Up)

Section name: Section 1  
 Year built: 1970  
 % complete: 100%  
 Stories: 1.00  
 Perimeter: 68 LF  
 Total area: 240 SF (all stories)

Occupancies	Designed Use	Actual Use	Units	Area per Unit	Construction Class	Avg Ht	Quality	CDU
	Mini-bank	Bank/Savings Institution	1	240	Masonry bearing walls	10.00	C (AV)	Average

Exterior walls HVAC	Component Description	Count	Stops	Area (sf)	Area (%)	Quality
	Brick with Block Back-up			240	100.0%	C (AV)
Package unit			240	100.0%	C (AV)

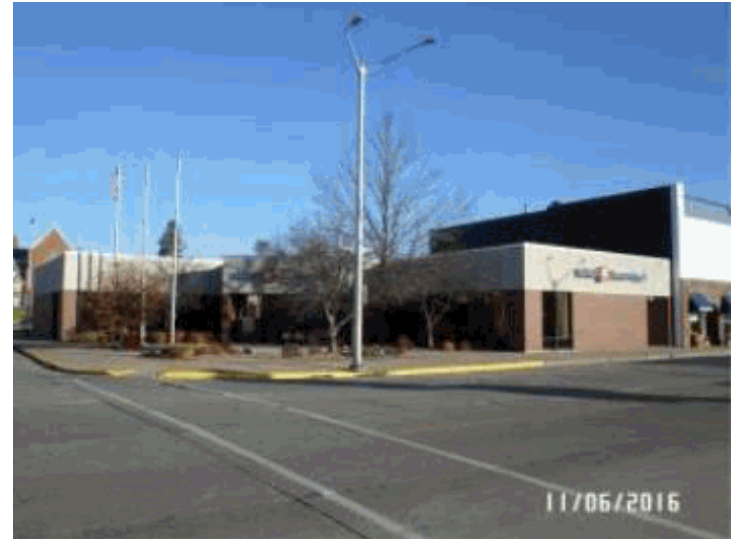
Commercial Building (BMO Harris Bank)

Section name: Section 1  
 Year built: 1979  
 % complete: 100%  
 Stories: 1.00  
 Perimeter: 428 LF  
 Total area: 8,464 SF (all stories)

Occupancies	Designed Use	Actual Use	Units	Area per Unit	Construction Class	Avg Ht	Quality	CDU
	Bank	Bank/Savings Institution	1	8,464	Masonry bearing walls	14.00	C (AV)	Average

Exterior walls	Component Description		Count	Stops	Area (sf)	Area (%)	Quality
	Brick, Solid				6,771	80.0%	C (AV)
Concrete Block, Textured Face				1,693	20.0%	C (AV)	
HVAC	Package unit				8,464	100.0%	C (AV)
