SUBJECT: Case Closure with Continuing Obligations
Neighborhood Cleaners (Former), 2702 North Richmond Street, Appleton, Wisconsin
DNR BRRTS Activity # 02-45-585245

The Neighborhood Cleaners (Former) site, as shown on the attached maps (Figure B.1.b.1, Former Site Plan, Sept 2021 and B.1.b.2, Current Detailed Site Map, Sept 2021), was investigated for a discharge of hazardous substances and/or environmental pollution in the area of the former dry cleaning business that was located in the northeastern portion of the site. Contamination from the former dry cleaning machine is located within the area of the northeast corner of the Aldi grocery store. Case closure is granted for the volatile organic compound (VOC) contamination investigated in soil and groundwater, and chlorinated volatile organic compound (CVOC) contamination investigated in vapor as documented in the case file. The remedial action consisted of excavation of approximately 1,000 tons of chlorinated volatile organic compound (CVOC) contaminated soils and disposal at

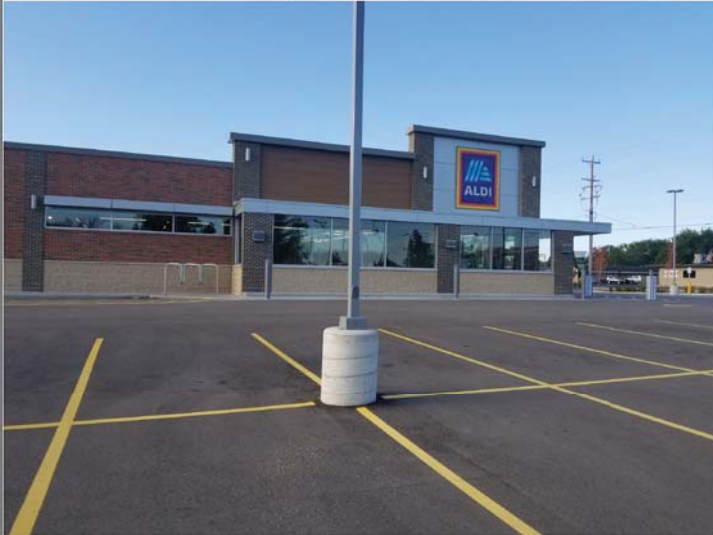
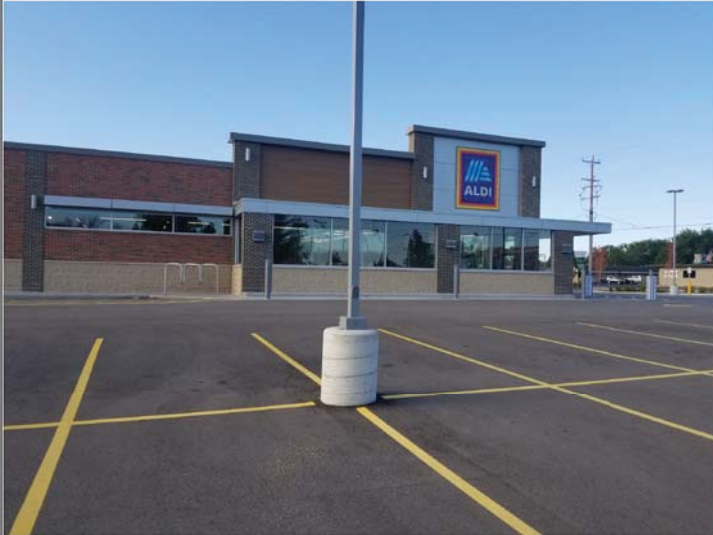
Title: View southwest toward northwest corner of Aldi.

Photographs including the condition and extent of the cover/barrier/building/slab at the time of the preparation of this cap maintenance plan are including in D.4.

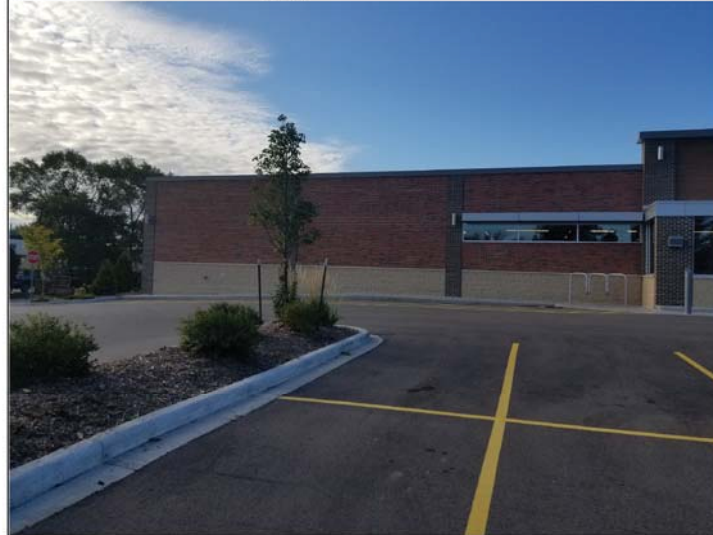
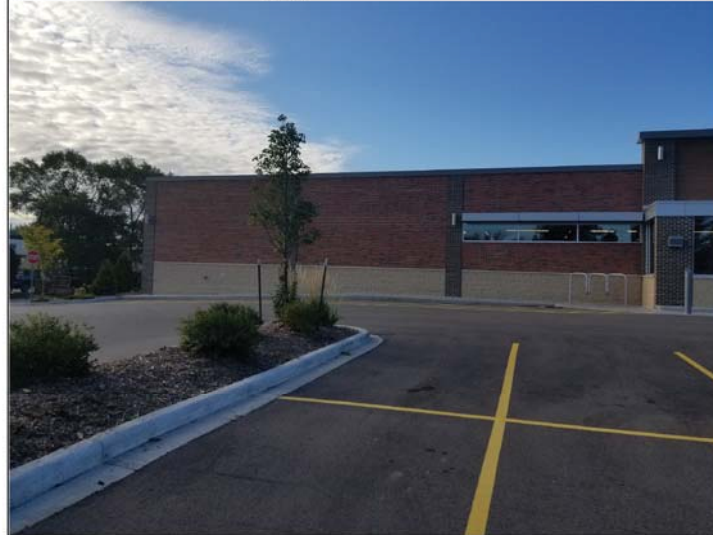
Title: View south toward northeast corner of Aldi.

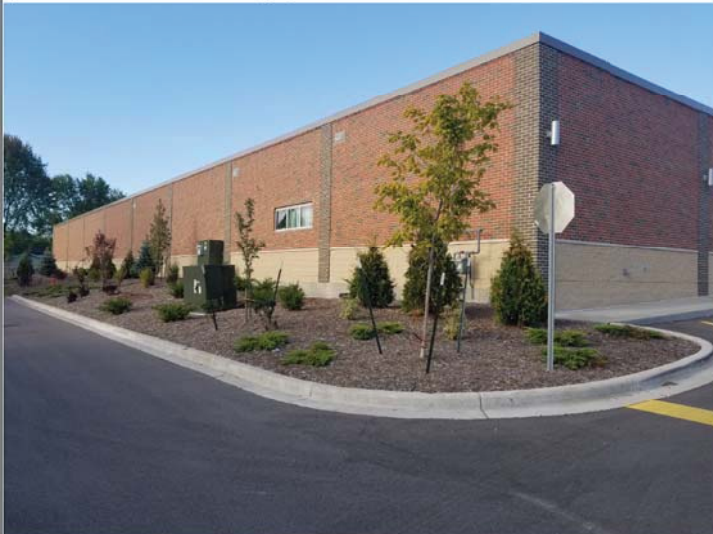
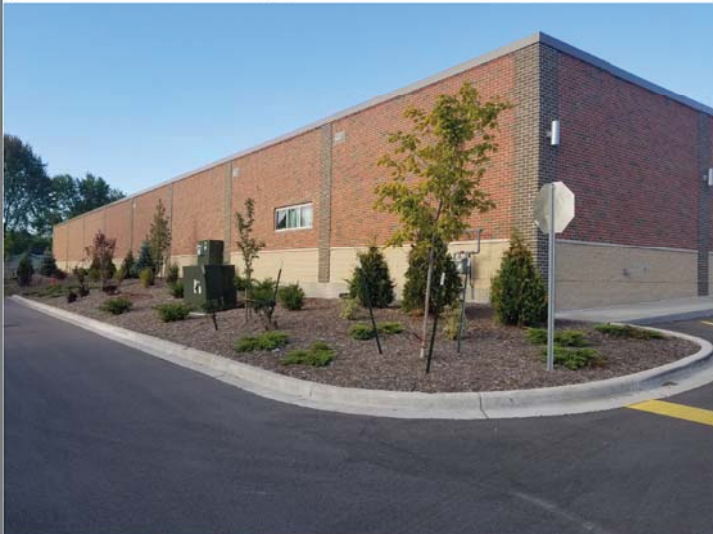
Title: View southwest toward northeast corner of Aldi.

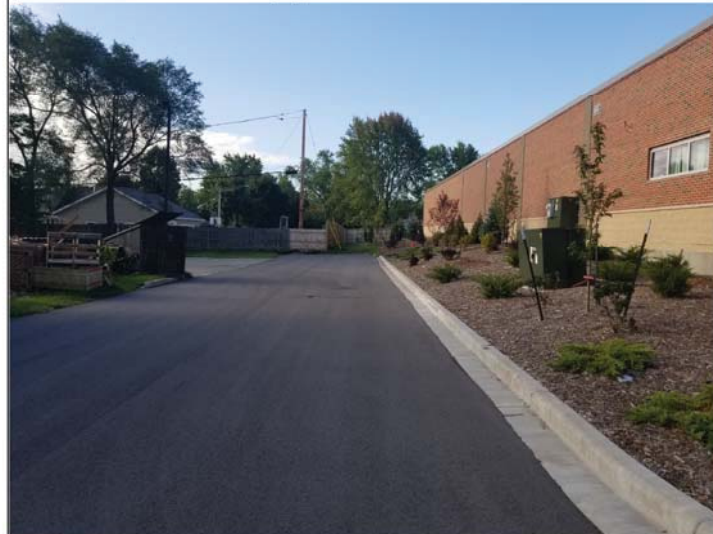
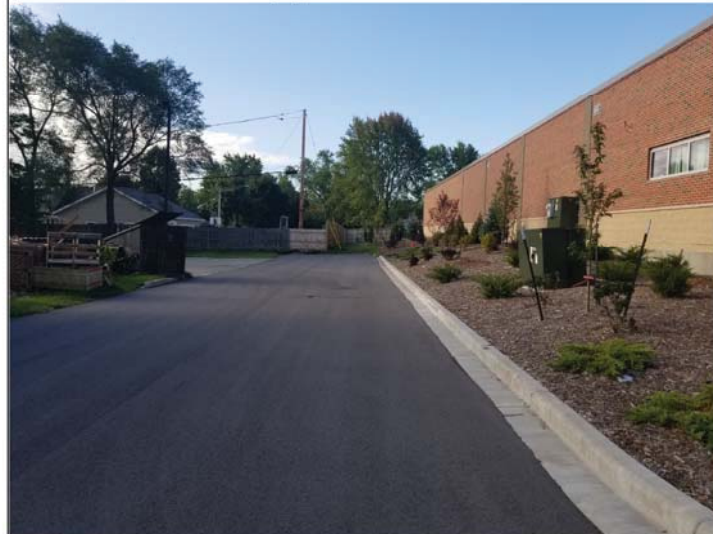
Title: View south down access drive between Play It Again Sports and Aldi.
