From: Jeffrey Howard Danko <jeffrey.howard.danko@jci.com>
Sent: Tuesday, January 21, 2020 1:11 PM
To: Joslin, Richard R - DNR
Cc: Neste, David E - DNR; Chronert, Roxanne N - DNR
Subject: RE: Additional Questions / Documentation for JCI Spills (SERTS #s 20190925NE38-1; 20191015NE38-1; and 20191108NE38-1)

RE: Spill Report for October 14, 2019 Event
Tyco Fire Products LP Facility
2700 Industrial Parkway
Marinette, WI
SERTS ID: 20191015NE38-1

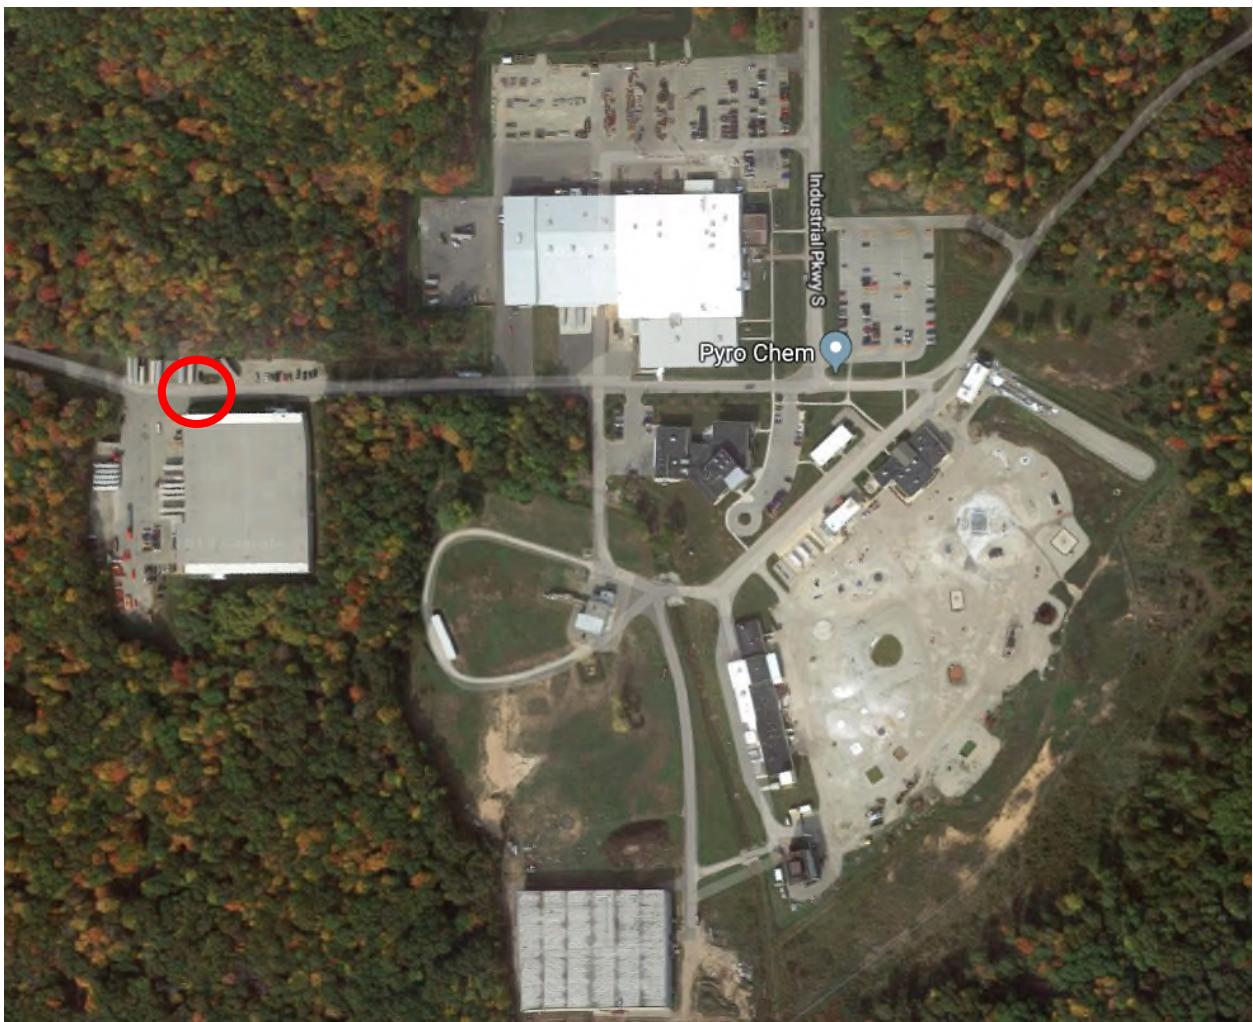
Site Figure showing location of foam/water release at 2700 Industrial Parkway South, Marinette, WI.

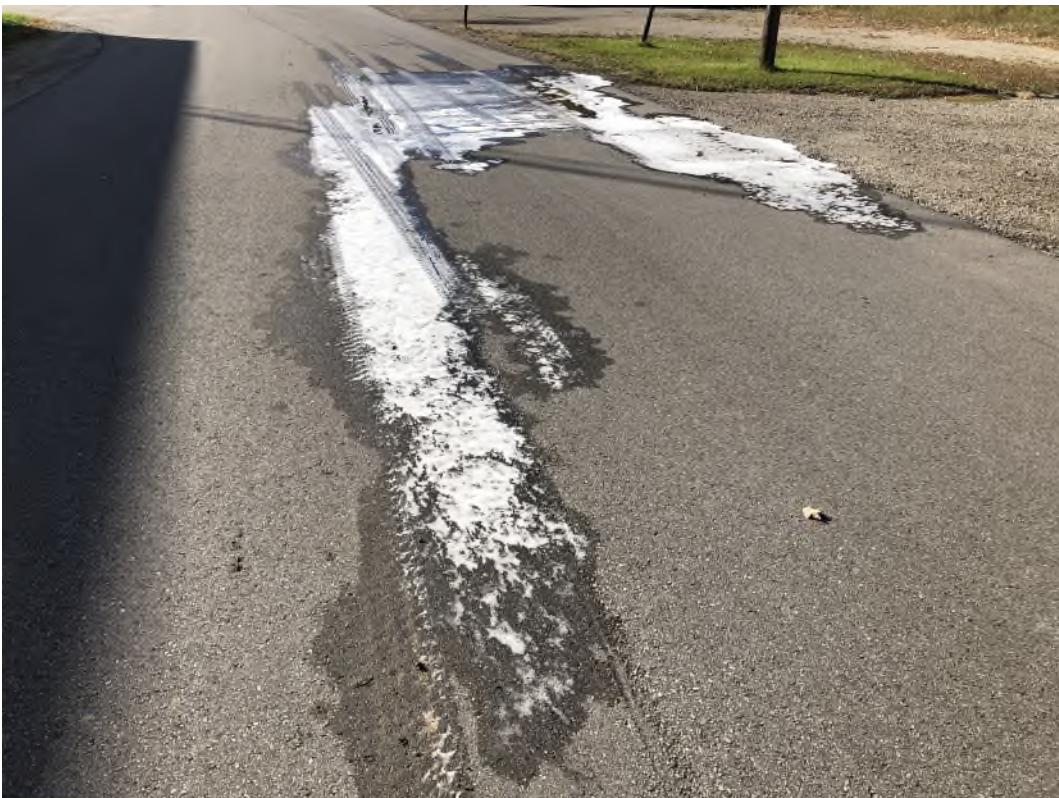
In the afternoon of October 15, 2019, a tanker filled with foam/water solution for eventual offsite disposal was being transferred to a staging area within the facility. Unknown to the technician that filled the tank or the driver, the top hatch of the tanker was not fully secured. During the transfer, the truck stopped at stop sign internal to the property and the solution splashed out of the hatch, with material released onto the tanker and asphalt road. A small portion of the material drained to a nearby grass and gravel area. The asphalt road was wiped clean using absorbent spill pads, water in the grassy area was captured using absorbent spill pads and the gravel were removed for disposal. The actual quantity of material released is unknown, but is estimated at no more than 30 gallons. Spill containment materials were placed under the tanker to capture any residual material dripping off the tanker. The captured water, gravel, and spent spill containment equipment were properly disposed.

Figure showing extent of foam/water release at 2700 Industrial Parkway South, Marinette, WI

Spill containment equipment was deployed after the release. The asphalt road was cleaned, water was removed from the grassy area and the gravel was removed. Spill containment equipment was deployed under the tanker to capture any residual material dripping from the tanker sides.

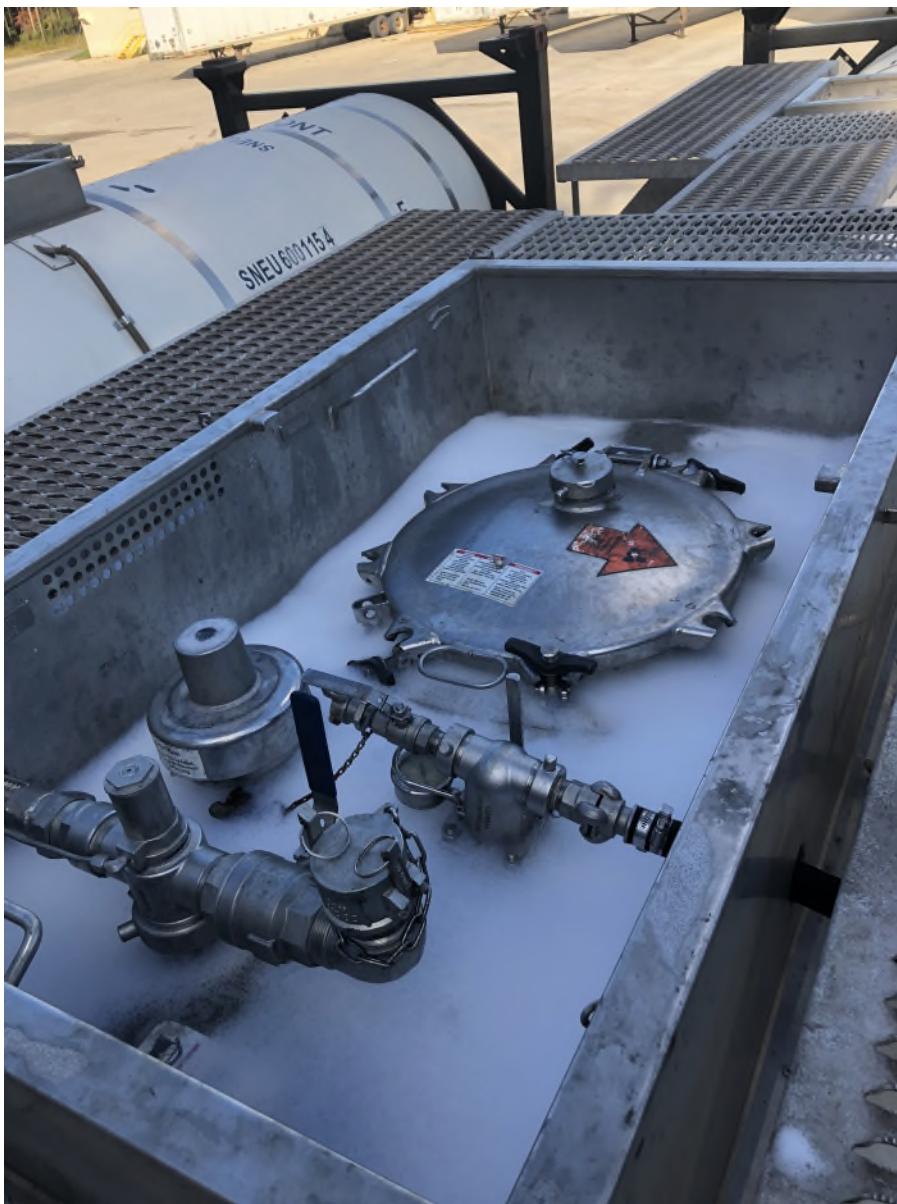
The hatch on the top of the tanker was not properly secured. These hatches are not operated on site at any time, so the hatch was likely left open when the tanker was initially brought on site. During transfer of the filled tanker to the staging area, the mixture splashed out of the unsecured hatch while the transfer truck stopped at a site stop sign.

Figure showing top hatch of trailer.

Technicians will inspect the tanker hatches to confirm the hatches are secure prior to filling the tanker. If the hatches are found to not be secured, they will not be filled until the hatch is confirmed to be closed. Tyco is additionally evaluating other control measures to prevent recurrence.
