Re: NR 716 Site Investigation Work Plan  
**BMO HARRIS BANK BRANCH**  
125 S. Chestnut Avenue  
Green Bay, Wisconsin  
**WDNR BRRTS No. 02-05-585287**  
PSI Project No.: 00542126

**NR 716 SITE INVESTIGATION WORK PLAN**

**BMO HARRIS BANK BRANCH  
125 S. Chestnut Avenue, Green Bay  
Brown County, Wisconsin  
WDNR BRRTS No. 02-05-585287**

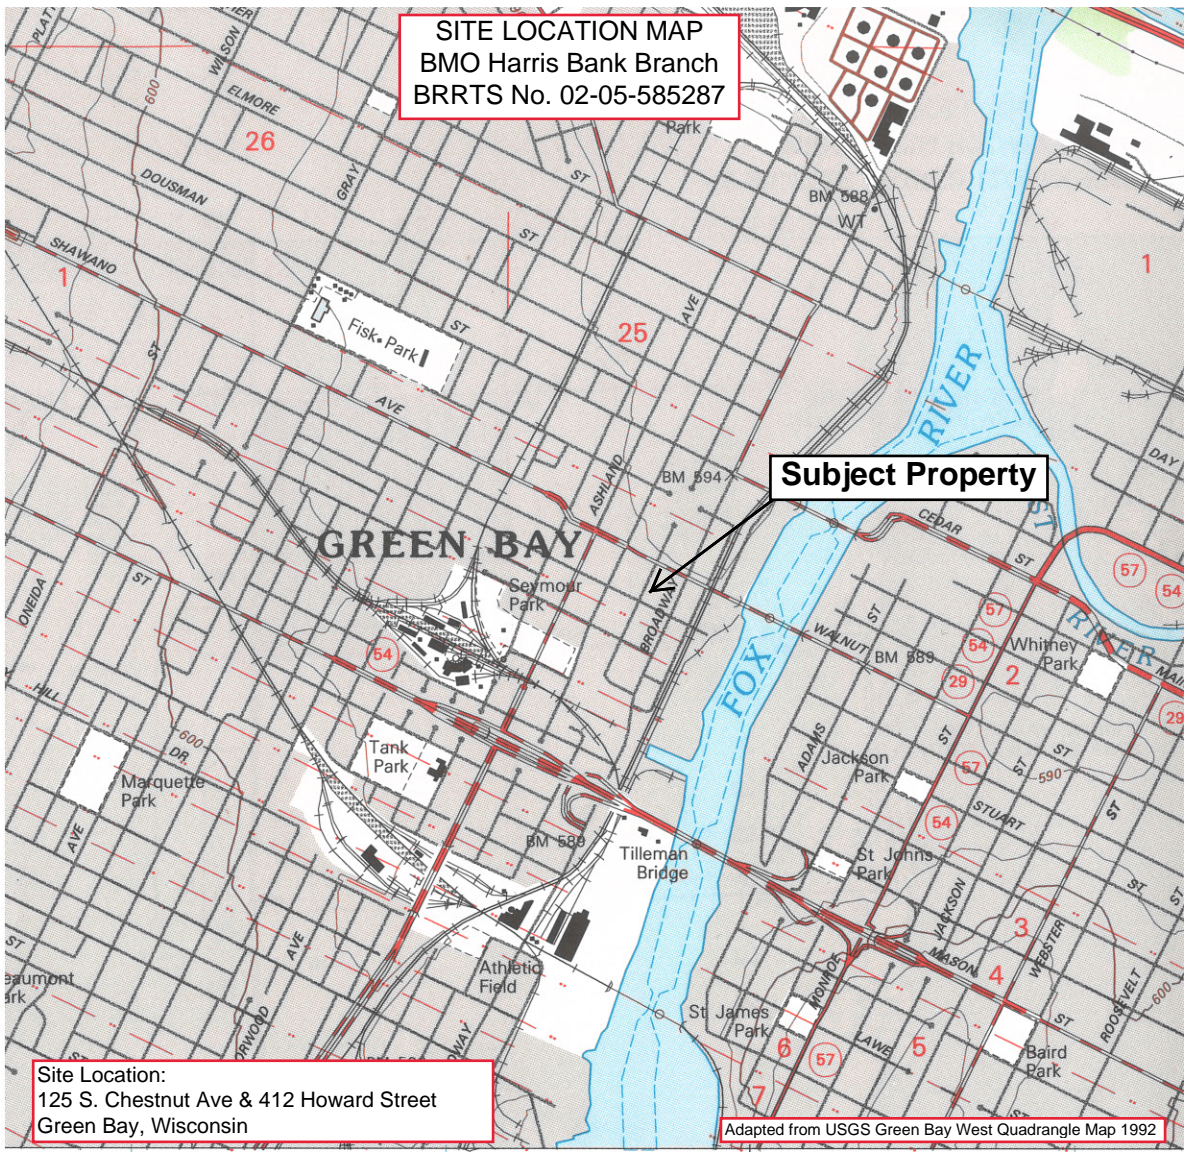
**SITE LOCATION MAP**  
**BMO Harris Bank Branch**  
**BRRTS No. 02-05-585287**

**Site Location:**  
 125 S. Chestnut Ave & 412 Howard Street  
 Green Bay, Wisconsin

Adapted from USGS Green Bay West Quadrangle Map 1992

PSI reviewed the United States Geological Survey (USGS) Green Bay West Quadrangle Map, dated 1992, showing the area of the Subject Property. According to the contour lines on the topographic map, it is located at approximately 590 feet above mean sea level (MSL). The contour lines around the Project Area indicate that the area is generally flat with a slight slope to the east. The nearest water body is the Fox River to the east. The site location is shown on the Site Location Map included in the Appendix.

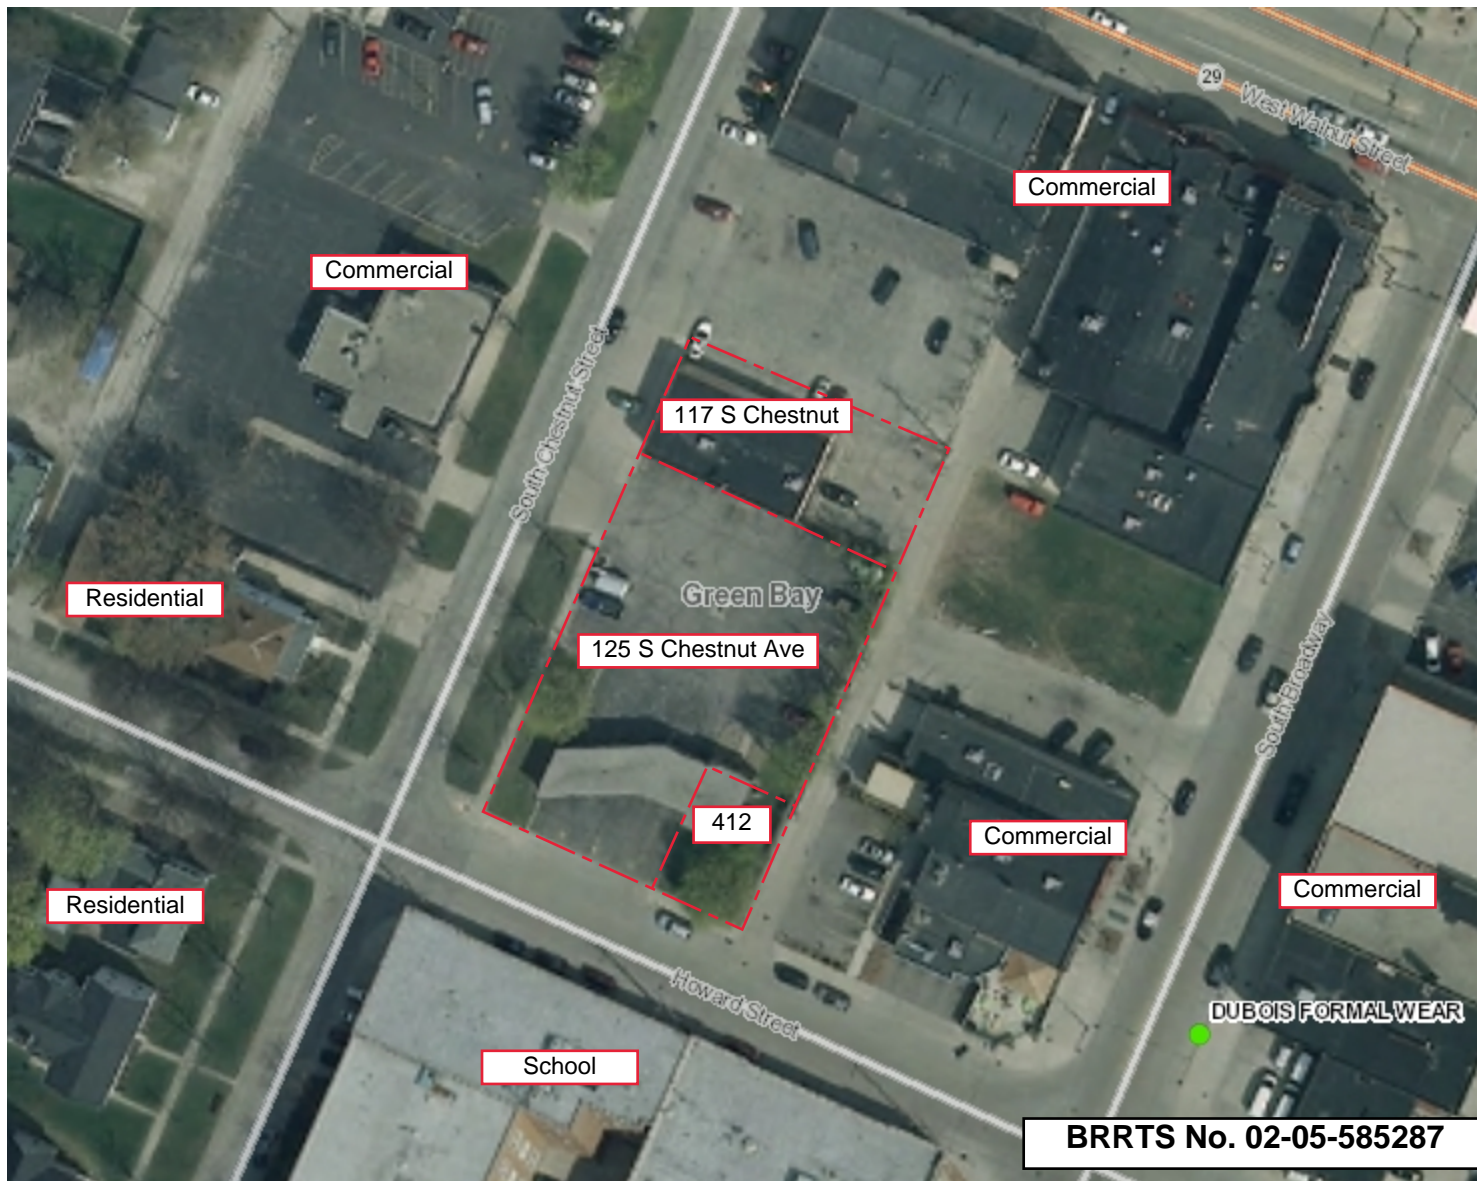
# SITE FEATURES DIAGRAM

117 & 125 S. Chestnut Avenue  
 (3-100 & 3-101)  
 412 Howard Street (3-325)

The Subject Property is geographically located in the Northeast  $\frac{1}{4}$  of the Northwest  $\frac{1}{4}$  of Section 36, in Township 24 North, Range 20 East, in the City of Green Bay, Brown County, State of Wisconsin. The location of the BMO Harris Bank Branch parcel is depicted on the attached Site Location Map. The general location of the Subject Property is shown on the Site Features Diagram, included herein.

The surrounding properties are generally occupied by commercial and residential properties and a school building. The Fox River is situated about 700 feet to the east of the Subject Property and flows to the north into Green Bay. The general location of the Subject Property is shown on the Site Location Map in the Appendix. A diagram showing the general site features is also included in the Appendix.

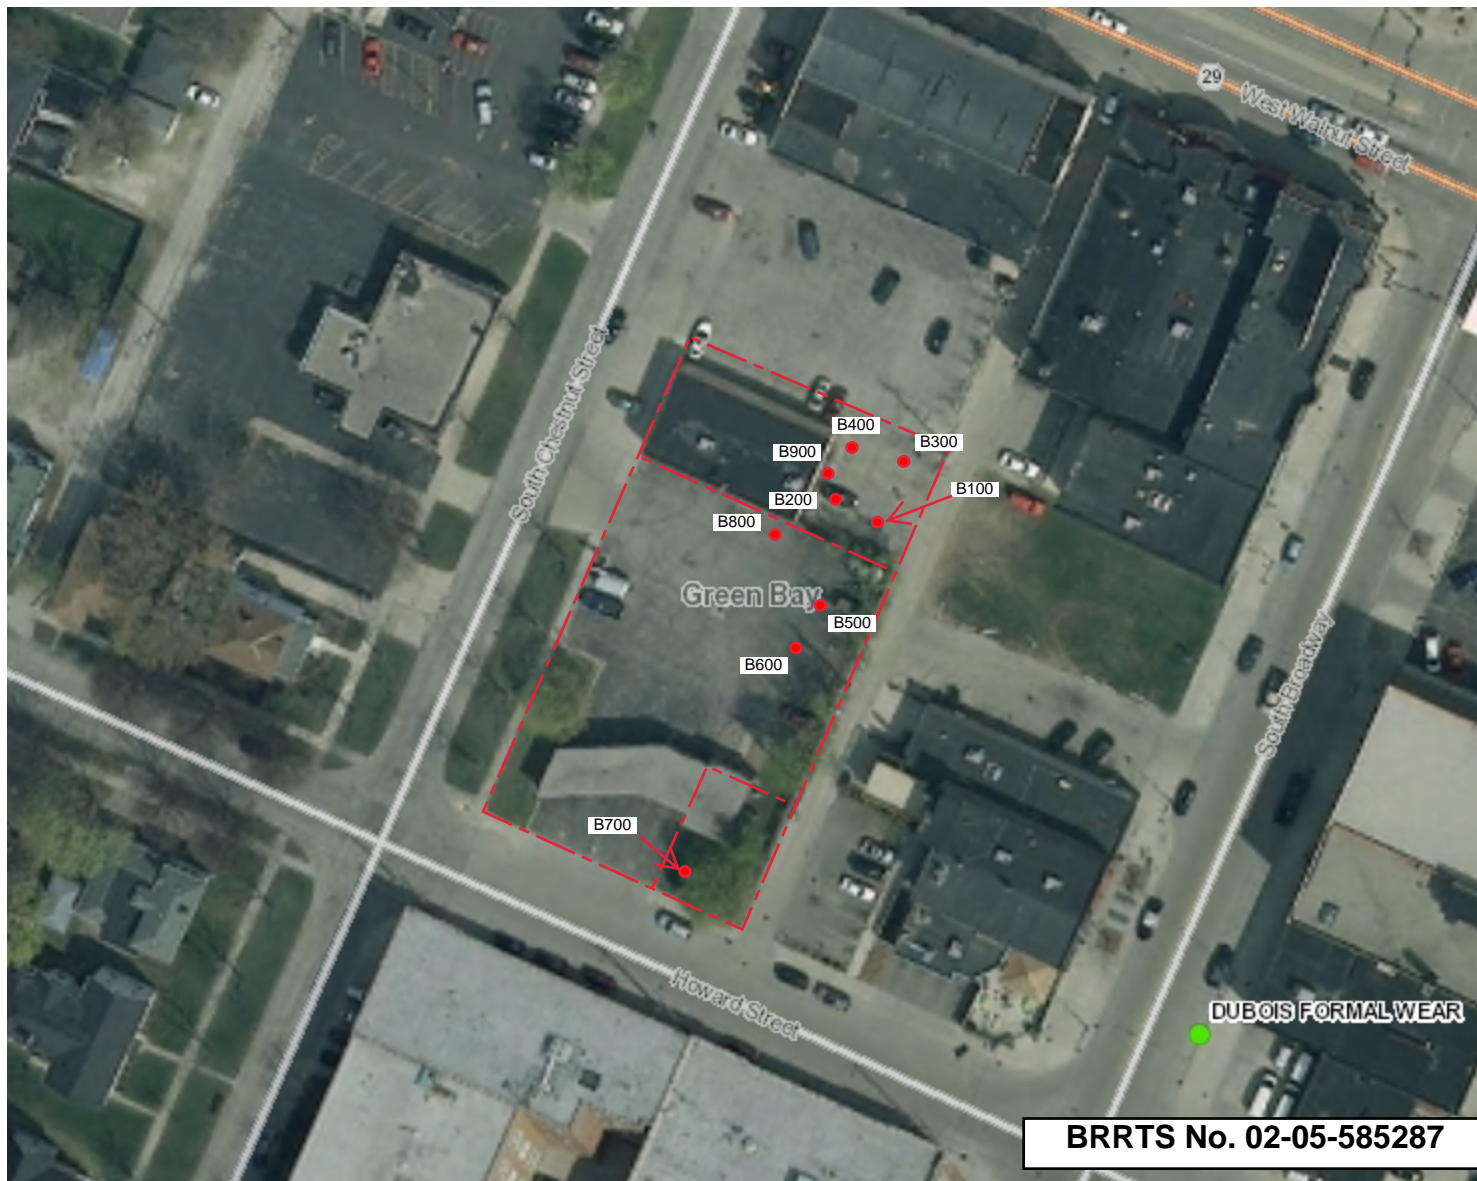
# PROBE LOCATION DIAGRAM-STANTEC

- Open Site
- Closed Site
- Continuing Obligations Apply
- Facility-wide Site
- : Approximate Probe Location-Stantec

During May and June 2019, Stantec Consulting Services Inc. (Stantec) completed a Phase II ESA on behalf of the City of Green Bay. During their Phase II ESA, nine soil borings (B-100 through B-900) were advanced at the Site with temporary groundwater monitoring wells constructed in four of the borings (TW-100, TW-600 TW-700 and TW-800). Eight of these borings were performed in the northeastern portion of the Subject Property, generally around the area of the dry cleaner. The other boring (B-700) was placed in the southeast corner of the Subject Property. In addition, two sub-slab vapor monitoring points were also installed within the Site building at 117 South Chestnut Avenue where the dry cleaner was located. Soil, groundwater and vapor samples were collected and tested for the presence of VOCs, PAHs, and RCRA Metals.

Stantec's laboratory analysis of soil samples detected multiple polynuclear aromatic hydrocarbons (PAHs), silver, and tetrachloroethene (PCE) exceeding the NR720 residual contaminant levels (RCLs) for groundwater protection and/or non-industrial direct contact. Stantec indicated that the PAH and silver detections are likely related to historic urban fill since contaminant concentrations generally decrease when native soils are encountered. They indicated that the PCE detections on the Site are likely related to the former drycleaner which historically operated on the Property identified in Tetra Tech's Phase I ESA. Stantec's laboratory analysis of groundwater samples collected from their temporary wells detected multiple RCRA metals and PCE exceeding their respective NR140 Preventive Action Limits (PALs). Multiple PAHs and vinyl chloride were also detected exceeding their respective NR140 Enforcement Standards (ESs). Sub-slab soil vapor analysis was performed on samples collected from the interior vapor points. Tetrachloroethene (PCE) was detected in both samples but below the target for sub-slab air concentrations. No other VOCs were detected above target limits for sub-slab air concentrations. Stantec indicated that the Phase II findings needed to be reported to the WDNR and additional site investigation would be required. The Stantec soil probes/borings are included on the attached Probe

Location Diagram-Stantec. The Stantec test results are included on the attached Stantec soil and water tables.

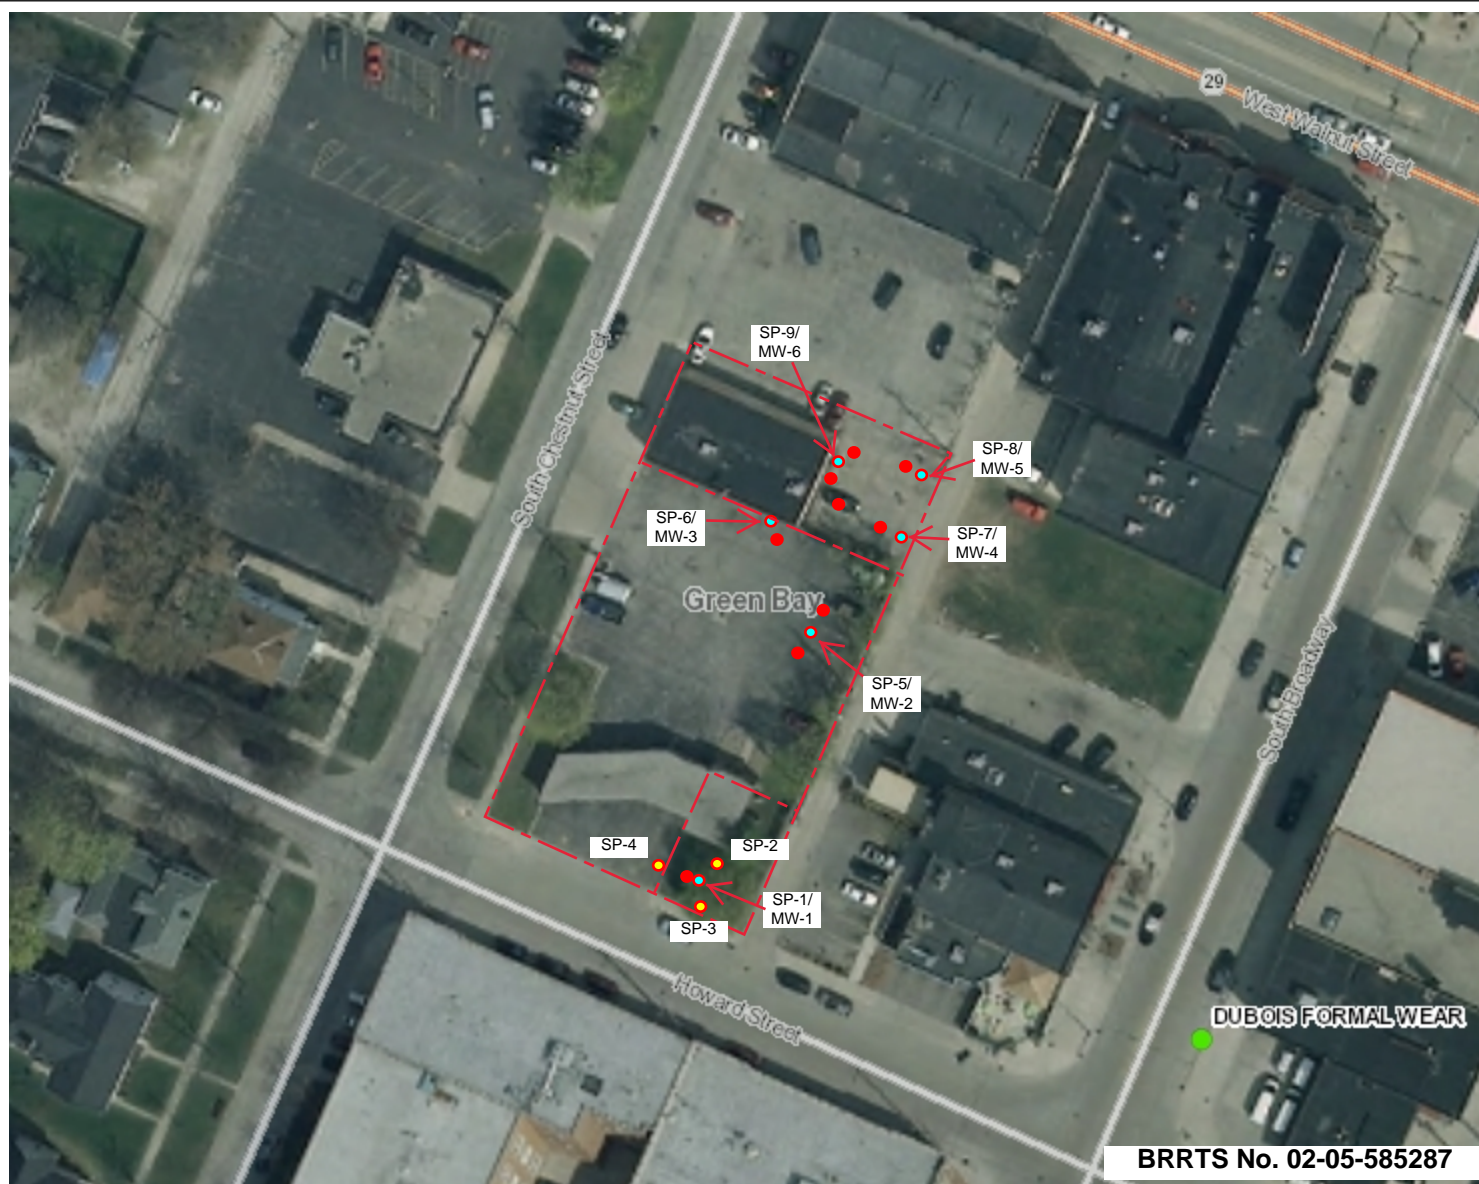
# PROBE & WELL LOCATION DIAGRAM-PSI

- Former Probe Location (Stantec)
- Soil Probe/Well Location (PSI)
- Soil Probe Location (PSI)

PSI was retained to perform additional site investigative services and notify the WDNR of the encountered contamination on February 7, 2020. On July 16, 2020, following approval, nine soil probes (SP-1 through SP-9) were placed on the Subject Property to evaluate the soil for the presence of petroleum and chlorinated contamination. Following soil sample collection, six of the borings were converted to groundwater monitoring wells to evaluate the groundwater for the presence of petroleum and chlorinated contamination. Three probes (SP-2, SP-3, and SP-4) and one well (MW-1) were placed in the southeast corner, while the other borings/wells were placed in the area of the former dry cleaner. Based upon the Stantec results, collected soil samples from the borings placed near the former dry cleaner were tested for the presence of VOCs, PAHs and Silver, while the samples collected from the borings placed near the southeast corner were tested for the presence of PAHs and Silver. Due to site conditions of shallow groundwater and previous sample collection depths, these soil samples were generally collected from the upper 5 feet. The PSI soil probes/wells are included on the attached Probe and Well Location Diagram.

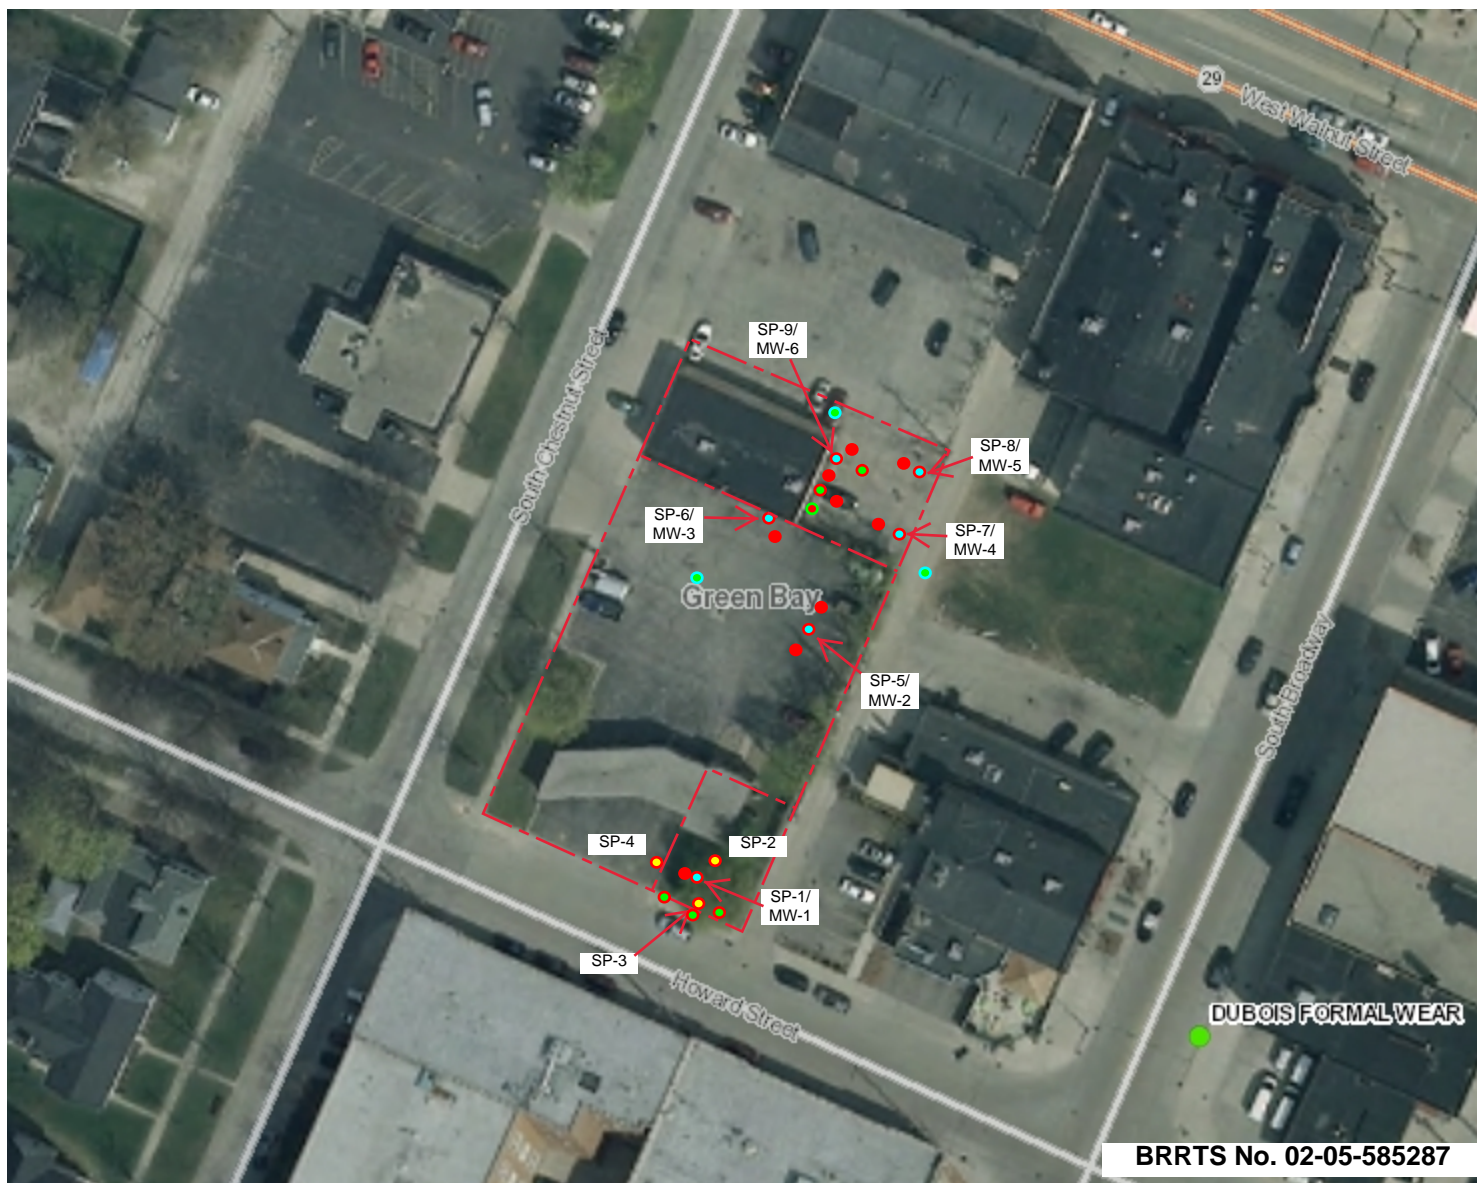
# PROBE & WELL LOCATION DIAGRAM-PSI

- Former Probe Location (Stantec)
- Soil Probe/Well Location (PSI)
- Soil Probe Location (PSI)
- Proposed Probe Location (PSI)
- Proposed Well Location
- Proposed Piezometer Location

The general proposed scope of work will consist of the following activities: the placement of four additional soil borings around SP-3; the placement of four additional soil borings around SP9; the collection of soil samples from these borings and laboratory analysis of selected soil samples for the presence of PAHs; the installation of groundwater wells to the north of MW-6, to the south of MW-3 and to the southeast of MW-4; the installation of a piezometer in the vicinity of MW-3; the collection of water samples from the three new wells and piezometer; laboratory analysis of water samples for the presence of chlorinated solvent contaminants; and data analysis and interpretation. Following data evaluation, and if favorable test results are received, a Site Investigation Report will be prepared.

1. Four 5-foot borings will be placed around SP-3 and three 5-foot borings and one 10-foot boring will be placed around SP-9. Soil samples will be continuously collected to the maximum depth explored. Representative samples will be obtained from the borings with a split-spoon sampler that will be decontaminated between sampling with Alconox and clean rinse water. Companion soil samples will be collected for laboratory analysis.
2. The collected soil samples will be field screened with a PID to monitor for the presence of volatile organic vapors.
3. Excess soil will be placed into drums for future disposal.

5. Following the soil sampling activities and boring procedures, three additional NR141-compliant groundwater monitoring wells will be installed to a depth of about 13 to 15 feet below grade to further evaluate the presence of chlorinated VOCs. These wells will be installed with 4" hollow stem augers. The groundwater monitoring wells will be installed in general accordance with WDNR procedures set forth in Chapter NR141. The well construction will consist of a 10-foot section of 2-inch diameter, Schedule 40 PVC screen with 0.010 inch factory cut slots and 2-inch diameter Schedule 40 PVC flush threaded riser pipe extending to about 6 inches below the ground surface. A steel protective flush mount cover will be placed over the top of each PVC riser pipe. Clean sand backfill will be utilized as a filter medium around the screened PVC to a level about two feet above the top of the screened section. The sand backfill will be placed into the annular space between the auger and PVC during progressive withdrawal of the auger. Bentonite chips will fill the annular space above the sand filter. The cover will be concreted in the surrounding pavement.
