Status Update Report-February 2022

BMO HARRIS BANK PARCEL
125 S. Chestnut Avenue
Green Bay, Brown County, Wisconsin

PSI Project Number 00542536

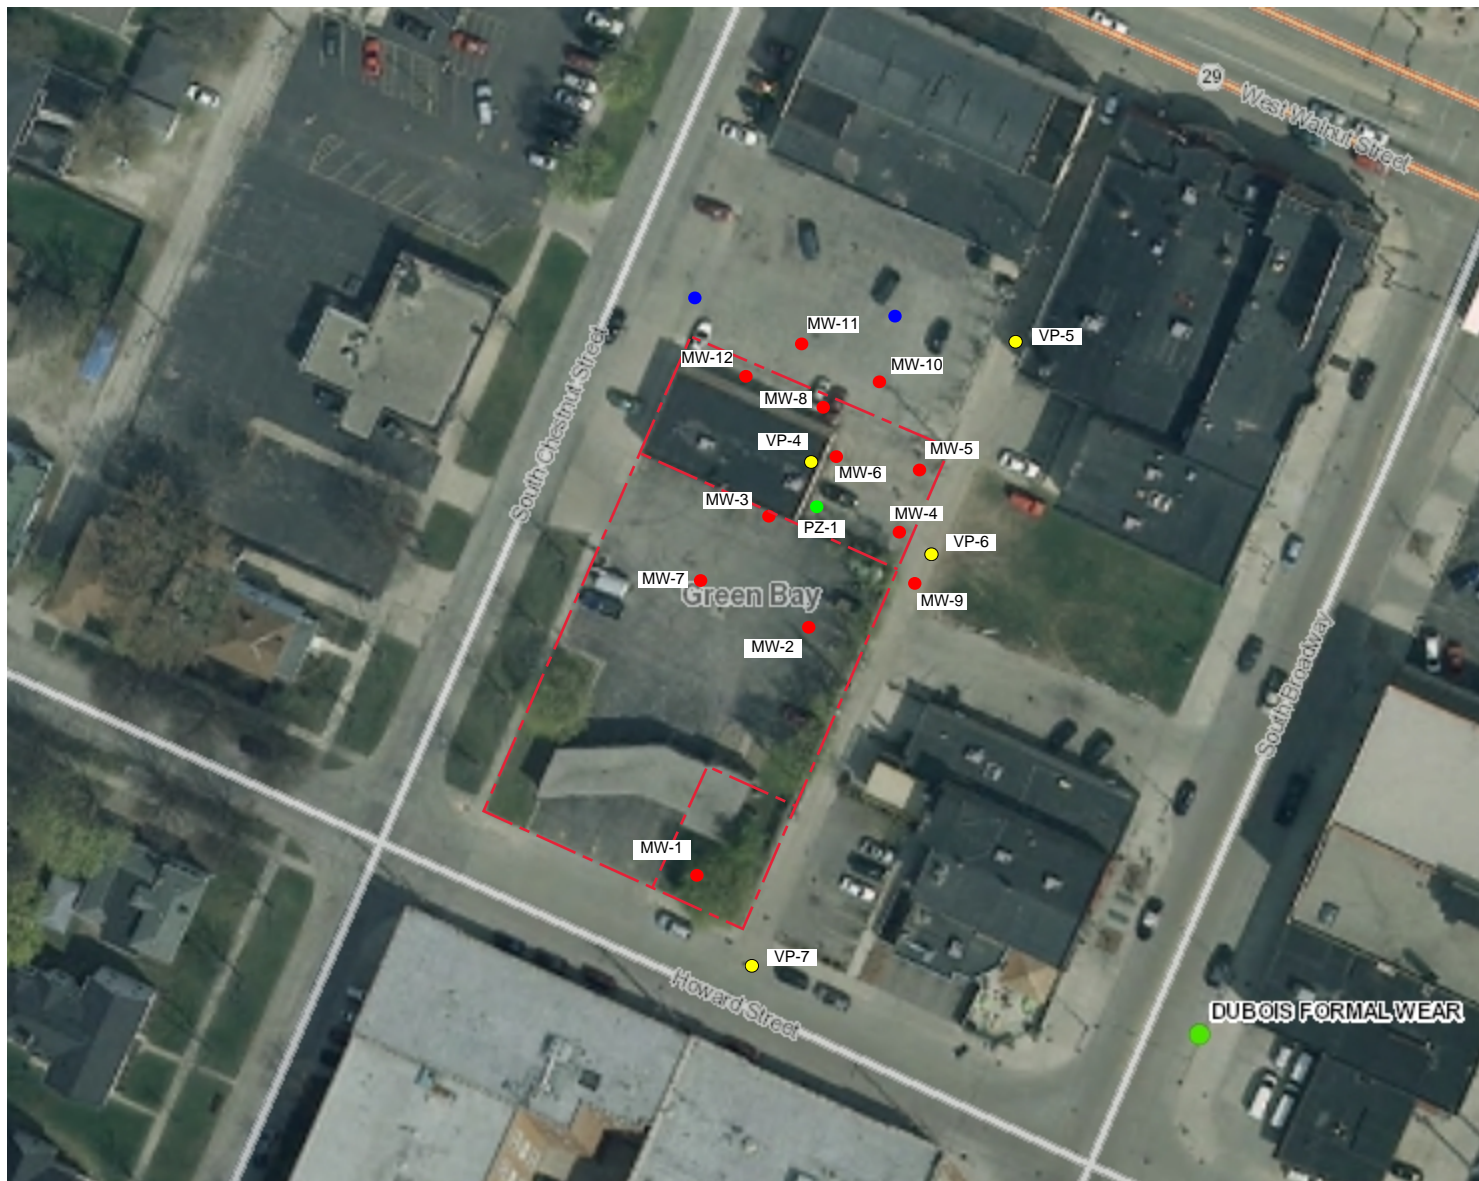
PROPOSED WELL LOCATION DIAGRAM-PSI

impacted groundwater has not been thoroughly defined. As such, it is recommended that one additional NR141-compliant groundwater monitoring well be installed to the north/northeast of existing wells MW-10 and MW-11 and an additional NR141-compliant groundwater monitoring well be installed to the north/northwest of existing well MW-12. These proposed well locations are shown on the proposed well location diagram included herein. Following well installation and development, the initial collected groundwater samples from these newly installed wells will be tested for the presence of VOCs. Based upon subsequent test results, testing may be reduced to only detected compounds above NR140 standards.

The recommended well installation activities and additional groundwater sampling event of the new and above-mentioned wells should be completed in April 2022.
