## Status Update Report-October 2022

BMO HARRIS BANK PARCEL  
125 S. Chestnut Avenue  
Green Bay, Brown County, Wisconsin

Professional Service Industries, Inc.  
821 Corporate Court  
Waukesha, WI 53189  
**BRRTS No. 02-05-585287**

Re: Status Update Report-October 2022  
**BMO HARRIS BANK PARCEL**  
125 S. Chestnut Avenue  
Green Bay, Wisconsin  
**WDNR BRRTS No. 02-05-585287**  
PSI Project Number: 00542693

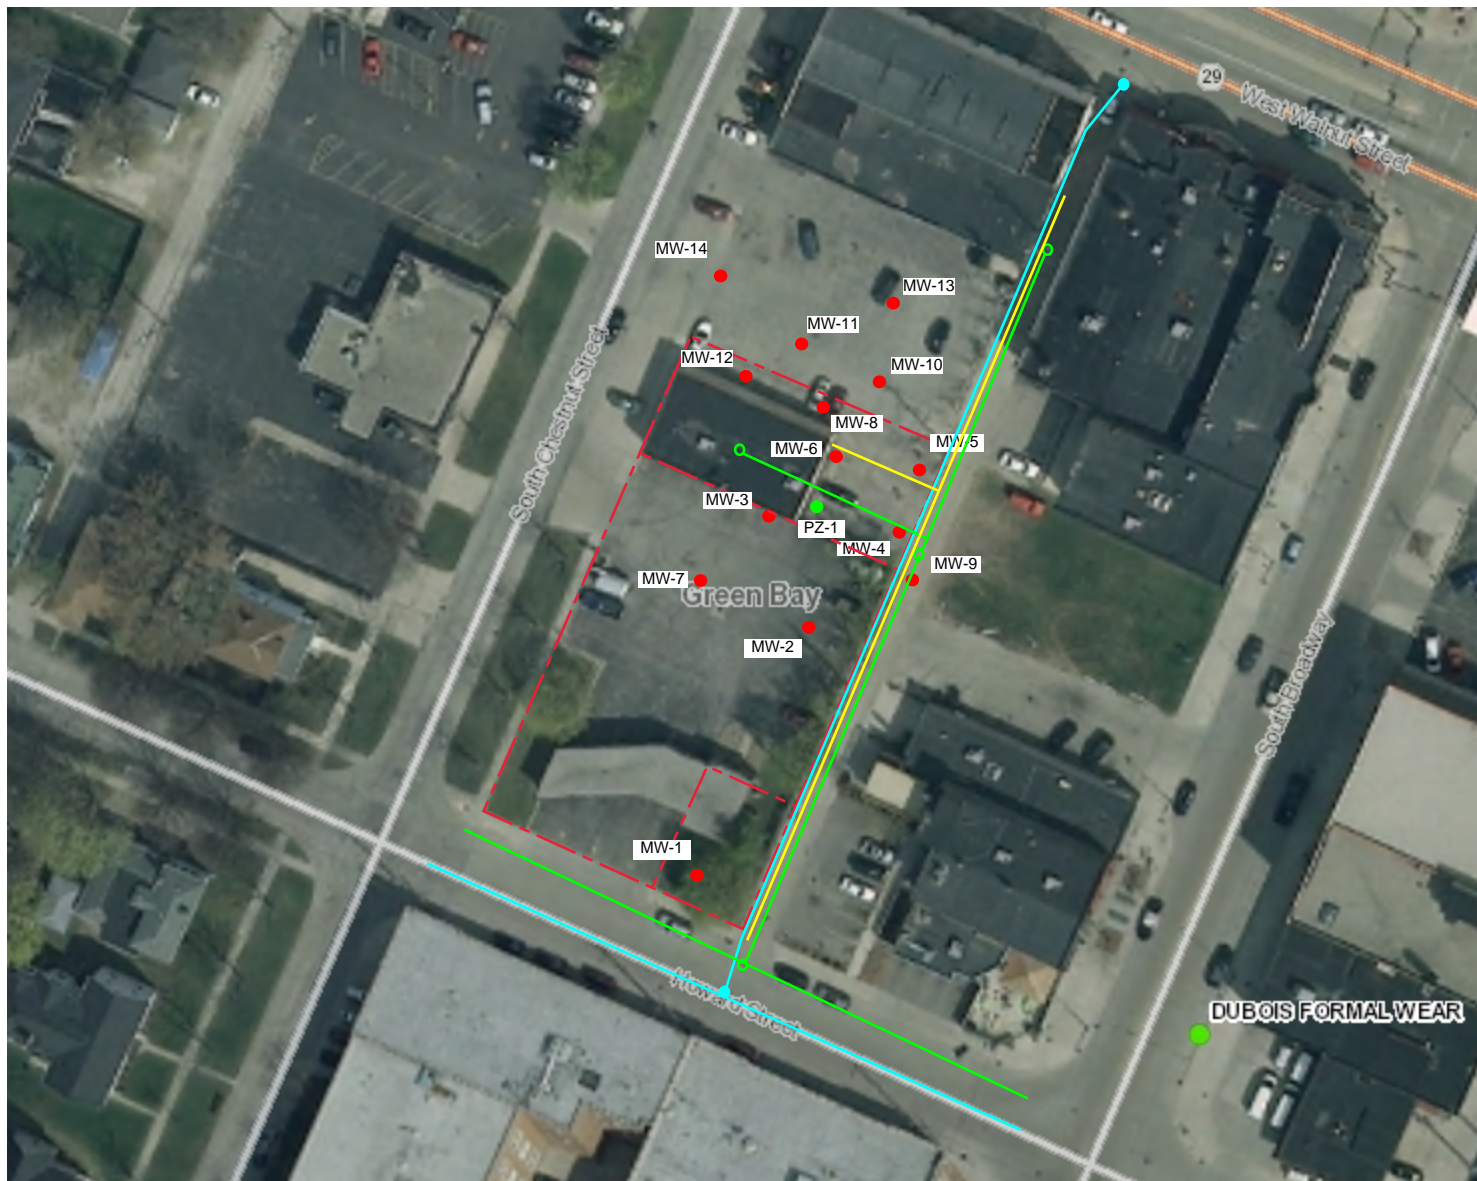
# WELL LOCATION DIAGRAM-PSI

PSI completed the field exploration activities for the Site Investigation on the Subject Property in July 2020 through July 2022. These activities were performed to evaluate the subsurface condition for the presence of contamination due to the former presence of a dry cleaners and an auto repair facility and consisted of the placement of fifteen soil probes and four soil vapor sample points, the installation of twelve groundwater monitoring wells and one piezometer on the Subject Property, within the eastern adjoining alley and within the northern adjoining property, and the collection and analysis of soil, soil vapors, and groundwater from these locations. The results of the analytical testing of the collected soil samples, soil vapor samples, and the water samples collected from the soil probes and wells were discussed in previous environmental reports. The general location of the wells is shown on the Well Location Diagram included in the Appendix. In addition, a diagram showing the estimated extent of the encountered soil contamination and groundwater contamination extent is included in the Appendix.

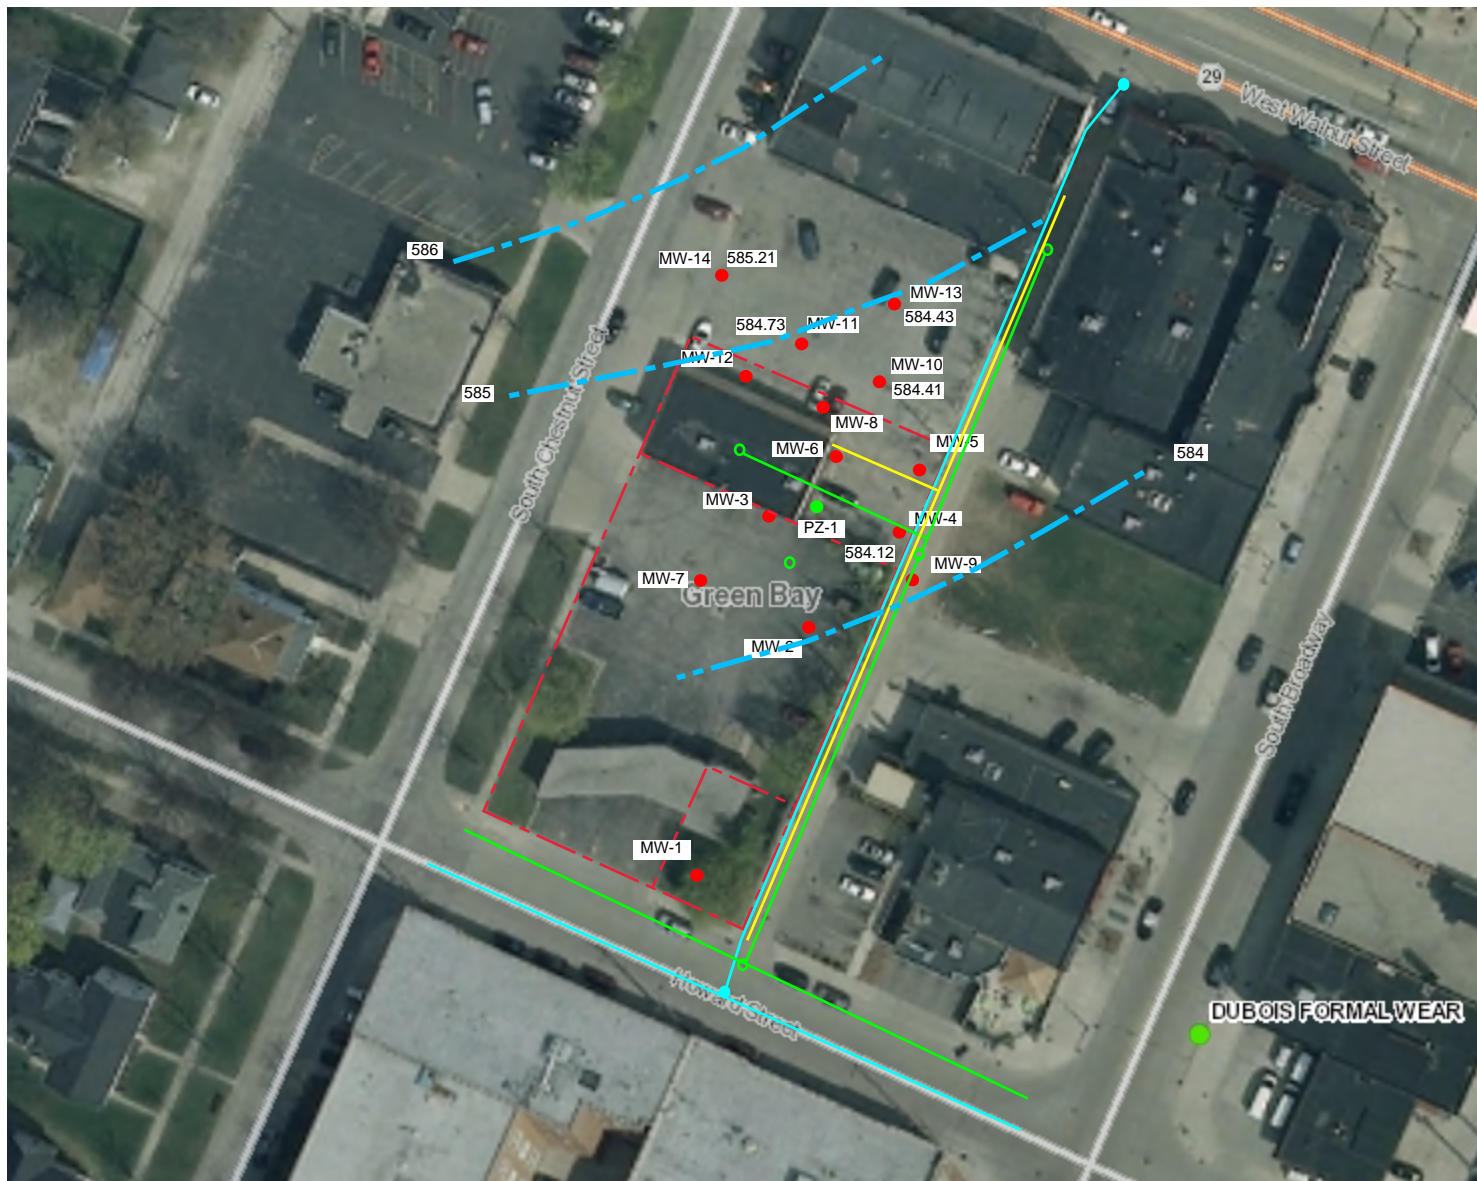
**GROUNDWATER ELEVATION CONTOUR DIAGRAM-October 2022**  
**BRRTS No. 02-05-585287**

The elevations of the top of the PVC riser pipe of each of the wells were previously determined by PSI personnel using conventional leveling techniques. The elevations were referenced to the bonnet flange of the fire hydrant at the northwest corner of Howard Street and Chestnut Avenue with an assigned elevation of EL. 590.53±. The groundwater levels were measured at depths ranging from about 3.25 feet to about 7.09 feet below top of casing (EL. 581.39± to EL. 585.69±). The depths to groundwater were not collected from MW-1, MW-2, MW-3, MW-5, MW-7, and PZ-1 during this sampling event. In review of recent and past groundwater level measurements, it is possible that the wells placed nearest to the existing building (MW-3, MW-6, MW-8, and MW-12) are being influenced by the foundation associated with the structure and are creating elevated groundwater levels. The groundwater flow direction generally appears to be towards the southeast in the direction of the Fox River and Green Bay. These elevations are shown on the Groundwater Elevation Table included in the Appendix. A groundwater flow diagram showing the estimated flow direction in October 2022 is included in the Appendix.
