Subject: Status Update Report-Additional Site Investigation Activities-May 2024  
**BMO Harris Bank Branch**  
117 S. Chestnut Avenue  
Green Bay, Wisconsin 54303  
PSI Project No. 00542978  
**BRRTS No. 02-05-585287**

**Status Update Report-May 2024**

**BMO Harris Bank Branch**  
117 S. Chestnut Avenue  
Green Bay, Wisconsin 54303

**BRRTS No. 02-05-585287**

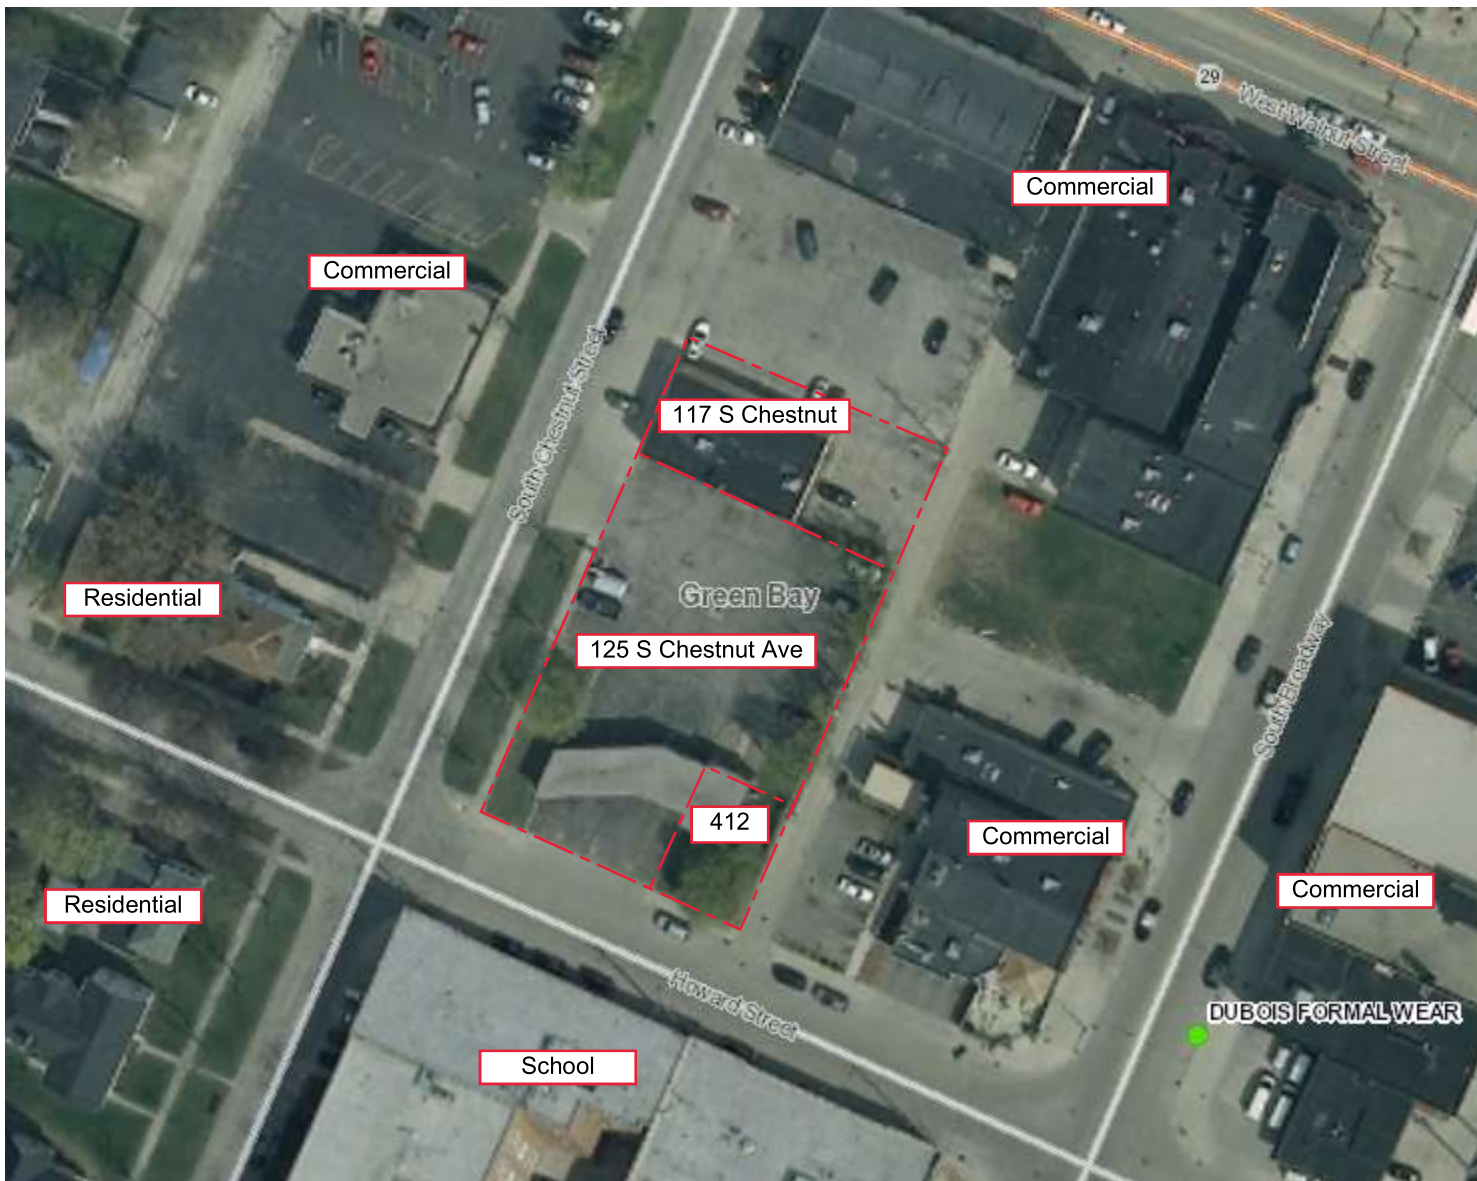
# SITE FEATURES DIAGRAM

A rectangular commercial structure, which has the address of 117 S. Chestnut Avenue, is situated in the northern quarter of the Subject Property and a dry cleaner formerly occupied a portion of this building and former buildings that were situated in the eastern half of this parcel. A parking area is present to the south of the building and a fenced-in storage area is present to the east of the building.
