September 17, 2021

SUBJECT: Review of the Site Investigation Report – Site Investigation Incomplete  
Riverpoint District - LGU, North 10<sup>th</sup> Street and Buffalo Street, Manitowoc, WI 54220  
BRRTS #: 02-36-585491

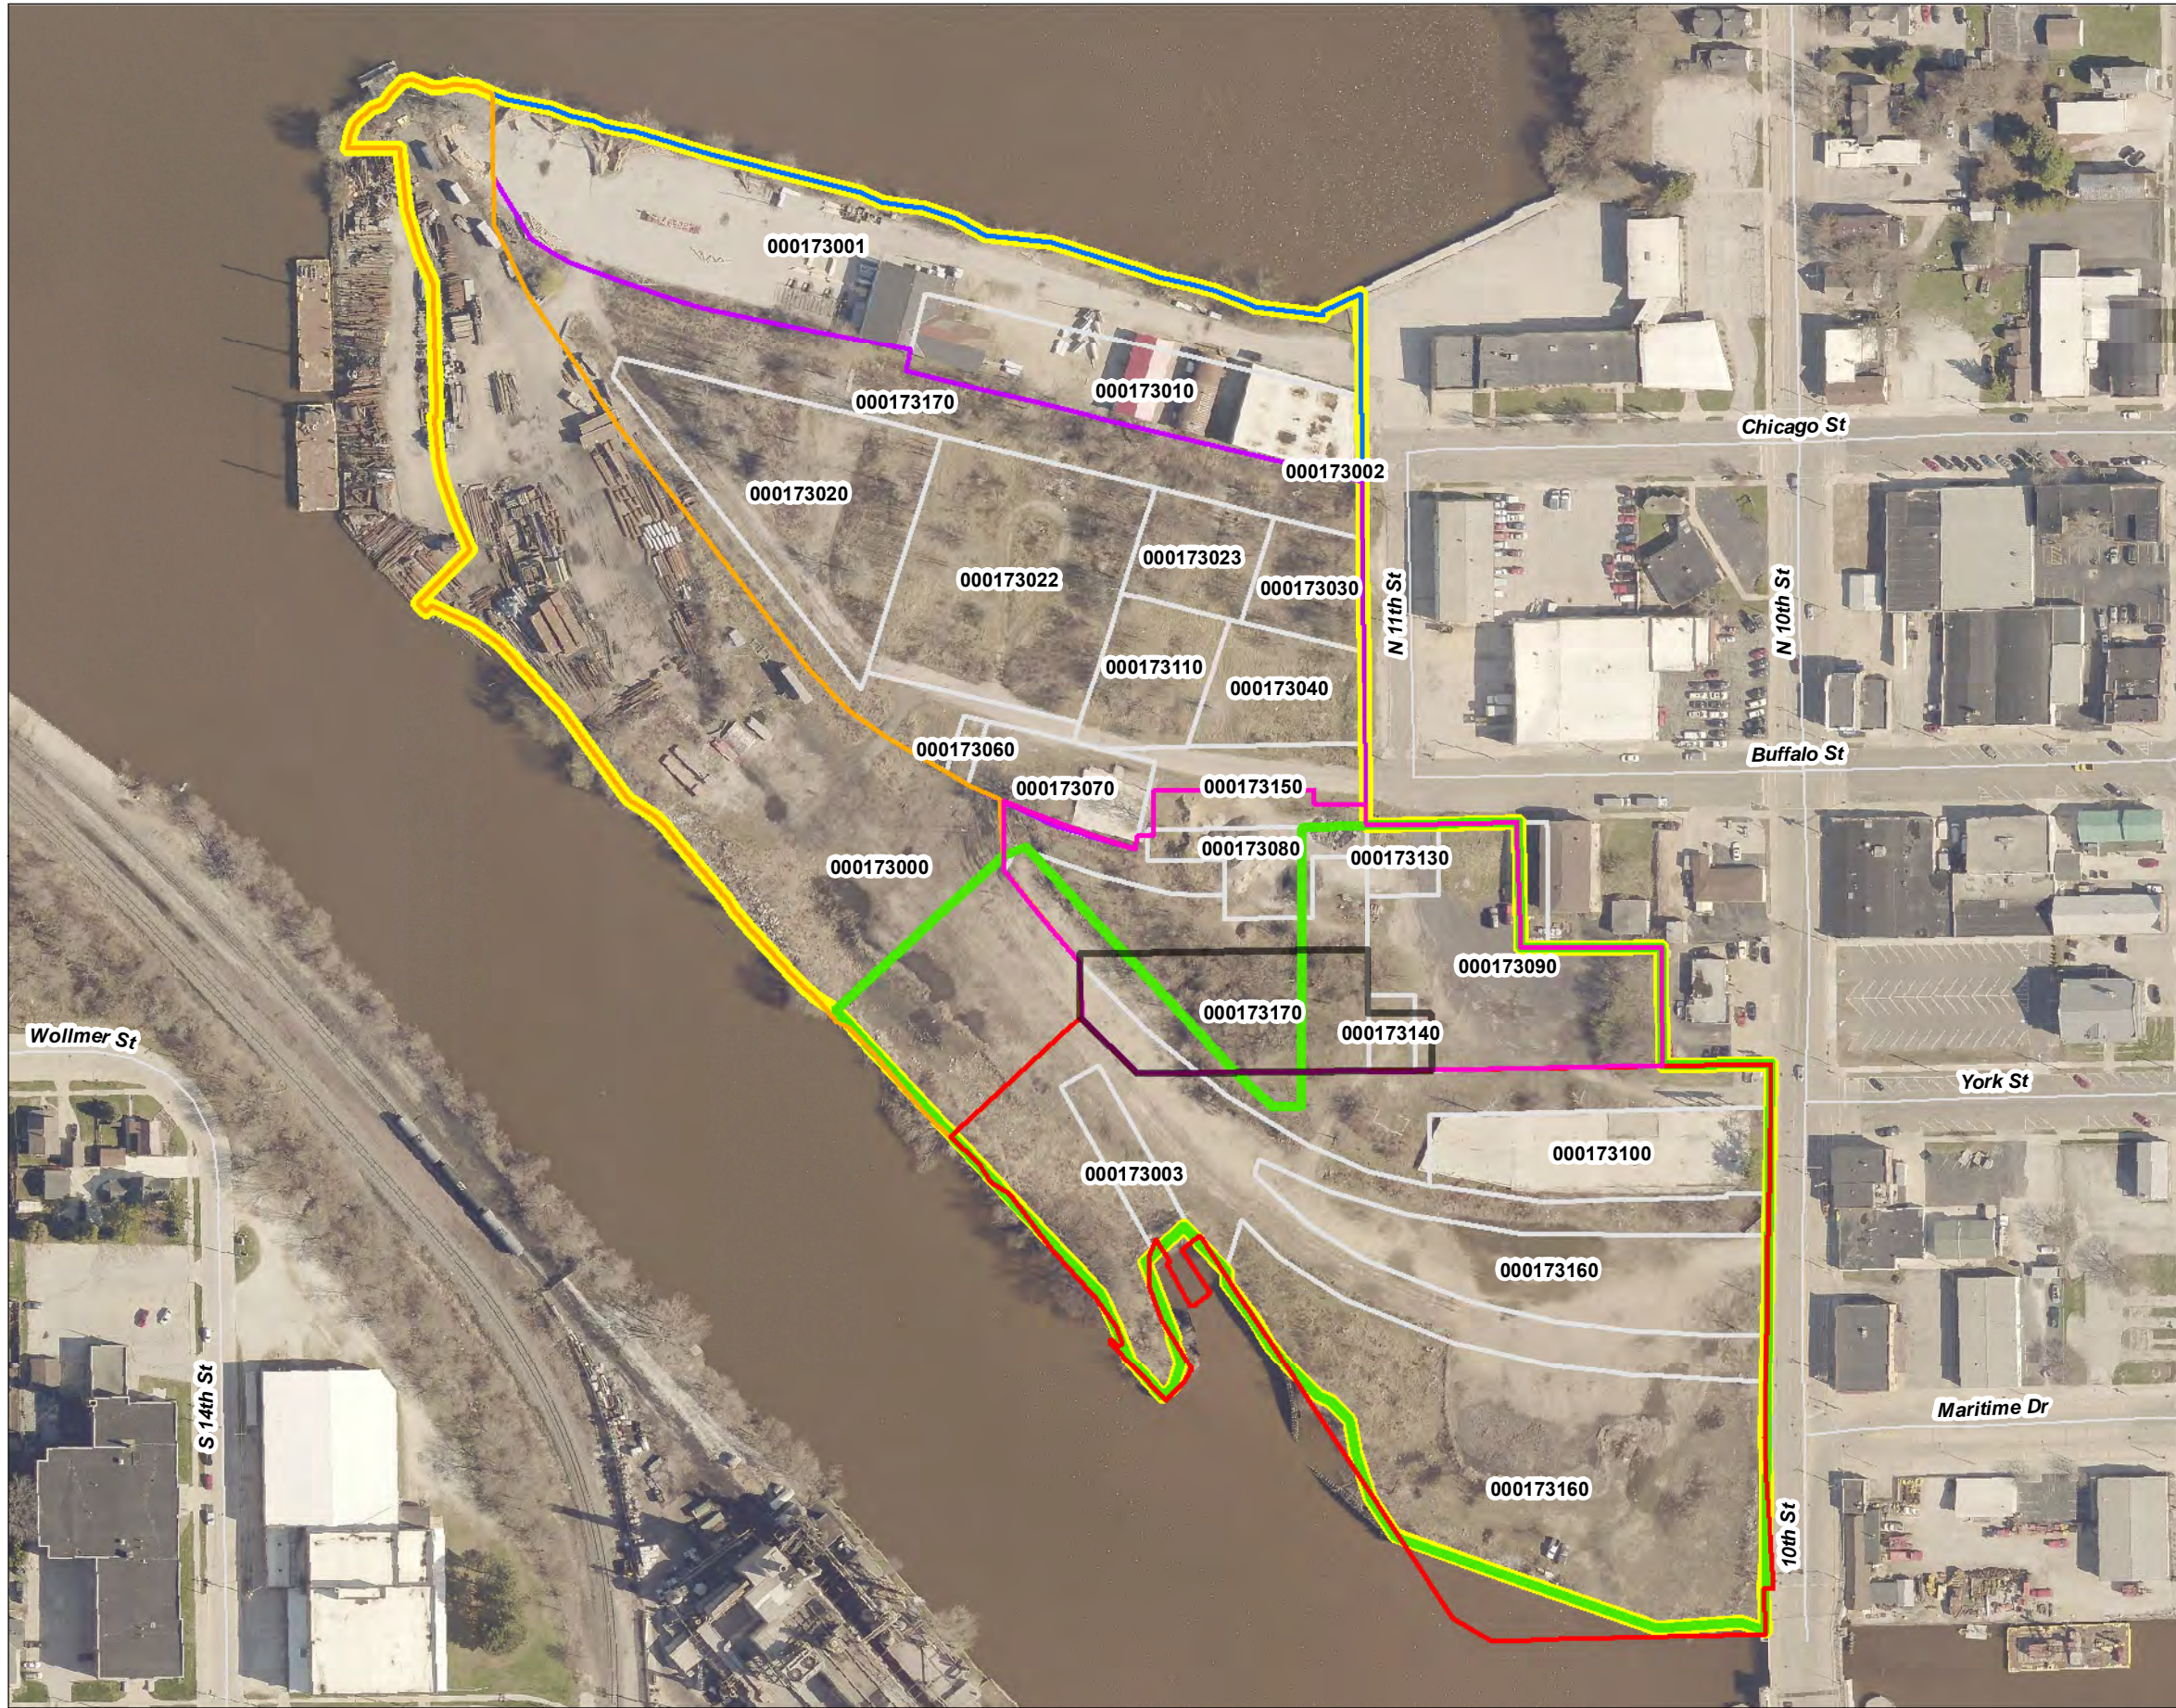
2

A Phase II Environmental Site Assessment (ESA) was submitted to DNR on March 23, 2020, for approximately 21 acres of the land located west of North 11<sup>th</sup> Street, Chicago Street, Buffalo Street, and North 10<sup>th</sup> Street, which is referred to as the Riverpoint District. Refer to *Figure 2, Project Area and Property Identification Numbers*, dated April 21, 2021, for a visual depiction of the Riverpoint District. A Bureau for Remediation & Redevelopment Tracking System (BRRTS) case was opened for the contamination identified in the Phase II ESA; however, the City of Manitowoc Community Development Authority (CDA) has the local government unit (LGU) liability exemption under Wis. Stat. § 292.11(9)(e), so no responsible party letter was issued. The City of Manitowoc has focused on the investigation of the Phase 1 development area of the Riverpoint District to prepare for redevelopment by the CDA and/or private parties. Therefore, the site investigation pertains to the Phase 1 area, which is approximately 7.7 acres of land that is located on the south/southeastern portion of the larger 21 acres of the Riverpoint District, as identified in the attached *Figure 3, Phase 1 River Point Development Certified Survey Map*, dated January 22, 2021. New BRRTS cases may be opened as additional developments occur within this area for land that the CDA does not plan to retain long-term ownership of.

**Project Area and Property Identification Numbers**

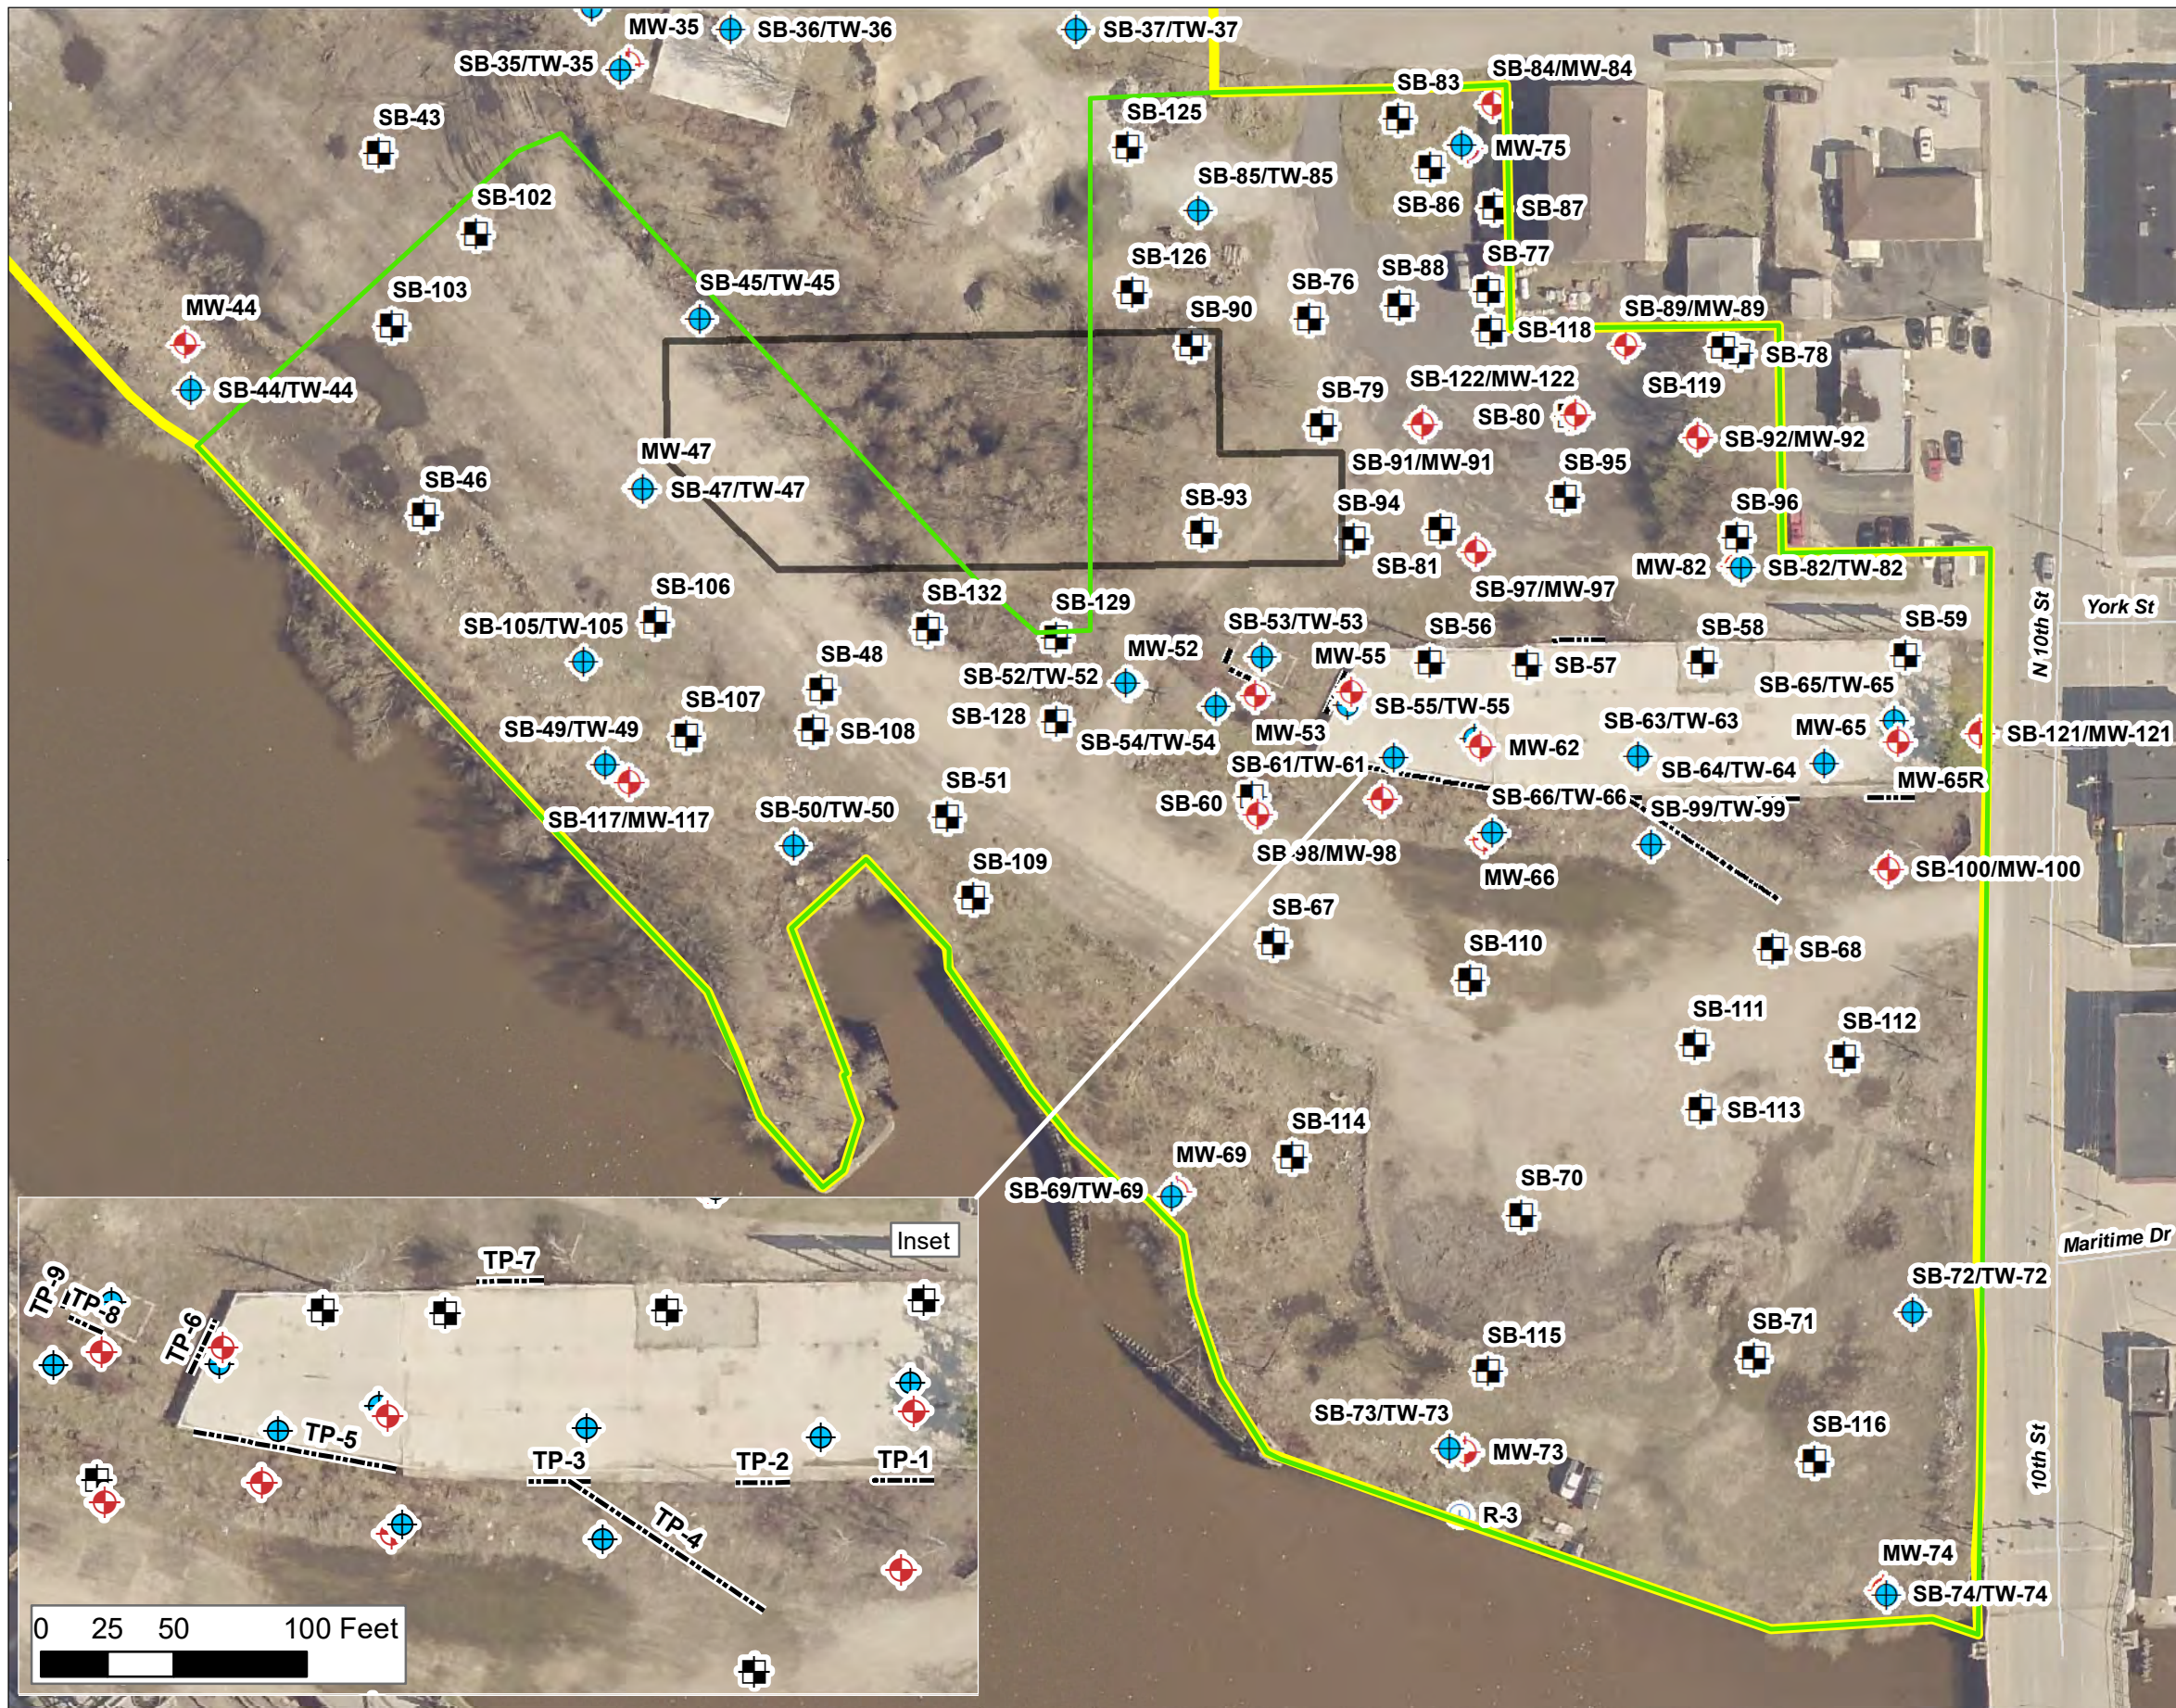
Figure No. **8**  
 Title  
**Soil and Groundwater Sample Locations**

The degree and extent of contamination in soil and groundwater is not complete in accordance with Wis. Admin. Code § NR 716.11. The following information are comments from DNR categorized by contaminants in soil and groundwater for the investigation (Refer to *Figure 8, Soil and Groundwater Sample Locations*, dated April 19, 2021, for specific sampling locations):

- Groundwater needs to be sampled at the existing monitoring well MW-89 to determine if PCBs are impacting groundwater since this location has the highest concentrations of PCBs.

- Identify on the soil figure that PAHs are above the Groundwater Pathway, Non-Industrial, and/or Industrial Direct Contact RCLs across the entire site in shallow soil fill. A separate delineation is needed for the SB-80 and SB-122 area since it appears there may be a point source at this location.

- Further sampling for delineation is needed around SB-112. Groundwater sampling may be needed if deeper sampling is above RCLs.
  - Soil needs to be resampled at SB-77 to determine if trichloroethylene (TCE) can be confirmed. If confirmed, groundwater sampling and off-site sampling may be needed.

- Delineate areas on the soil figure with more elevated VOCs above Groundwater Pathway and/or Direct Contact RCLs (SB-49 area, SB-80 area, SB-53/54/61/TP-5/TP-7 area, and SB-112 area). Delineation needs to include any impacts on off-site properties after additional investigation.

- Exceedances and delineation for Groundwater Pathway RCLs has not been provided in the report. Exceedances need to be identified on the soil tables (RCL = 9.4 ug/kg) and delineation needs to be added to the soil figure. Delineation needs to include any impacts on off-site properties after additional investigation.

- MW-92 has ES exceedances for arsenic (12 & 13 ug/L above ES of 10 ug/L). MW-92 needs to be resampled to ensure concentrations remain stable.
  - Identify on the soil figure that metals are above Groundwater Pathway and/or Direct Contact RCLs across the entire site in shallow soil fill. A separate delineation is needed for metals found in the former junkyard area, including any impacts on off-site properties after additional investigation.
