Re: *Summerfest Lagoon Sampling Technical Memorandum*
Milwaukee Estuary Area of Concern
Milwaukee, Wisconsin
EPA GLRI Grant No. GL-00E02392

Characterization of Sediments in Kinnickinnic River and Milwaukee Bay of the Milwaukee Estuary Area of Concern

Summerfest Lagoon Sampling Technical Memorandum

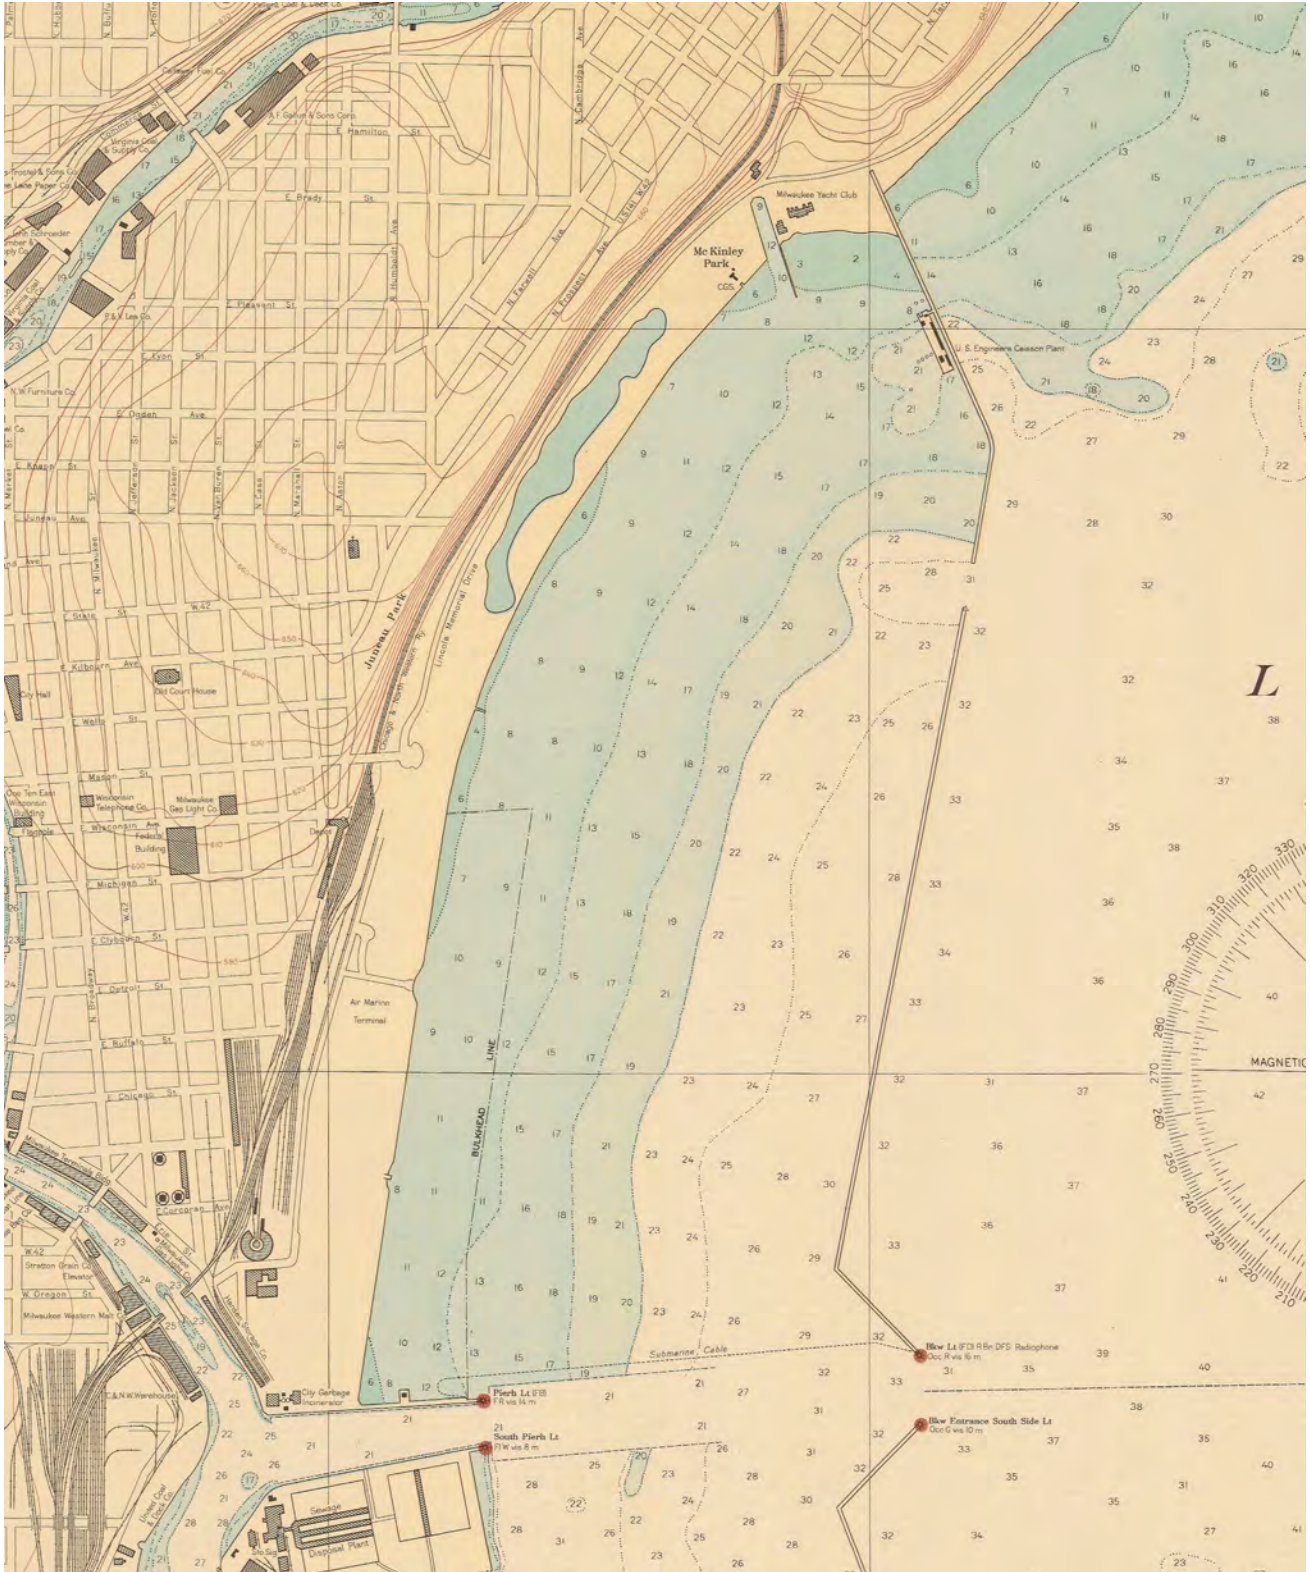
Source: USACE Milwaukee Harbor Project Map, June 1939 Edition.

The Summerfest Lagoon area has changed dramatically over the past century as observed on U.S. Army Corps of Engineers and National Oceanic and Atmospheric Administration historical maps. In the 1930s, the area comprised Lake Michigan shoreline with one of the city's first airstrips¹ (Figure 2-1a). By the 1950s, the airstrip was replaced with a military installation, established to protect the city during the Cold War (Figure 2-1b). Major infilling of the shoreline began in the 1970s with the construction of McKinley Marina, as well as the expansion of the Pier Wisconsin area (Figure 2-1c). Shoreline development continued into the 2000s with the development of the Lakeshore State Park (Figure 2-1d) and the establishment of the two basins (Figure 2-1e). The site history of the Maritime Basin and Quiet Water Basin are further described in the following sections.

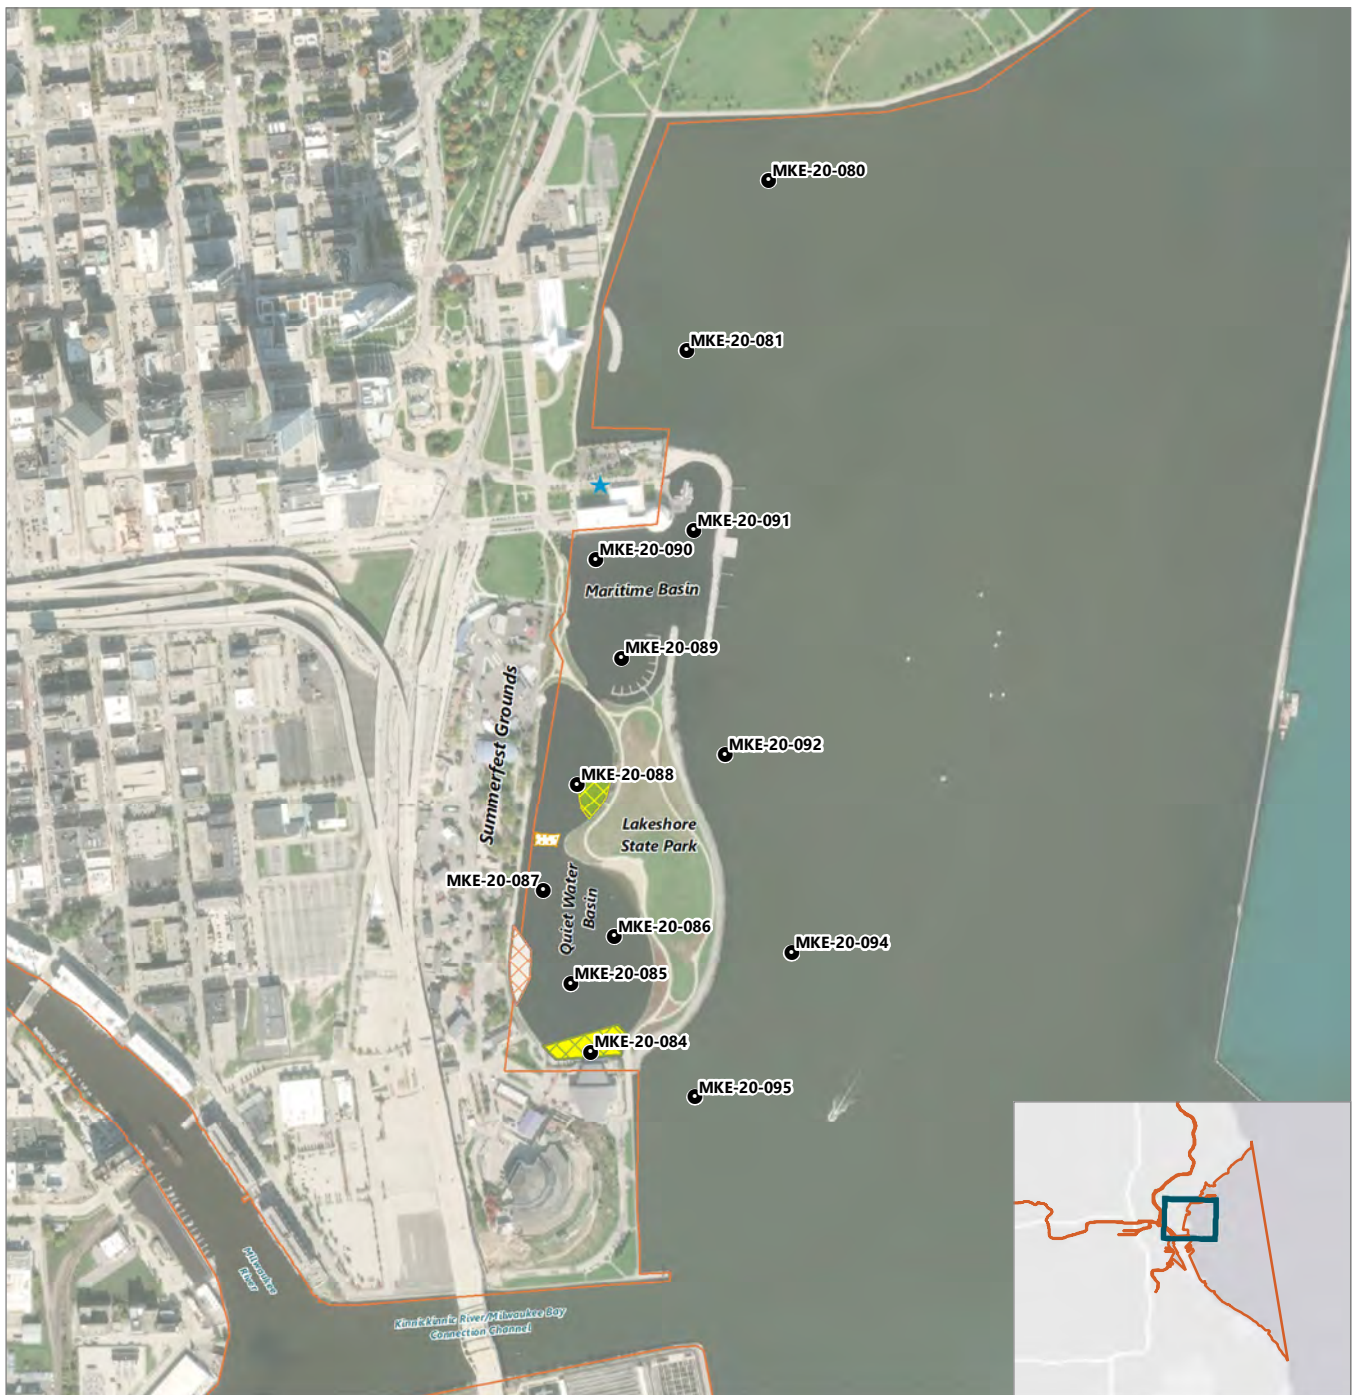
Figure 2-1e
Shoreline Features – 2012

- Milwaukee Estuary AOC
- 2020 Sediment Location (n= 13)
- ★ Discovery World
