Characterization of Sediments in Kinnickinnic River and Milwaukee Bay of the
Milwaukee Estuary Area of Concern

Forensic Evaluation and Source Review Technical Memorandum

Prepared for Wisconsin Department of Natural Resources
EPA GLRI Grant No. GL-00E02392

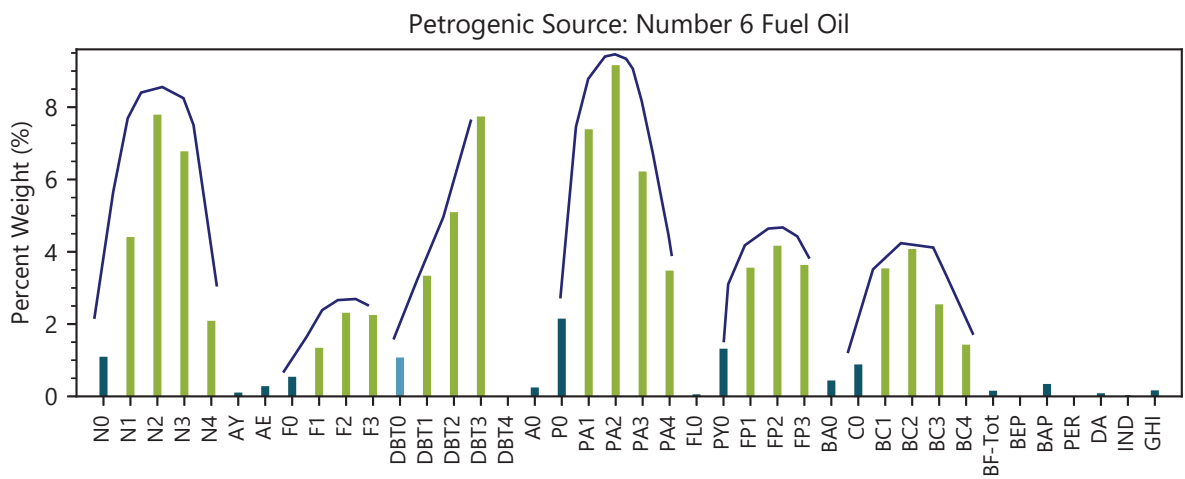
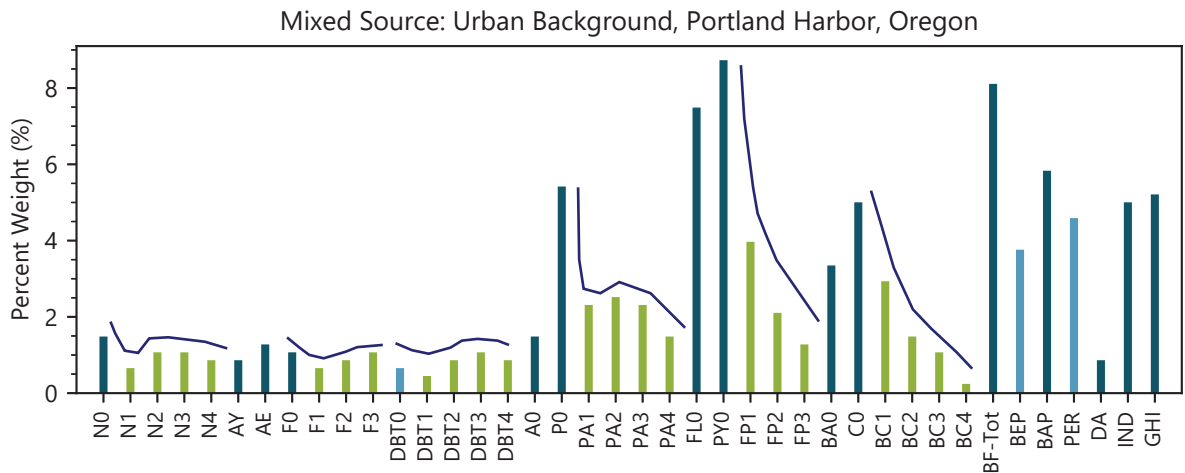
Figure 2-1
Typical PAH Fingerprints from Published Reports
 Characterization of Sediments in Kinnickinnic River and Milwaukee Bay of the Milwaukee Estuary Area of Concern
 Milwaukee, Wisconsin

Experimental Fresh Coal Tar reference from Uhler and Emsbo-Mattingly 2006.
 Number 6 Fuel Oil reference from sample P128 from EPRI 2000.
 Urban background, Portland Harbor, Oregon, reference from Stout et al. 2004.
 See Table 2-1 for x-axis PAH abbreviation definitions.

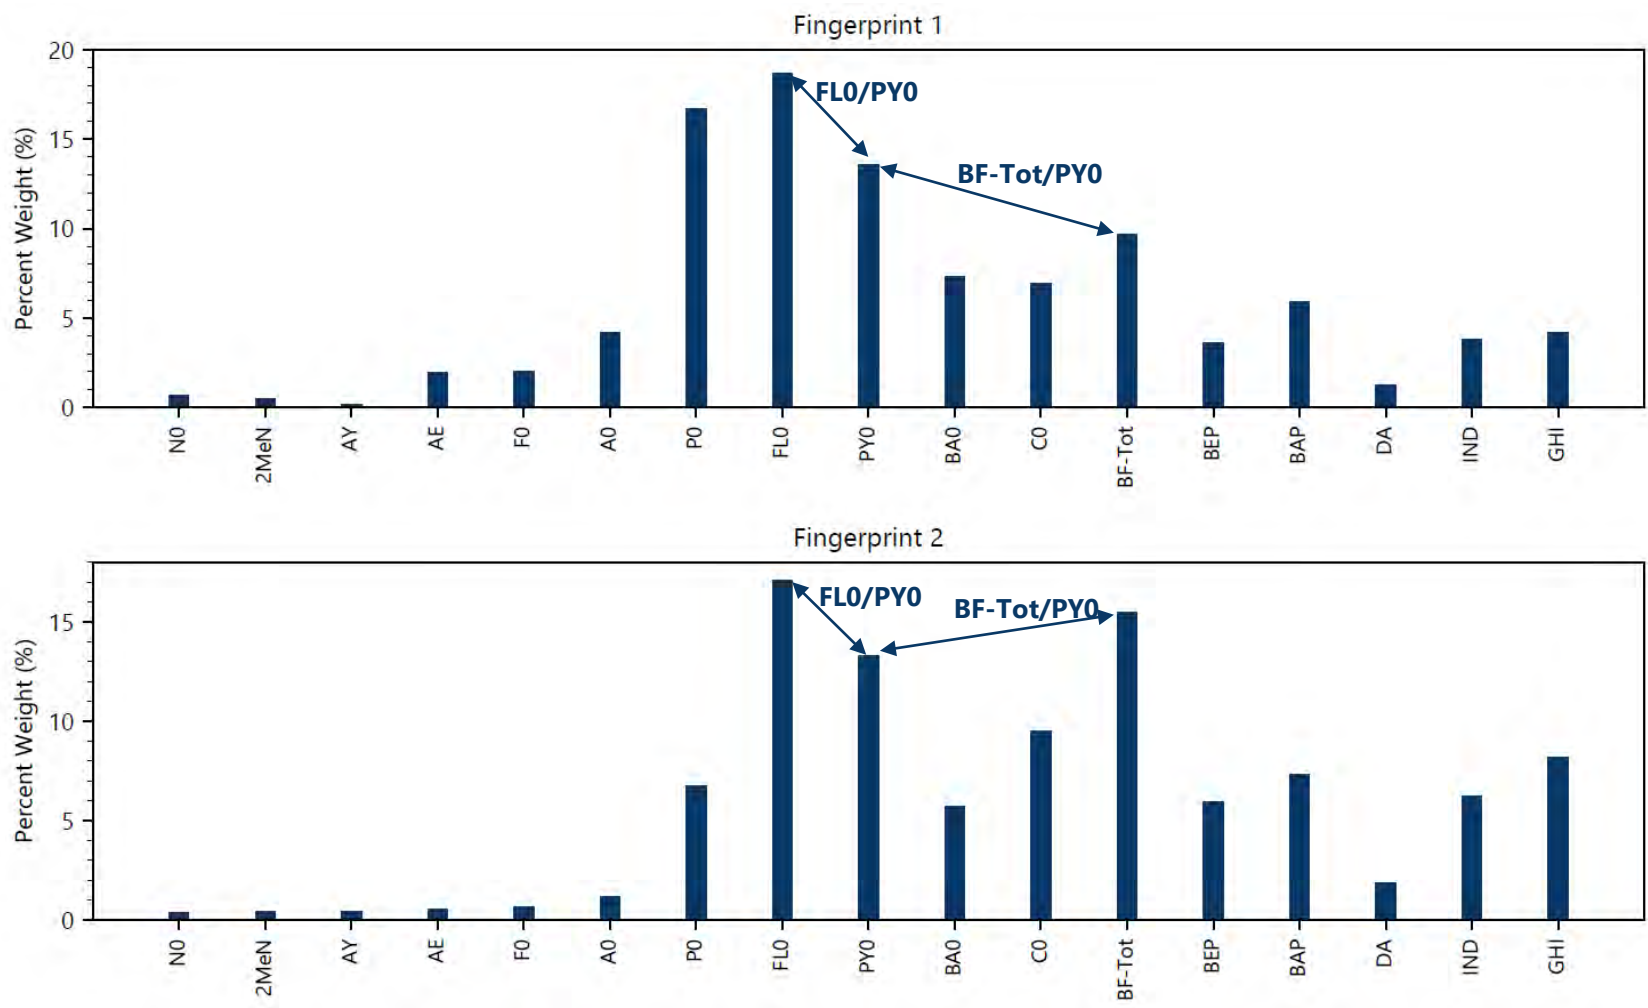
See Table 2-1 for x-axis PAH abbreviation definitions.
 Fingerprint 1 sample ID: KKR-20-023-C-00-01-200914.
 Fingerprint 2 sample ID: KKR-20-010-C-00-01-200918.
 Lines with arrows indicate the PAHs that are the ratios being evaluated.

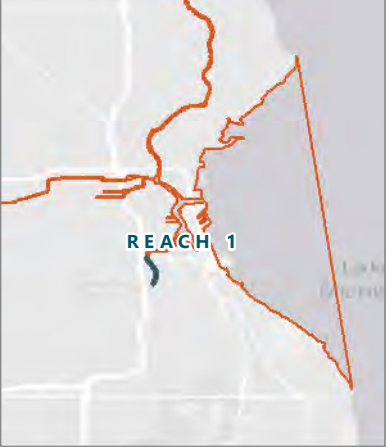
- 1) Horizontal datum: Wisconsin State Plane, South Zone, North American Datum of 1983 (NAD83), U.S. Feet
- 2) Reach 1 includes the Kinnickinnic River downstream from the bridge at South Chase Avenue to the bridge at West Becher Street.
- 3) Core counts only include cores within reach.

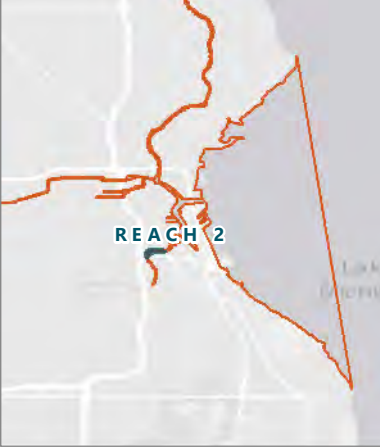
- 1) Horizontal datum: Wisconsin State Plane, South Zone, North American Datum of 1983 (NAD83), U.S. Feet
- 2) Reach 2 includes the Kinnickinnic River from the West Becher Street bridge downstream to the South Kinnickinnic Avenue bridge.
- 3) Core counts only include cores within reach.

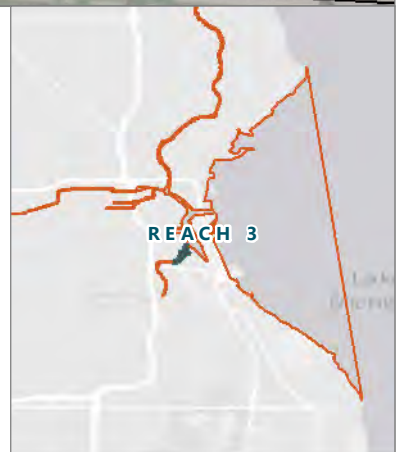
- 1) Horizontal datum: Wisconsin State Plane, South Zone, North American Datum of 1983 (NAD83), U.S. Feet
- 2) Reach 3 includes the Kinnickinnic River downstream of the South Kinnickinnic Street bridge to the upstream mouth of the Turning Basin.
- 3) Core counts only include cores within reach.
- 4) Samples collected as part of this investigation generally targeted locations outside the federal channel. The USACE conducted investigation of the Navigation Channel in 2020 at the request of EPA and DNR (JV 2020).
