Technical Memorandum

To: Nick Larabel, Enbridge Energy
From: Ryan Erickson and Jes Pedersen
Subject: Superior Terminal Tank 2 Ring Road Historical Response
WDNR BRRTS #: 02-16-586743
Date: December 18, 2020
Project: 49161092.08 003 004
Site Coordinates: 46.684174°, -92.057037° (NAD83)

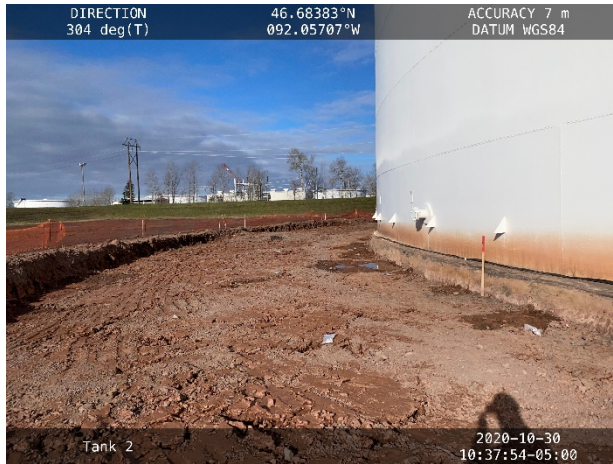
Photo 1

Photo 1: Tank 2 ring road excavation on southwest side of the tank. Photo taken facing northwest on October 30, 2020.

The Tank 2 ring road replacement excavation was approximately 700 feet in total length, 30 feet wide (out from the tank wall), and between 2 and 3 feet deep (Photos 1, 3, 5, 8; Figure 2; Attachment B – Sheets 1 through 3). Approximately 1 foot of road base gravel material and 1 to 2 feet of fat clay were excavated. Based on communications from the contractor, most of the soil with apparent hydrocarbon impacts was within 3 lateral feet of the tank wall and the top 2 vertical feet. The exception to this was the additional impacts on the north side of the tank up to 20 feet out from the tank wall. Small areas of standing water were present on the ground surface near the tank and no sheen was observed on the water surface by the contractor or Barr (Photos 2 and 7).

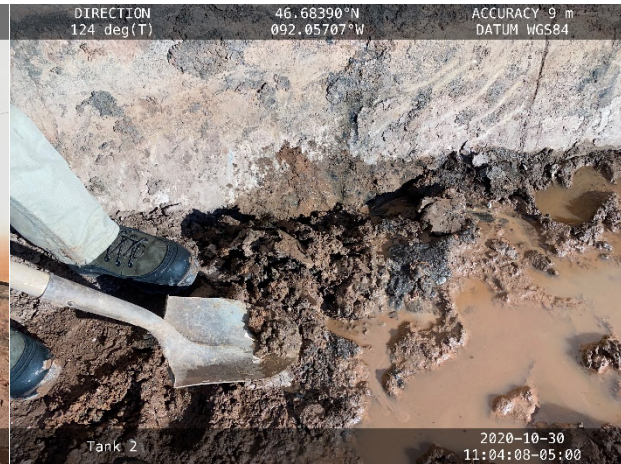
Photo 2

Photo 2: Area of localized contamination on the south side of Tank 2. Analytical sample *TK2 Road-B-1* was collected at this location. Photo taken October 30, 2020.

Based on the field screening results, four areas with evidence of residual contamination (soil headspace greater than 10 ppm) were identified in the base of the final excavation. Specifically, the areas with residual impacts (headspace readings between 15.7 and 55.6 ppm) were identified on the south side of the tank (Photos 1 and 2) and the north side of the tank (Photos 5 and 6). Soil with elevated headspace readings typically also had a light to moderate hydrocarbon odor and discoloration. The soil with the highest headspace reading (*B-14=55.6 ppm; 11/5/2020*) was near the D-door on the north side of the tank (Photos 5, 6).

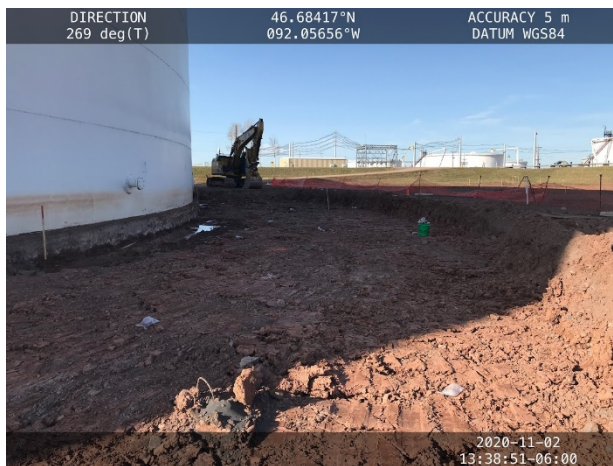
Photo 3

Photo 3: Tank 2 ring road excavation on the southeast side of the tank. Photo taken facing north on November 2, 2020.

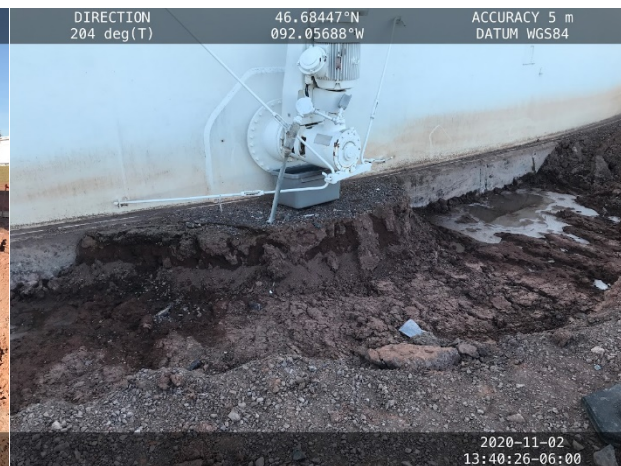
Photo 4

Photo 4: Area of impacted soil beneath mixer valve on the northeast side of Tank 2. Analytical sample *TK2 Road-B-2* was collected at this location. Photo taken facing south on November 2, 2020.

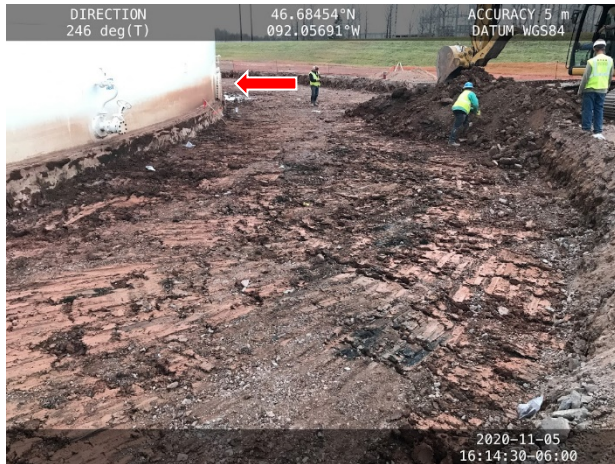
Photo 5

Photo 5: Tank 2 ring road excavation with discolored soil on the north side of the tank. The red arrow is pointing at the northern D-door. Photo taken facing southwest on November 5, 2020.

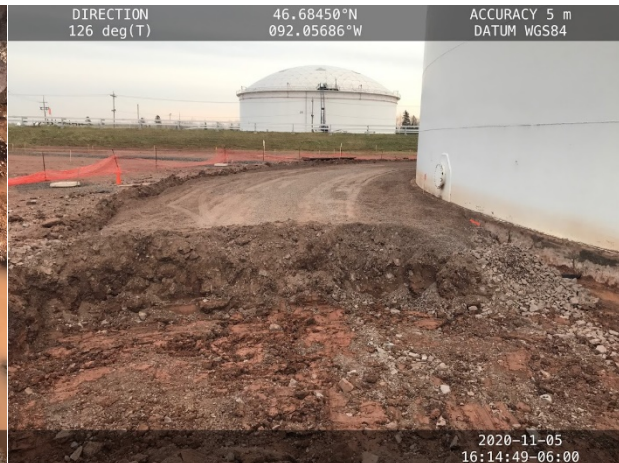
Photo 8

Photo 8: New road fill material and the road cut (photo foreground) near the northeast side of Tank 2. Photo taken facing southeast on November 5, 2020.

Based on the field screening observations and the presence of Terminal infrastructure, additional excavation activities did not go beyond the final road grade. The new ring road was constructed, which included a geotechnical liner and between 2 and 3 feet of clean fill material (Photos 8 and 9).

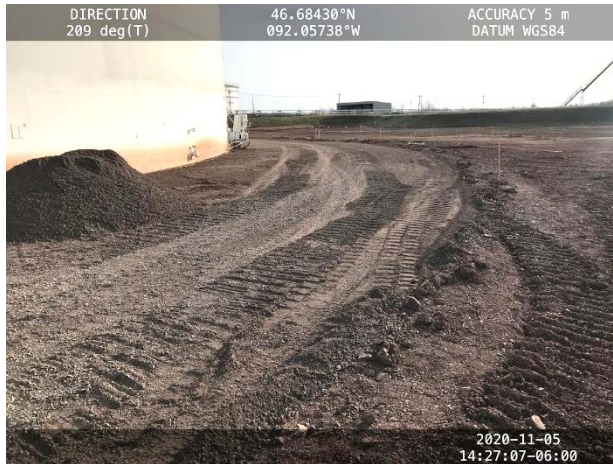
Photo 9

Photo 9: Ring road during construction on the west side of Tank 2. Photo taken facing south on November 5, 2020.

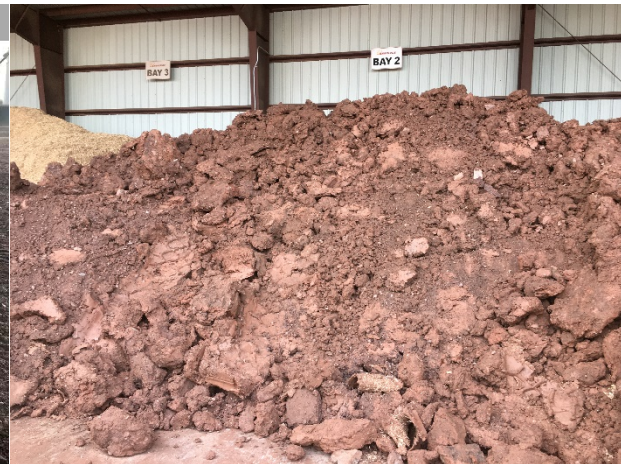
Photo 10

Photo 10: Contaminated soil stockpile in the Terminal Soil Management Area. Photo taken on October 28, 2020.

During the excavation and replacement of the ring road, soil with evidence of contamination was either transported to the Terminal Soil Management Area contaminated soil building (Photo 10) or direct hauled to the landfill, once approval was granted. On October 28, 2020, Barr collected characterization samples *TK2 RD-Stockpile-1* and *TK2 RD-Stockpile-2* from the contaminated soil stockpile for laboratory analysis at ALS Laboratory. The samples were analyzed for diesel range organics and benzene, toluene, ethyl benzene, and xylenes. The laboratory report and waste profile application were submitted to the VONCO V landfill in Duluth, Minnesota and the soil was assigned waste profile #20-107-I. A total of 706.3 tons of contaminated soil was hauled to the landfill November 4 through 10, 2020. The waste profile documents, waste characterization laboratory report, and landfill summary report are included in Attachment D.

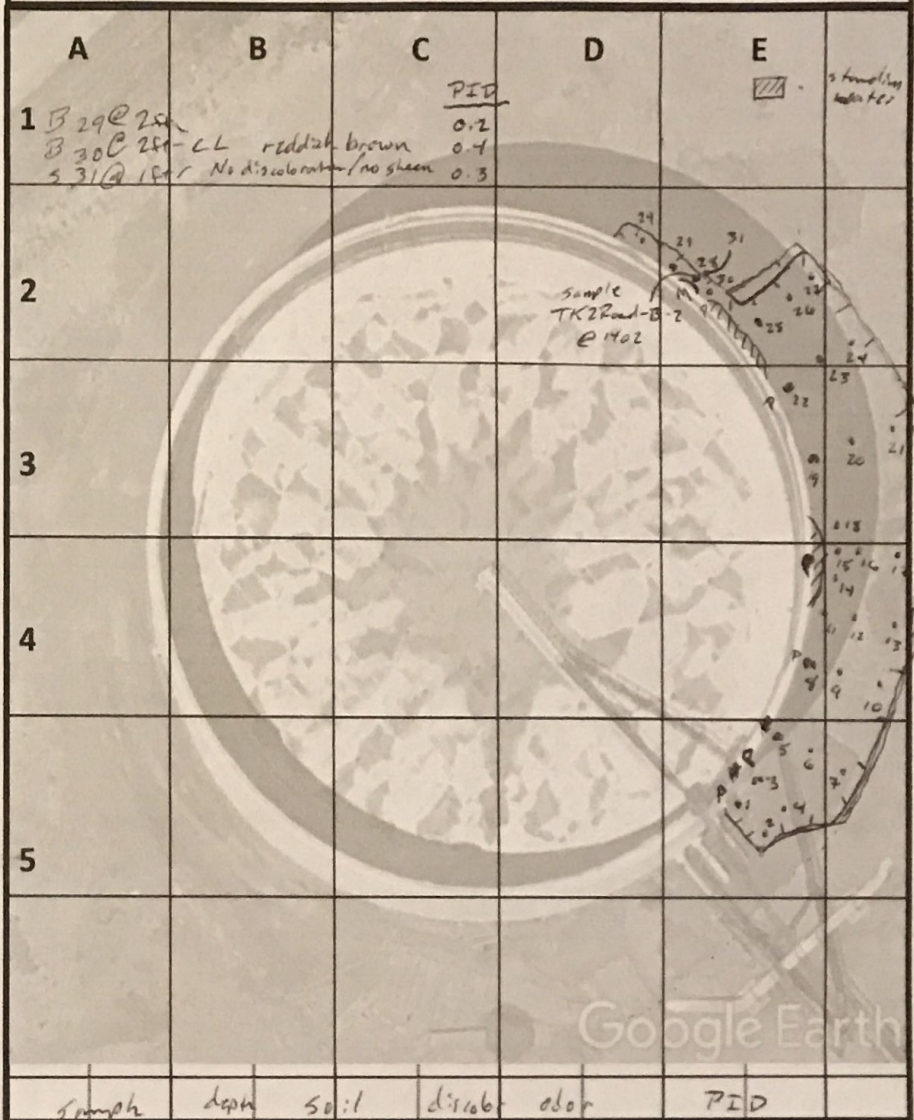
SITE SKETCH: north is up; excavation extents & depths, impacted areas, sample locations, borings, wells, structures, utilities, natural features...
1 inch/grid = 50 FEET
