**Re: Former Shorewood Queensway Cleaners**  
4300 N. Oakland Avenue  
Shorewood, Wisconsin  
WDNR BRRTS Case No. 03-41-586899

**Subject: Site Investigation Work Plan for Petroleum Release**

# Site Investigation Work Plan

**Former Shorewood Queensway Cleaners**  
4300 N. Oakland Avenue  
Shorewood, Wisconsin

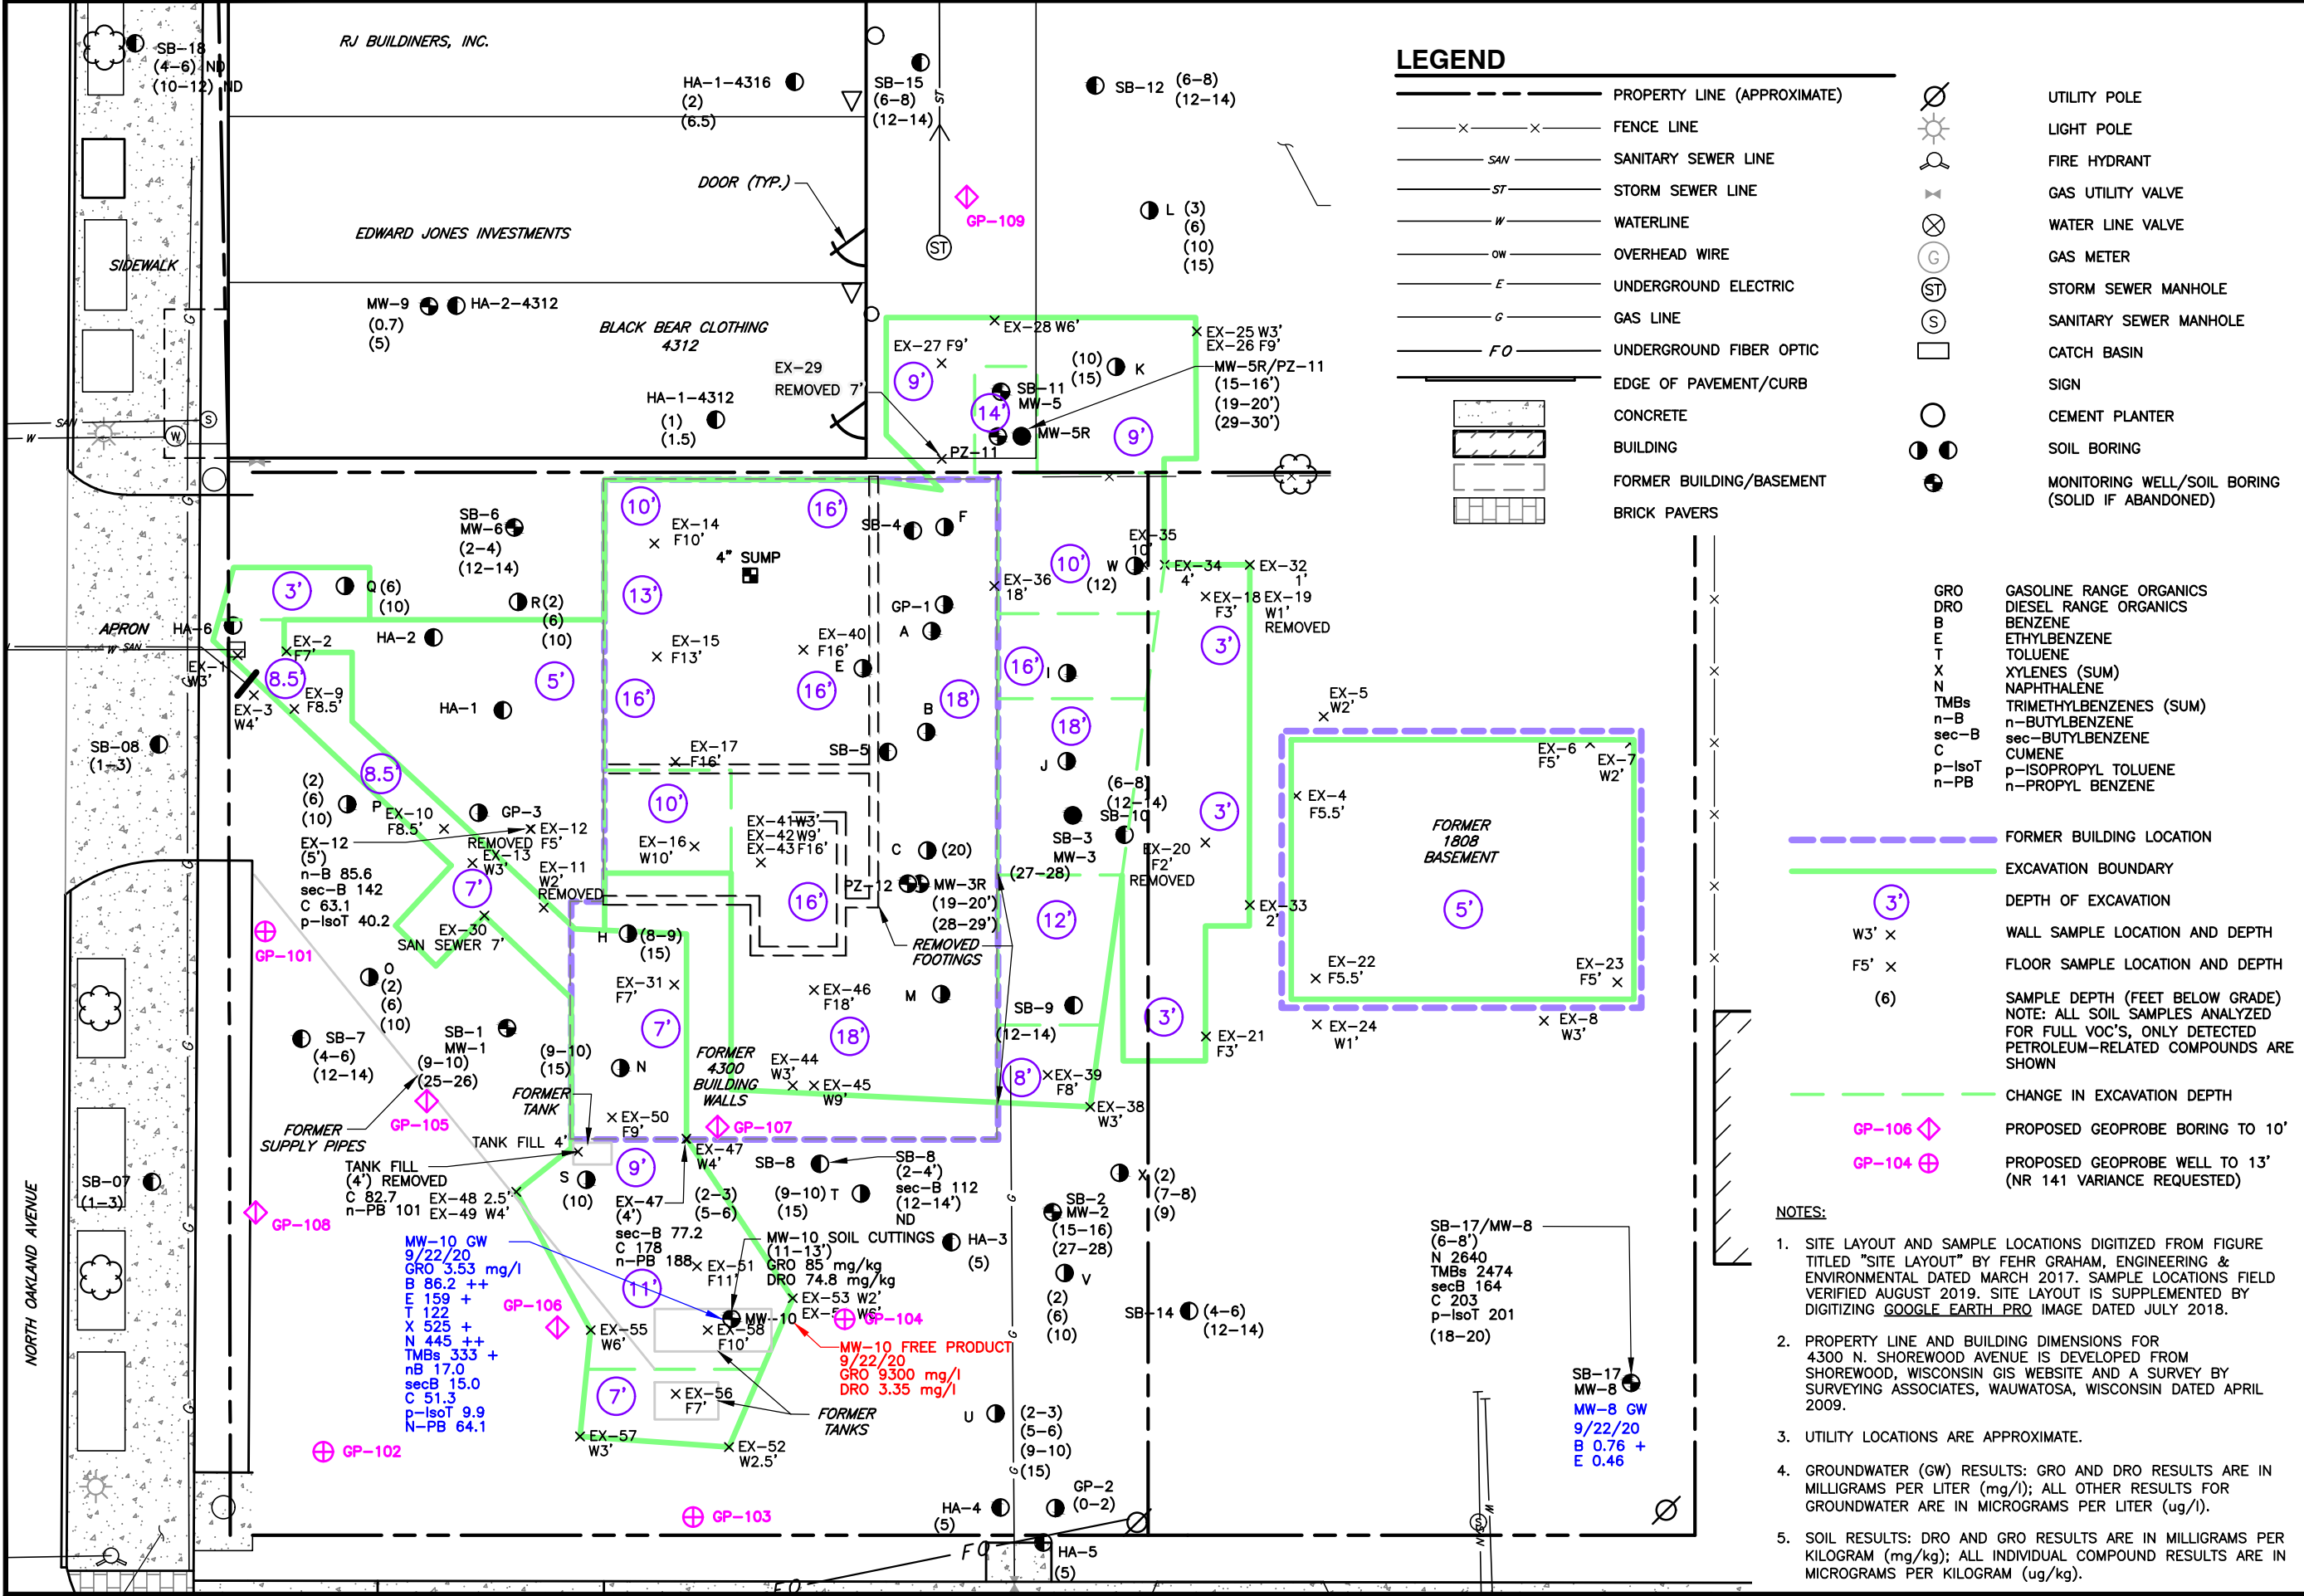
### FIGURE 7

An estimated eight Geoprobe™ soil borings (GP-101 to GP-108) will be advanced. The borings will be advanced to a depth of 10 to 13 feet below grade, with continuous soil samples retained for observation and analysis. The macrocore drilling method will be used, advancing a 2.5-inch diameter sample tube lined with a disposable five-foot long poly-acetate liner into the dense native silty clay soil. Excellent sample recovery has been noted in previous borings that were drilled at the site using this method.

One soil boring (GP-109) is planned for drilling related to the drycleaner investigation in the alley north of the Property. This boring is proposed to define the extent of observed soil impacts containing PCE north of the north wall of the July 2020 excavation. Two soil samples will be obtained from this boring at approximately five feet and ten feet below grade, with laboratory analysis of full VOCs.

If a boring displays obvious field impacts, an additional “step out” boring will be advanced an estimated 15 to 20 feet further from the source area (tanks) in an effort to define the extent of the observed contamination.
