Ramboll Project:  
**1690020998**

# **NR 716 SITE INVESTIGATION**

**RETAIL STORE**

**1305 NORTH JOHNS STREET**

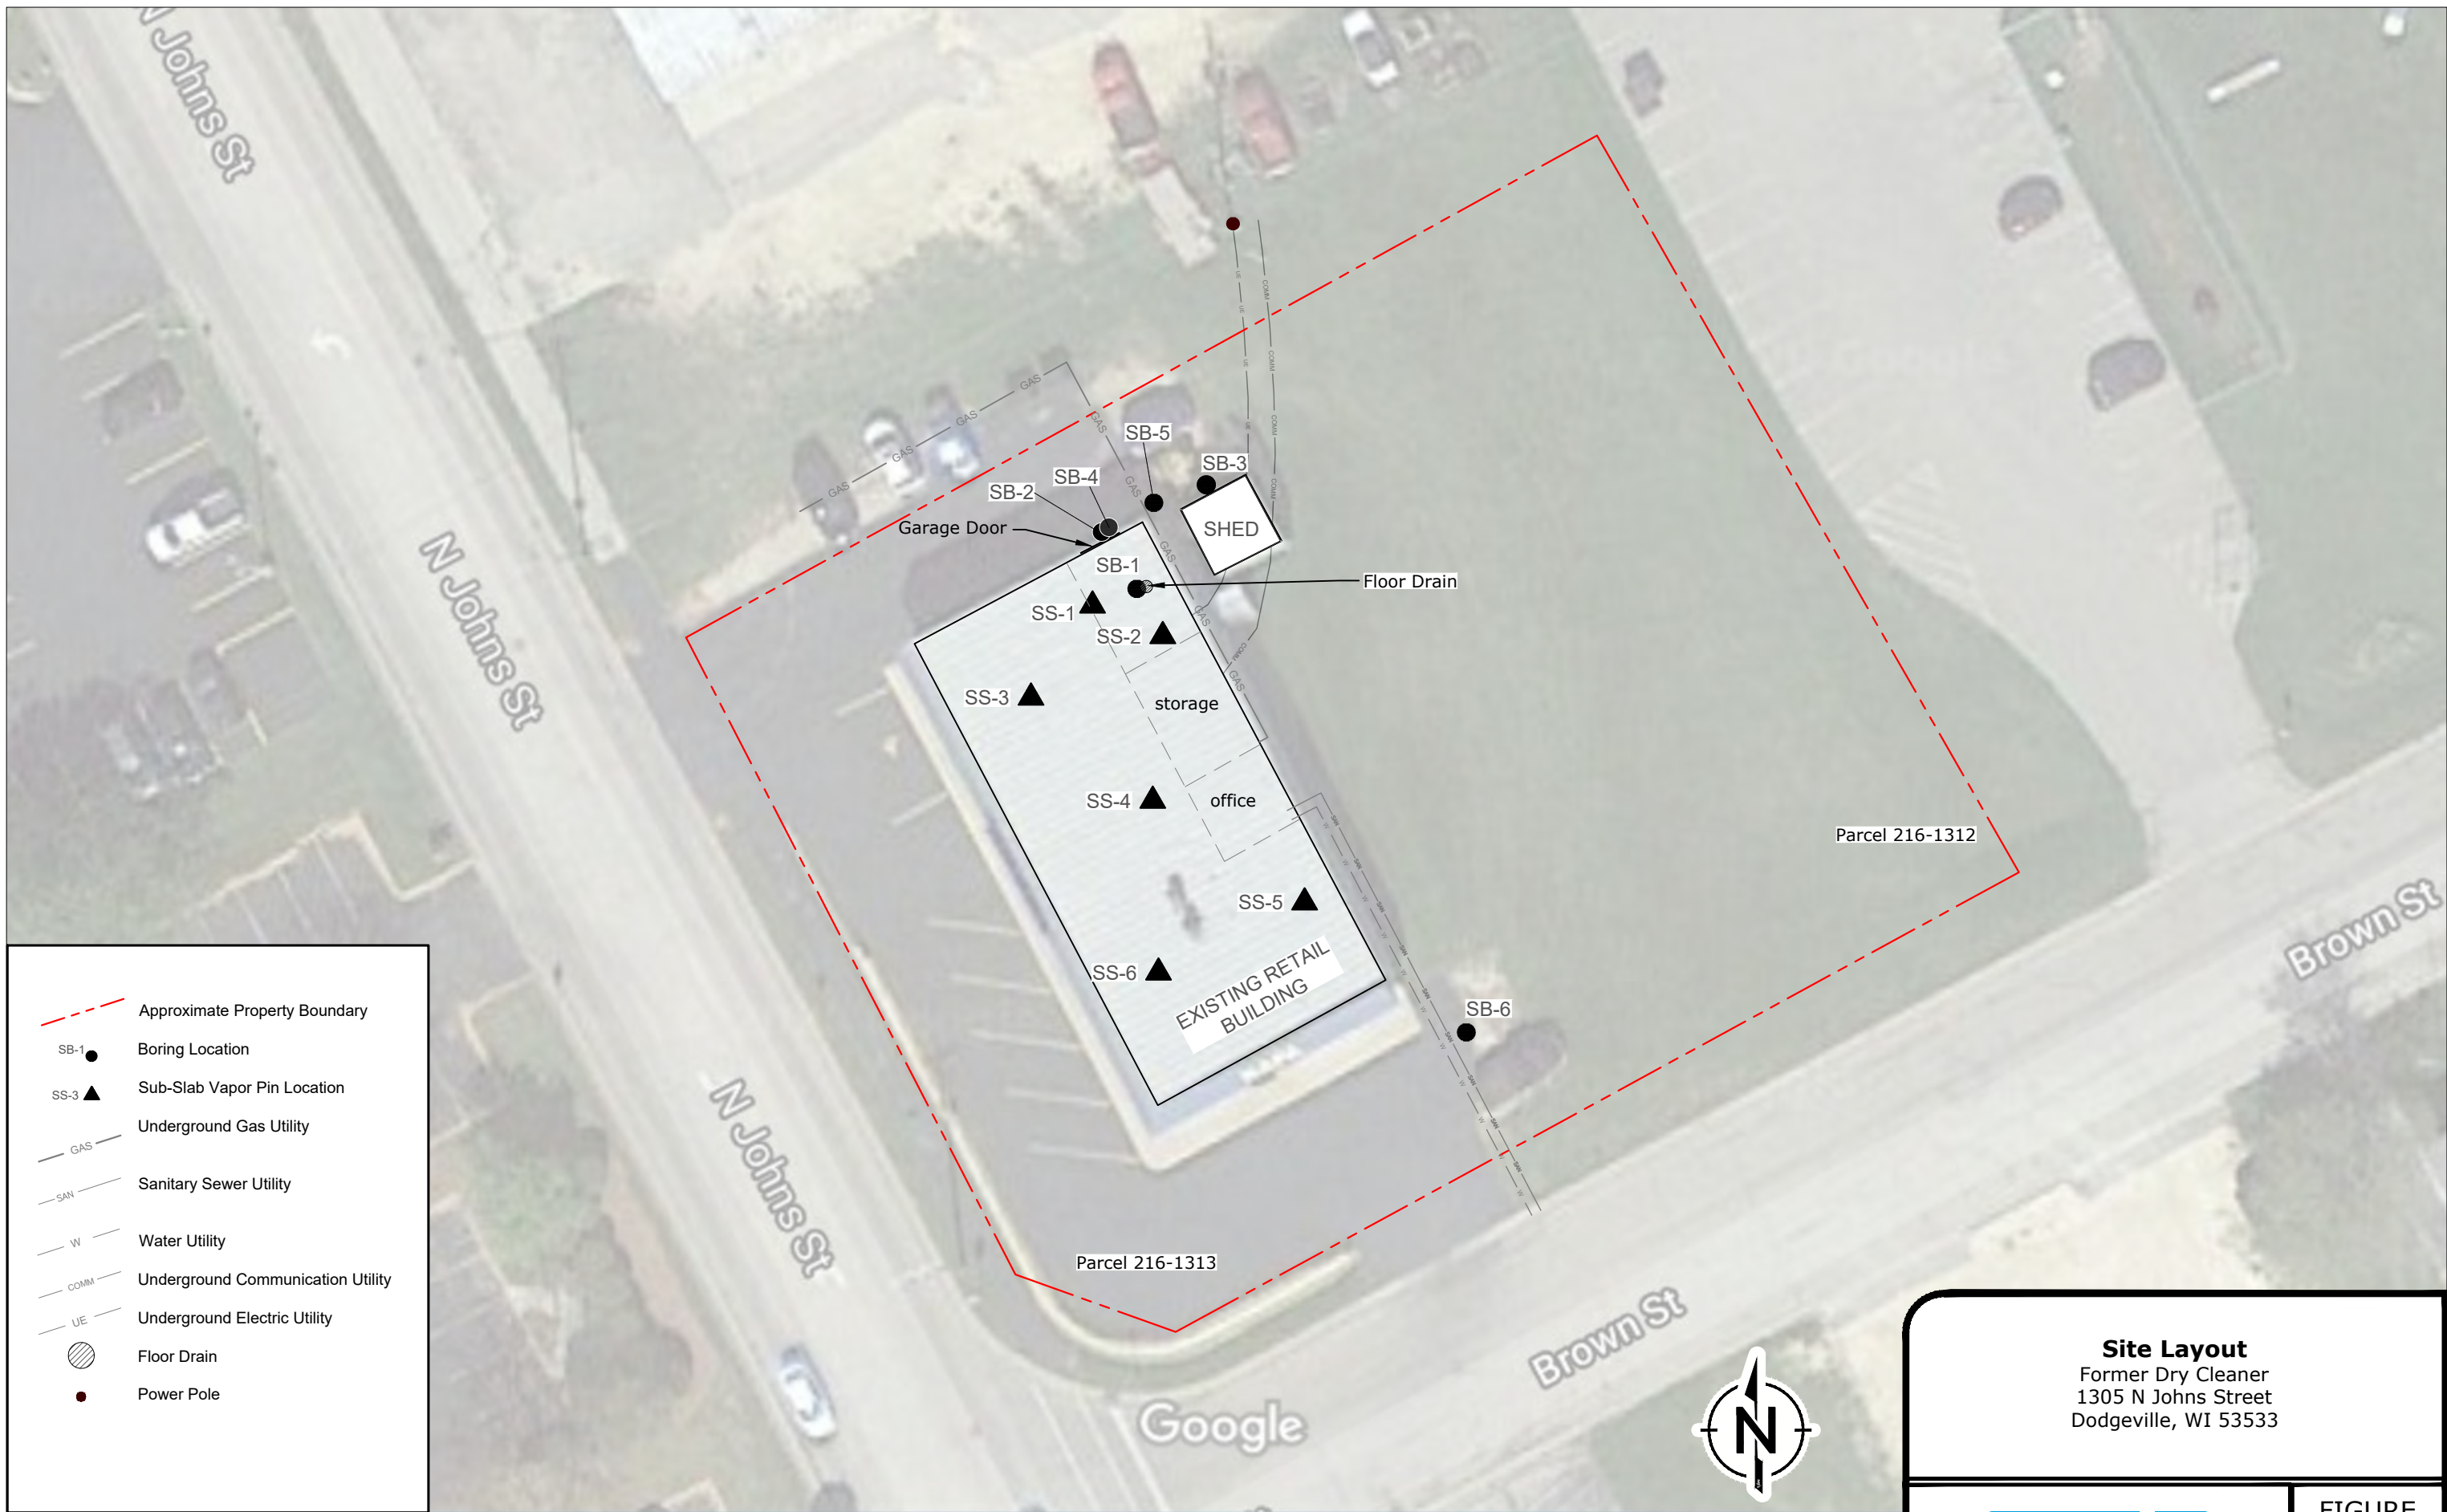
<p><b>Site Layout</b> Former Dry Cleaner 1305 N Johns Street Dodgeville, WI 53533</p>	
	<p>FIGURE <b>1</b></p>
<p>DRAFTED BY: rpm</p>	<p>DATE: 04/29/2021</p>

Approximate Property Boundary
	Boring Location
	Sub-Slab Vapor Pin Location
	Underground Gas Utility
	Sanitary Sewer Utility
	Water Utility
	Underground Communication Utility
	Underground Electric Utility
	Floor Drain
	Power Pole

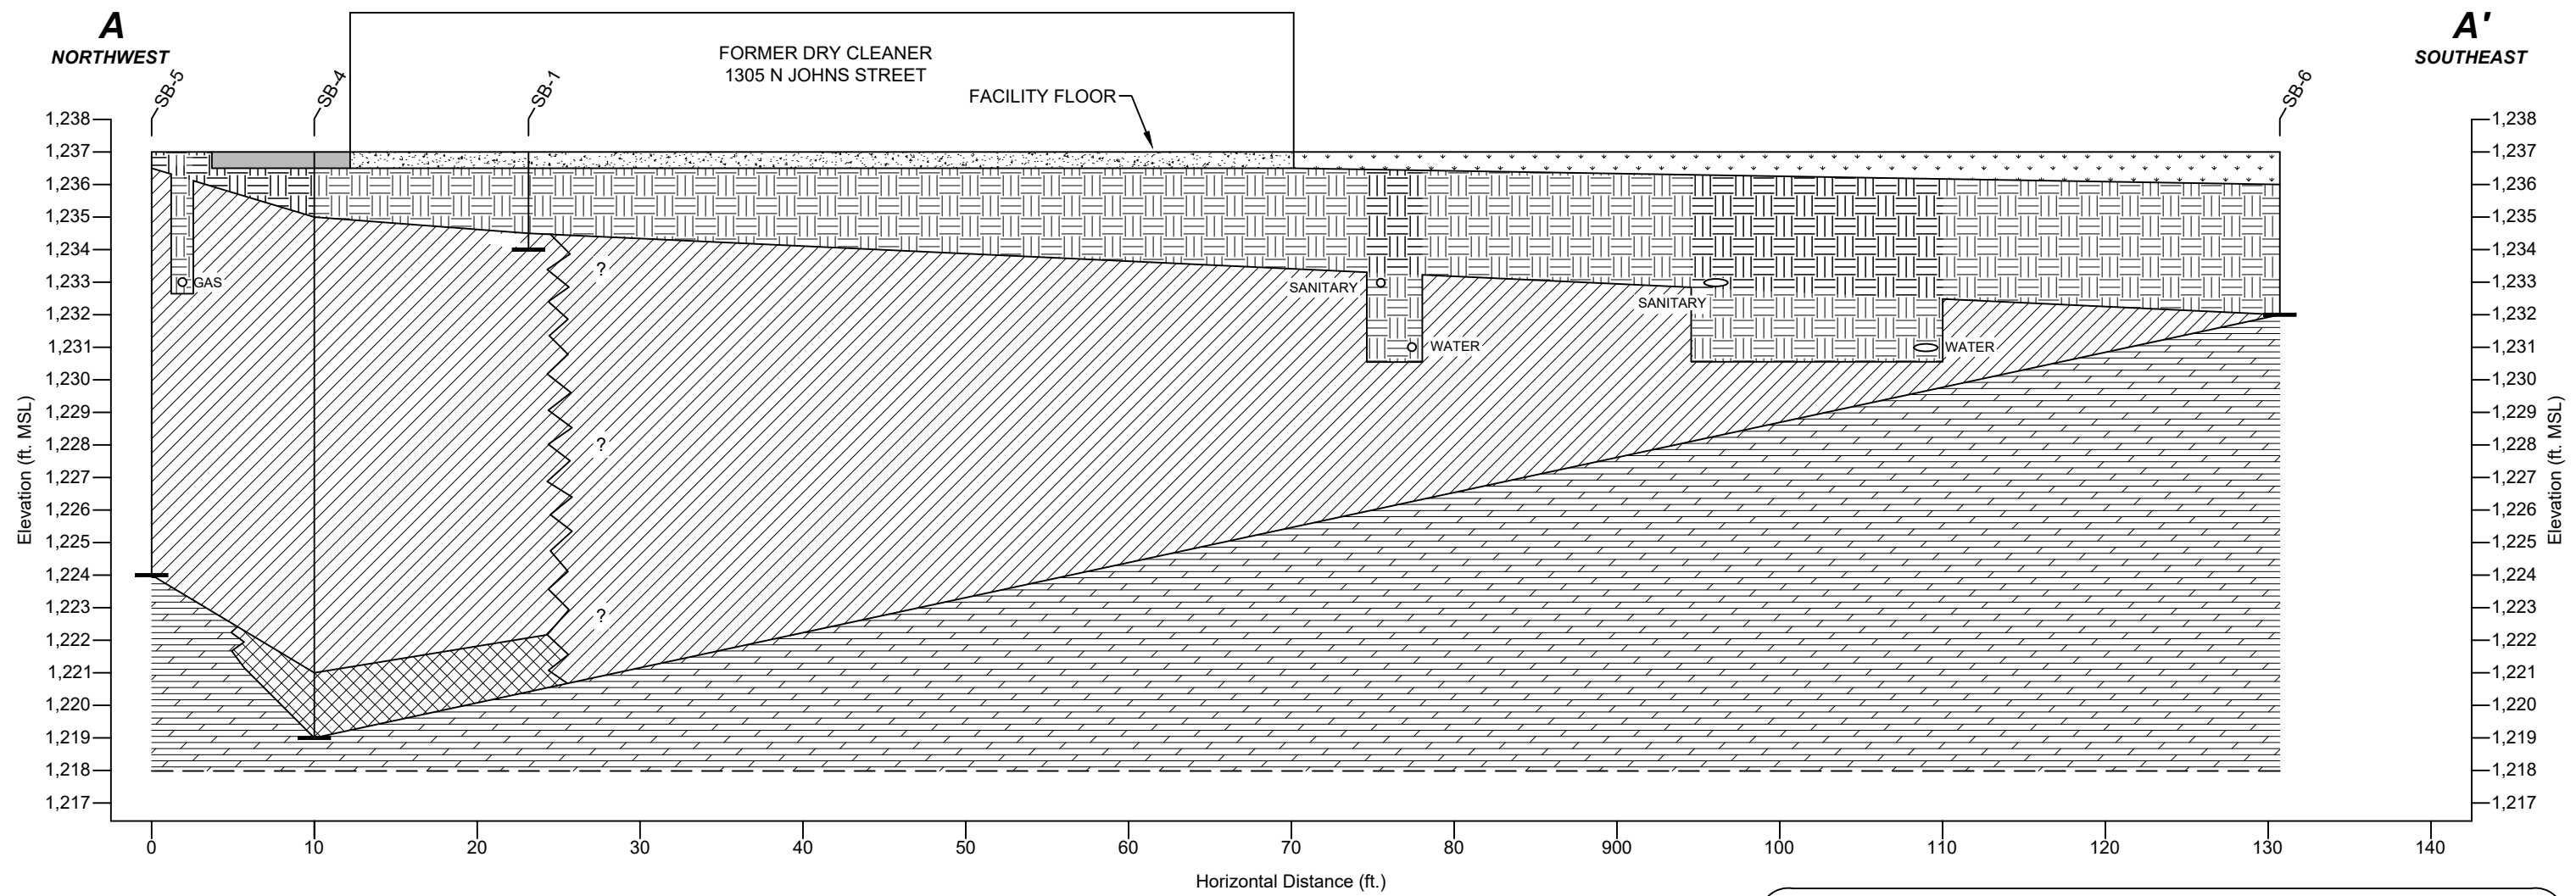
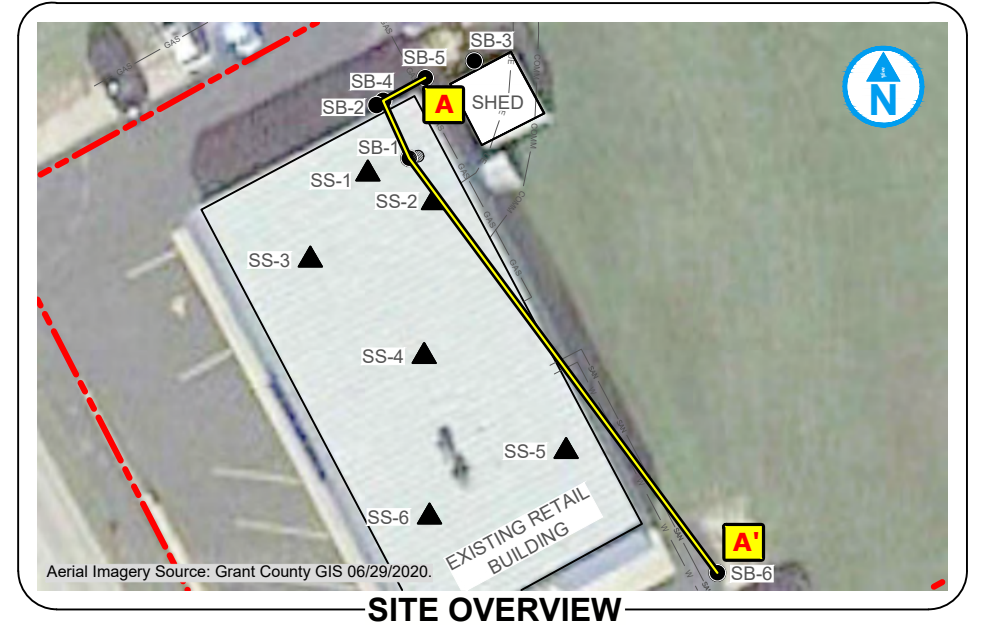
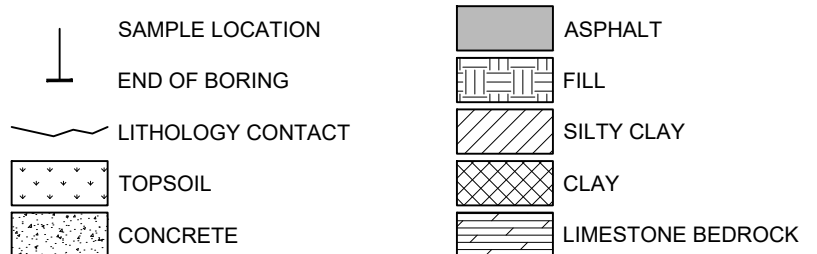
**FIGURE 3**

**GEOLOGIC CROSS-SECTION A-A'  
(NORTHWEST-SOUTHEAST)**

The soil observed during the field investigations consists of fill soils (loose silty sand, silty clay, and clayey silt with variable amounts of sand, gravel, and organic material) from 2 to 8 feet bgs. Native soils consist primarily of silty clay with traces of sand to 18 feet bgs (SB-4). Limestone bedrock was encountered at 5 feet bgs in boring SB-6, 13 feet bgs in boring SB-5, and at 18 feet bgs in boring SB-4 (bedrock at the Site slopes to the southwest). No odors or other indications of contamination were encountered during the advancement of the three borings. Minimal PID measurements were measured that ranged from 0.0 to 0.3 I.U., with the highest PID reading at 2 to 3 feet bgs in boring SB-4. Low permeability silty clays would tend to impede or lessen the effects of vapor intrusion into the building at the Site. No groundwater was observed in any of the borings. A geological cross-section illustrating the subsurface features at the Site is provided in **Figure 3**.
