## Technical Memorandum

**To:** Nick Larabel, Enbridge Energy  
**From:** Ryan Erickson  
**Subject:** Enbridge Terminal – FIAT 2800 (Booster 1) Historical Response  
**WDNR Site BRRTS #:** 02-16-588091  
**Date:** March 24, 2022  
**Project:** 49161092.11 003 002  
**Site Coordinates:** 46.688581°, -92.055853° (NAD83)

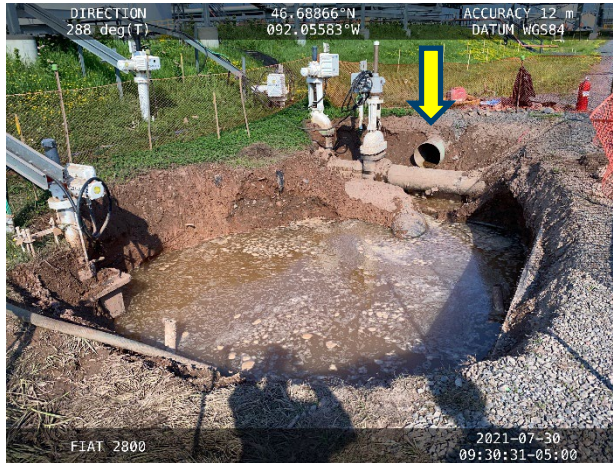
**Photo 1**

**Photo 1:** Project excavation. Sheen observed on far end of excavation near buried stormwater culvert (yellow arrow). Photo taken facing northwest on July 30, 2021.

On July 30, 2021, Barr inspected the site. Groundwater in the excavation was approximately 2 feet below ground surface (bgs), as shown in Photos 1 and 2. A light sheen was observed on the groundwater in the north end of the excavation (Photo 3). Excavation soil samples were not collected at the time because of the presence of groundwater. No evidence of soil impacts (e.g., sheen, discoloration) were observed in the sidewalls exposed above the water line. Barr collected water characterization sample *FIAT-2800-Water 1* from the standing water in the excavation. The sample was submitted to the ALS Environmental laboratory in Holland, Michigan for analysis of diesel range organics (DRO) and benzene, toluene, ethylbenzene, and xylenes (BTEX). BTEX analyte concentrations were below the laboratory reporting limits and Wisconsin Administrative Code NR 140 Enforcement Standard (ES) and Preventative Action Limit (PAL) criteria. DRO was detected at 0.25 milligrams per liter (mg/L) but there are no NR 140 ES or PAL criteria for DRO. Additional information regarding the disposal of the water is provided in the *Material Management* section of this document.

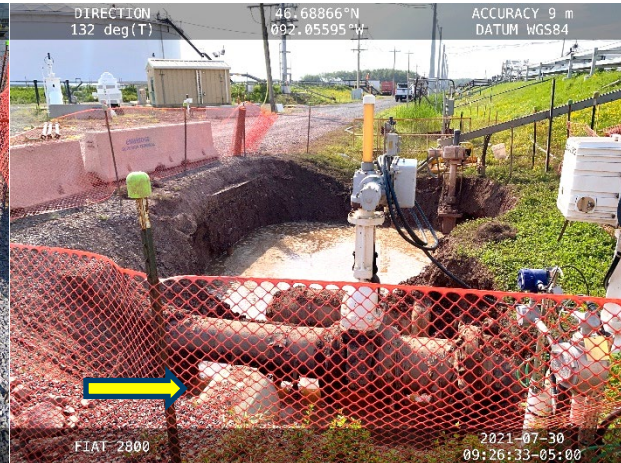
**Photo 2**

**Photo 2:** Project excavation. Sheen observed near buried stormwater culvert (yellow arrow). Photo taken facing southeast on July 30, 2021.

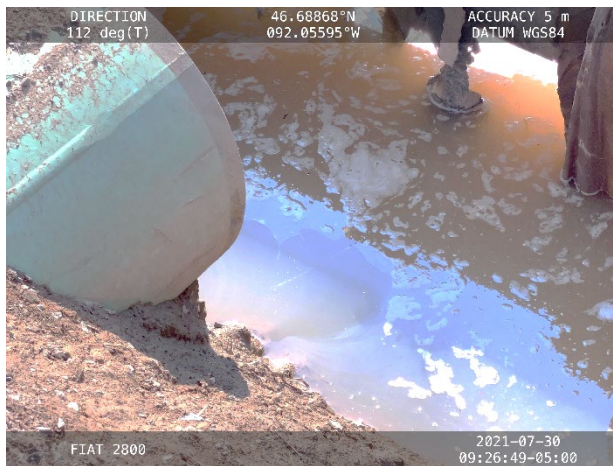
**Photo 3**

**Photo 3:** Sheen observed on groundwater in northern end of excavation near buried stormwater culvert (green pipe on left side of photo). Photo taken facing southeast on July 30, 2021.

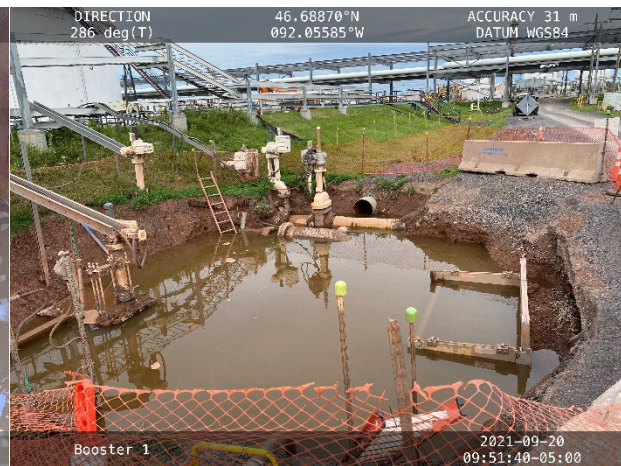
**Photo 4**

**Photo 4:** Project excavation. No sheen observed. Photo taken facing northwest on September 20, 2021.

On September 20, 2021, Barr inspected the site again and no sheen was observed on the water surface (Photo 4). Enbridge intended to have Barr return to the site to field screen and sample the final excavation sidewalls and bottom. However, the infrastructure project was delayed and when it was completed on October 12, 2021, the project team backfilled the excavation with clean fill before soil samples could be collected.

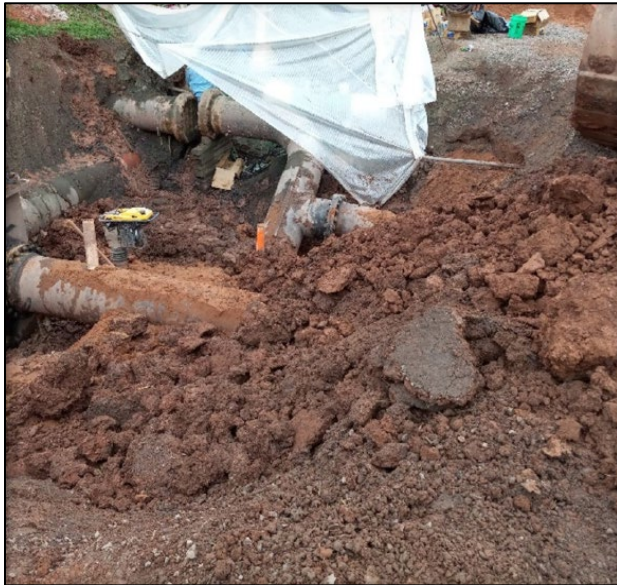
**Photo 5**

**Photo 5:** Final project excavation after infrastructure work and before backfilling. Photo taken by inspector facing northwest on October 12, 2021.

During the final infrastructure activity on October 12, 2021, the site inspector observed that excavation soil and groundwater conditions. During that work, the inspector observed no oil, oil sheen or grease or other evidence of petroleum impacts. Photographs 5 and 6 depict the final excavation and backfill.

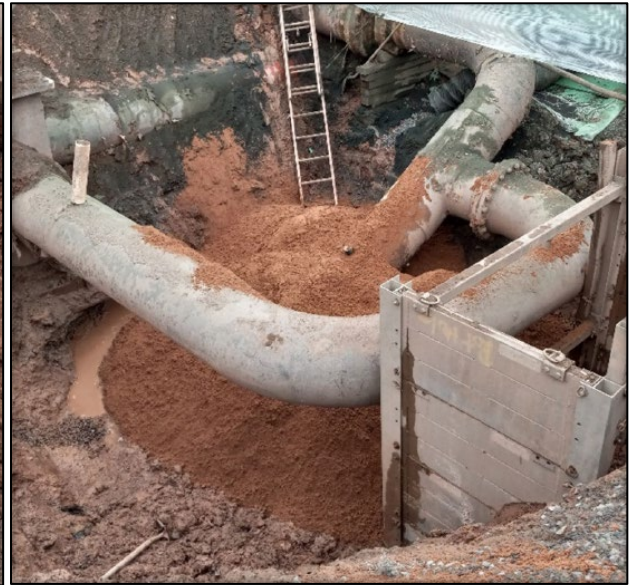
**Photo 6**

**Photo 6:** Final project excavation after infrastructure work. Clean sand fill is shown in the middle of the photo. Photo taken by inspector facing west on October 12, 2021.
