January 29, 2021
File No. 25219179.00

Subject: Interim Action Report for Vapor Mitigation System
Golden Flame Family Restaurant
2604 Custer Street, Manitowoc, WI
Susie's Restaurant Site, BRRTS #02-36-000516

Figure 1
Vapor Mitigation System

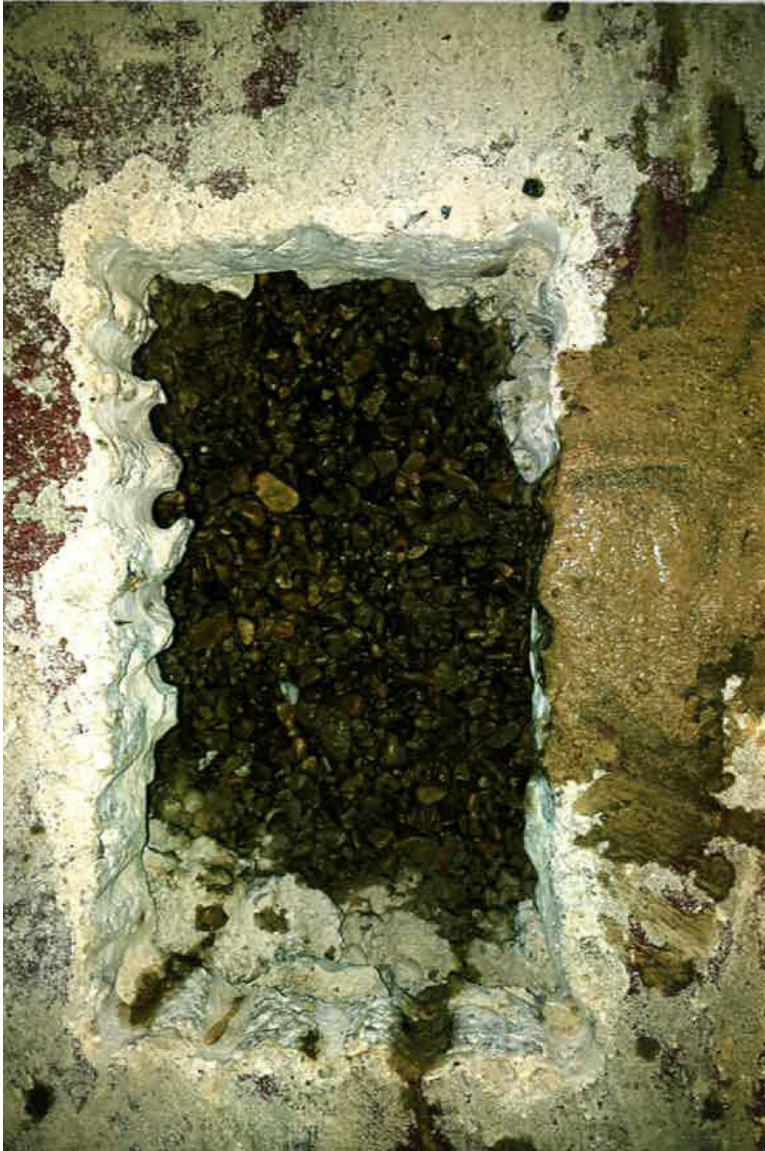
Photo 1: Excavation through floor slab at Pickup Point 1.

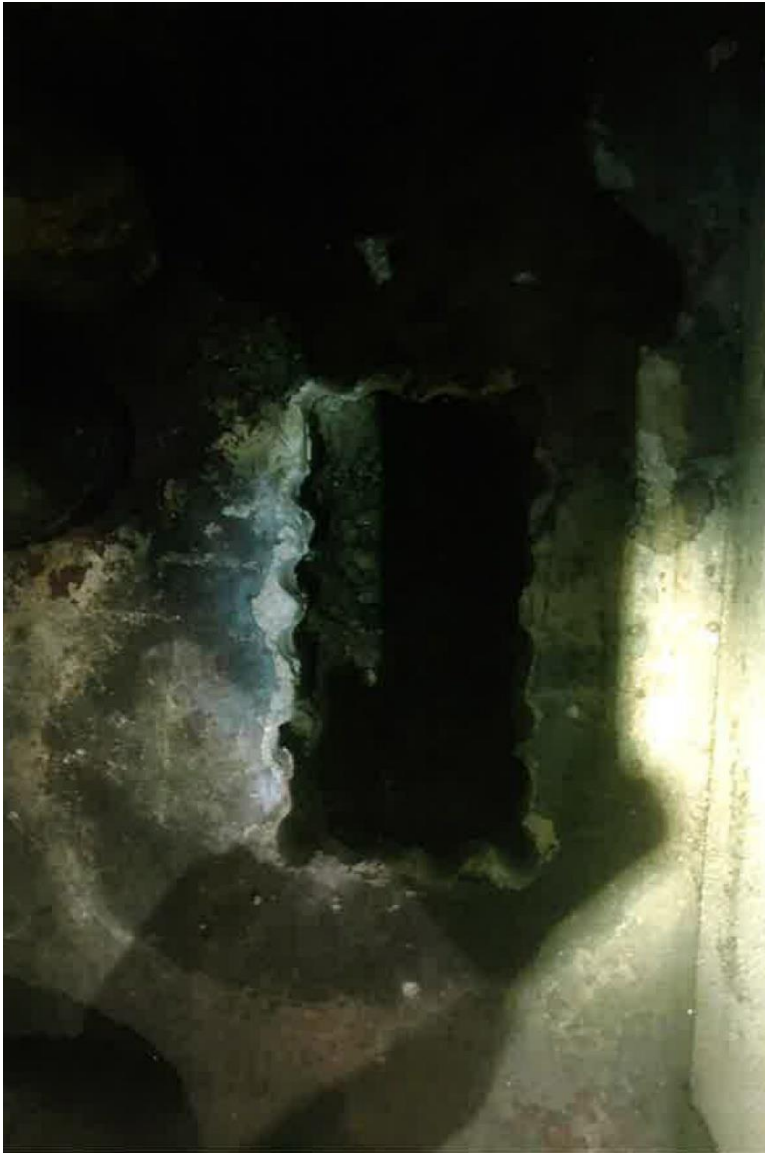
Photo 2: Excavation through floor slab at Pickup Point 2.

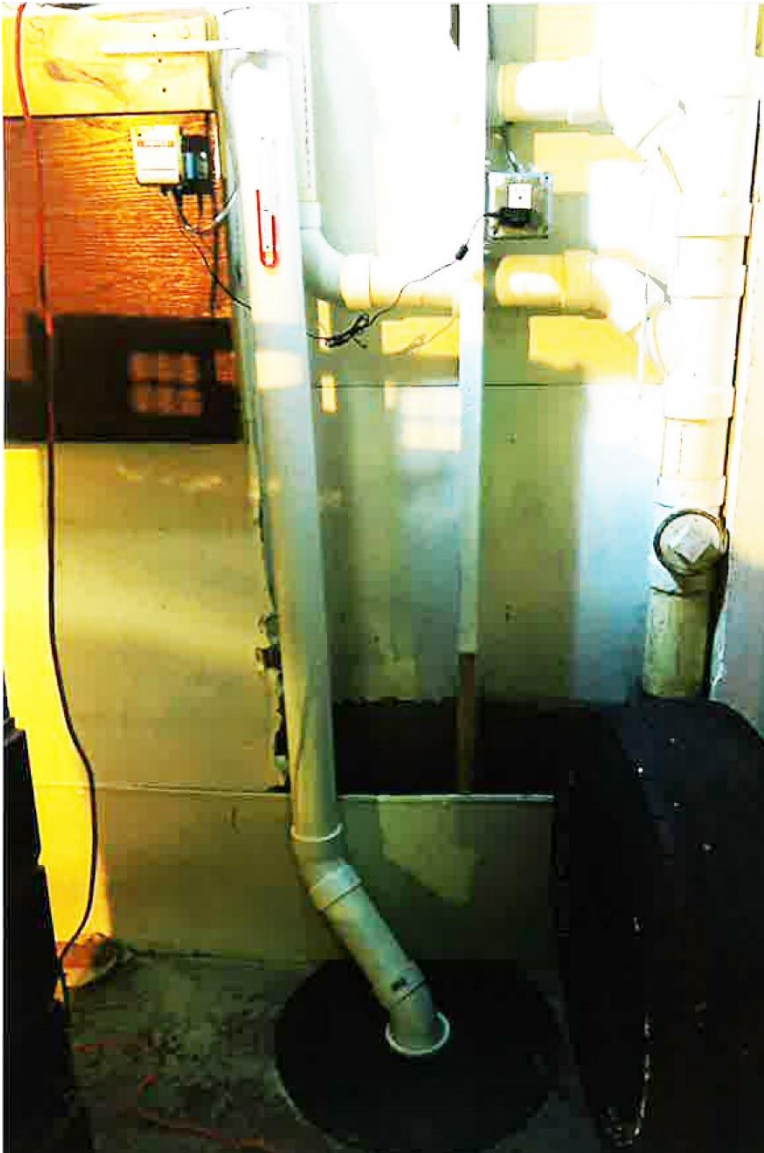
Photo 3: Seal and piping at Pickup Point 1.

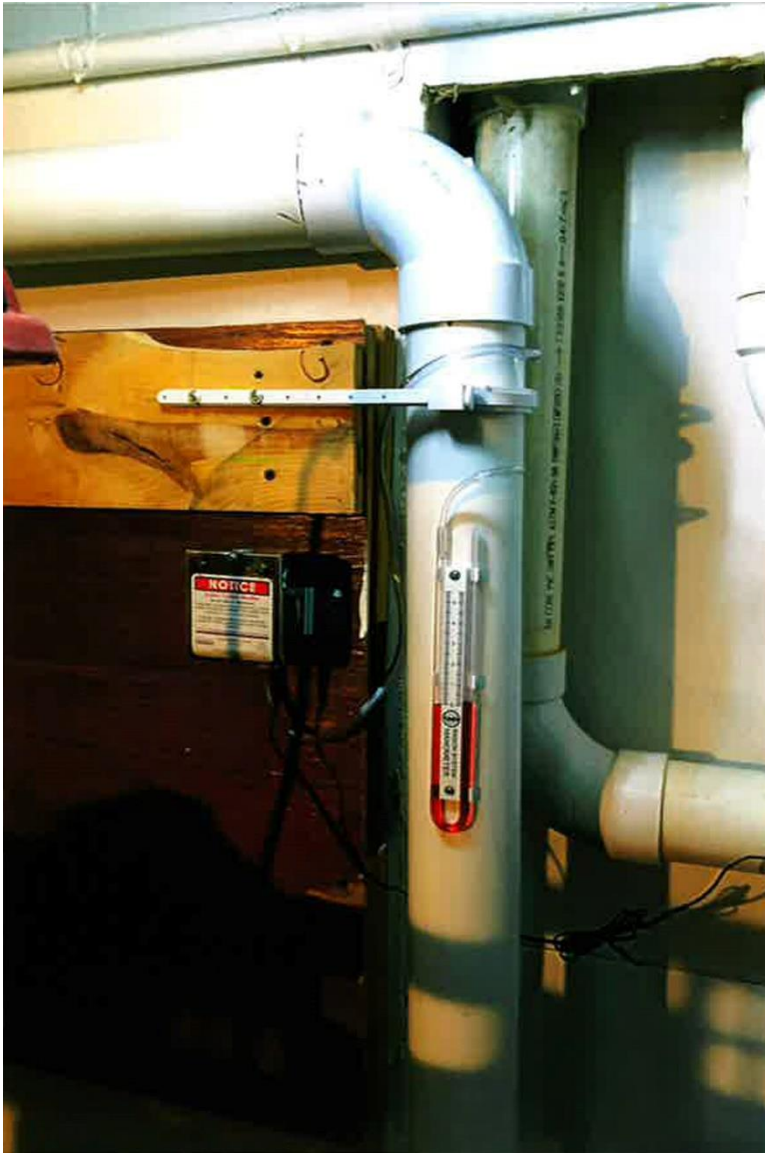
Photo 4: Manometer and system alarm at Pickup Point 1.

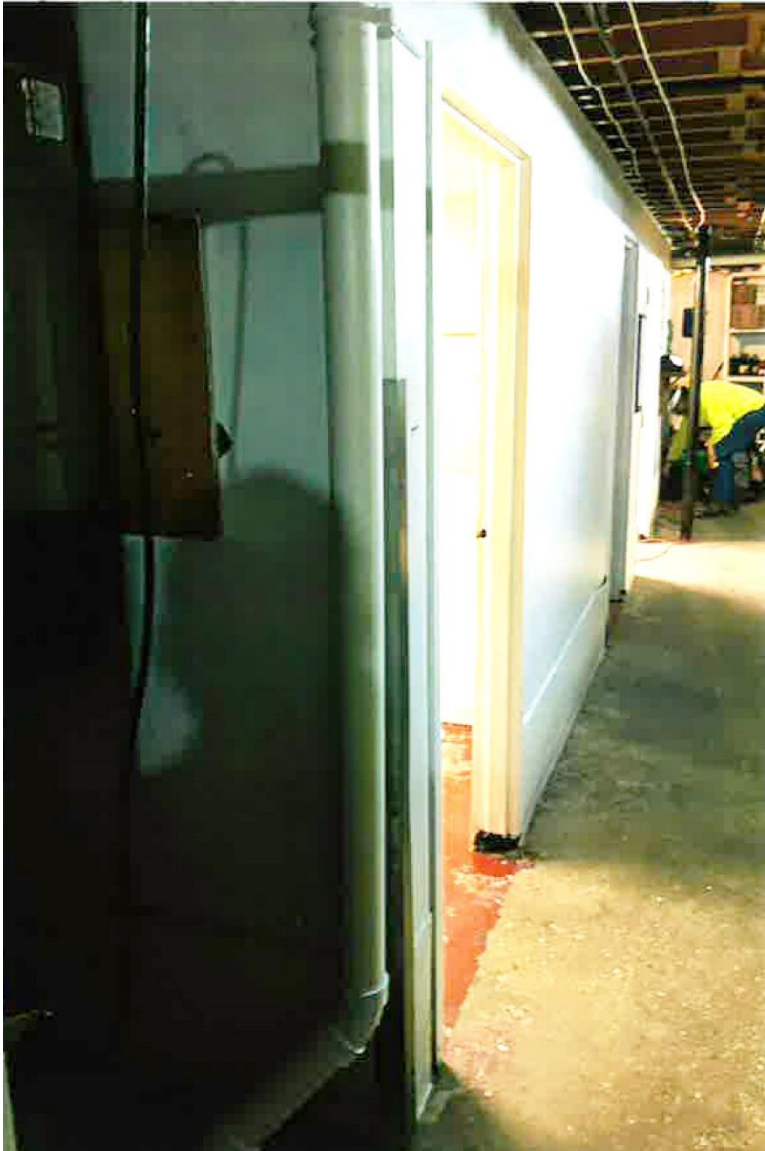
Photo 5: Pickup Point 2.

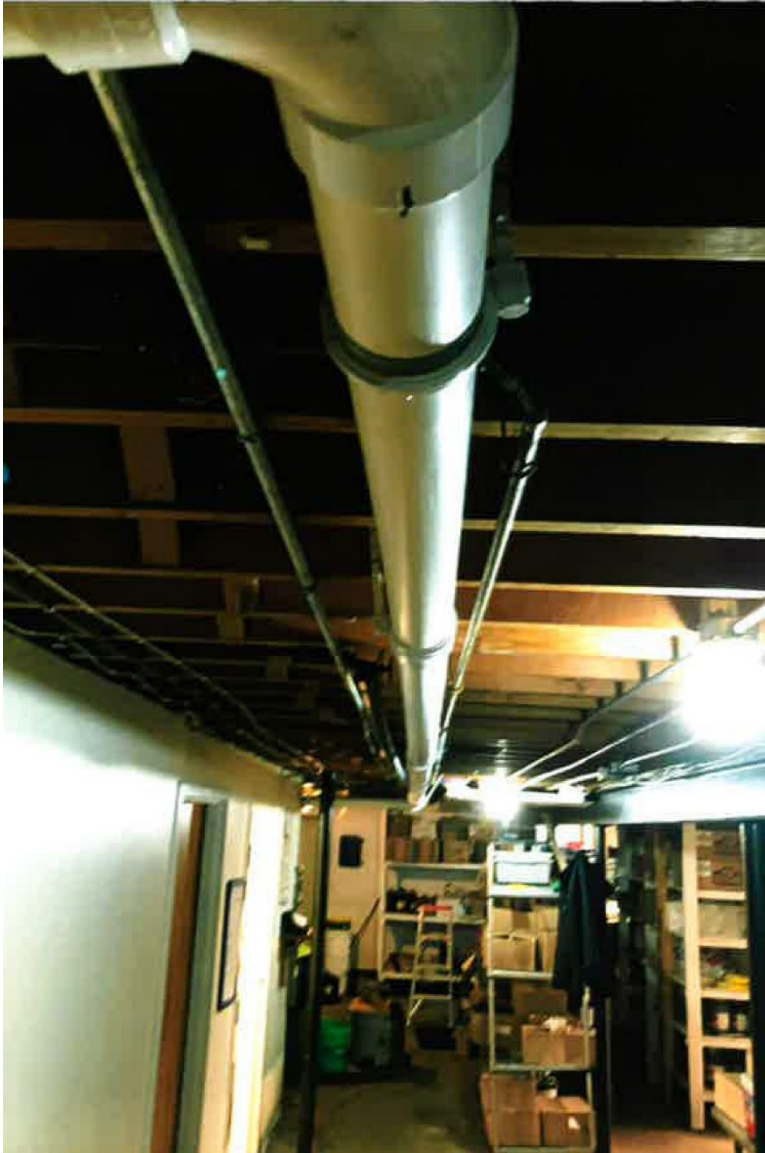
Photo 6: Piping run from Pickup Point 2.

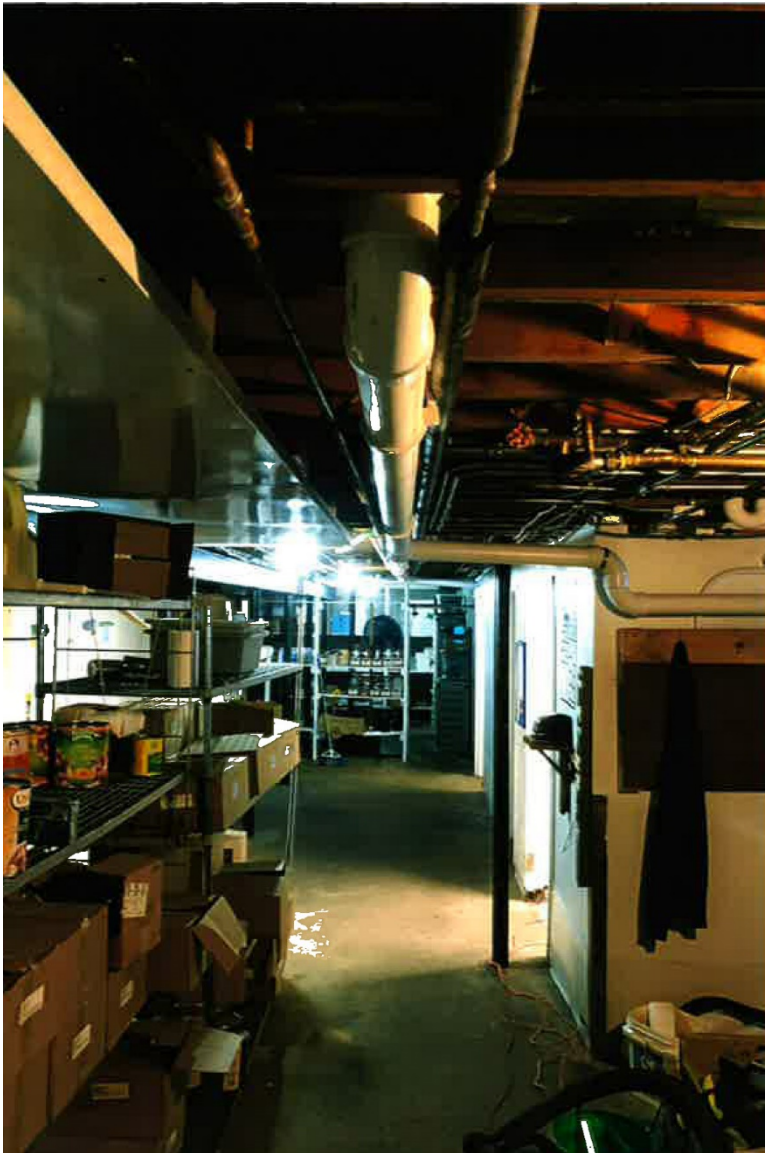
Photo 7: Piping run from Pickup Point 1.

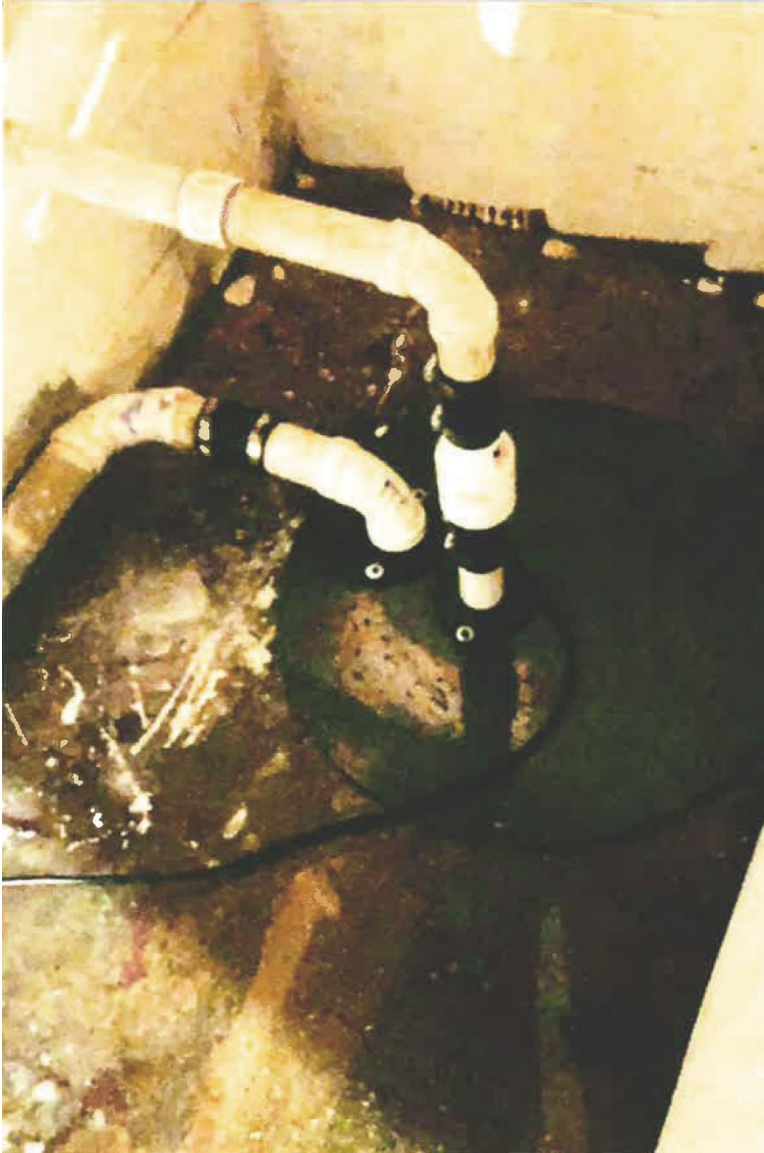
Photo 8: Sealed sump with ice machine and sump pump discharge lines.

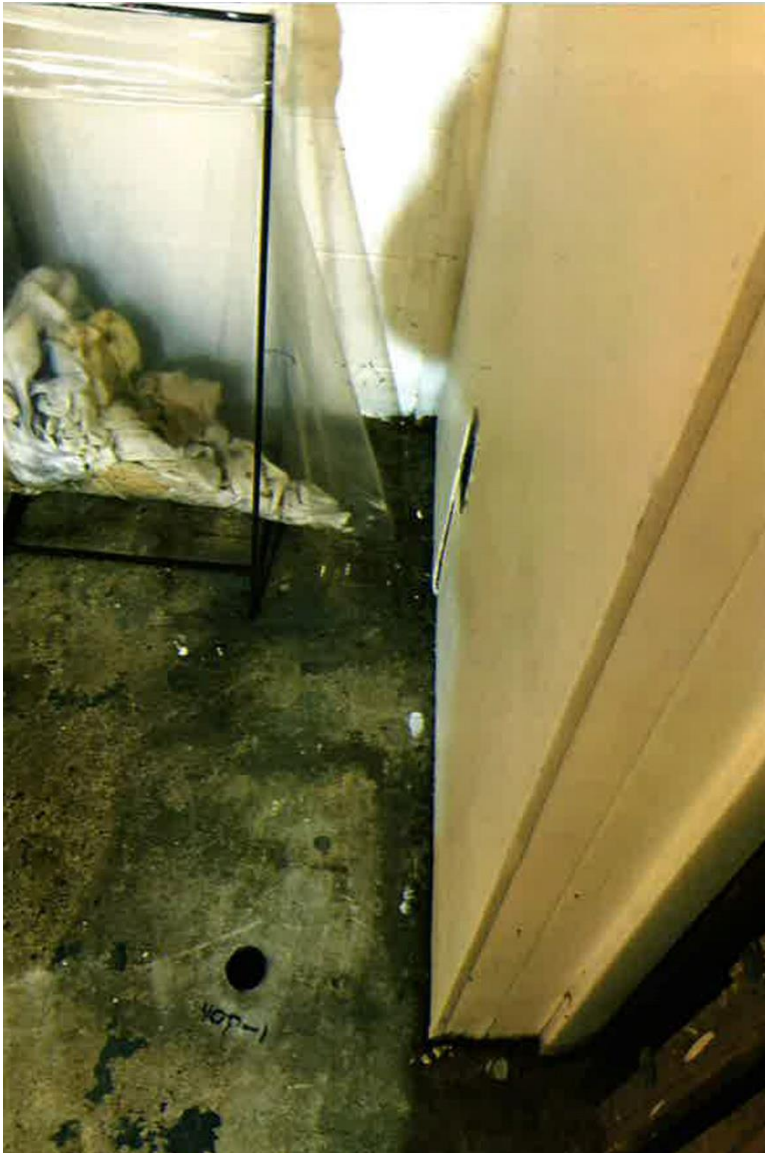
Photo 9: Sub-slab vacuum observation point VOP-1.

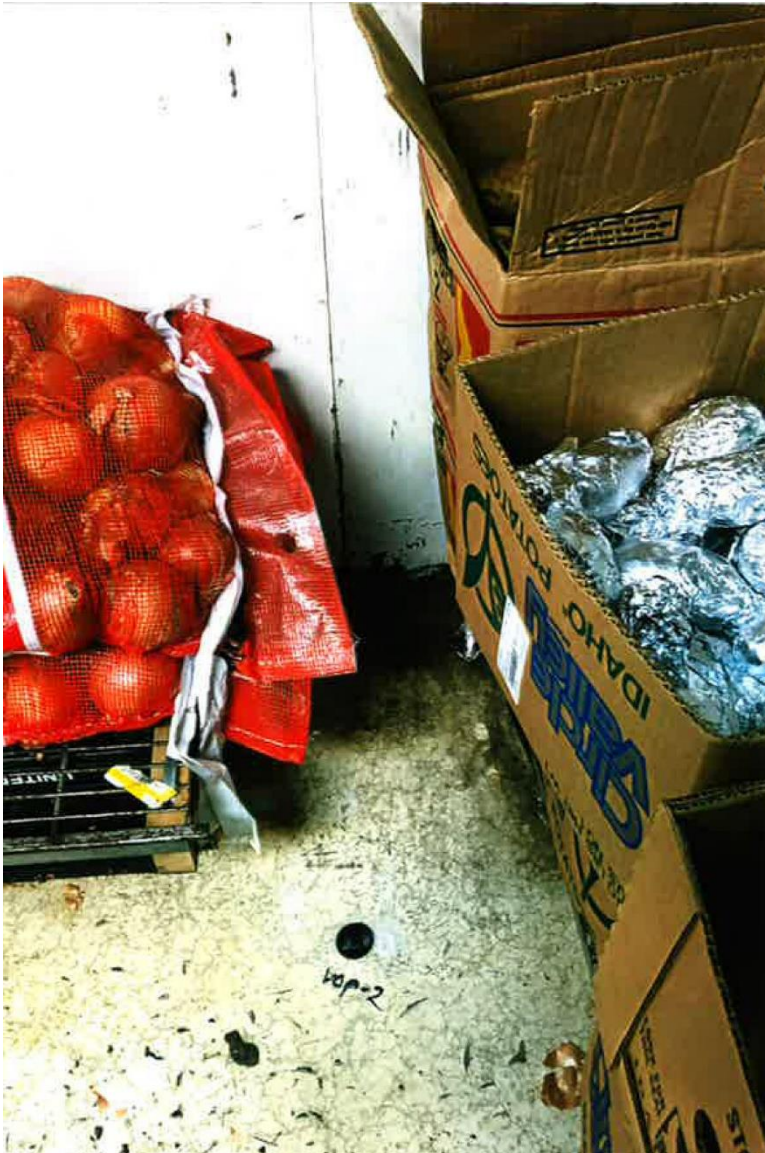
Photo 10: Sub-slab vacuum observation point VOP-2.

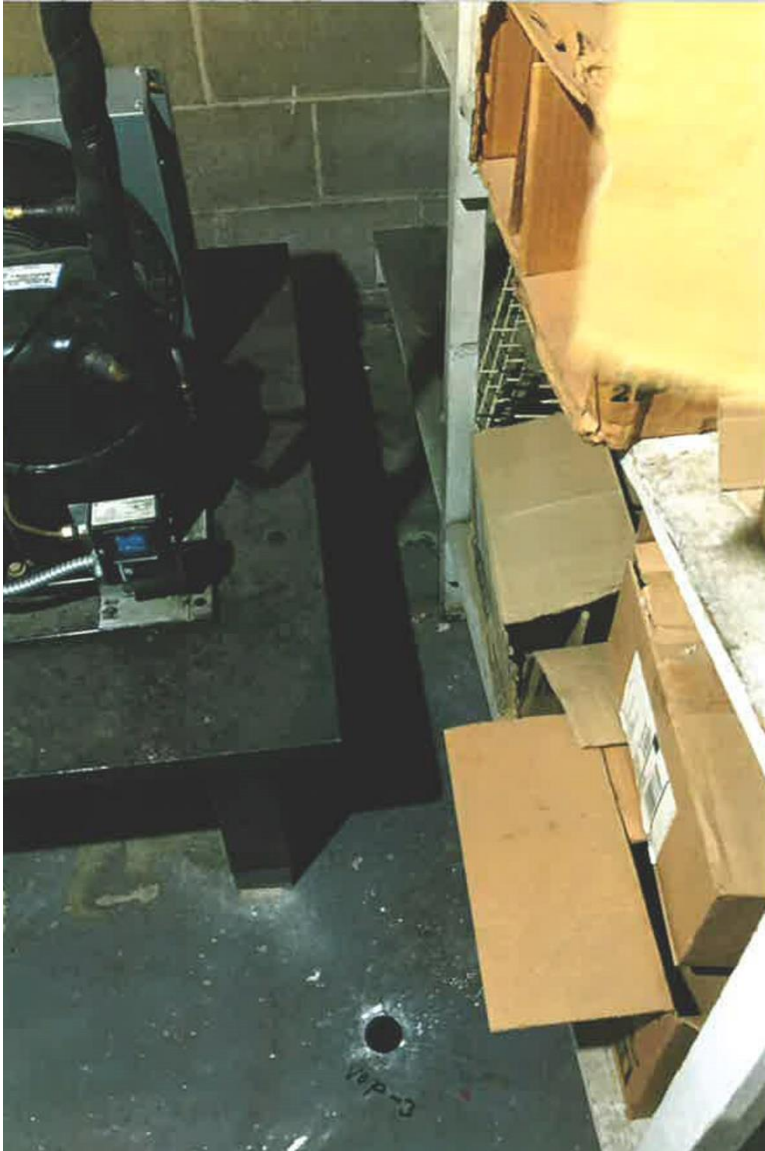
Photo 11: Sub-slab vacuum observation point VOP-3.

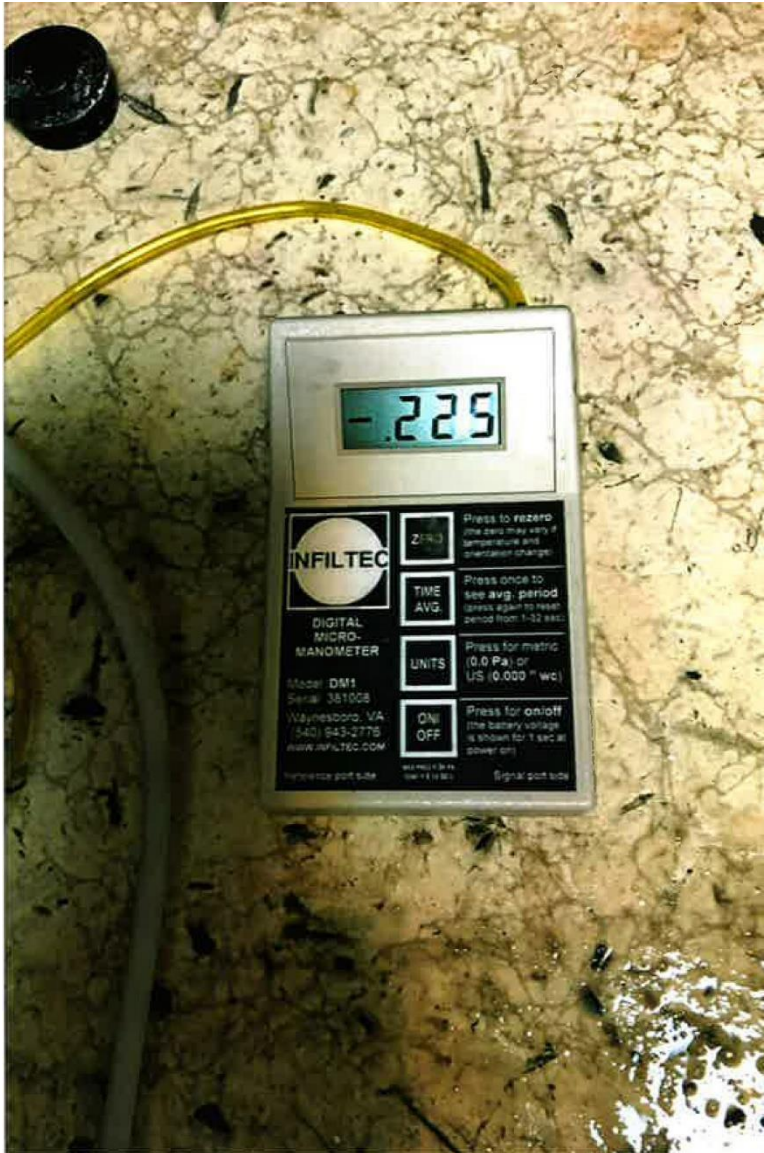
Photo 13: Sub-slab vacuum at VOP-2 following system startup.

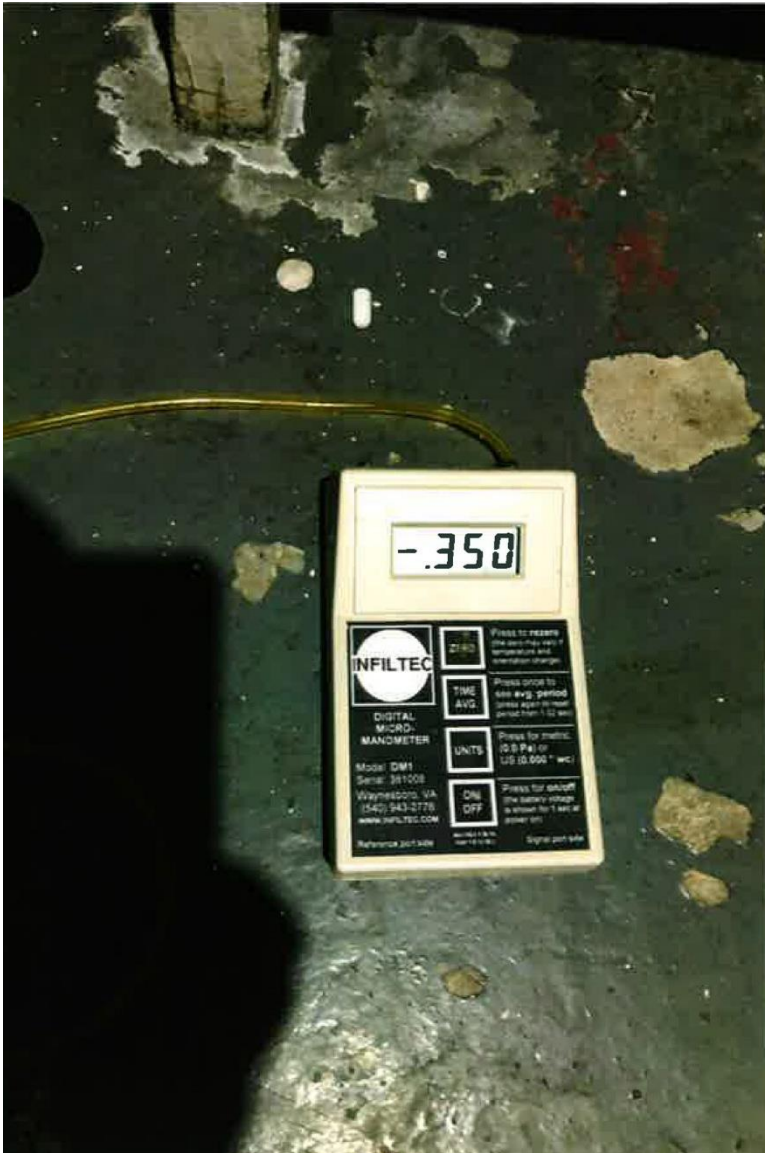
Photo 14: Sub-slab vacuum at VOP-3 following system startup.

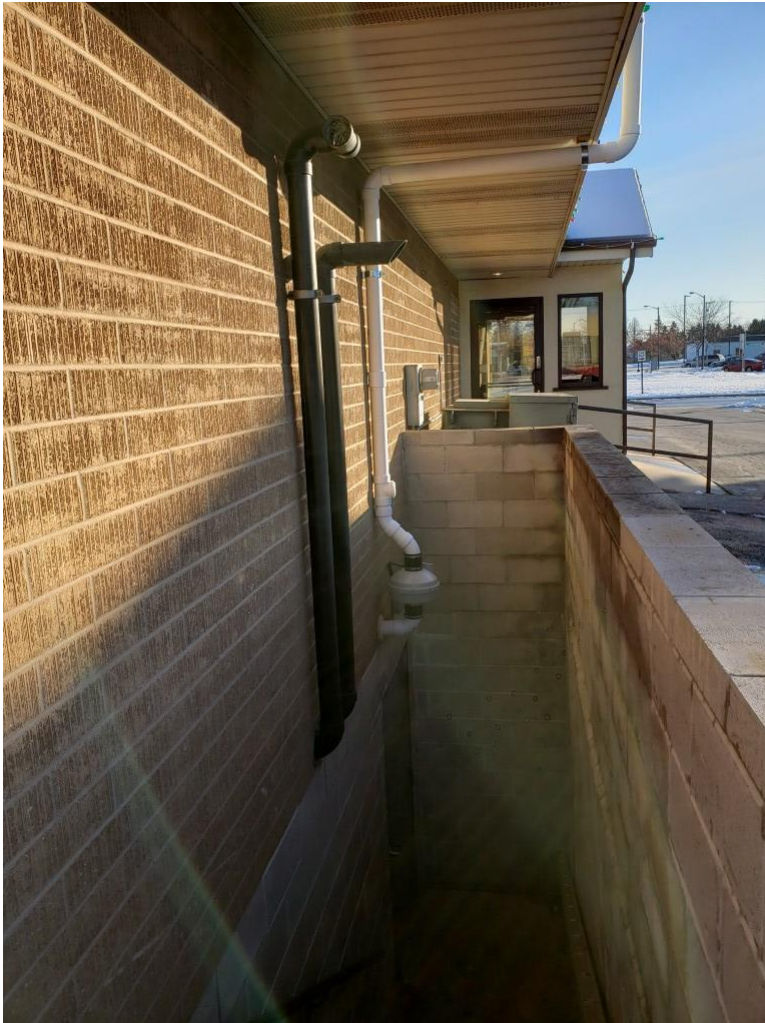
Photo 15: Vapor mitigation system fan and exhaust.

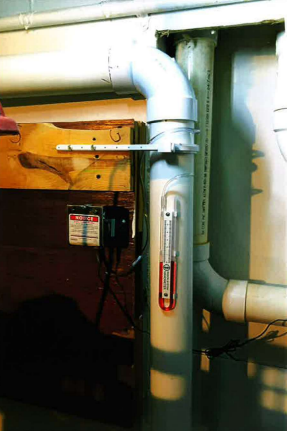
SYSTEM COMPONENT NAME	WHAT DOES IT DO?	WHAT DO I CHECK?	WHAT SHOULD I SEE?	DATE: WHAT TO FIX?
Manometer or Differential Pressure Gauge	Measures differential pressure between vacuum side of vent pipe and indoor space. This measurement confirms there is a vacuum being pulled by the fan.	Liquid Level on Manometer or Gauge	Liquid level in manometer should be offset (not level with each other).	A change in liquid level indicates a change in the vacuum below foundation. This could be caused by failure of fan, blockage of vent pipe, change in water level below building, or other conditions. Hire a professional to identify cause and repair if needed.
PHOTO

NOTES: (Record the reading on the gauge. Identify specific building and location description:) <input type="checkbox"/> Not Applicable The manometer and vacuum alarm are located on Pickup Point No. 1 at the north end of the Golden Flame Restaurant basement. When the system was started up in October 2019 the manometer read 1.4 inches of water column (WC). The fan is capable of pulling up to approximately 4 inches of WC vacuum. The system should be inspected for leaks or other issues if the vacuum falls below approximately 0.5 inches WC.

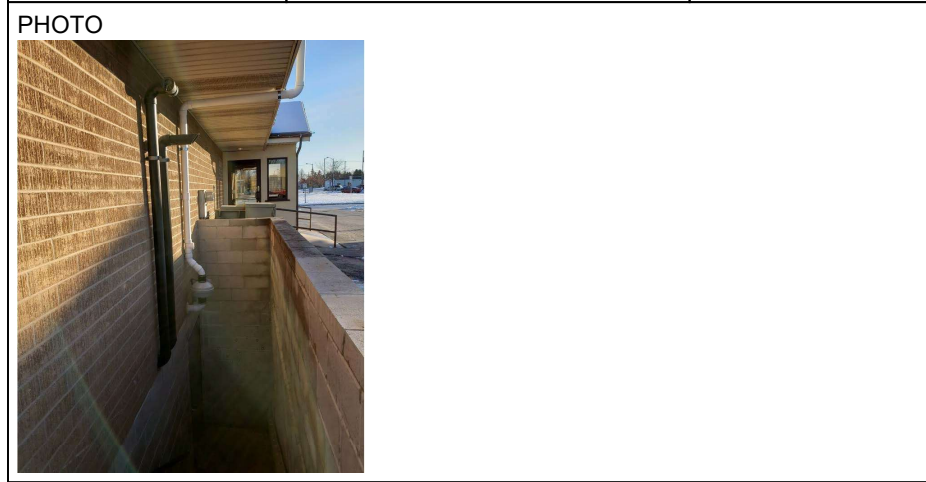
SYSTEM COMPONENT		WHAT DO I CHECK?	WHAT SHOULD I SEE?	DATE:
NAME	WHAT DOES IT DO?			WHAT TO FIX?
Fan	<p>Fan creates a vacuum and lowers pressure below foundation.</p> <p>The fan also removes soil gases from below foundation for discharge to atmosphere.</p>	<p>Fan Operation</p> <p>Fan Location</p> <p>Motor Noise</p>	<p>Fan is on.</p> <p>Fan mounted outside & secure.</p> <p>Fan motor is quiet (loud motor may indicate problem).</p>	<p>Replace the fan immediately once the fan stops running. Fans typically run for 10-20 years, but it may be less.</p> <p>Replacement fan to have similar specifications as original with respect to flow and vacuum.</p> <p>After a fan is replaced, the system should be evaluated by a mitigation professional to verify effectiveness, which includes pressure readings.</p> <p>The fan is an AMG Eagle radon fan.</p>

The fan is located on the exterior of the Golden Flame Restaurant building near the northwest corner of the building.

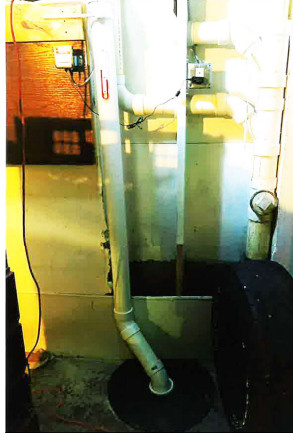
SYSTEM COMPONENT		DATE:		
NAME	WHAT DOES IT DO?	WHAT DO I CHECK?	WHAT SHOULD I SEE?	WHAT TO FIX?
<p>Suction Drop Point w/ Vent Pipe</p>	<p>Suction Point : Soil gases are collected in a void space below the foundation, and tight seal prevents soil gas from getting inside the home.</p> <p>Vent Pipe: Pipe conveys the vacuum from the fan, and collects soil gases for discharge to the atmosphere.</p>	<p>Suction Point Seal</p> <p>Vent Pipe Condition</p>	<p>Seal is air tight around pipe penetration.</p> <p>Vent pipe is connected to fan, has not cracked.</p>	<p>Suction point seal or vent pipe may need to be sealed or replaced if cracks or leaks appear.</p> <p>If any piping or sealing of the system is altered or replaced, the system should be evaluated by a mitigation professional to verify effectiveness, which includes pressure readings.</p>
<p>PHOTO</p>

<p>NOTES: (Identify specific building and location description:)</p> <p><input type="checkbox"/> Not Applicable</p> <p>Pickup Point No. 1 is located in the north end of the Golden Flame Restaurant basement.</p>

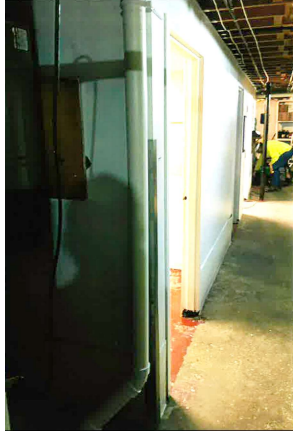
<p>Sealed Sump w/Vent Pipe</p>	<p>Sump Cover: Soil gases are collected in sump and the cover prevents soil gas from getting inside home.</p> <p>Vent Pipe: Pipe transports the soil gas from the sump for discharge to the atmosphere.</p>	<p>Suction Point Seal</p> <p>Vent Pipe Seal Condition</p>	<p>Seal is airtight to floor.</p> <p>Vent pipe is connected to the sump cover and is not cracked.</p>	<p>Sump cover or vent pipe may need to be sealed or replaced if cracks or leaks appear.</p> <p>If any piping or sealing of the system is altered or replaced, the system should be evaluated by a plumber or a mitigation professional to verify effectiveness, which includes pressure readings.</p>
<p>PHOTO</p>

<p>NOTES: (Identify specific building and location description:)</p> <p><input type="checkbox"/> Not Applicable</p> <p>Pickup Point No. 2 is located in the south end of th Golden Flame Restaurant basement.</p>

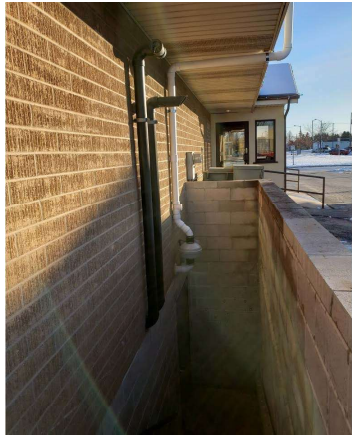
SYSTEM COMPONENT	WHAT DOES IT DO?	WHAT DO I CHECK?	WHAT SHOULD I SEE?	DATE:
NAME				WHAT TO FIX?
Outdoor Vent Pipe	Pipe transports the soil gas from beneath the foundation for discharge to the atmosphere.	Vent Pipe Condition Vent Pipe Location	Vent pipe remains connected to fan. End of pipe free from obstructions. The exhaust is more than 15 feet from windows or air intakes.	Vent pipe may require replacement, or cleaning to remove ice or debris. If any piping or sealing of the system is altered or replaced, the system should be evaluated by a mitigation professional to verify effectiveness, which includes pressure readings.

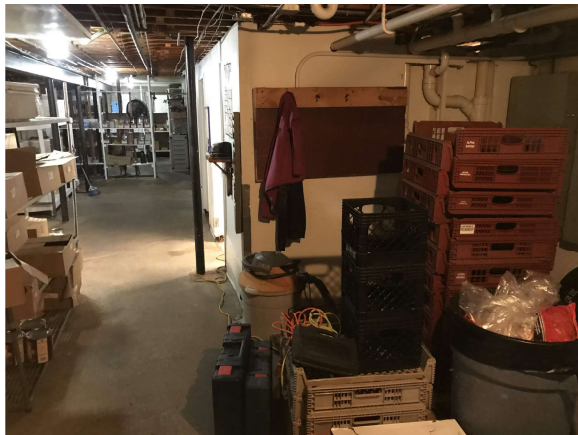
Foundation Floor	Foundation is a barrier that minimizes soil gas entry into building, and helps fan to work efficiently.	Foundation Condition Foundation Footprint	No penetrating cracks or holes in foundation. Check if there have been alterations or additions to building or footprint.	Seal cracks or other penetrations as you would to prevent water from entering. If building floor plan has changed, notify DNR and contact a mitigation professional to evaluate if modifications to the vapor mitigation system are necessary.
-------------------------	---	--	--	---

The Golden Flame Restaurant basement floor shall be maintained.

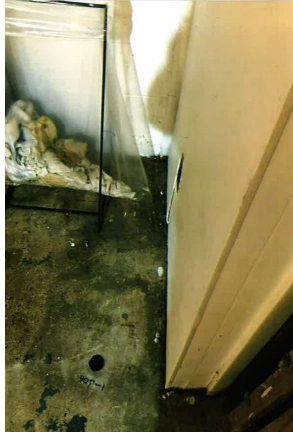
SYSTEM COMPONENT				DATE:
NAME	WHAT DOES IT DO?	WHAT DO I CHECK?	WHAT SHOULD I SEE?	WHAT TO FIX?
Sub Slab Vapor Port	This is a sample port to measure vacuum or take sample of soil gas if needed. It needs to remain sealed when not in use to prevent soil gas entry into the home.	Port Seal/Cap	If able to measure the vacuum with a micromanometer, the pressure differential should be at least 0.004 inches of H ₂ O or at least one Pascal.	Repair or replace the seal and cover as needed.
		Port Condition	Port is sealed and capped when not in use.	Permanently seal hole if sample port is ever removed.
PHOTO			<p>NOTES: (If taken, record the pressure differential reading. Identify specific building and location description:)</p> <input type="checkbox"/> Not Applicable

Sub-slab Vacuum Observation Point No. 1 located in northeast corner of Golden Flame Restaurant basement.	
Sub Slab Vapor Port	This is a sample port to measure vacuum or take sample of soil gas if needed. It needs to remain sealed when not in use to prevent soil gas entry into the home.	Port Seal/Cap	If able to measure the vacuum with a micromanometer, the pressure differential should be at least 0.004 inches of H ₂ O or at least one Pascal.	Repair or replace the seal and cover as needed.

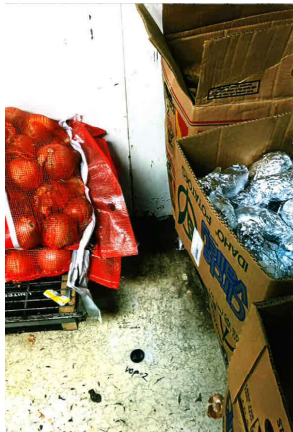
Port Condition	Port is sealed and capped when not in use.	Permanently seal hole if sample port is ever removed.
PHOTO			<p>NOTES: (If taken, record the pressure differential reading. Identify specific building and location description:)</p> <input type="checkbox"/> Not Applicable

Sub-slab Vacuum Observation Point No. 2 located in northeast corner of Golden Flame Restaurant basement in wash/storage room.
