Subject: Liability Clarification and “No Action Required” Determination Letter
Village Mini Mart, 201 North Rochester Street, Mukwonago, Wisconsin 53132
Parcel #: MUKV 1976-091-022
BRRTS Activity Name: Village Mini Mart
BRRTS #: 07-68-588586 and 09-68-588589, FID #: 268270640

Site Plan and Soil Sample Location Map

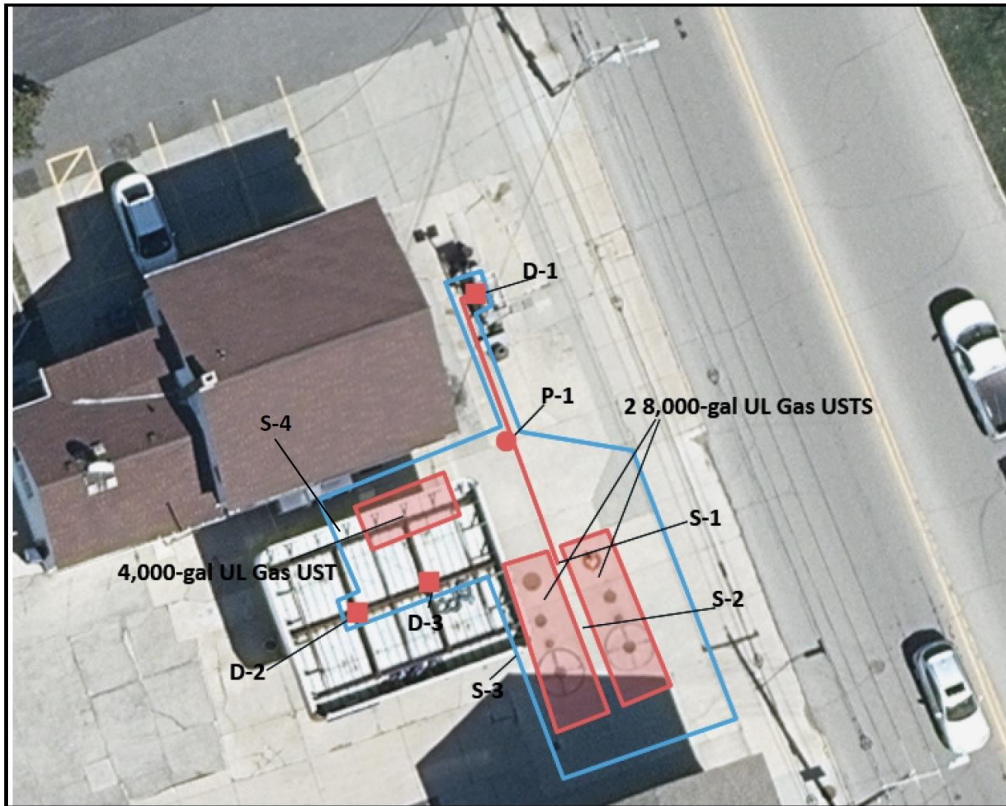
Red Rectangles: Former USTs
Red Dot: Piping Sample
Red Squares: Dispenser Locations

Blue Lines: Limits of Excavation

Note: Due to the large amount of pea gravel backfill many of the sidewall and bottom samples could not be collected due to concerns with regard to cave in along North Rochester Street, the driveway to the south and along the south side of the site building.

In June 2021, the underground storage tank (UST) system, which included three fiberglass unleaded gasoline USTs, fiberglass piping, and dispensers, was removed from the Property. Two of the tanks were located on the southeast side of the Property, and one tank was located south of the onsite building. No groundwater was encountered in the tank cavity, and native soil was identified as sand with cobbles. The tanks were inspected after removal, and no holes or cracks were identified. GEC conducted a tank system site assessment (TSSA) to document the removal which included the collection of eight soil samples from native soil beneath the dispensers, piping and from the tank excavation cavities. The presence of pea gravel in the tank excavation cavities prevented the collection of sidewall and base samples in these areas. The soil samples were laboratory analyzed for PVOCs and naphthalene.

Laboratory analytical results identified benzene above Wis. Admin. Code ch. NR 720 residual contaminant levels (RCLs) for groundwater pathway in two samples collected at 11 and 13 feet below ground surface (bgs) in the tank cavity on the southeast side of the Property. The residual groundwater contaminated with PVOCs is located in the area of these two soil samples. During the LUST investigation, groundwater was identified at 9 to 12 feet bgs. Groundwater was not encountered during the TSSA sampling because of an unseasonable dry spring. The TSSA soil samples in this area were collected at the soil water table interface.
