**SUBJECT:** Case Closure with Continuing Obligations  
Innovation Park – Lot 3 and Outlot 3, 1401 Discovery Parkway, Wauwatosa, WI 53226  
BRRTS #: 02-41-588671, FID #:341361240

**LOT 3 & OUTLOT 3  
 INNOVATION PARK  
 WAUWATOSA, WISCONSIN**

**LOT 3 & OUTLOT 3  
 INNOVATION PARK  
 WAUWATOSA, WISCONSIN  
 CAP LOCATION MAP**

# ENGINEERED BARRIER PHOTOGRAPHS

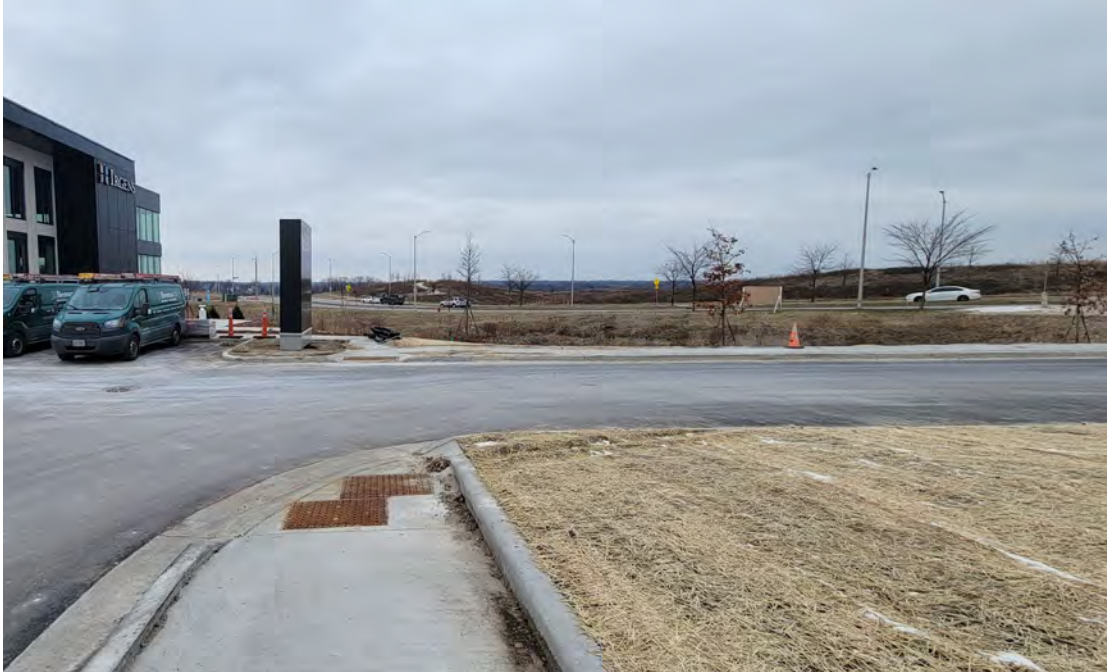
Photo 1: Construction of greenspace cap (foreground) and asphalt pavement / concrete curb and gutter cap (mid-background) within Outlot 3 area of the site.  
View to north; photograph taken on December 21, 2022.

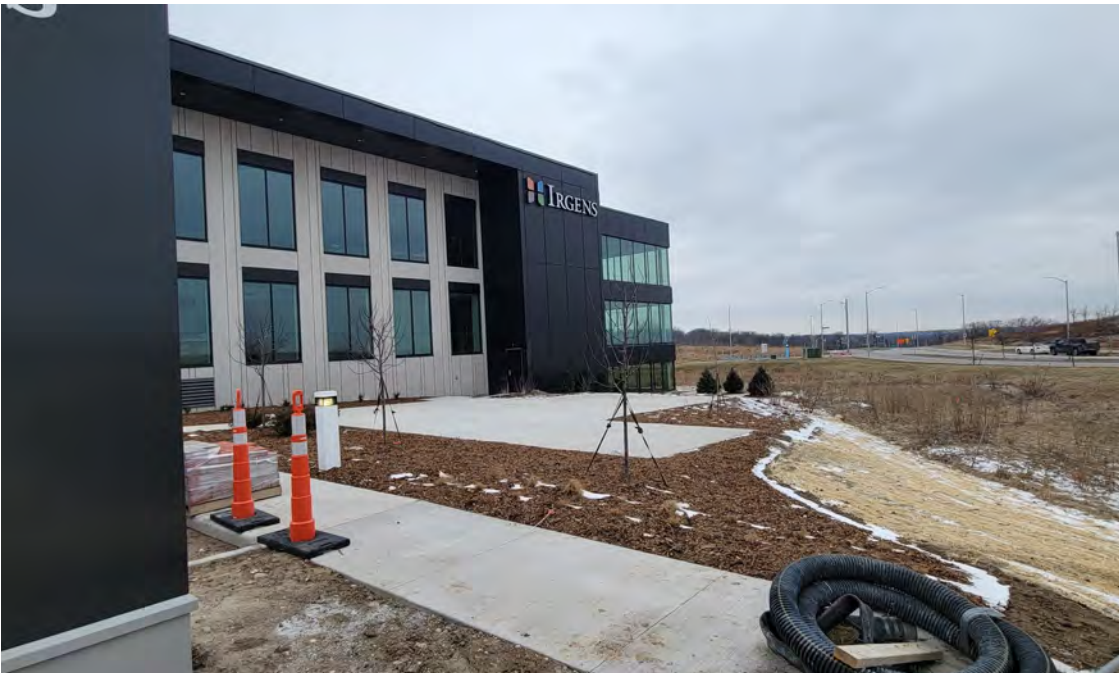
Photo 2: Construction of greenspace cap (foreground) and concrete paved sidewalk (foreground) and patio space (background) of Lot 3 area of the site (east side of Lot 3).  
View to northwest; photograph taken on December 21, 2022.

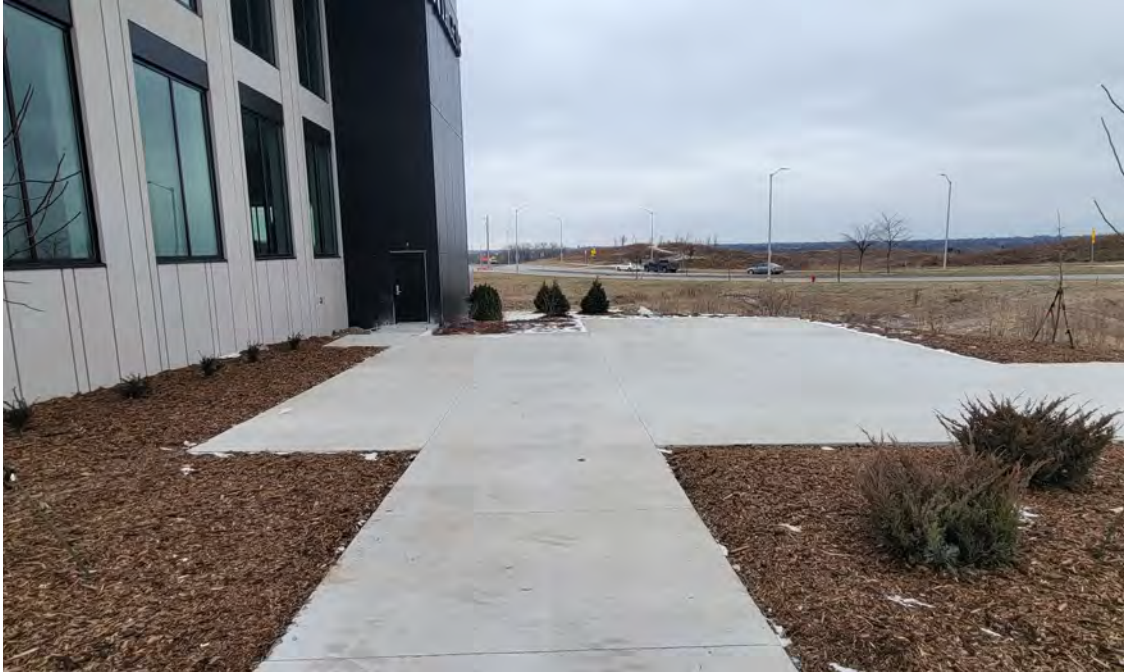
Photo 3: Construction of concrete paved patio space of Lot 3 area of the site (east side of Lot 3) with surrounding mulched landscaping (greenspace).  
View to north; photograph taken on December 21, 2022.

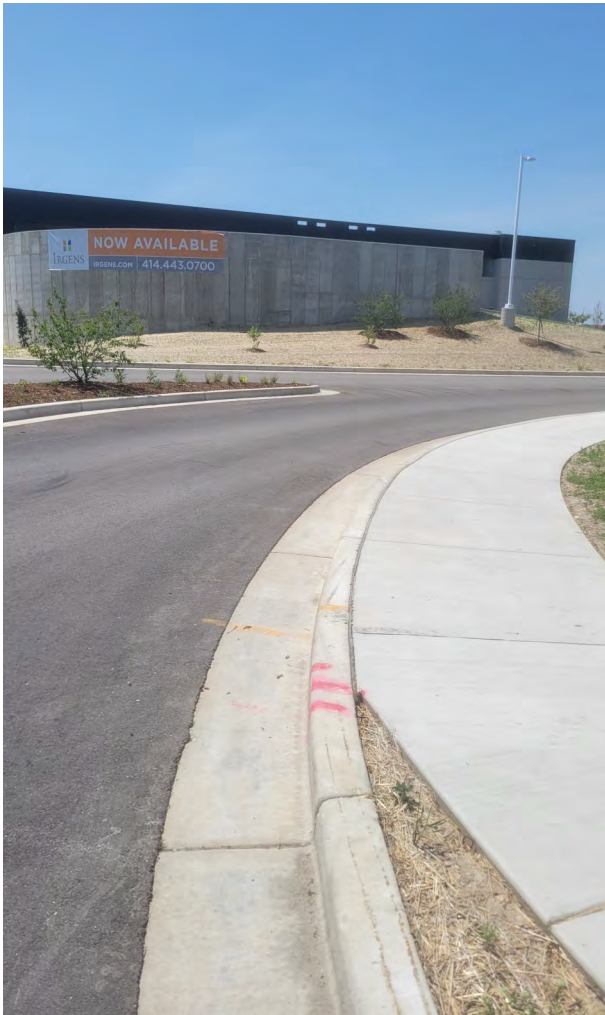
Photo 5: Concrete curb and gutter and sidewalk along the north side of Outlot 3 entrance driveway into the site. Limited greenspace (mulched or grass) within median and along sidewalk. View to southwest; photograph taken on June 1, 2023.

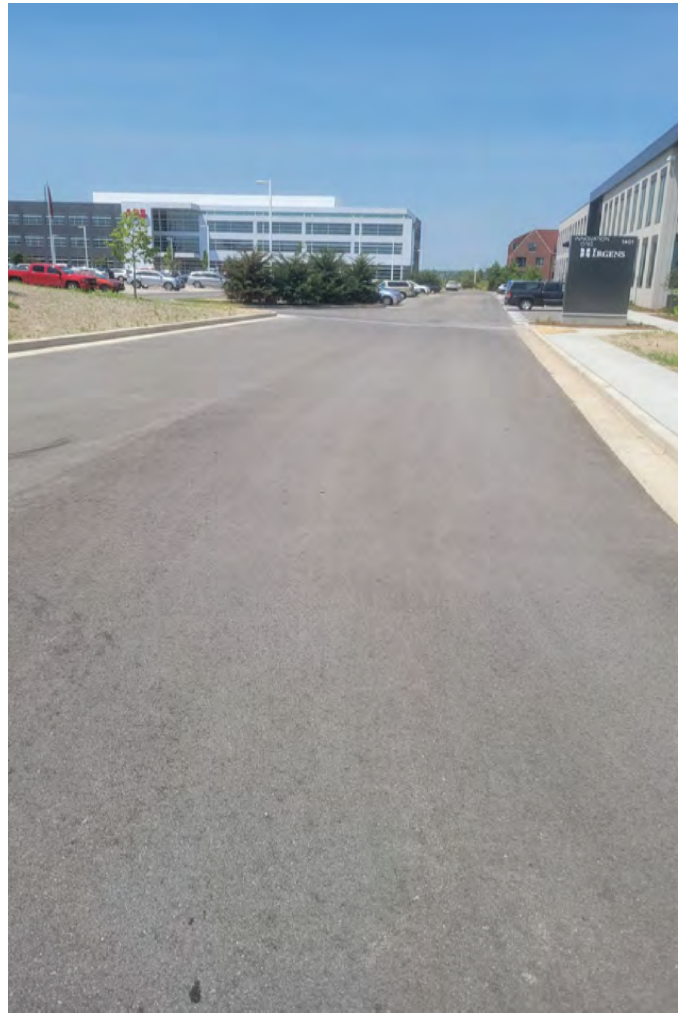
Photo 6: Asphalt paved entrance to Lot 3 and driveway along Building A. Concrete curb and gutter and sidewalk along the south side of Lot 3. View to west; photograph taken on June 1, 2023.

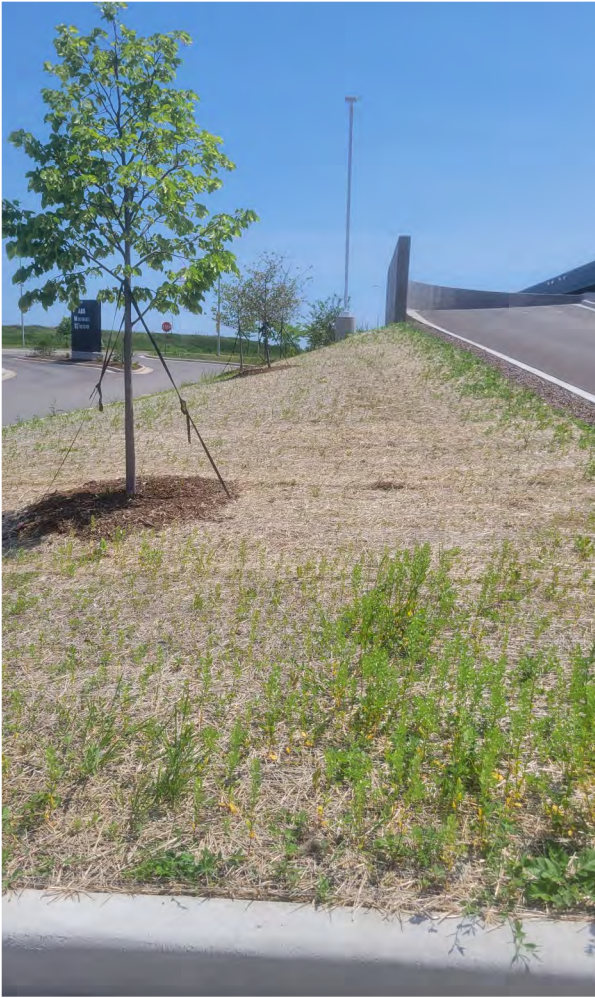
Photo 7: Greenspace along south side of Outlot 3. Cap consists of 6-inches of topsoil with native prairie grass plantings and small trees. Limited use. View to east; photograph taken on June 1, 2023.

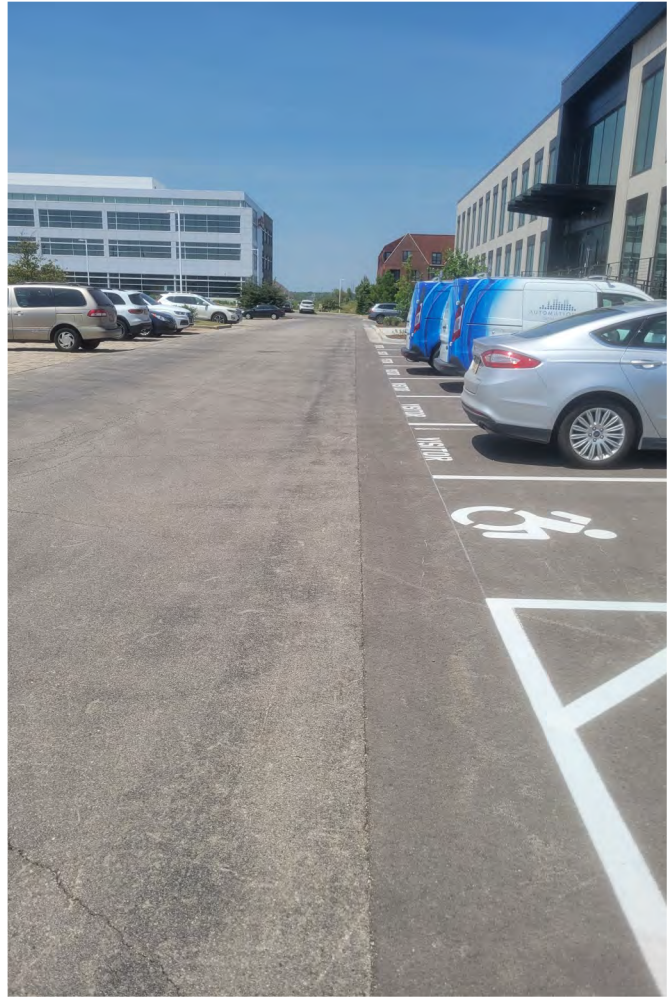
Photo 8: Asphalt paved entrance to Lot 3 and driveway along Building A. View to west; photograph taken on June 1, 2023.

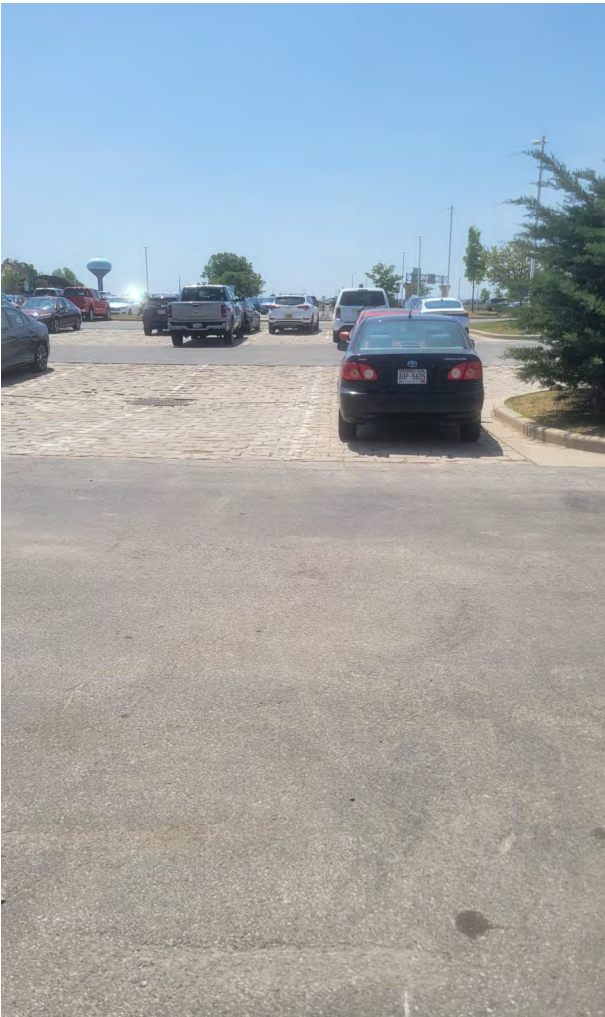
Photo 9: Asphalt paved parking lot of Lot 3 (east of ABB building). Permeable pavers along parking rows of ABB parking lot. View to south; photograph taken on June 1, 2023.

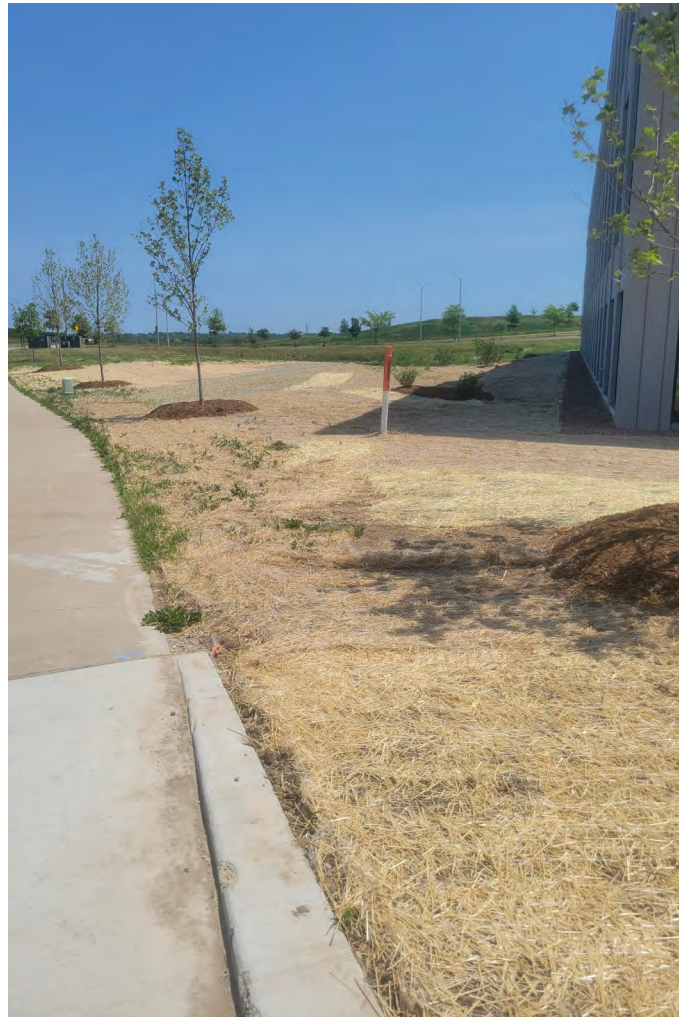
Photo 10: Greenspace cap along north side of Lot 3 and Building A area. Cap consists of 6-inches of topsoil with native prairie grass plantings and small trees. Limited use. View to northeast; photograph taken on June 1, 2023.

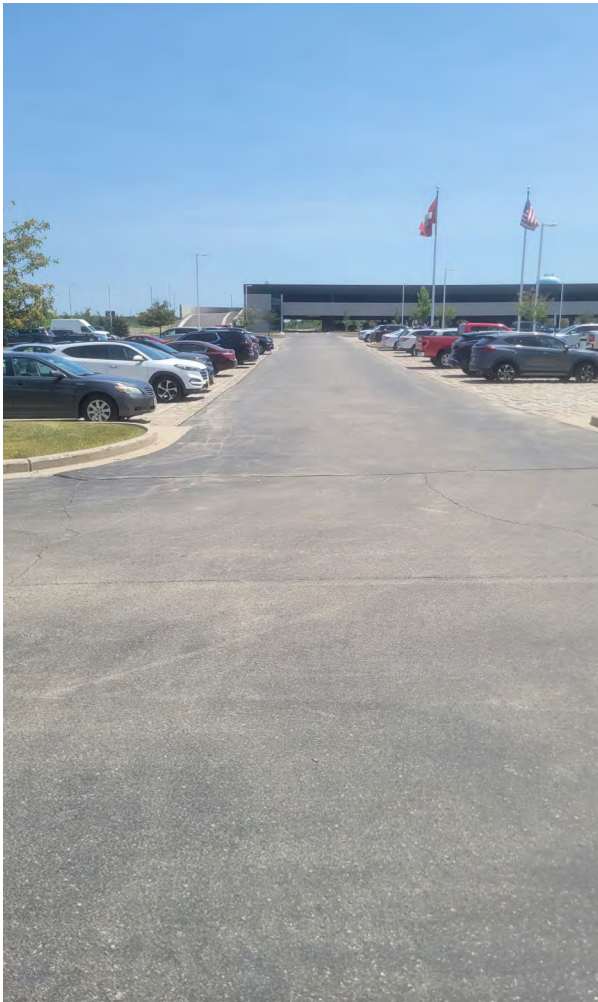
Photo 11: Asphalt paved parking lot within northwest portion of Lot 3 (east of ABB building). Permeable pavers along parking rows of ABB parking lot. View to east; photograph taken on June 1, 2023.

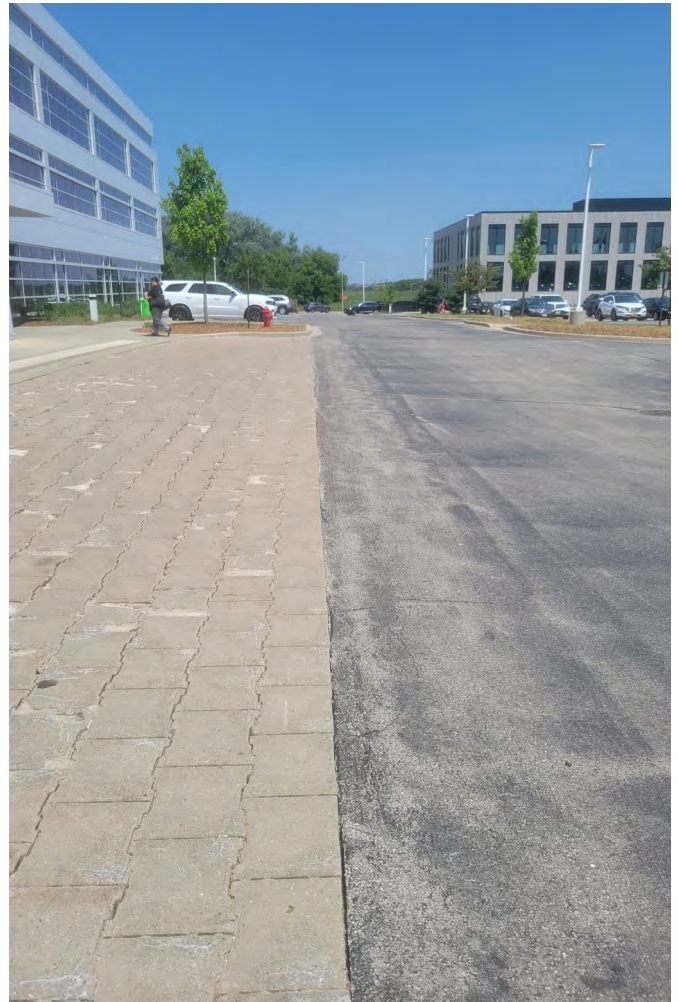
Photo 12: Asphalt paved parking lot within western portion of Lot 3 (east of ABB building). Permeable pavers along parking rows of ABB parking lot. View to north; photograph taken on June 1, 2023.

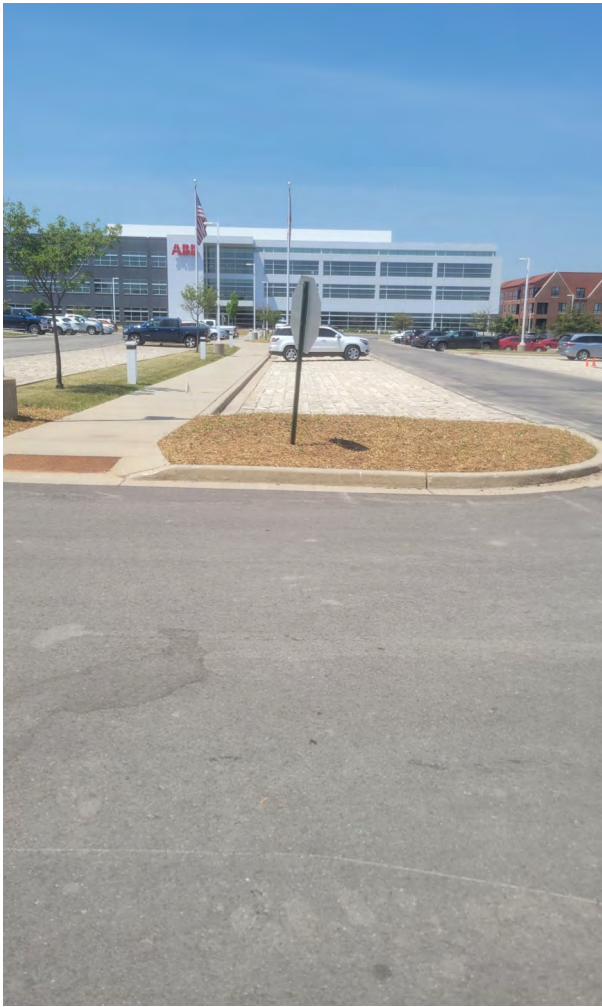
Photo 13: Asphalt paved parking lot within eastern portion of Lot 3 (east of ABB building). Permeable pavers along parking rows of ABB parking lot. Mulched and vegetated topsoil cover within greenspace islands (limited use). View to west; photograph taken on June 1, 2023.
