January 17, 2022

RE: Off-Site Liability Exemption and Liability Clarification Application
Heimes Garage - Former
3418 – 66th Street
Kenosha, WI
BRRTS#: 03-30-409382
FID#: 230058620

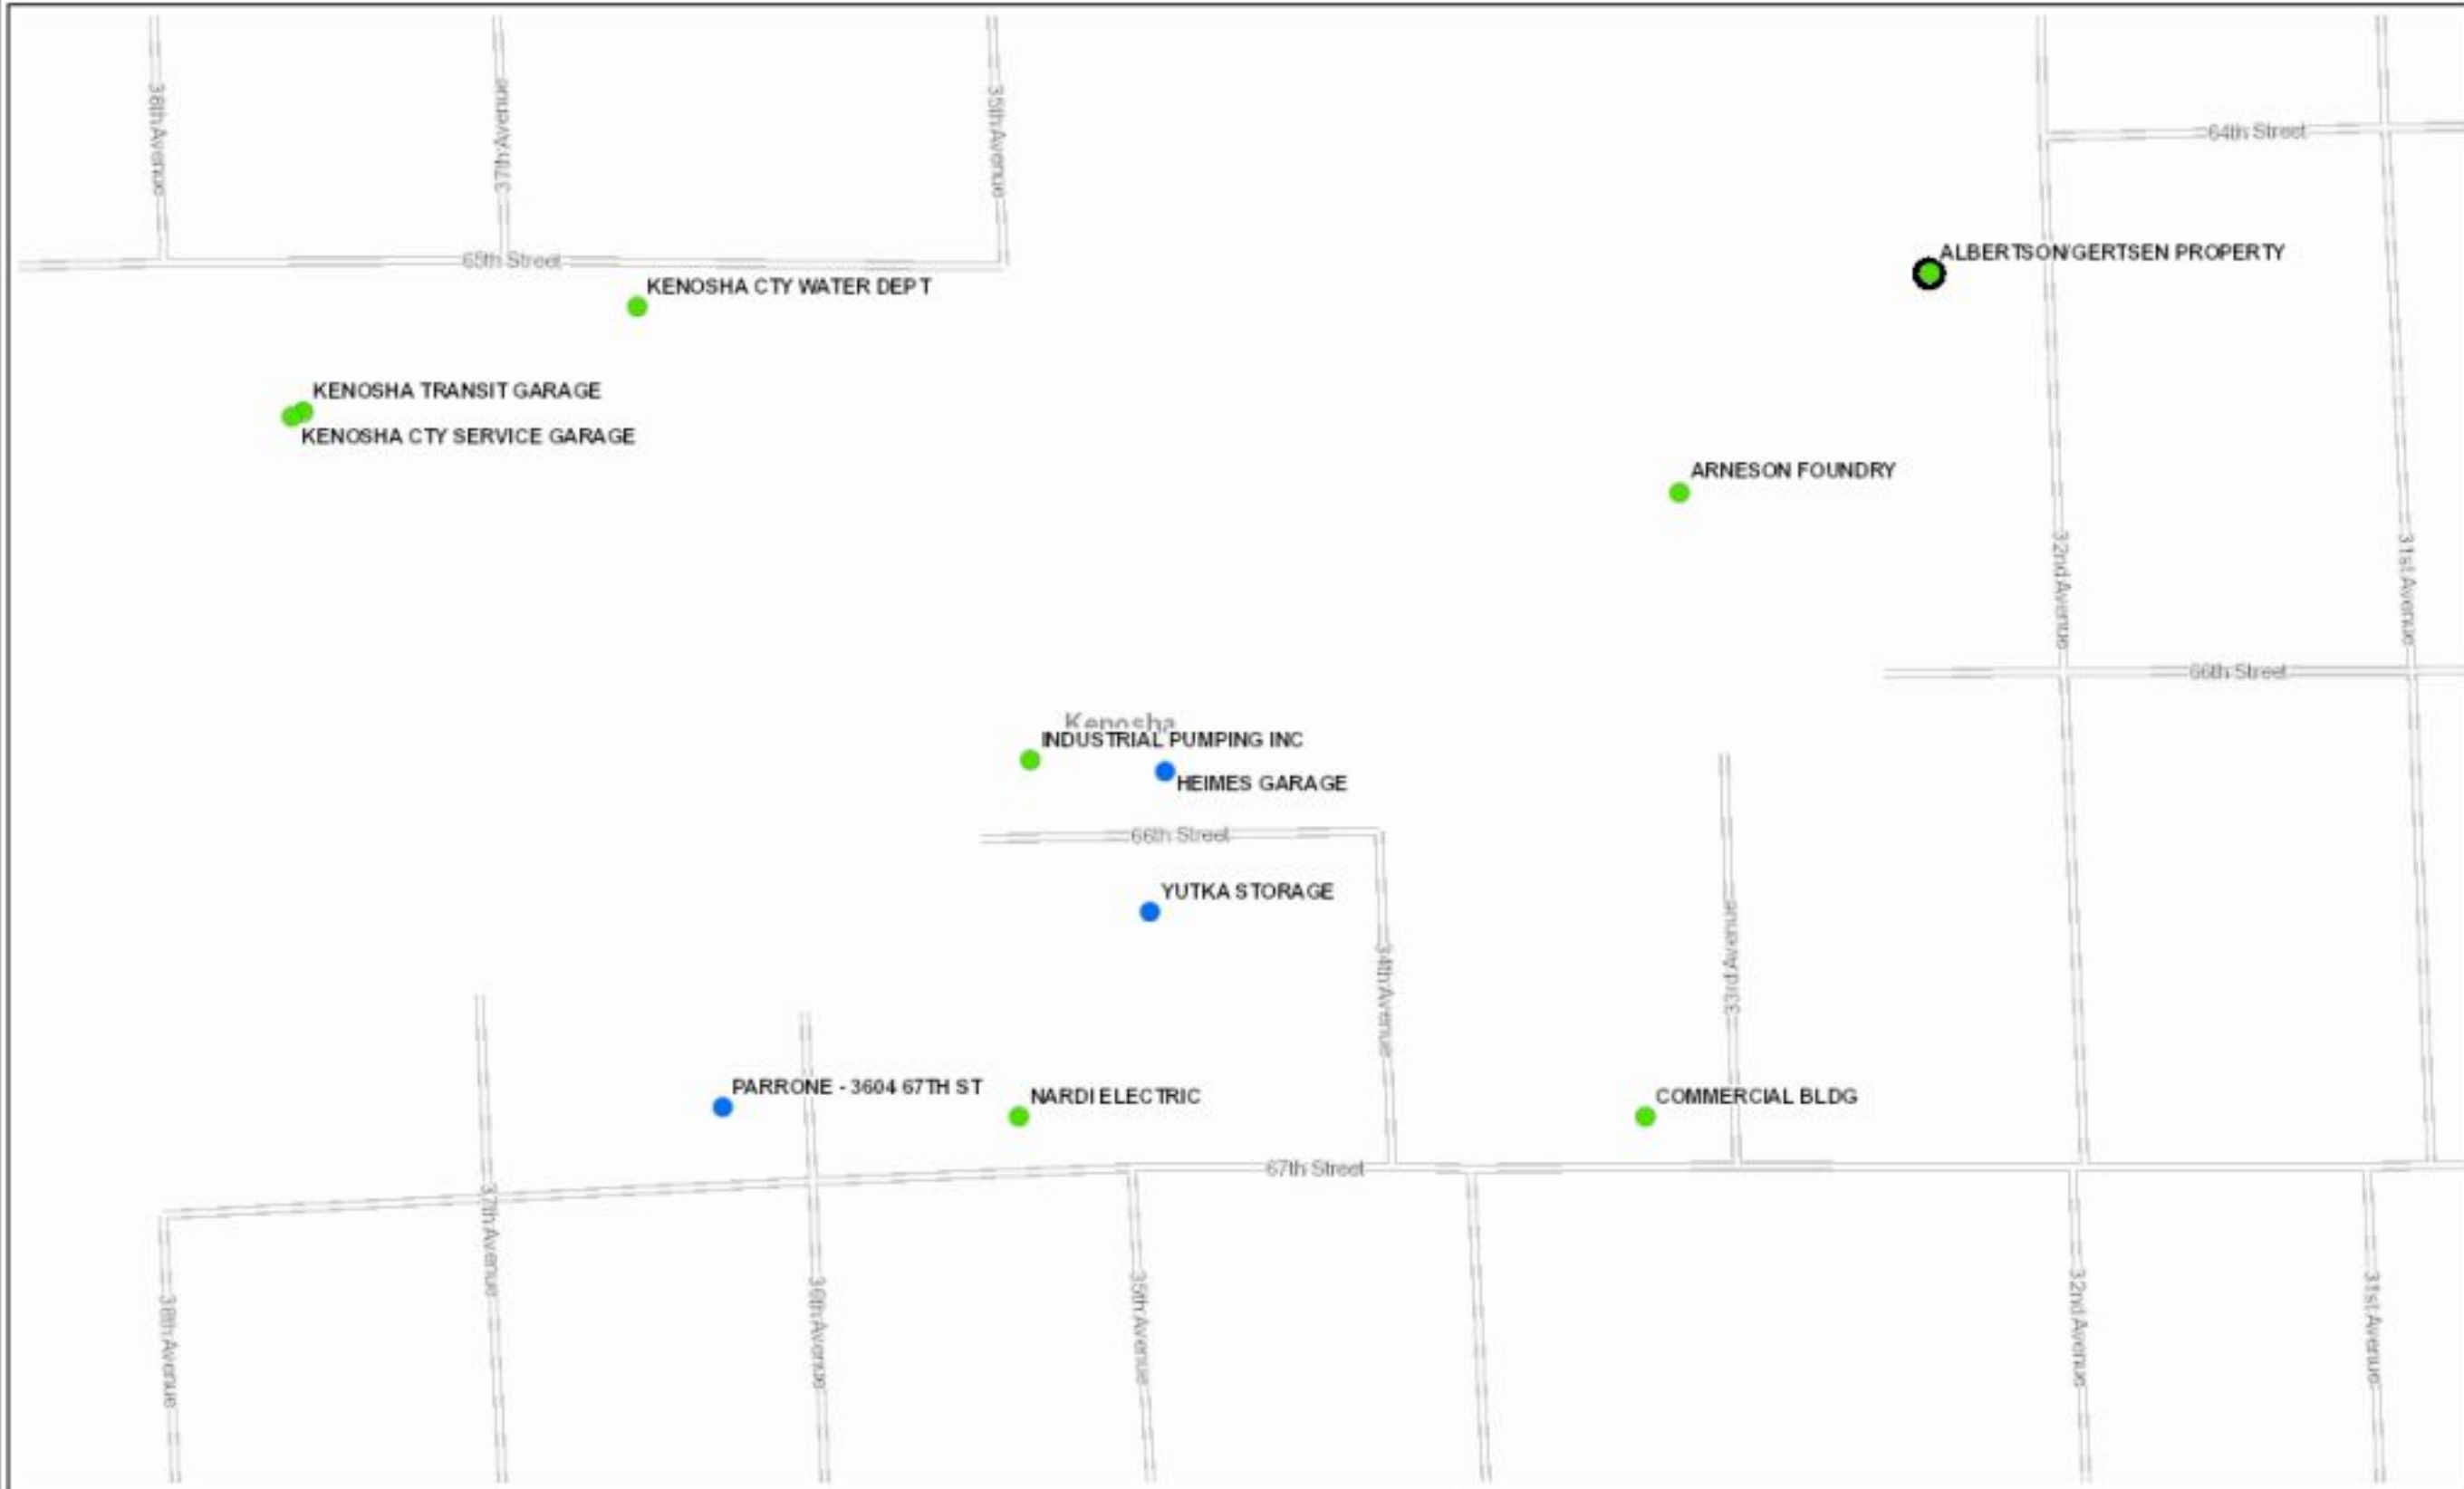
WDNR RR SITES MAP

Former Heimes Garage SIWP
3218 – 66th Street
Kenosha, WI

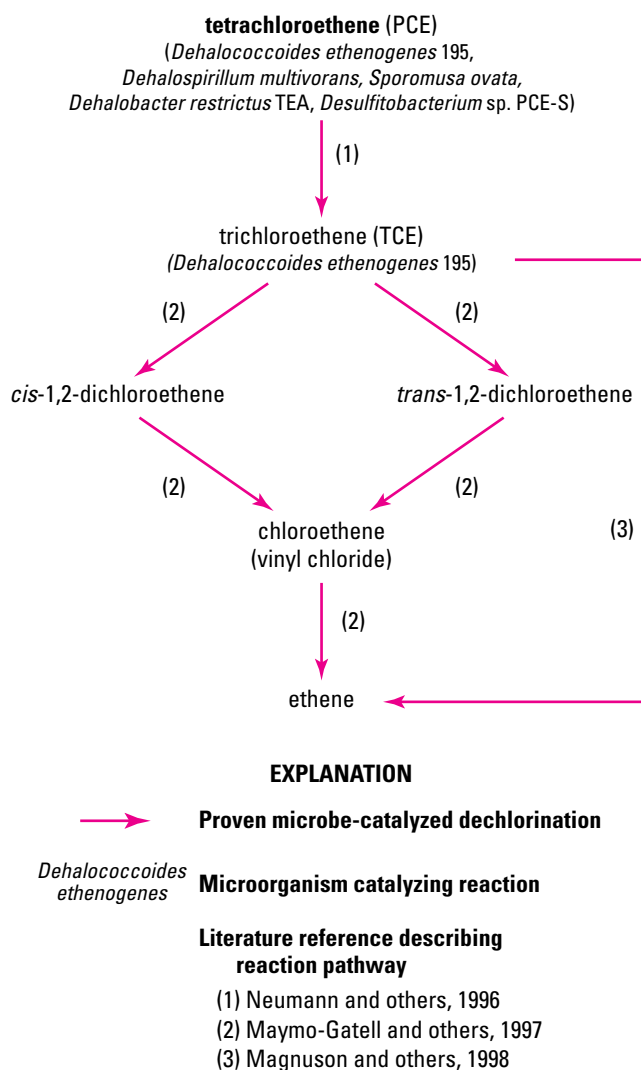
Figure 8. Laboratory-derived pathway for the anaerobic biodegradation of tetrachloroethene (modified from Ellis and Anderson, 2005).
