Client:	C.Reiss	Project:	Dock
Site Name:		Site Location:	Superior, WI
Photograph ID: 1	 		
Photo Location: C.Reiss - Superior WI			
Direction: South			
Survey Date: 11/13/2023			
Comments: Sand Encountered in Excavation for Pond Bottom with hydrocarbon odor.			
Photograph ID: 2	 		
Photo Location: C.Reiss - Superior WI			
Direction: South			
Survey Date: 11/13/2023			
Comments: Sand below Clay Liner

From: [Morberg, Kyle](#)
To: [Graham, Joseph R - DNR](#)
Cc: [Lennie, Brian](#); [Cull, Whitney](#); [Christian Zuidmulder](#); [Gross, Stu](#)
Subject: RE: Action Requested by 01/31/2024, C. Reiss , 02-16-589248: Supplemental Site Investigation Report
Date: Thursday, February 08, 2024 9:12:18 AM
Attachments: [C.Reiss Stormwater Pond Construction - 2024.02.08 Photo Log.pdf](#)

Our Supplemental Site Investigation Report for the C. Reiss Dock in Superior, Wisconsin has now been uploaded to the portal under BRRS Case # 02-16-589248. This report details soil and groundwater sampling activities that occurred in 2023 to delineate the extents of arsenic and polycyclic aromatic hydrocarbons at the site. The information contained within this report should satisfy the items in your email reques

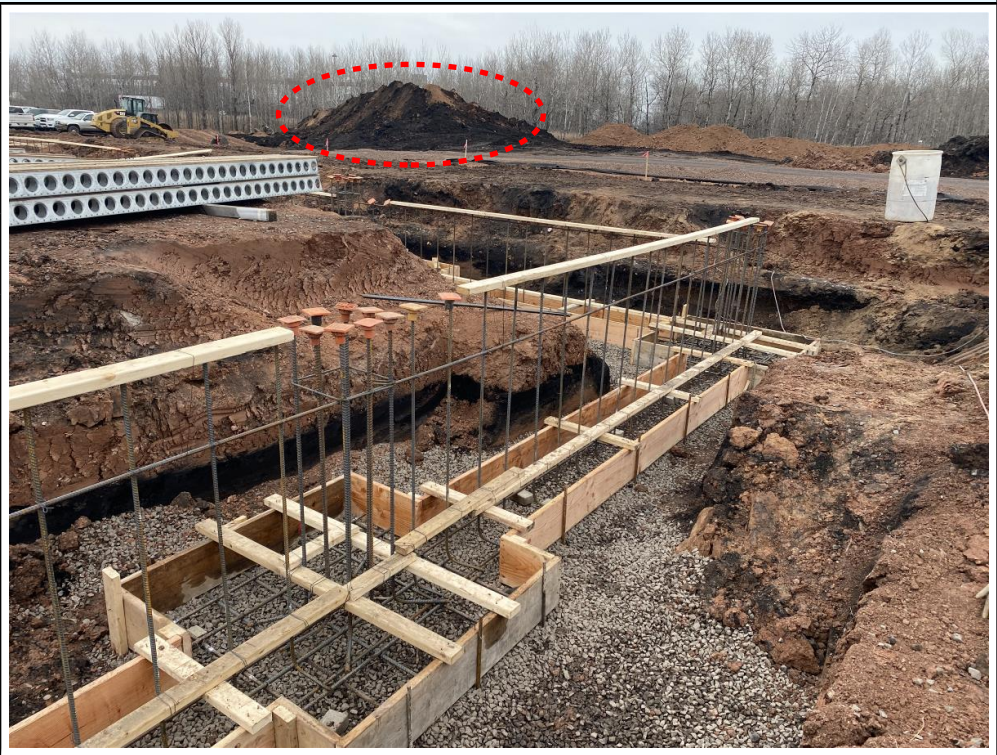
Photograph ID: 9

Comments:
Sand Pile stockpiled in background, some topsoil material mixed on surface due to transport.

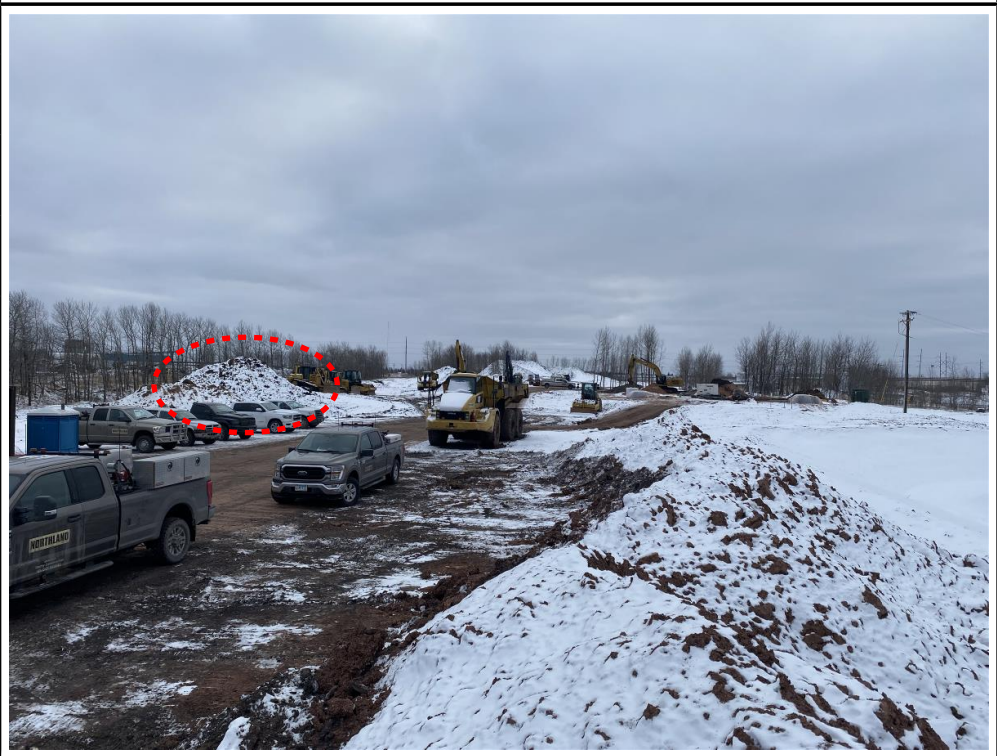
Photograph ID: 10

Comments:
Sand Pile capped with clay

- Less than 100 cubic yards (CY) of silty sand required excavation to meet desired depths to construct the pond. Approximately 20 CY of silty sand, located immediately adjacent to the proposed forebay, was placed within the forebay to slightly elevate this area, then capped with 2-foot of clay. The remaining excess silty sand was transported to the proposed berm area, stockpiled, and temporarily covered with clay. Once the berm reaches final grades, the silty sand will ultimately be covered by the final clay cap for the proposed berm.

The 20 CY of silty sand used within the forebay was moved less than 10 feet from its original

location, placed at an elevation that was similar to or higher than its original location, and is above the groundwater table. Placement of the material in this manner does not appear to contradict the WDNRs location criteria exemption approval to relocate contaminated soil within 3 feet of the high groundwater level.
