RE: Limited Phase II Environmental Site Assessment for Vapor Intrusion at 505 Grand Avenue, Little Chute, Wisconsin – Cedar Corporation Project Number: F6983-001

Cedar Corporation (Cedar) is providing this Limited Phase II Environmental Site Assessment (ESA) for vapor intrusion at 505 Grand Avenue in Little Chute, Outagamie, Wisconsin (Site) (reference Figure 1 – Detailed Site Map, attached). Cedar completed sub-slab vapor sampling at the Site based on an agreed upon scope of work between Todd Fischer (Client), and Cedar.

Client	Todd Fischer
Project	505 Grand Avenue
Prepared By	Quin Lenz

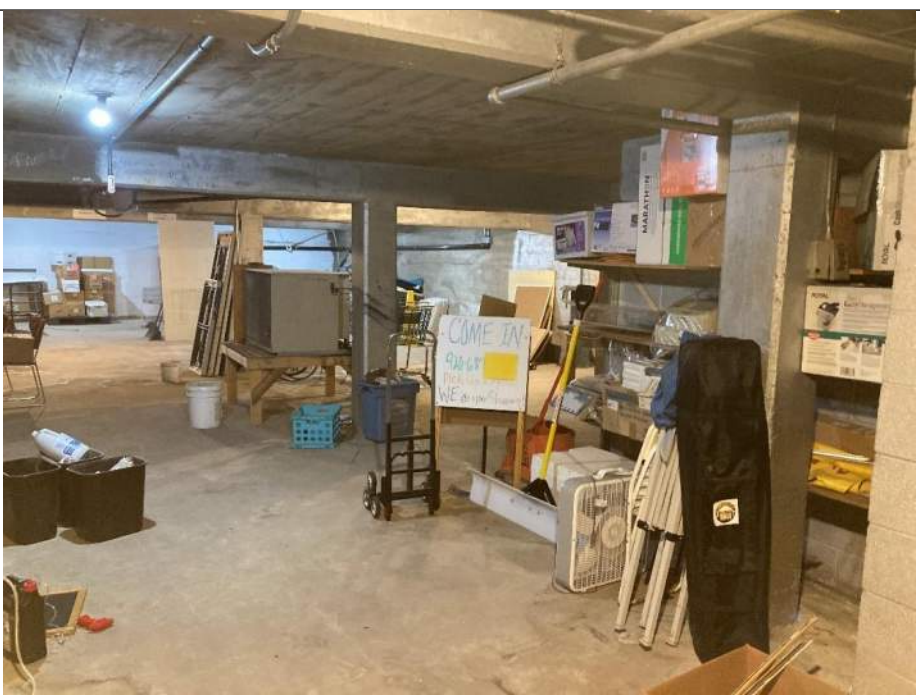
Photo No.	Date	Image
2	9/5/2023

Direction Photo Taken		
Southeast		
Description		
General view of the eastern basement, northern half.

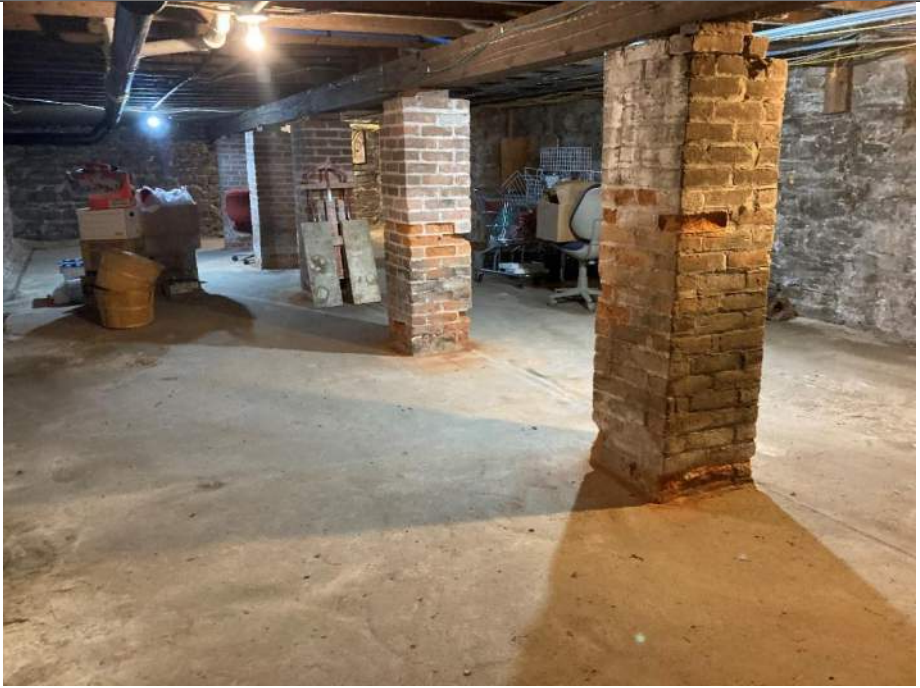
3	9/5/2023	
Direction Photo Taken		
Southeast		
Description		
General view of the eastern basement, southern half.

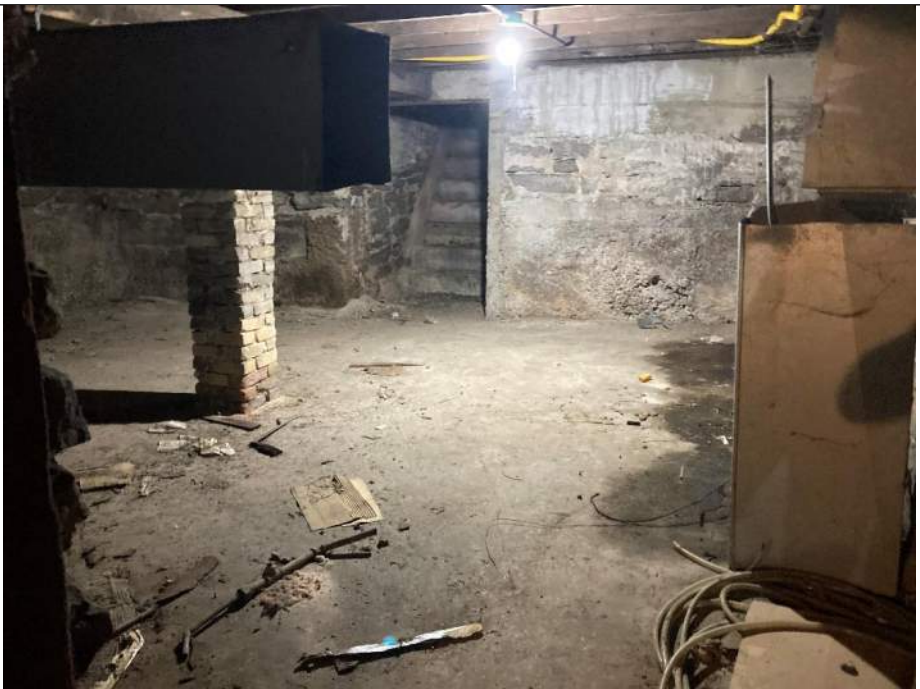
4	9/5/2023	
Direction Photo Taken		
Southwest		
Description		
General view of the eastern basement, southern half.

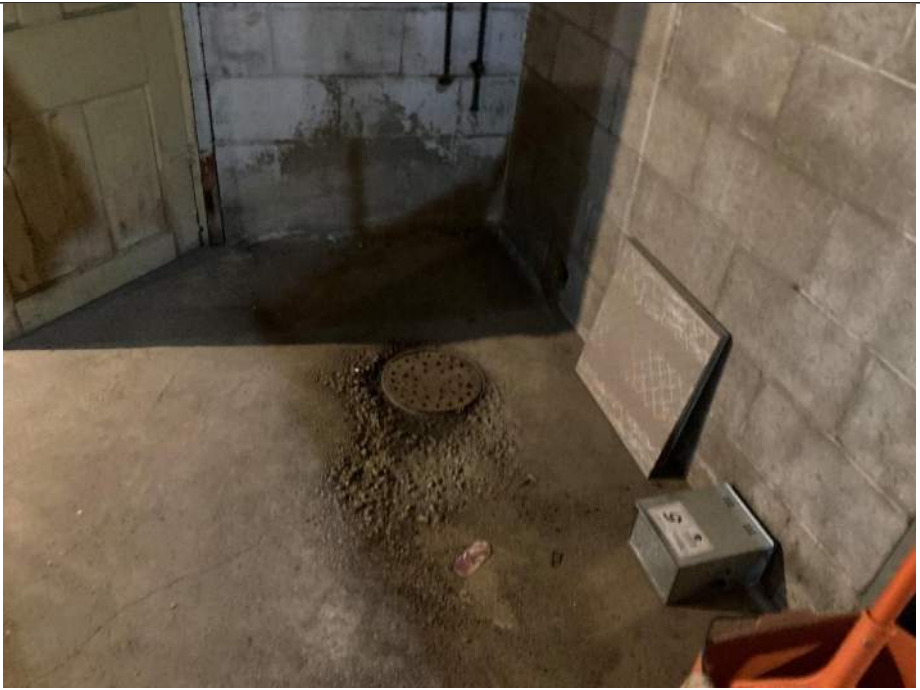
The concrete slab in the basement appeared to be in good condition. The walls in the basement were constructed of concrete block or brick. The concrete block walls appeared to be in good condition with little evidence of water staining/seepage. There were two floor drains observed within the basement slab. The floor drains are presumed to drain to the Village of Little Chute's sanitary department.

5	9/5/2023	
Direction Photo Taken		
South		
Description		
<p>Floor drain within the eastern basement, northern half.</p>

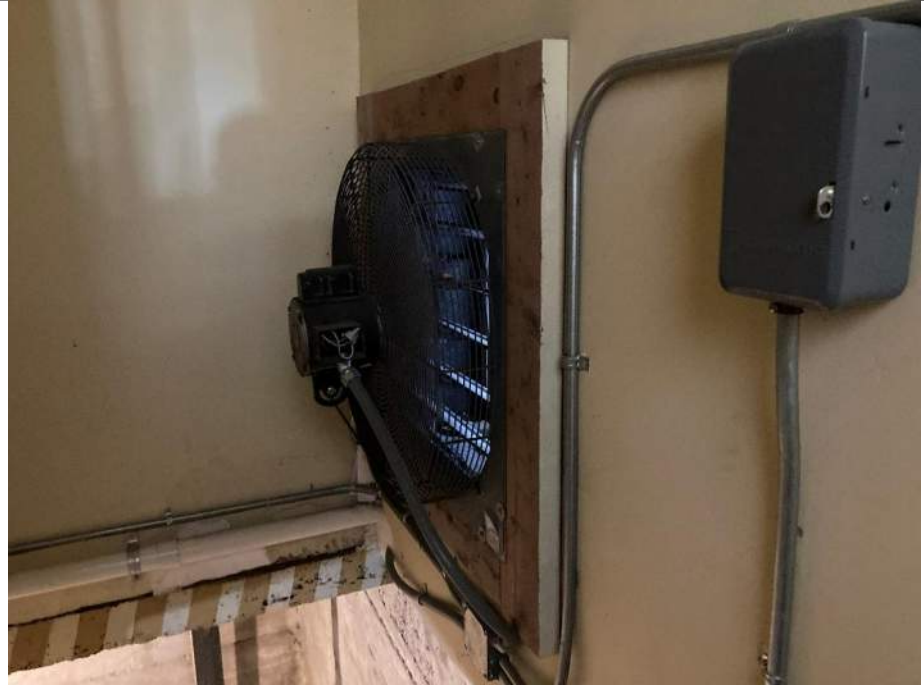
At the time of sampling, Cedar observed the basement to contain three (3) cooling systems for the freezers located in the bakery storefront on the main level. There was a box fan installed in the wall to regulate the temperature in the basement. The box fan was mainly used in the summers to help push hot air out of the basement. In the winter months, it appears that the box fan was not used in an attempt to keep heat within the basement. Additionally, there was an active vapor extraction system installed in the basement. The system was hung in the ceiling and vented outdoors (reference Photo Log, attached). There was no pressure meter as it was not a traditional sub-slab vapor system. At the time of the site visit, the fan to the system appeared to be off and/or not working properly.

Photo No.	Date
7	9/5/2023
Direction Photo Taken	
West	
Description	
Box fan installed in the north side of the building to help regulate the temperature in the basement. The PVC piping below the box fan is where the vapor mitigation system leaves the building.

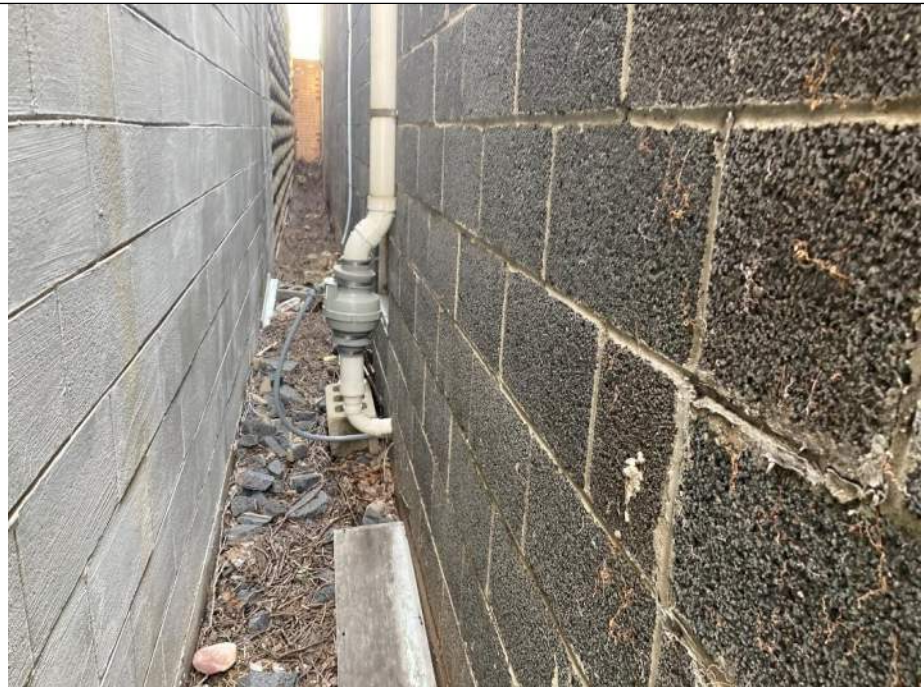
Photo No.	Date
8	9/5/2023
Direction Photo Taken	
East	
Description	
Active vapor mitigation system on the north side of the building in the alley.

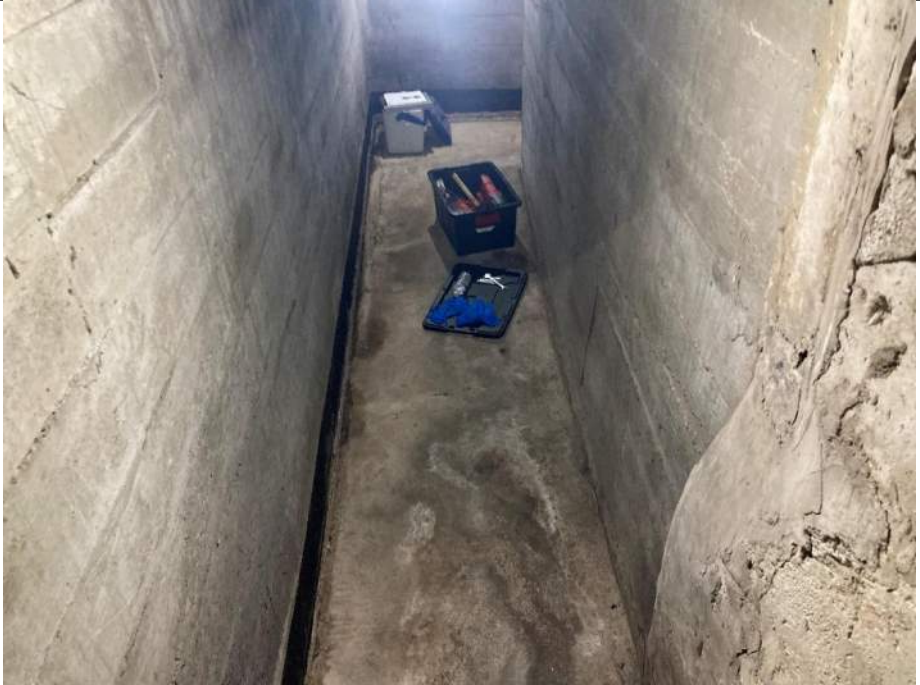
9	9/5/2023	
Direction Photo Taken		
North		
Description		
General view of the western basement hallway.

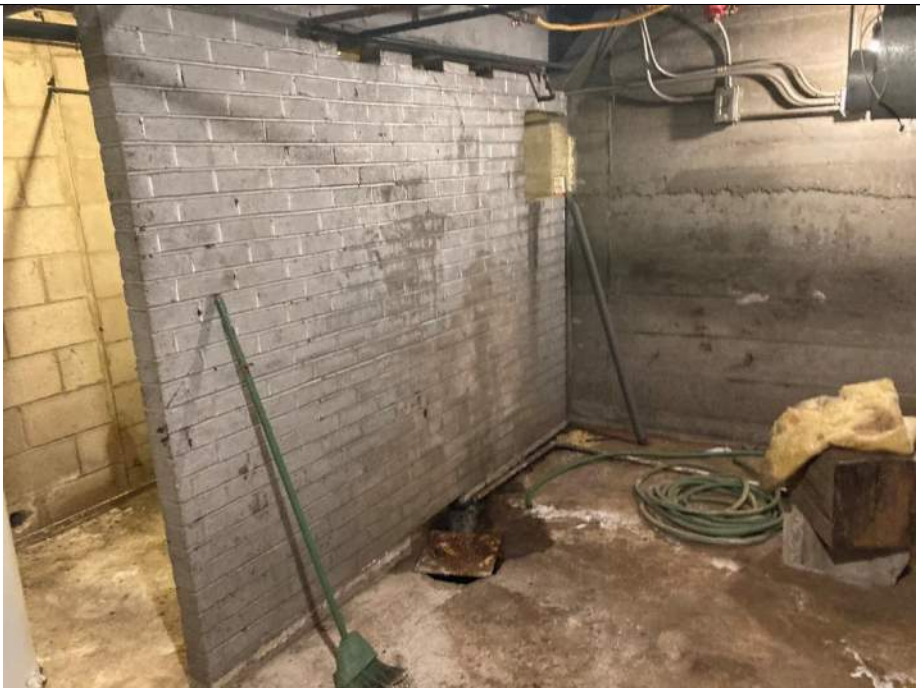
10	9/5/2023	
Direction Photo Taken		
Southeast		
Description		
General view of the western basement.

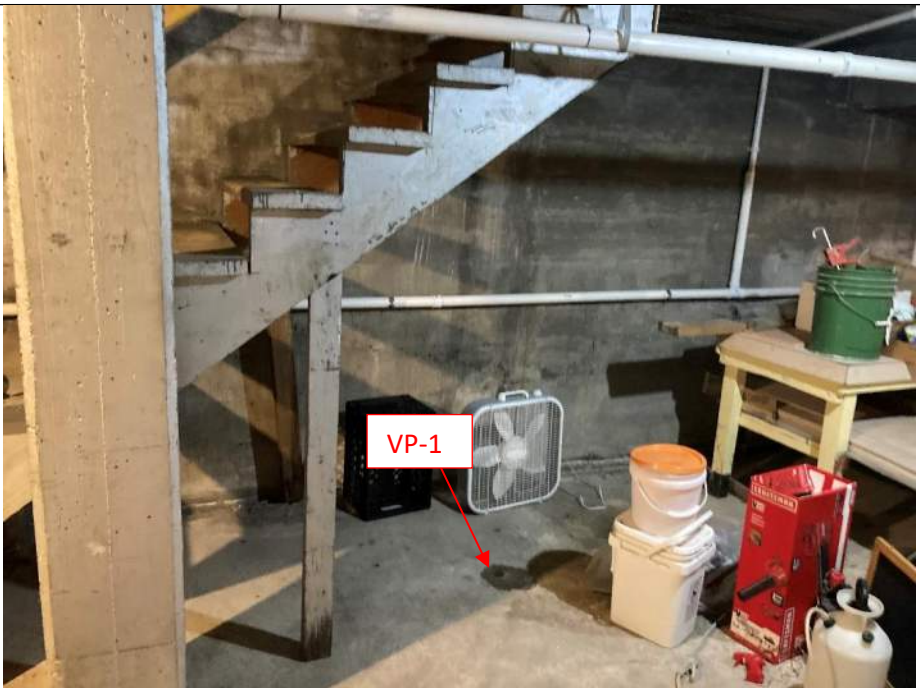
The September 5, 2023, sampling event identified cis-1,2-dichloroethene (95,000 micrograms per cubic meter (ug/m^3)) and vinyl chloride ($2,550 \text{ ug}/\text{m}^3$) at VP-1 exceeding the Small Commercial WI VRSLs. Tetrachloroethene (PCE) ($6,900 \text{ ug}/\text{m}^3$) and trichloroethene (TCE) ($1,140 \text{ ug}/\text{m}^3$) at VP-2 exceeding the Small Commercial WI VRSLs. These analytes detected are commonly associated with chlorinated solvents.

12	9/5/2023	
Direction Photo Taken		
North		
Description		
Location of VP-1.

Cedar recommends the results from this Limited Phase II ESA be submitted to the WDNR under the Sandies Dry Cleaners & Laundry (Former) – SL (BRRTS #02-45-552222). The analytes detected are consistent with the analytes detected in the Sandies Dry Cleaners & Laundry (Former) – SL (BRRTS #02-45-552222) which adjoining the Site to the north. Additionally, Cedar recommends that an active sub-slab vapor mitigation system be installed in the basement to prevent infiltration into the building.

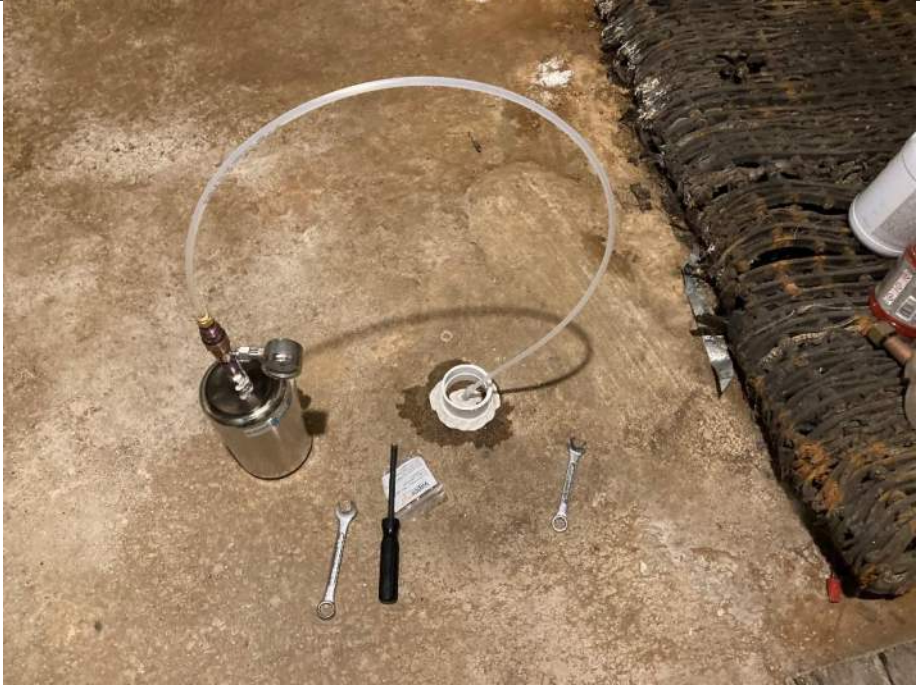
A water dam was placed around the vapor pins to verify and ensure a proper seal around the vapor pin. The water dam showed no visual indications of air gaps or compromised sampling conditions at any of the vapor pins. Once sampling quality was verified, the tubing connecting the pin to the flow regulator was purged prior to sample collection. Once the tubing was purged, air flow to the vapor canister was engaged. Prior to engaging the regulators, Cedar recorded the initial vacuum readings and times were collected in order to compare against the vacuum readings at the time of finalizing the sample collection. Vapor canisters were shut off at pressures between four and two inches of mercury (Hg). The final times and pressures were recorded (reference Photo Log, attached). After sub-slab samples were collected the vapor pins were removed and the pin locations were sealed with concrete.

13	9/5/2023	
Direction Photo Taken		
South		
Description		
Typical vapor sampling setup. Sampling VP-2.

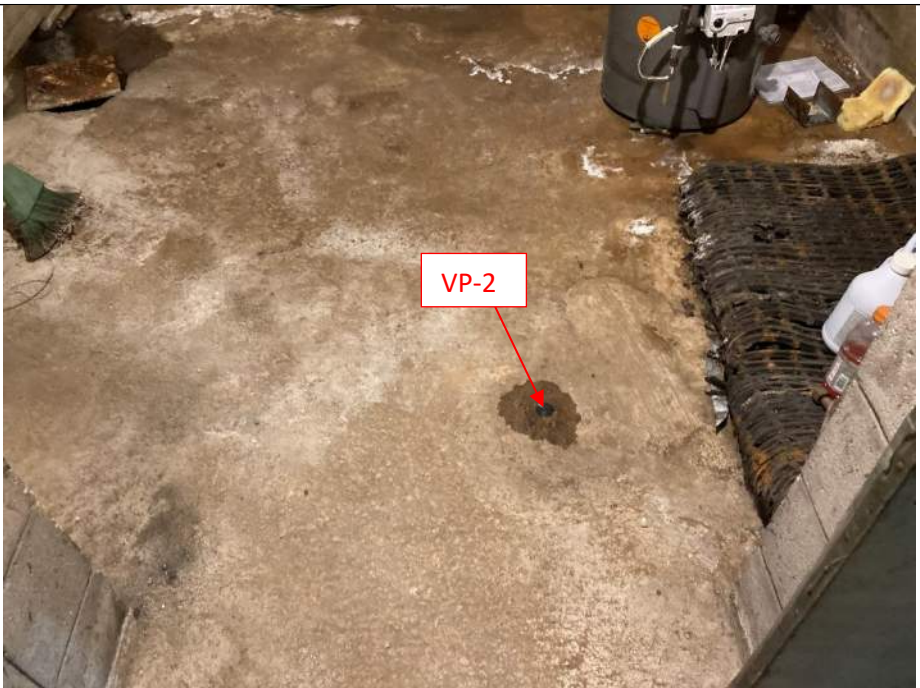
14	9/5/2023	
Direction Photo Taken		
South		
Description		
Location of VP-2.

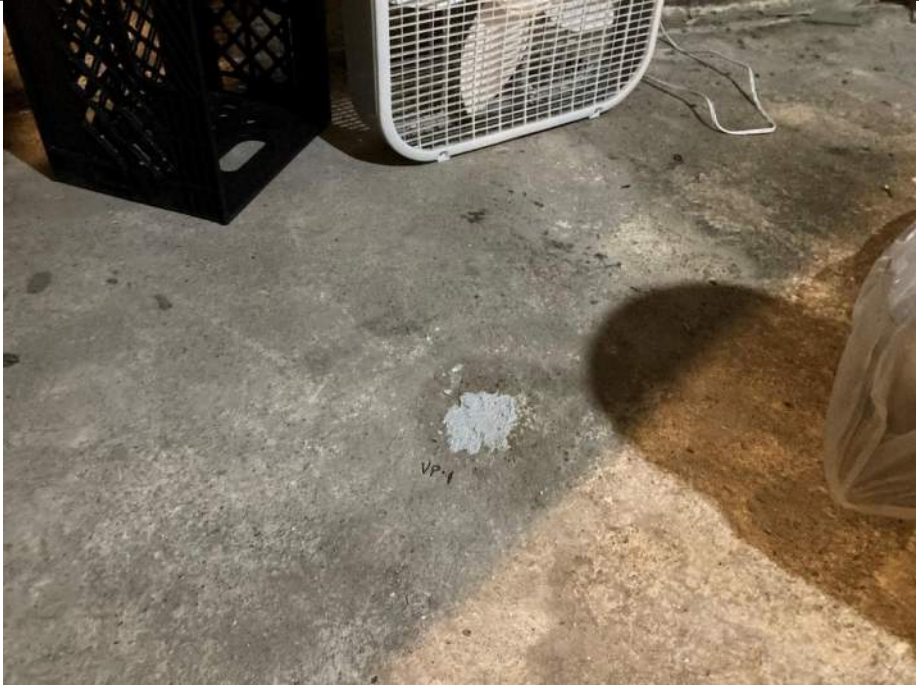
15	9/5/2023	
Direction Photo Taken		
Northeast		
Description		
Abandonment of VP-1.

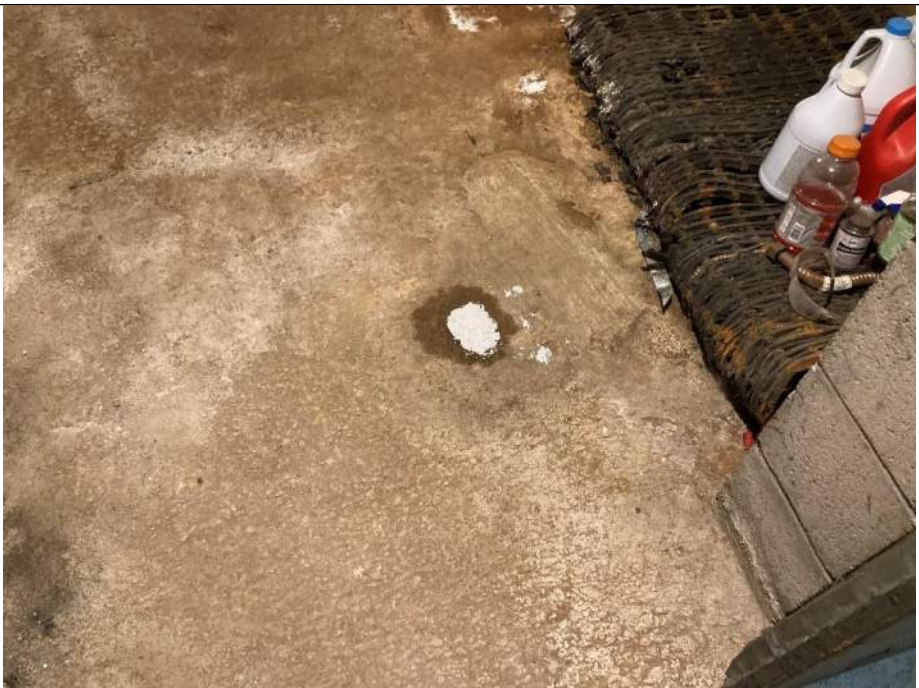
16	9/5/2023	
Direction Photo Taken		
Southwest		
Description		
Abandonment of VP-2.
