#### Development at Historic Fill Site or Licensed Landfill Exemption Application

C. Reiss Coal Dock Property		E ½ N	E ¼ of S16, and	l the E	1/2 SE 1/4	, S9, T49N, R14W
Is the site known by another name(s)? OY	es () No () Unknown	• Cit	ty () Town () \	/illage		
If yes, provide name: Murphy Marine T		of	Superior		_	
Does the site have a license number? OY	es  No  Unknown	State	ZIP Code		County	
If yes, License Number:		WI	54880		Dougla	IS

#### Section V, Summary of Existing and Potential Impacts: C Reiss Coal Dock Property, Superior, Wisconsin

**Property Redevelopment Plans**

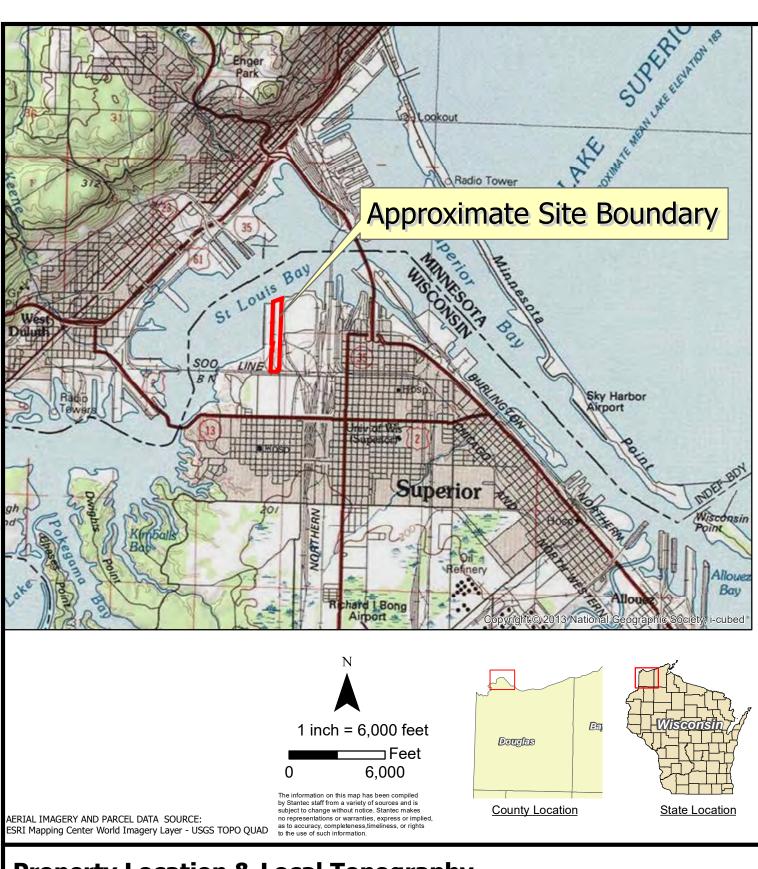
### **Property Location & Local Topography**

#### C. REISS DOCK ST. LOUIS BAY, SUPERIOR, WI

The C. Reiss Coal Dock property in Superior, Wisconsin (herein referred to as the "Property") is located in the east ½ of the northeast ¼ of Section 16 and the east ½ of the southeast ¼ of Section 09, Township 49 North, Range 14 West, Douglas County, Wisconsin. It is bordered by St. Louis Bay to the north, active industrial dock properties to the west and east, and the Burlington Northern Santa Fe Railway right-of-way to the south. Further surrounding land uses are primarily industrial in nature. The general location of the Property is illustrated on **Figure 1**.
