## Technical Memorandum

**To:** Joseph Pearson, Superior Refining Company, LLC  
**From:** Lynette Carney and Kaitlin Montz  
**Subject:** Platformer Concrete Replacement  
**Date:** February 28, 2023  
**Project:** 49161468.03 100 104  
**WDNR BRRTS:** 02-16-591050

This memorandum summarizes the environmental response activities performed by Superior Refining Company LLC (SRC) following the discovery of historical petroleum impacts in the Platformer Unit at the SRC Refinery in Superior, Wisconsin (Figure 1).

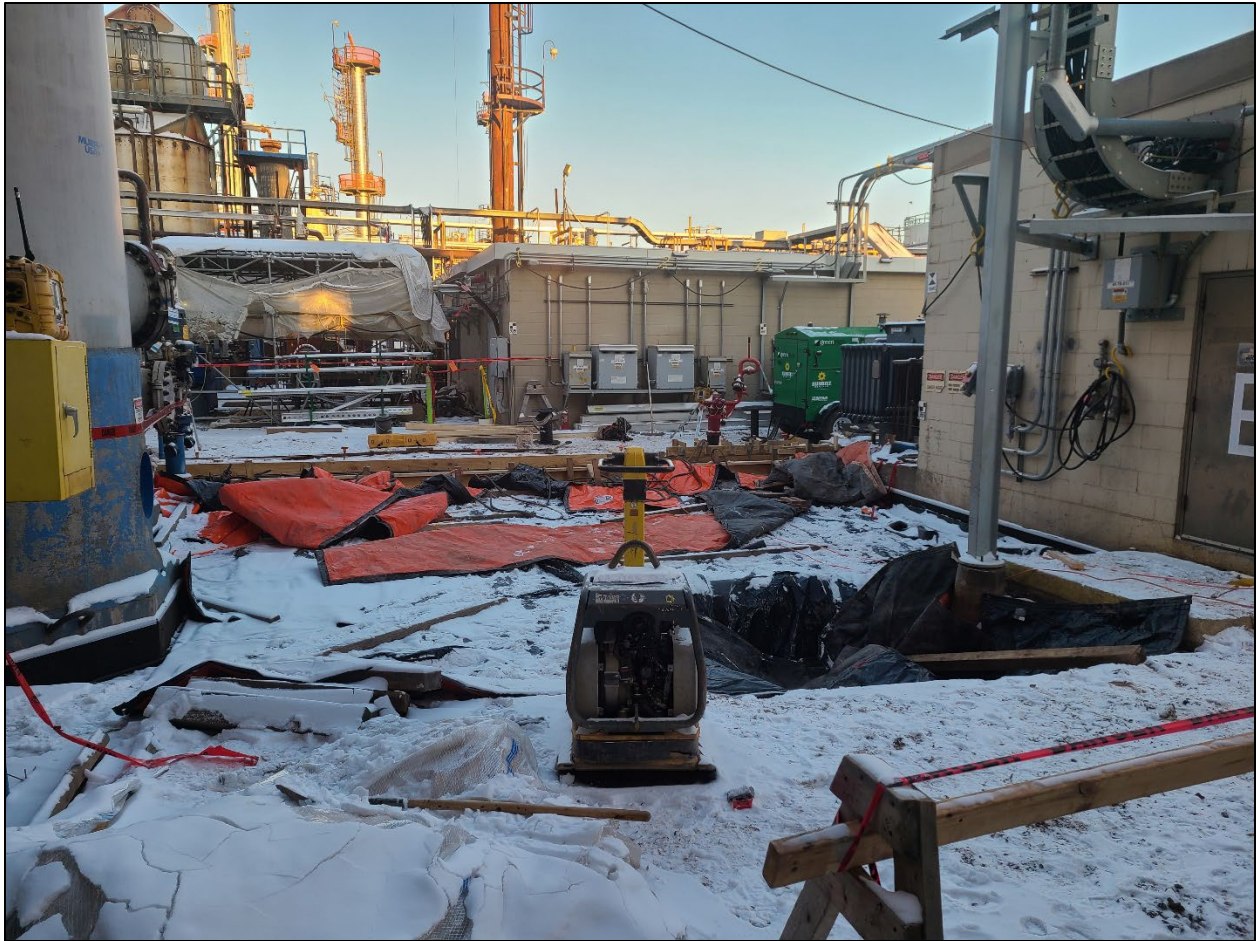
**Photo 1** Excavation area in Platformer Unit. Photo taken on December 7, 2022, by Insight.

On December 7, 2022, Insight Environmental (Insight) was on site to document response cleanup activities and to collect soil field screening samples from the excavation (Photo 1 and Photo 2). A soil headspace screening sample was collected from the bottom of the excavation and tested for the presence of organic vapors using a 10.6 eV photoionization detector (PID). PID readings and other evidence of petroleum impacts, such as odor, were recorded on the field sampling and screening log provided in Attachment B.

The final excavation extent was approximately 8 feet (northeast to southwest) by 10 feet (northwest to southeast) and up to 3.5 feet below ground surface (bgs) (Attachment B). Clay soil was observed in the excavation sidewalls and bottom.

Upon completion of the project activities, the excavation was backfilled with clean fill and the concrete was replaced.

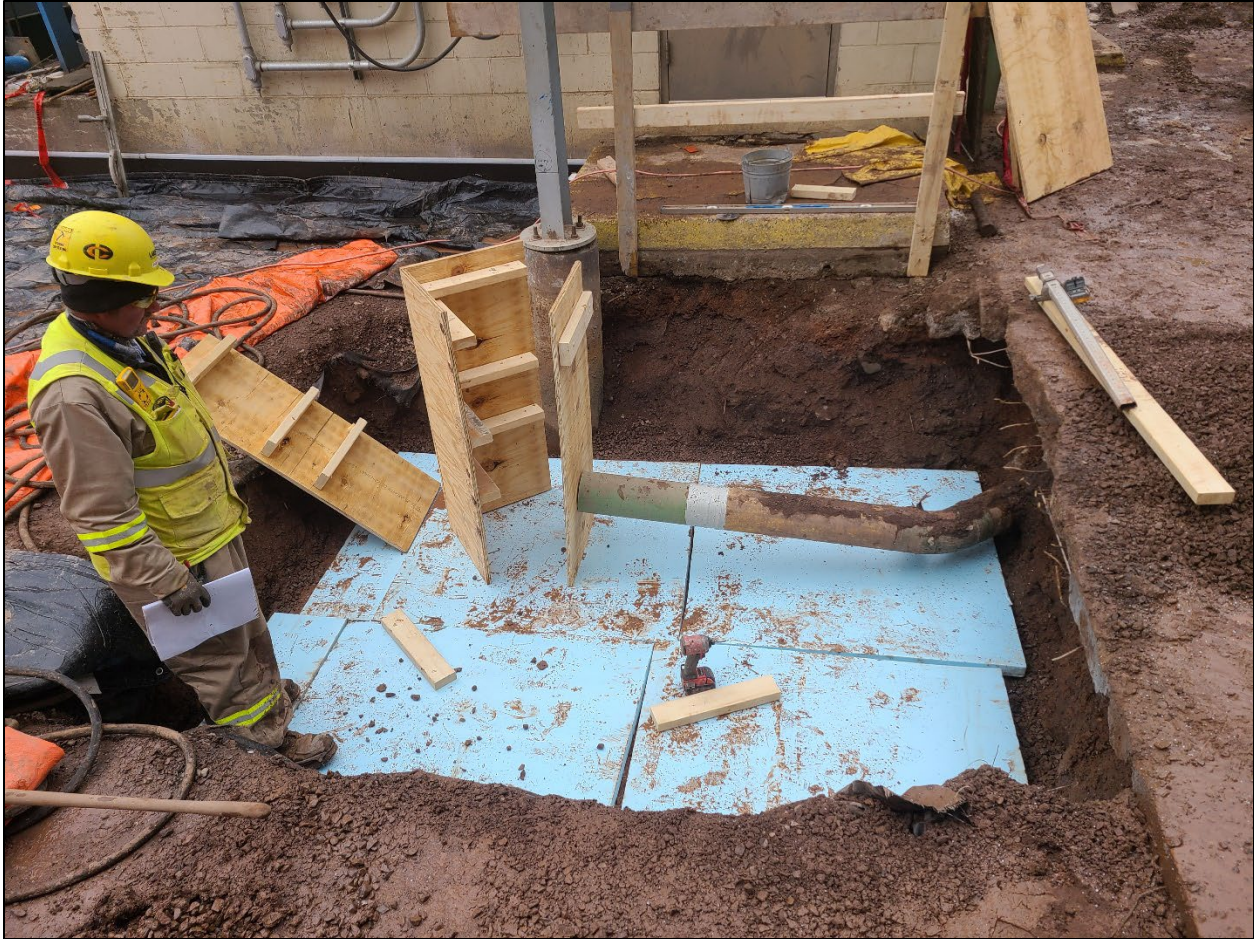
**Photo 2** Excavation extent in Platformer Unit. Photo taken on December 7, 2022, by Insight.

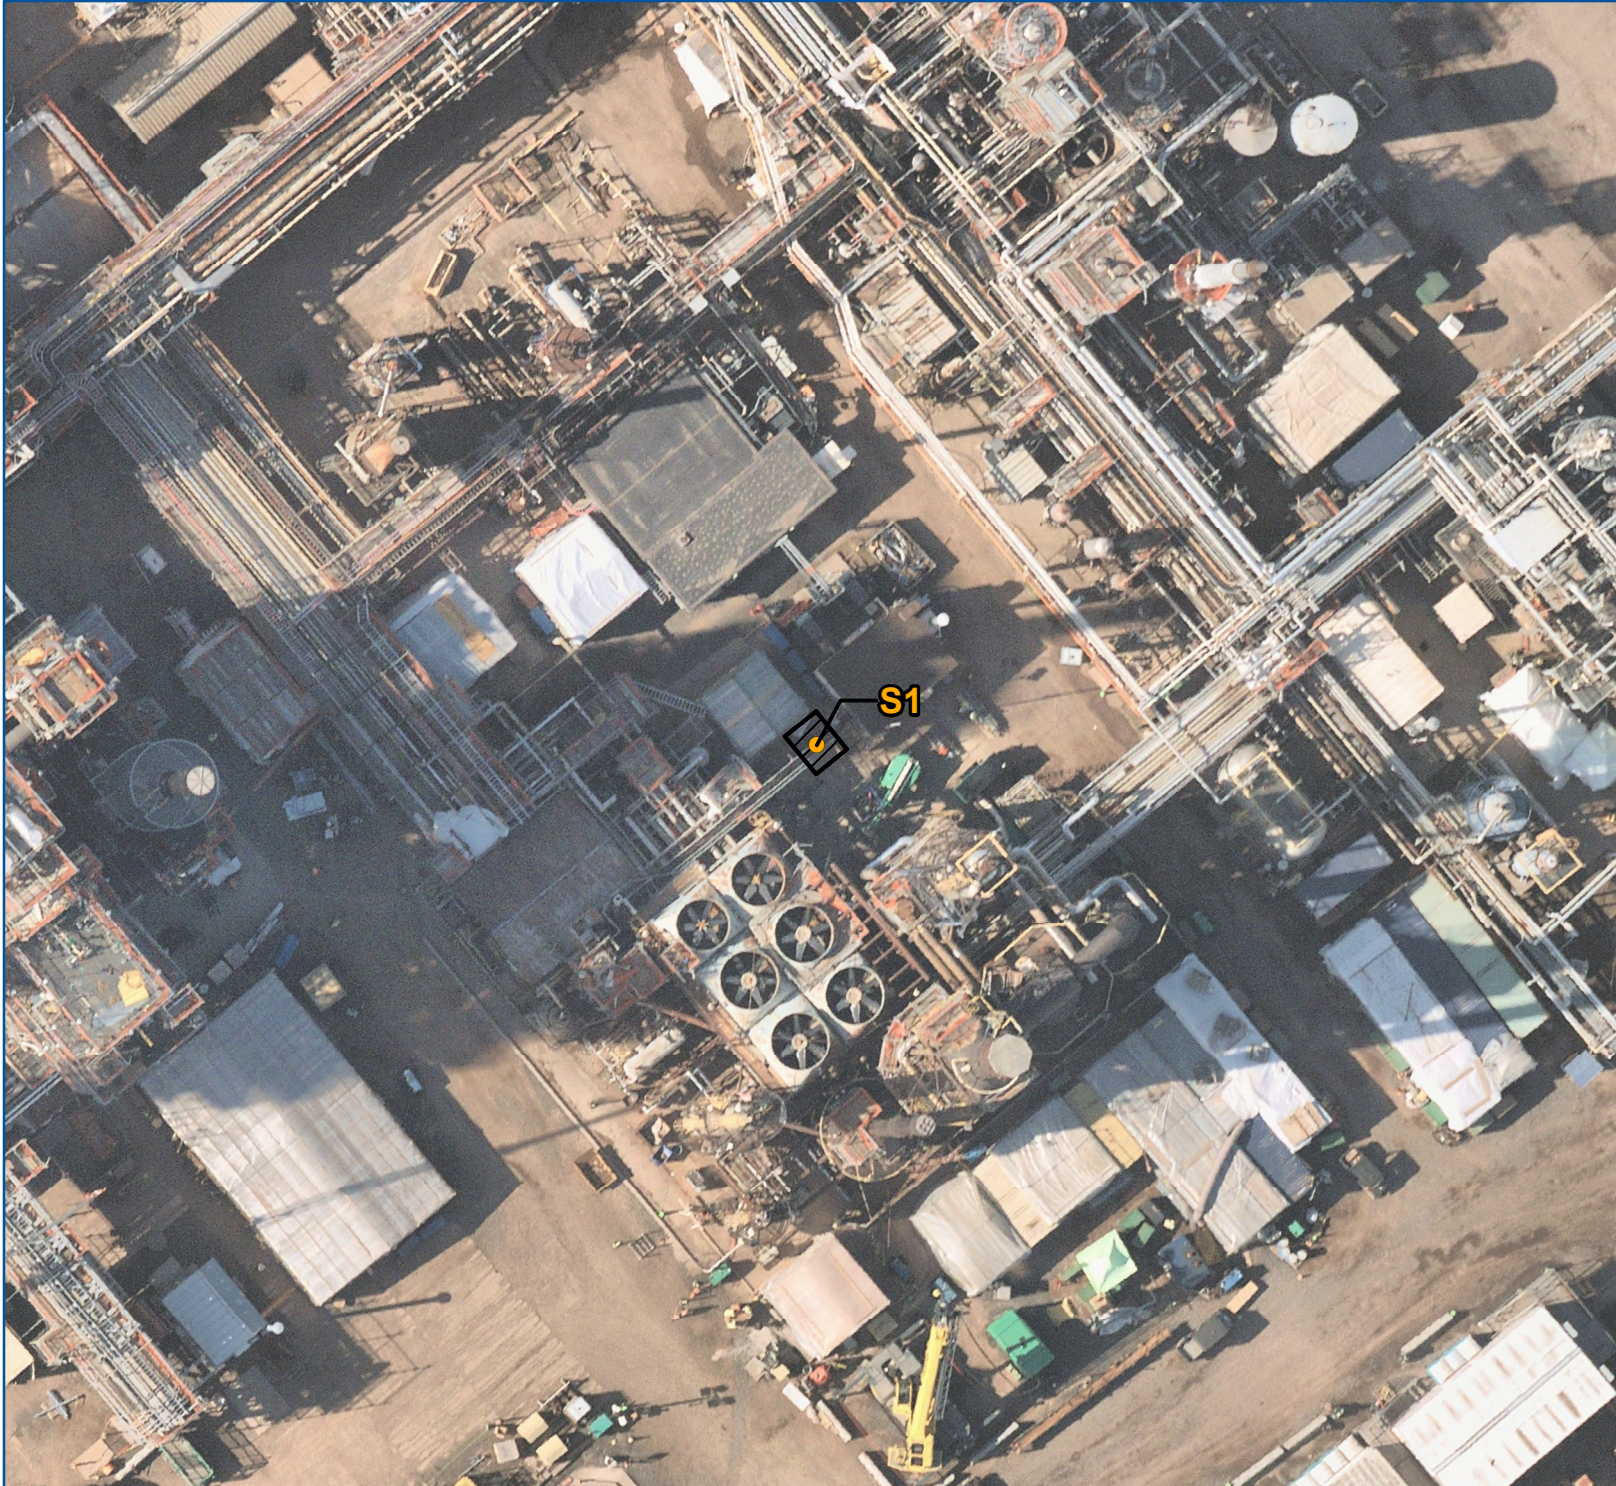
FIGURE 2

- Analytical Sample Location
- ▨ Excavation Extent

**SITE LAYOUT**  
PLATFORMER CONCRETE  
REPLACEMENT  
Superior Refining  
Company LLC (SRC)  
Superior, WI

On December 6, 2022, SRC contractors removing concrete and replacing a catch basin encountered an apparent petroleum odor and petroleum impacted soil in the Platformer Unit (hereafter referred to as the Site; Figure 2). SRC personal did not identify an active spill in the area.

Insight collected one field screening soil sample and one analytical confirmation soil sample (S7). The soil analytical sample was submitted to Pace Analytical (Pace) in Duluth, Minnesota for analysis of petroleum volatile organic compounds (PVOCs) and polycyclic aromatic hydrocarbons (PAHs). The analytical confirmation soil sample location is shown on Figure 2.
