Technical Memorandum

To:Nick Larabel, Enbridge EnergyFrom:Ryan EricksonSubject:Enbridge Superior Terminal – Manifold 221 ResponseWDNR BRRTS #'s:0216577298 (Manifold Corridor); 1616560657 (Terminal Facility-wide)Barr Project:49161092.11 003 007Site Coordinates:46.689020°, -92.058239° (NAD83)Date:December 18, 2022

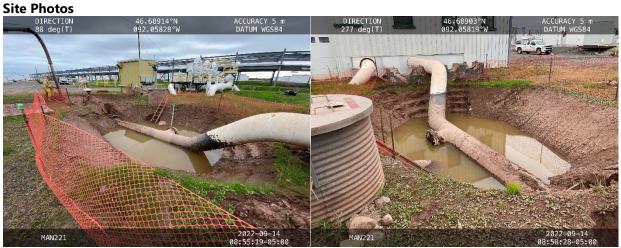
Photo 1

- No apparent soil impacts (e.g., discoloration, petroleum sheen) or definitive sources of sheen were observed in the excavation sidewalls at the time.
- No sheen was observed on water in the southwestern half of the excavation (Photo 2). The project
 inspector reported that a sheen had been observed there the previous day but was no longer
 present.
- A sheen was observed on water in the northeastern half of the excavation (Photos 3 and 4) where excavation with a hydrovacuum truck (hydrovac) was ongoing.

Photo 1: Manifold 221 excavation. Photo taken facing east on September 14, 2022.Photo 2: Western half of Manifold 221 excavation. Photo taken facing west on September 14, 2022.

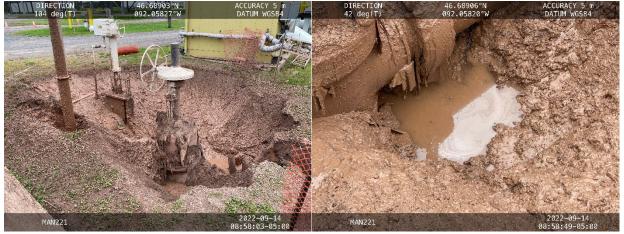
Photo 4

Photo 3: Eastern half of Manifold 221 excavation. Photo taken facing southeast on September 14, 2022. **Photo 4:** Sheen on water in bottom of eastern half of the Manifold 221 excavation. Photo taken facing northeast on September 14, 2022.

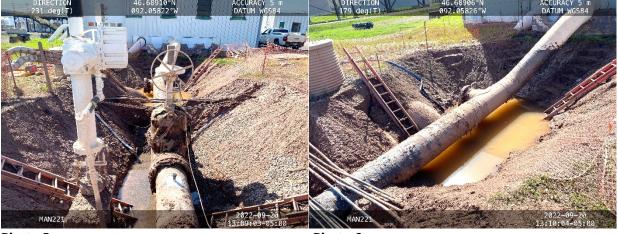
Photo 6

Barr collected fifteen field screening soil samples from the excavation sidewalls (Photos 5 and 6; Attachment A). No soil samples were collected from the excavation bottom due to the presence of excavation water and gravel. The soil samples were tested for the presence of organic vapors using a 10.6eV photoionization detector (PID) and inspected for the presence of other potential indicators of petroleum impacts such as odor, discoloration and sheen. The soil had headspace readings between 0.0 and 1.5 parts per million (ppm) and no discoloration, petroleum odor, or sheen were identified in the soil. However, a small, perched water zone with a rainbow sheen was observed within sandy fill material around electrical lines in the northwest sidewall at approximately 3 feet bgs (Photos 7 through 10). The electrical lines bisect the excavation. Water was not observed coming out of fill material in the southeast sidewall.

Photo 5: Manifold 221 excavation. Photo taken facing southwest on September 20, 2022. **Photo 6:** Electrical lines near center of Manifold 221 excavation. Photo taken facing south on September 20, 2022.

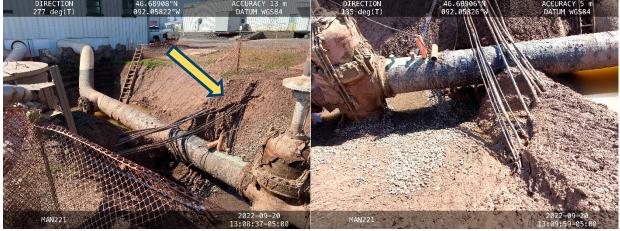
Photo 8

Photo 7: Manifold 221 excavation. Water (yellow arrow) from sandy fill around electrical lines on northwest sidewall. Photo taken facing west on September 20, 2022.

Photo 8: Electrical conduit on northwest sidewall. Photo taken facing down to the southeast on September 20, 2022.

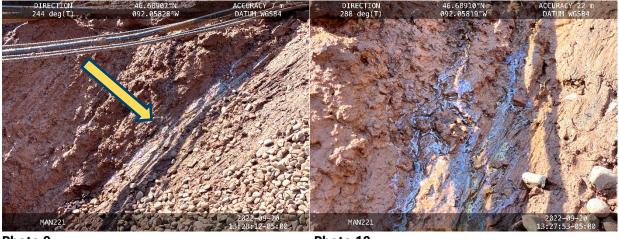
Photo 9

Photo 9: Water (yellow arrow) from sandy fill around electrical lines. Photo taken facing southwest on September 20, 2022.

Photo 10: Petroleum sheen on water. Photo taken facing northwest on September 2, 2022.

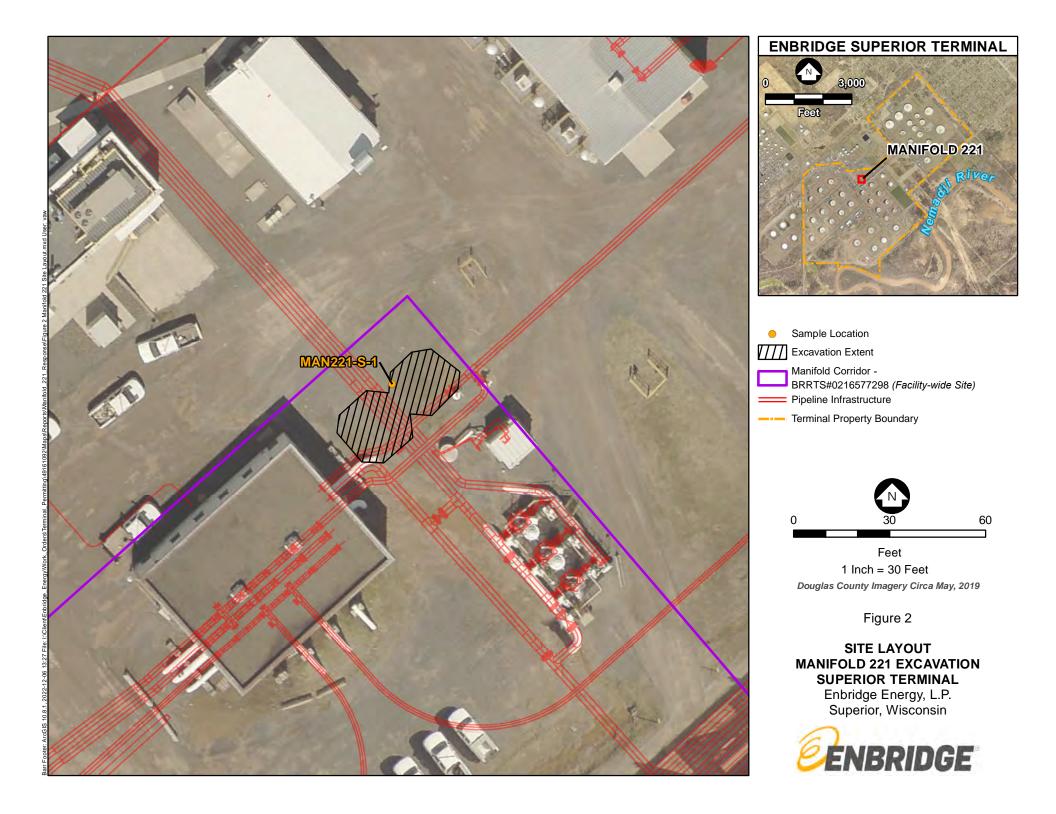
Analytical confirmation soil sample *MAN221-S-1* was collected from the fill material around the electrical lines from a depth of 3 to 3.5 feet bgs (Figure 2; Attachment A). The sample was submitted to ALS Environmental Laboratory (ALS) in Holland, Michigan for analysis of petroleum volatile organic compounds (PVOCs) and naphthalene. The analyte concentrations were below the laboratory method detection limits except for naphthalene (0.64 mg/kg); which is below the WDNR Groundwater Residual Contaminant Levels (RCLs; naphthalene = 0.6582 mg/kg). The laboratory report is provided in Attachment B.

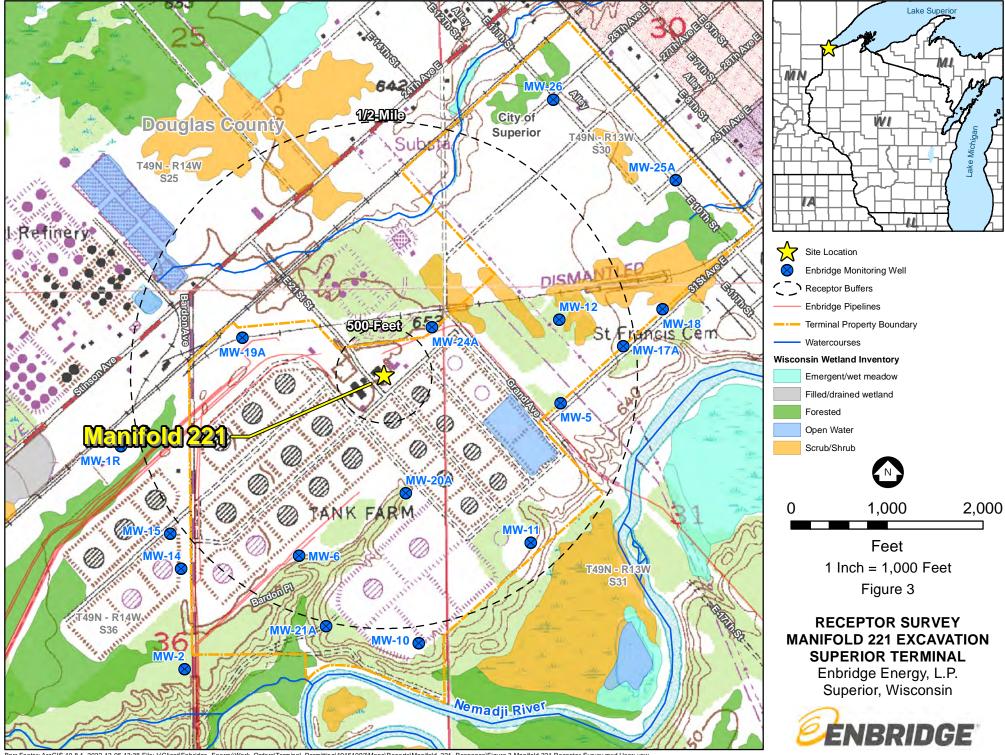
Barr Footer: ArcGIS 10.8.1, 2022-12-06 13:38 File: 1:Client\Enbridge_Energy\Work_Orders\Terminal_Permitting\49161092\Maps\Reports\Manifold_221_Response\Figure 3 Manifold 221 Receptor Survey.mxd User: vaw

No direct contact risks were identified based on the field observations by the project team and due to the clean fill material used to backfill the excavation. No impacts to surface water were identified during the project and there is little risk of future surface water impacts based on field observations, distance to surface water receptors, and the use of clean backfill. No groundwater risks were identified based on the results of the analytical sample collected from the excavation and based on the results of the annual

facility-wide groundwater monitoring program. Specifically, the groundwater pathway at the Superior Terminal is addressed on a facility-wide basis through the established hydrogeologic performance standard approved by the WDNR; Enbridge samples the Terminal groundwater monitoring well network (Figure 3) on an annual basis and provides the data to the WDNR. The nearest downgradient monitoring well is MW-24A located approximately 600 feet to the northeast. No vapor receptors were identified as the nearest enclosed structure is approximately 30 feet west of the electrical lines, and the structure is an above grade pipeline-operation building with no basement and limited human occupancy. Further, Terminal employees are required to wear four-gas detectors that would alert them to a potentially hazardous atmosphere.
