Technical Assistance, Environmental Liability Clarification or Post-Closure Modification Request

Location Map
Millis Transfer
 3001 W HOLY HILL ROAD
 VILLAGE OF RICHFIELD
 WASHINGTON COUNTY, WISCONSIN

Detailed Site Map
Millis Transfer
 3001 W HOLY HILL ROAD
 VILLAGE OF RICHFIELD
 WASHINGTON COUNTY, WISCONSIN

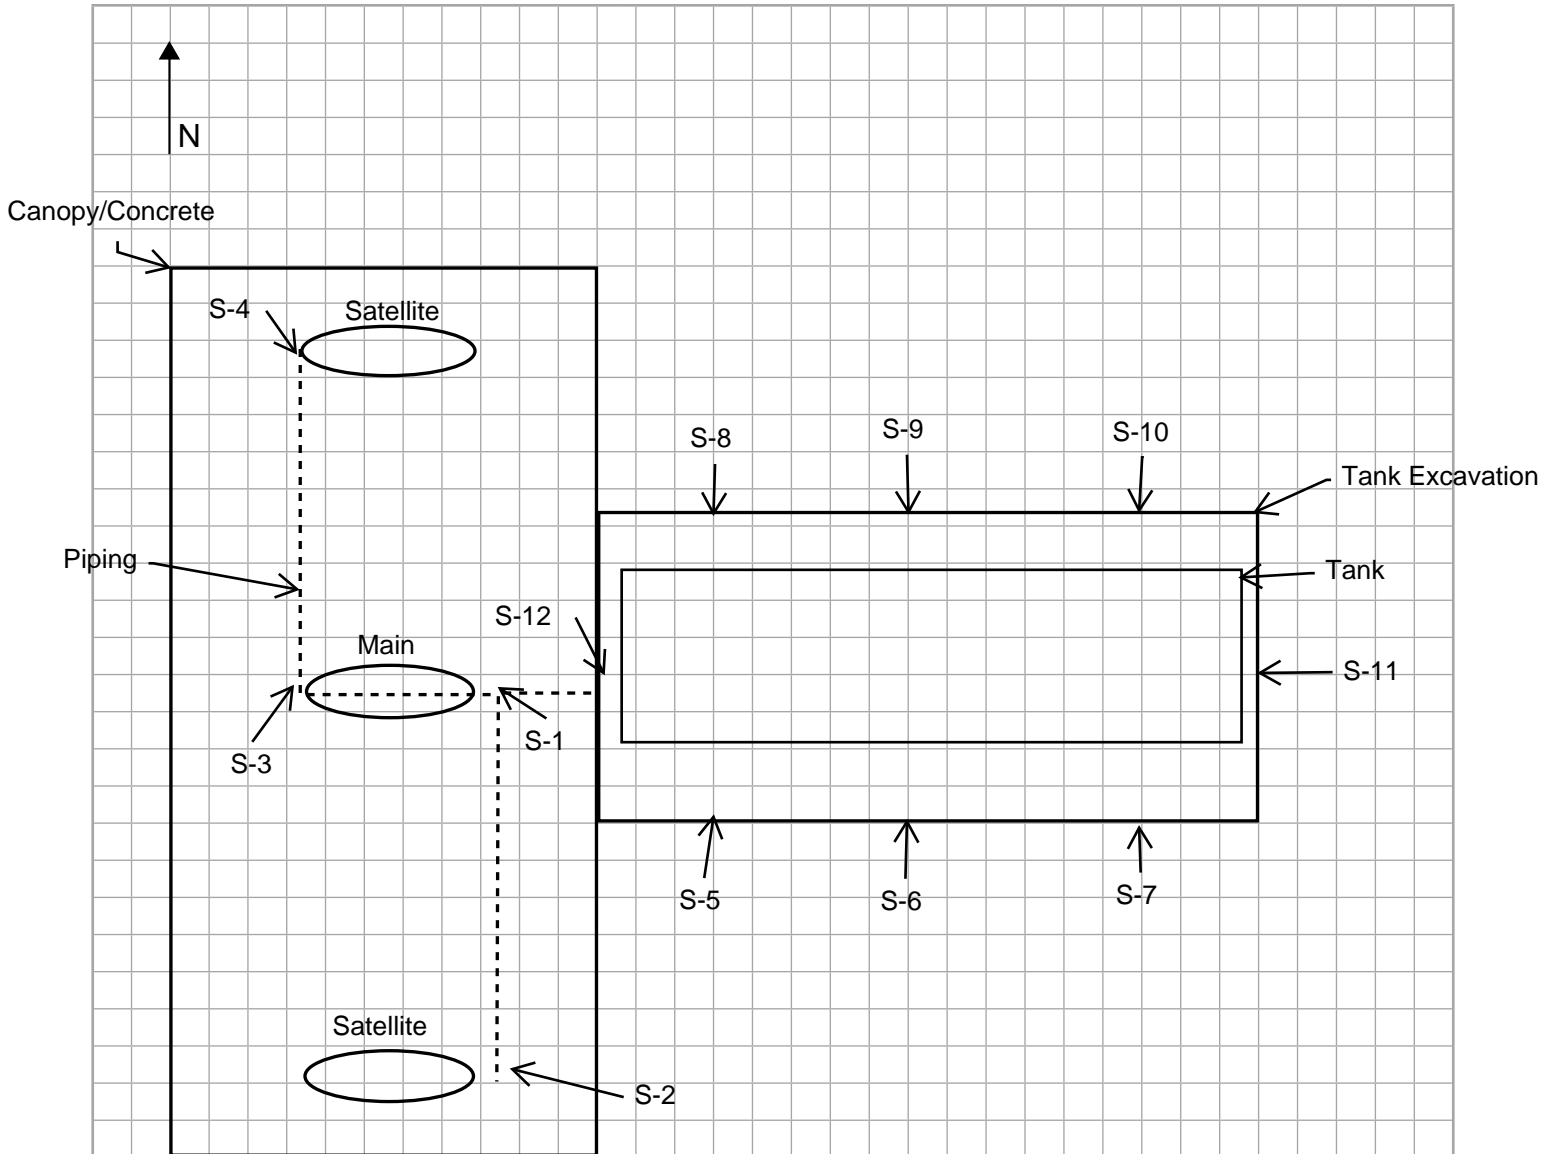
Figure 1 - Detailed Site Map

- Tank size ~ 9'x32'.
- Tank excavation ~ 34'x17'.
- Piping samples collected at 3' below ground surface (bgs).
- Tank samples collected at 12' bgs.
- No base samples due to groundwater encountered at 13' bgs.

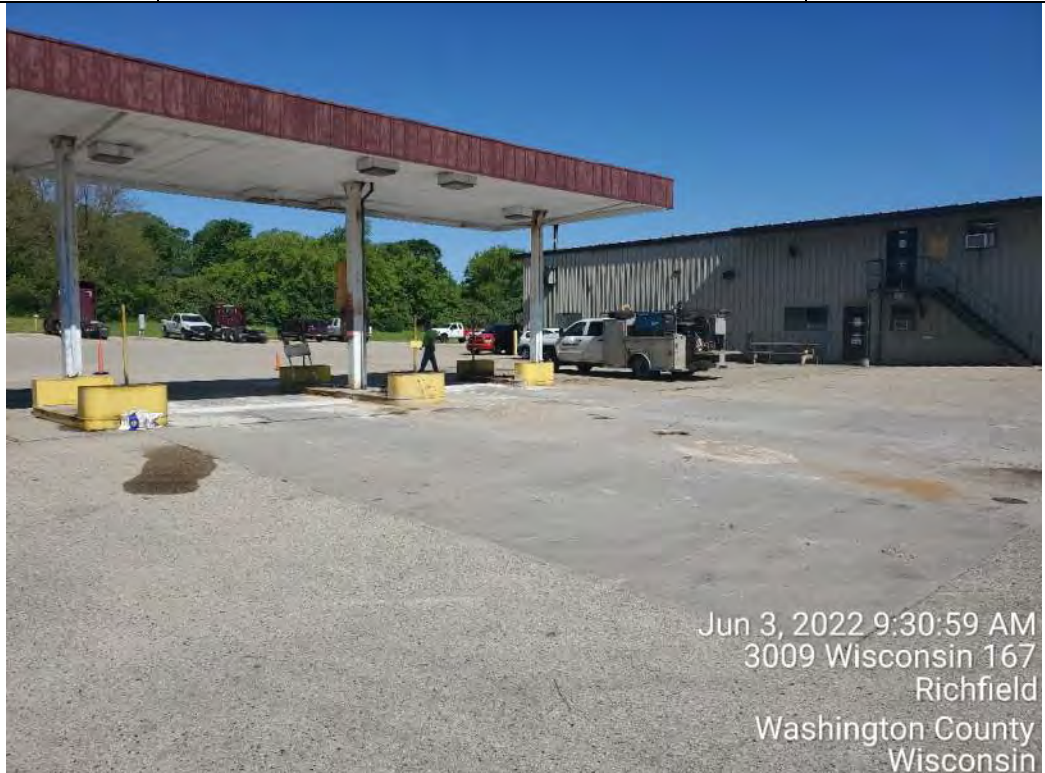
View of the tank location prior to removal.

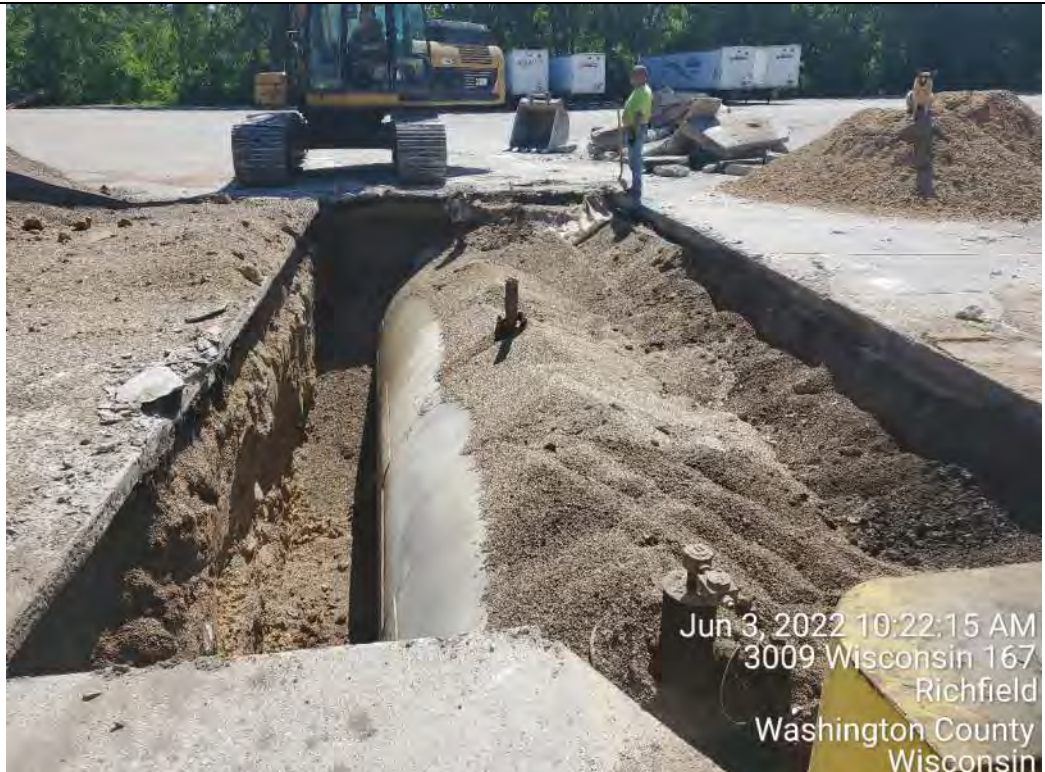
Photo No.
2

View of the tank during removal.

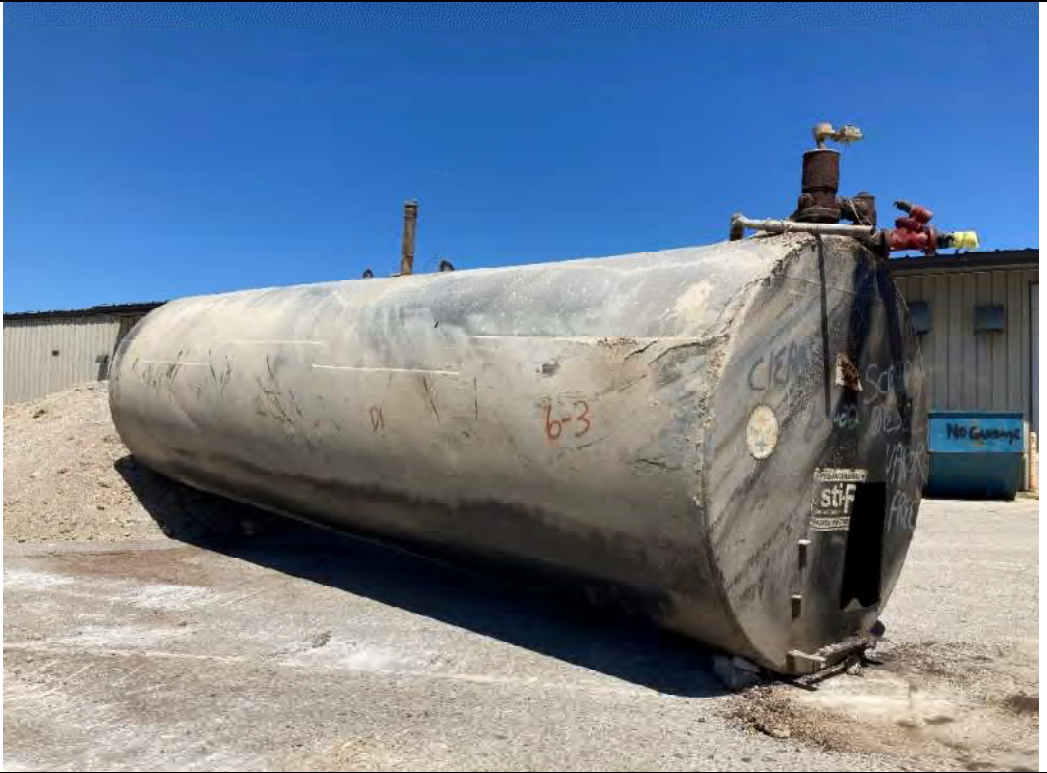
Photo No. 3	Date: 6/3/2022
Direction Photo Taken: Northwest	
Description: 15,000-gallon tank removed from the Site.

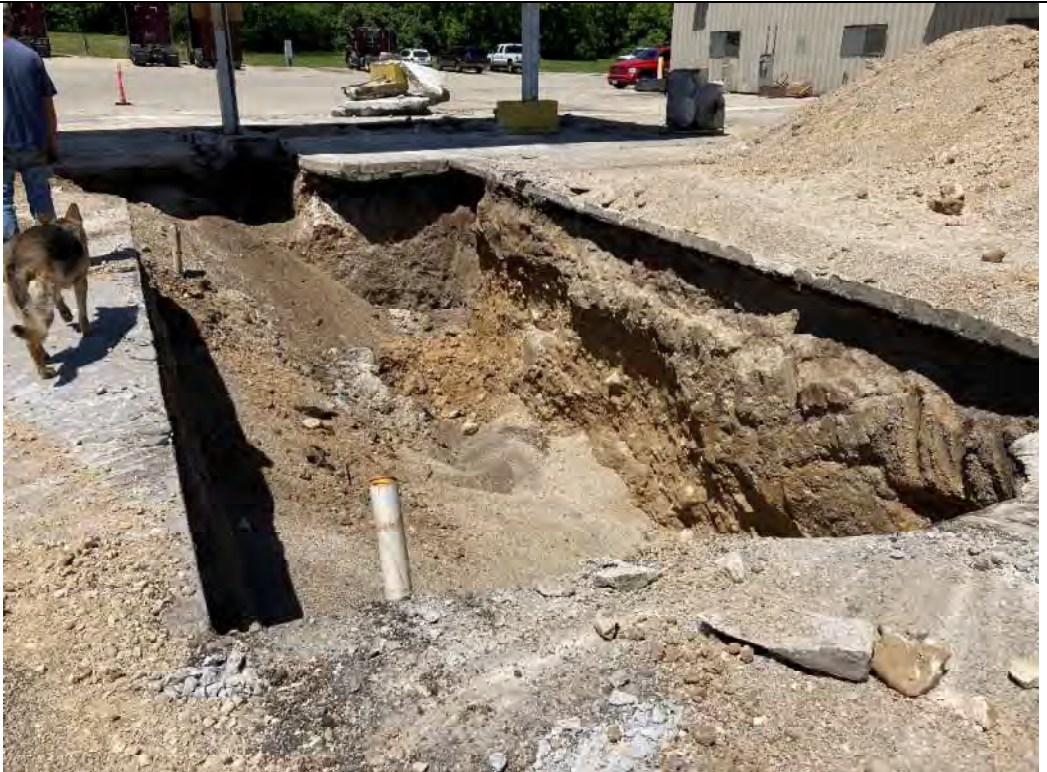
Photo No. 4	Date: 6/3/2022
Direction Photo Taken: West	
Description: Area of the tank excavation.

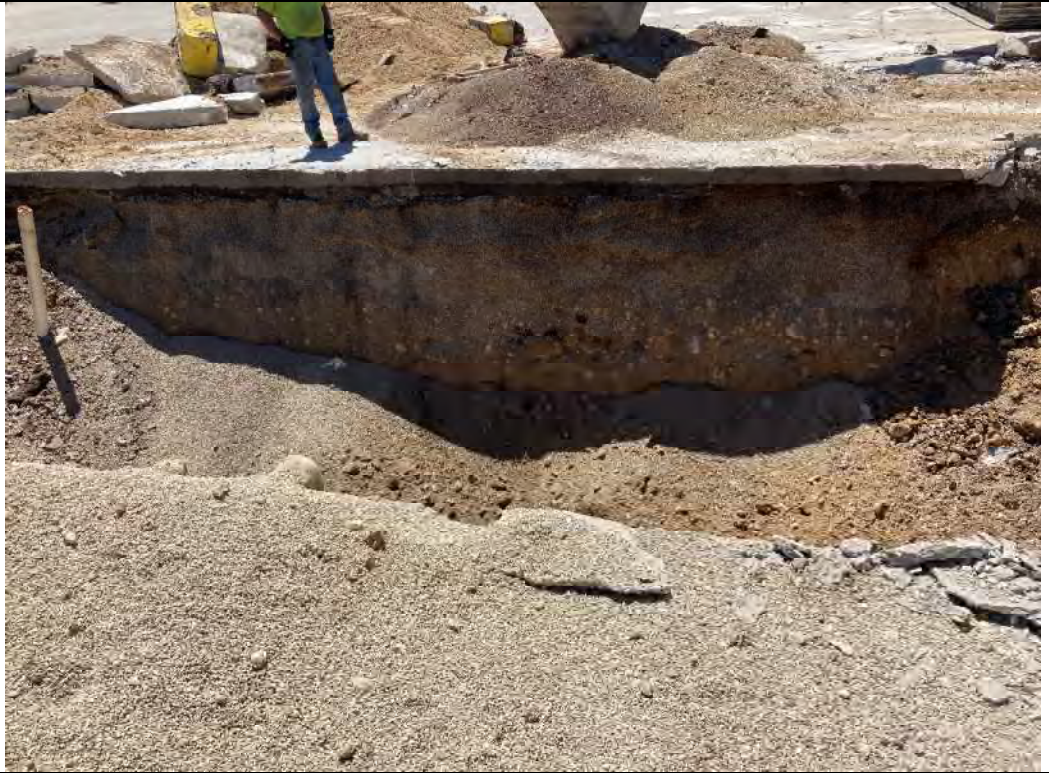
Photo No. 5	Date: 6/3/2022
Direction Photo Taken: South	
Description: View of the south sidewall of the tank excavation.

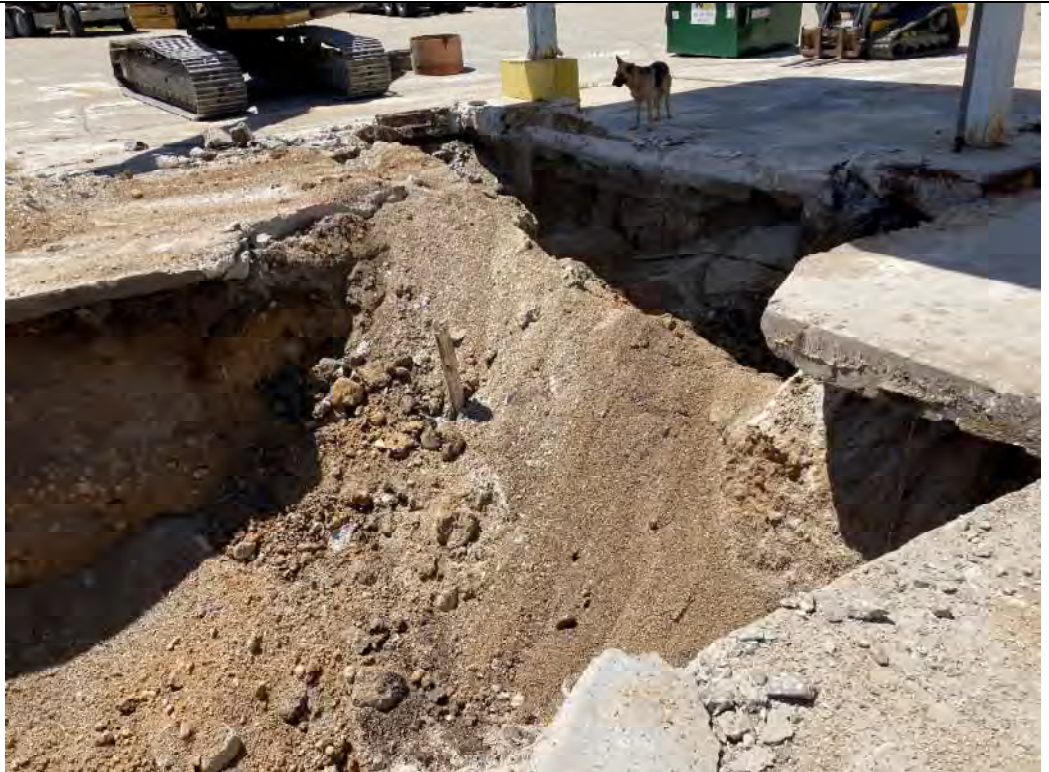
Photo No. 6	Date: 6/3/2022
Direction Photo Taken: Southwest	
Description: View of the west sidewall of the tank excavation

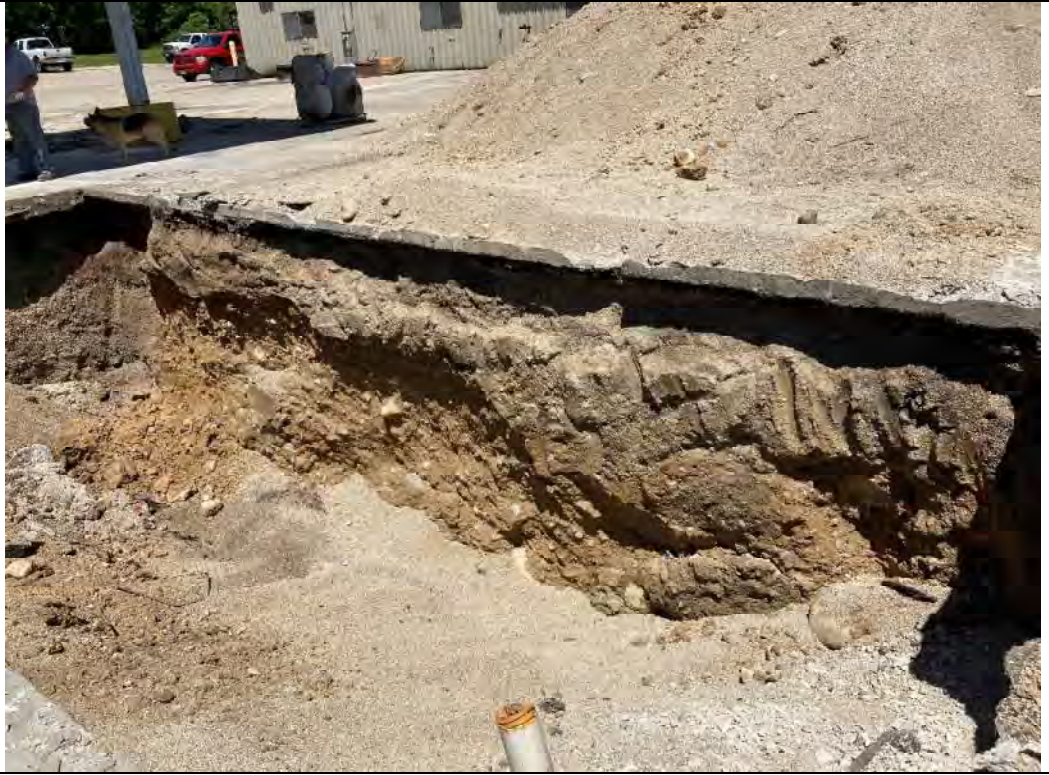
Photo No. 7	Date: 6/3/2022
Direction Photo Taken: Northwest	
Description: View of the north sidewall of the tank excavation.

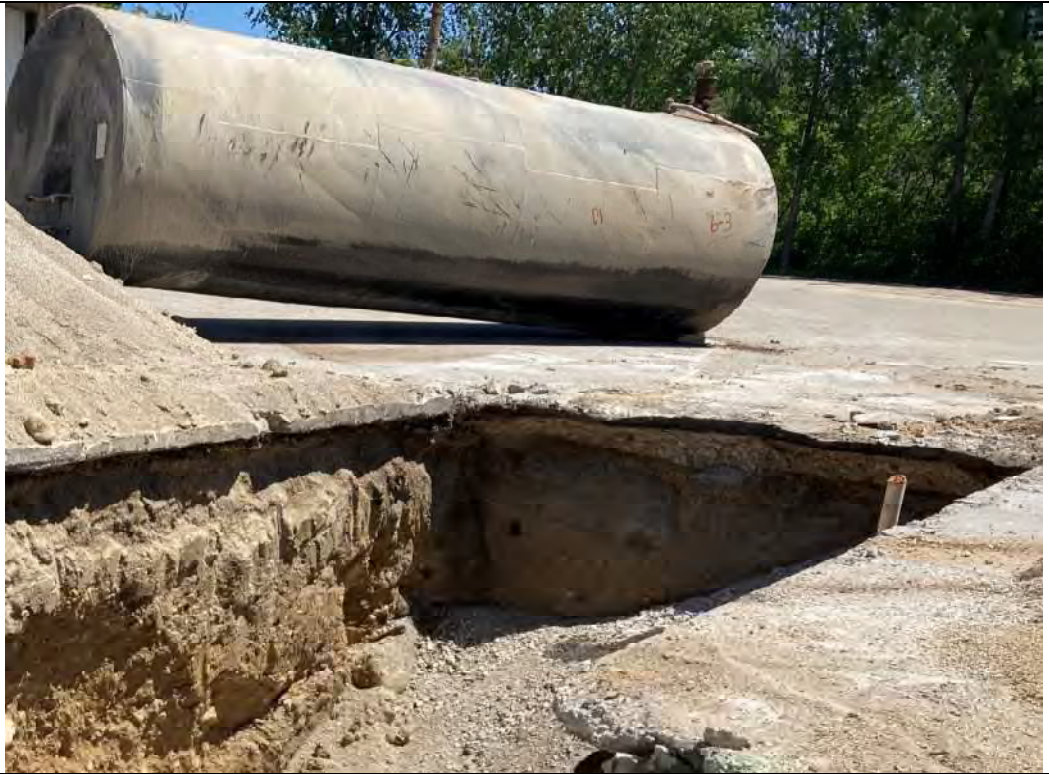
Photo No. 8	Date: 6/3/2022
Direction Photo Taken: Northeast	
Description: View of the east sidewall of the tank excavation.

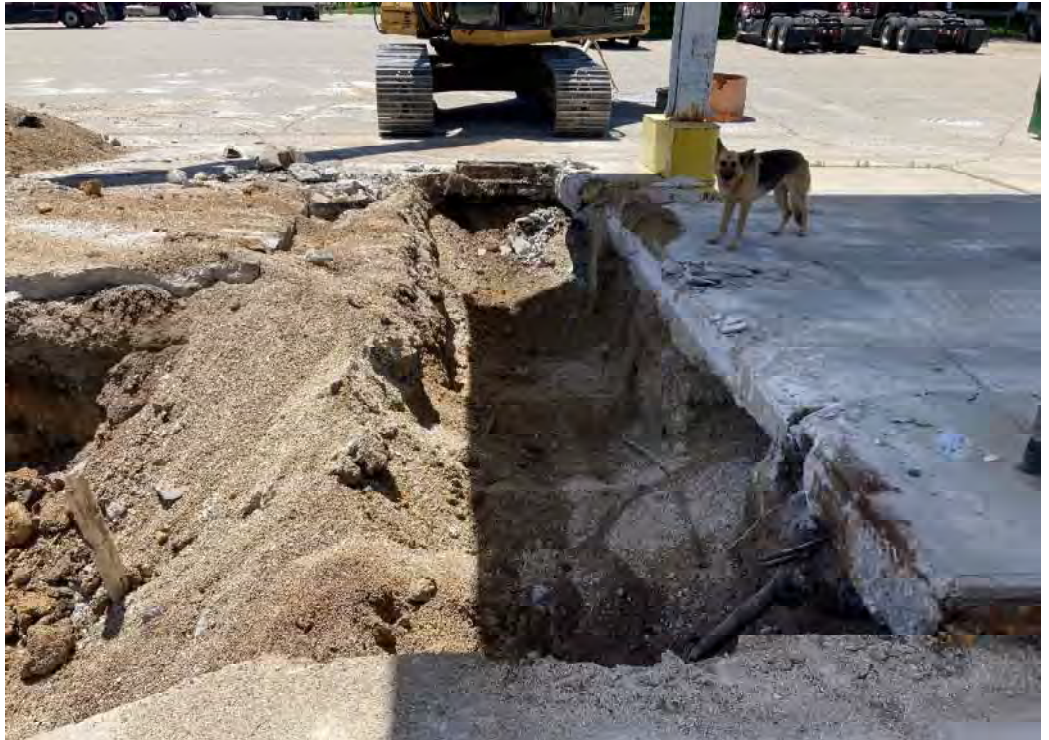
Photo No. 9	Date: 6/3/2022
Direction Photo Taken: North	
Description: View of the pipe excavation running from the main to the northern satellite.

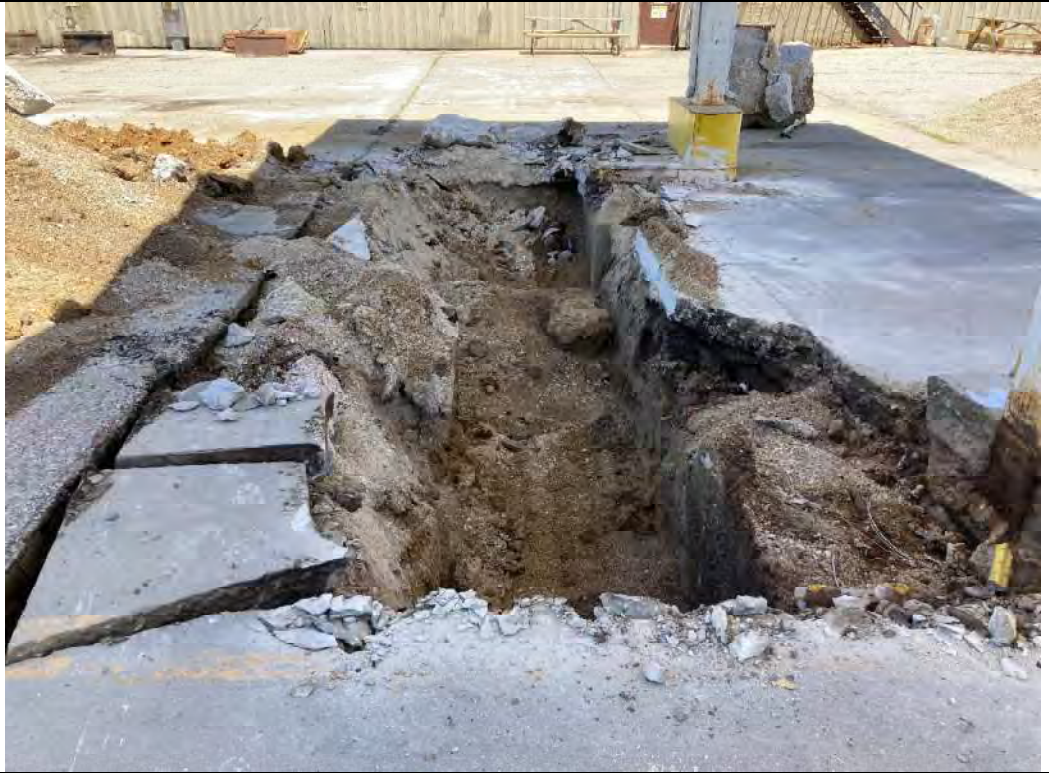
Photo No. 10	Date: 6/3/2022
Direction Photo Taken: North	
Description: View of the pipe excavation running from the main to the northern satellite.

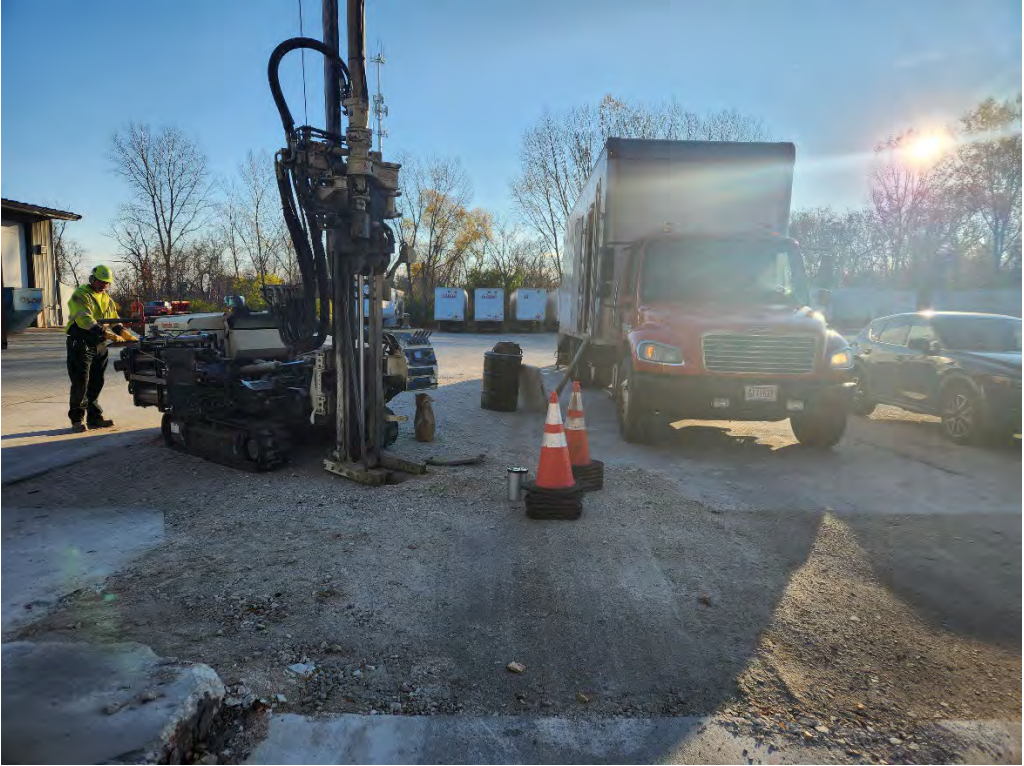
Client Name: Millis Transfer		Site Location: Richfield, WI	Project No. M6838-001
Photo No. 1	Date: 11/2/2022

Direction Photo Taken: East			
Description: Drilling MW-1

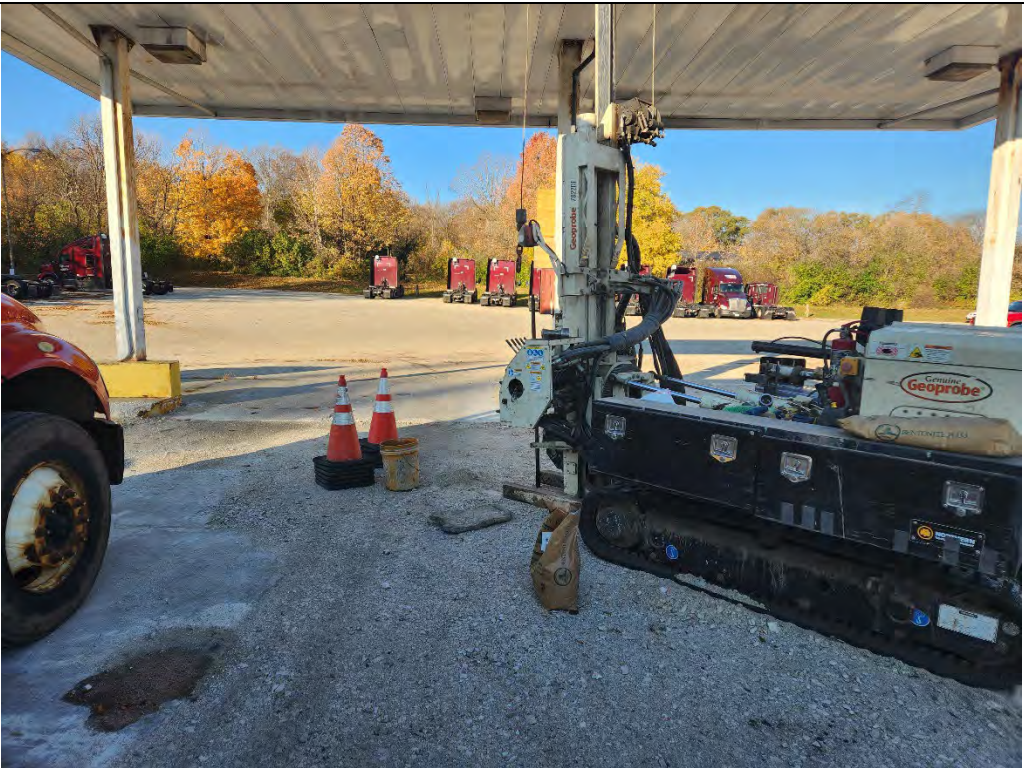
Photo No. 2	Date: 11/2/2022

Direction Photo Taken: West			
Description: Drilling MW-1

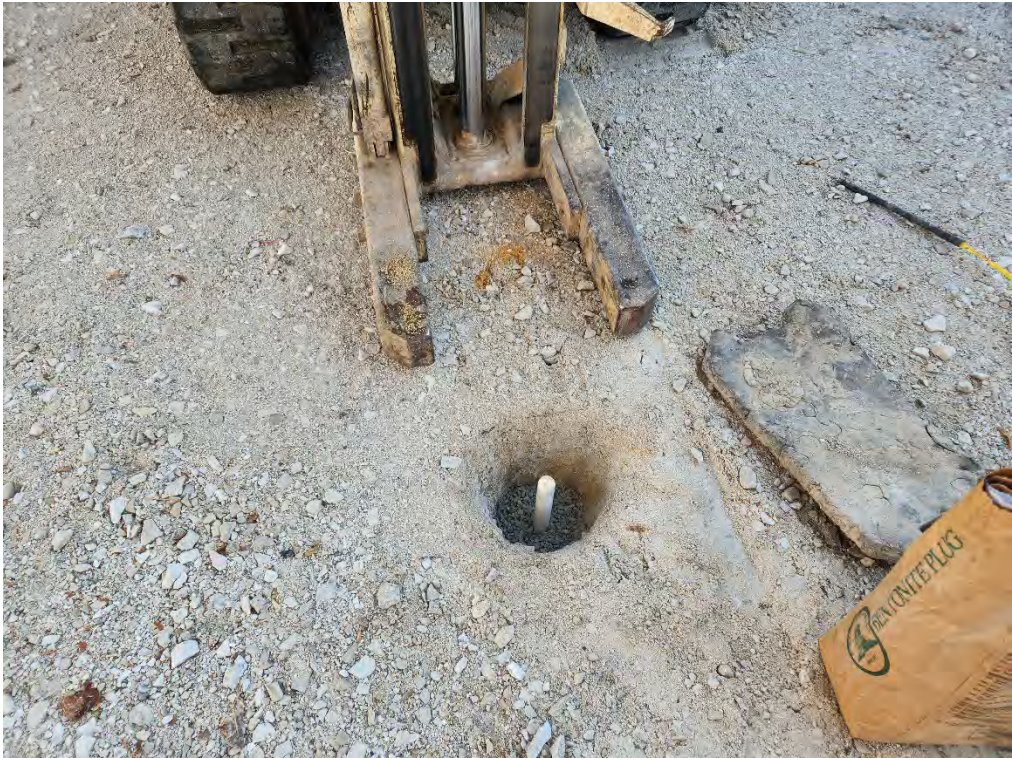
Client Name: Millis Transfer		Site Location: Richfield, WI	Project No. M6838-001
Photo No. 3	Date: 11/2/2022

Direction Photo Taken:			
Description: Constructed MW-1

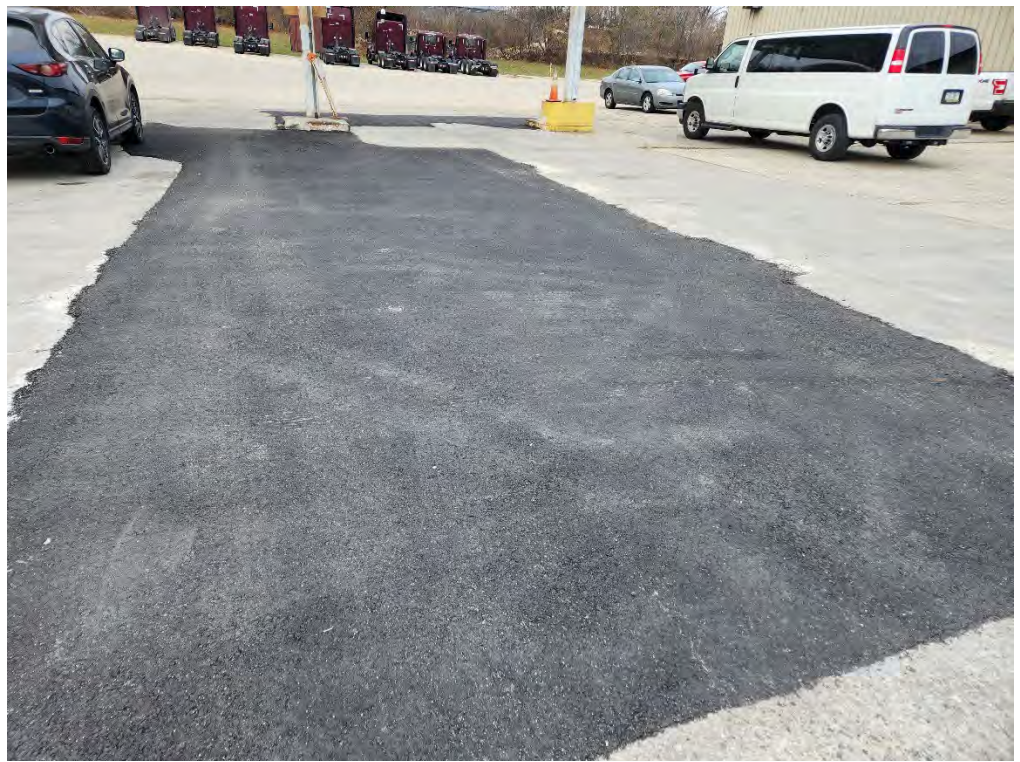
Former tank cavity paved over

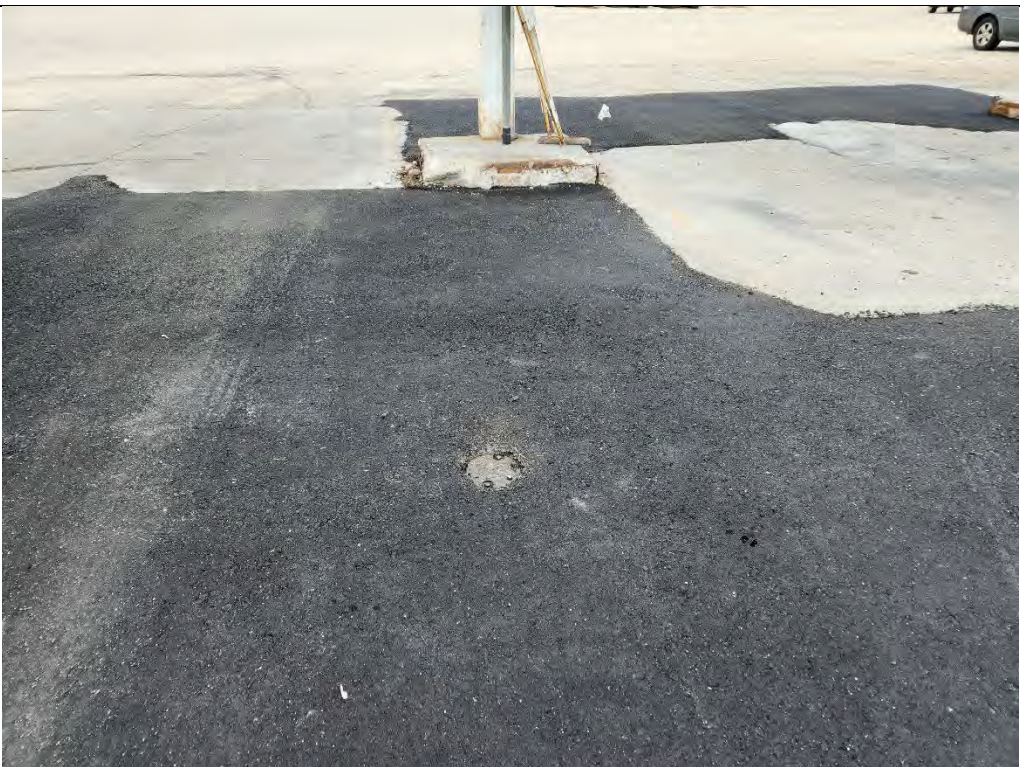
Photo No.
8 **Date:**
12/2/2022

Former tank cavity paved over – MW-1 in sound condition

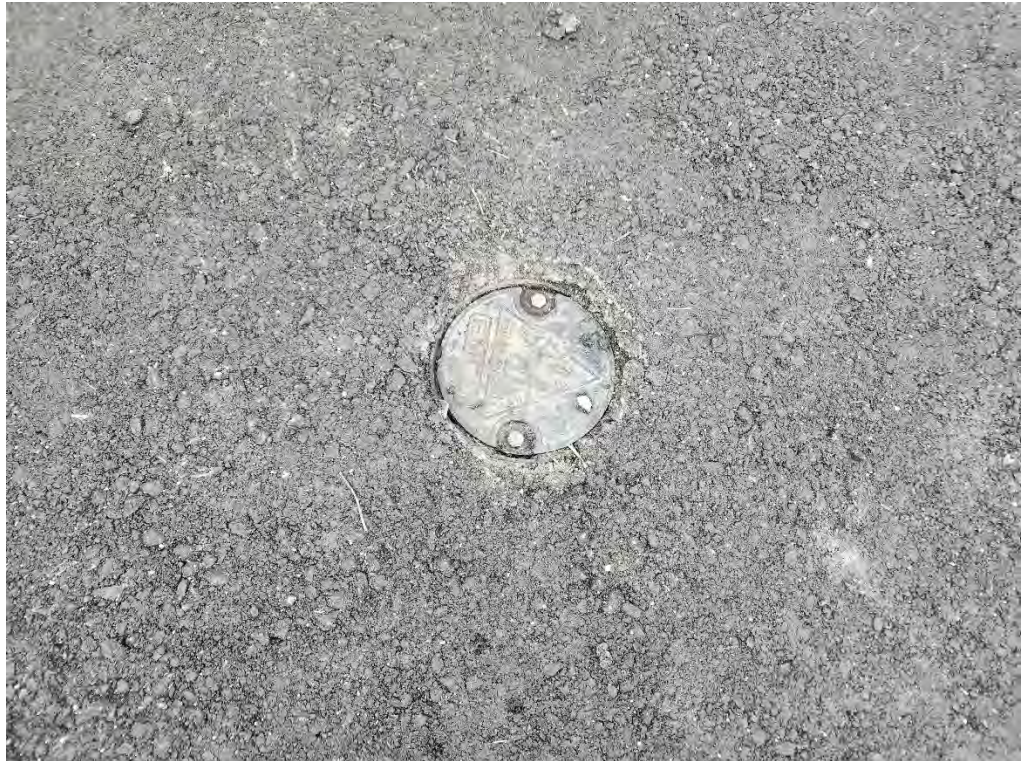
Former tank cavity paved over – MW-1 in sound condition
