Re: Komatsu Mining Corp, South Harbor Facility SERTS ID 20231206SE41-1

Komatsu is following up to summarize activities performed in response to the release at their South Harbor facility, located at 311 E. Greenfield Avenue in Milwaukee, that occurred on 12/4/2023, and was subsequently reported to the WDNR Spills Hotline.

Photo Log

SERTS ID 20231206SE41-1

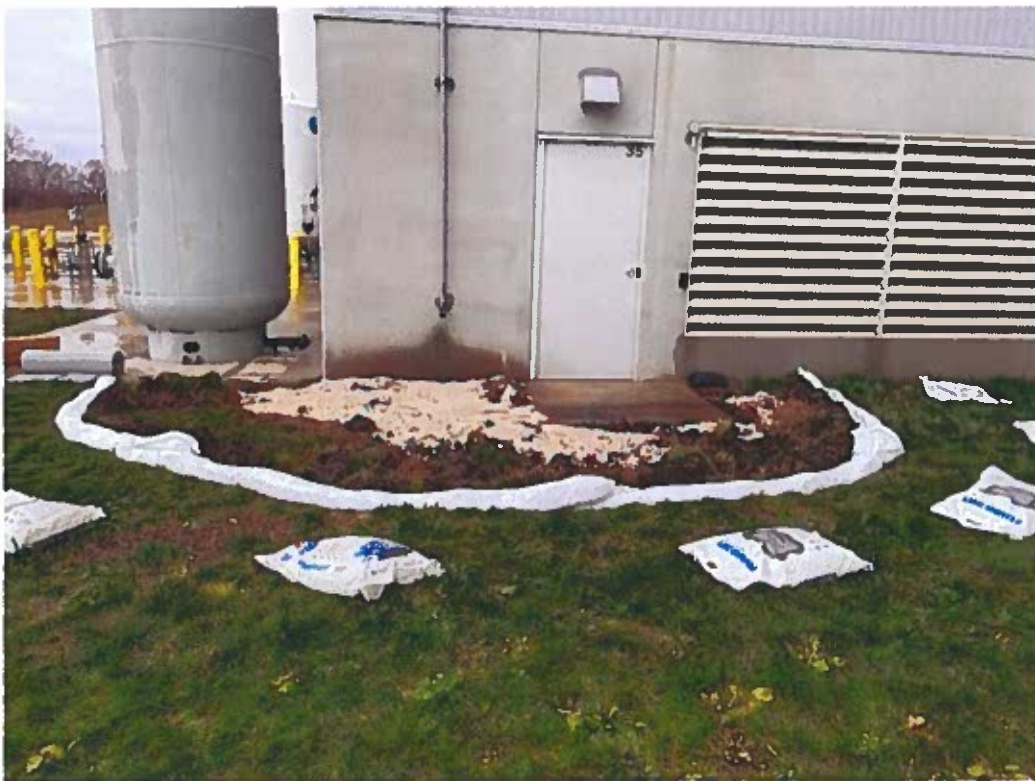
Mid-Project: Hydrophobic absorbent booms placed inside trench surrounding perimeter of release area.

On 12/5/2023 Veolia contractor North Shore Environmental (North Shore) mobilized to the site for initial evaluation. Any free-standing condensate water with oil was absorbed using granular absorbents, a shallow dike was dug around the impacted area and filled with absorbent socks, and the area was covered with a plastic sheet to protect from potential precipitation until response activities could be completed.

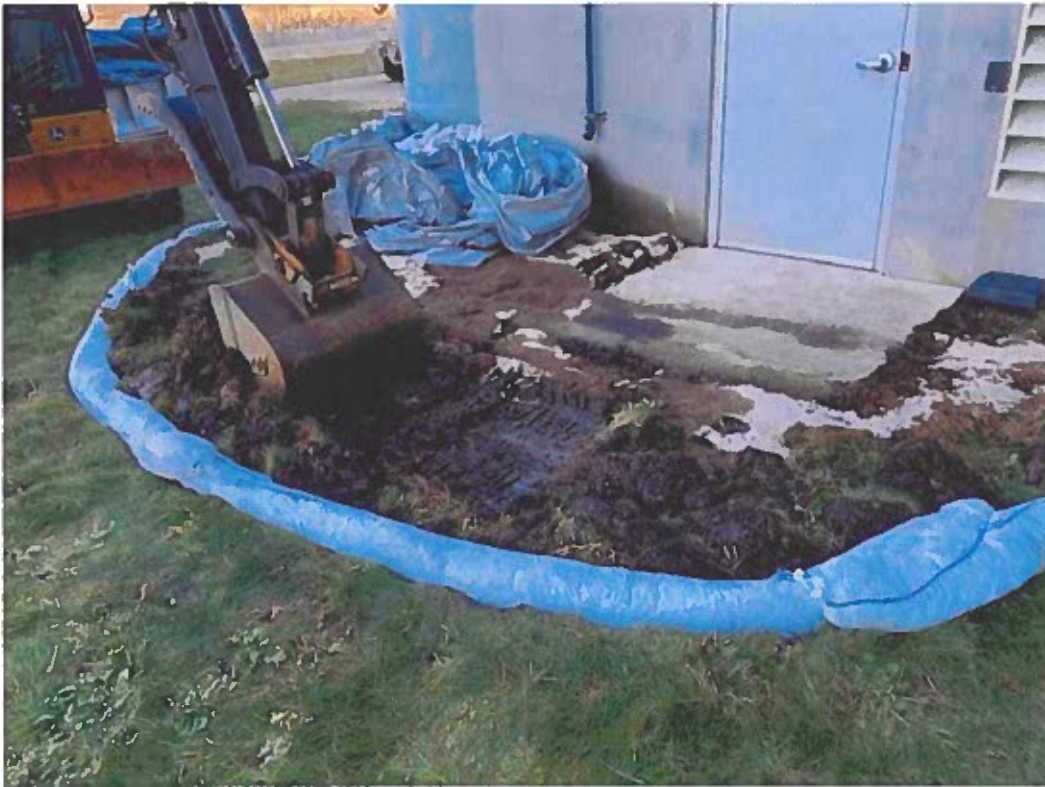
Mid-Project: Removing impacted soil with a mini-excavator.

On 12/8/2023 North Shore mobilized to the South Harbor site with an excavator and a waste roll off bin. The impacted grass area was excavated and visual, olfactory and PID readings were used to determine the extent of excavation. The excavation was completed at less than one foot of depth. The excavated soil was placed into the lined roll off bin. A representative from Veolia collected a sample of the soil for waste profiling purposes. After excavation was complete, clean

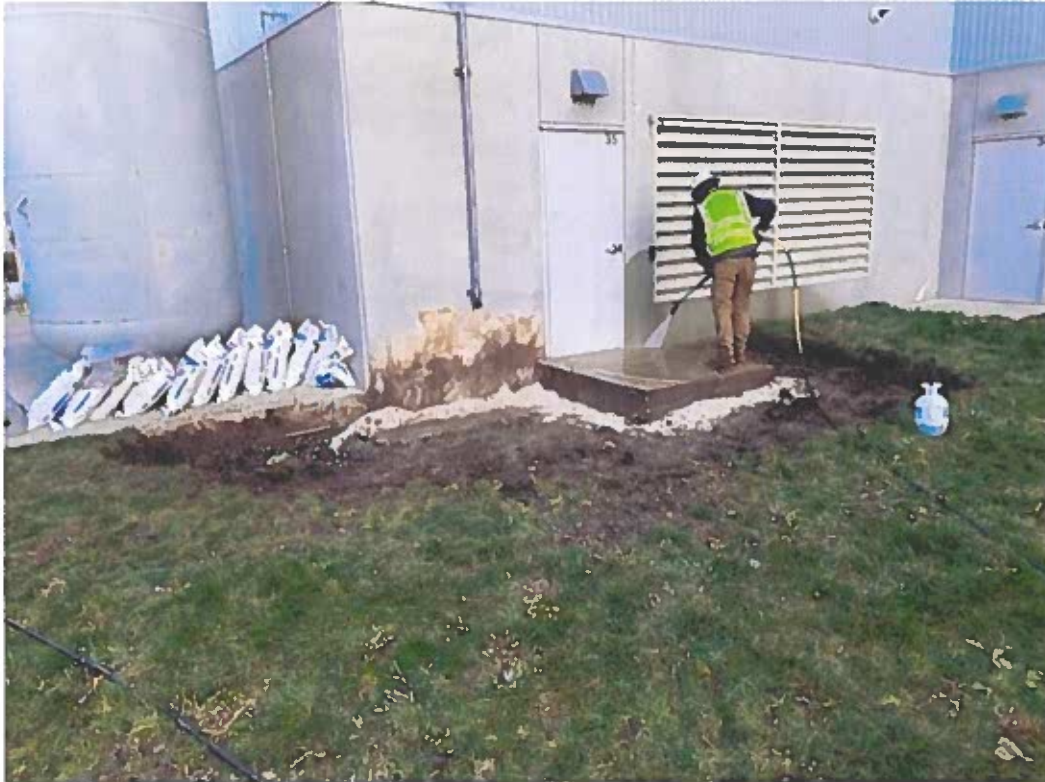
Mid-Project: Pressure washing the impacted wall and concrete slab following the detergent application.

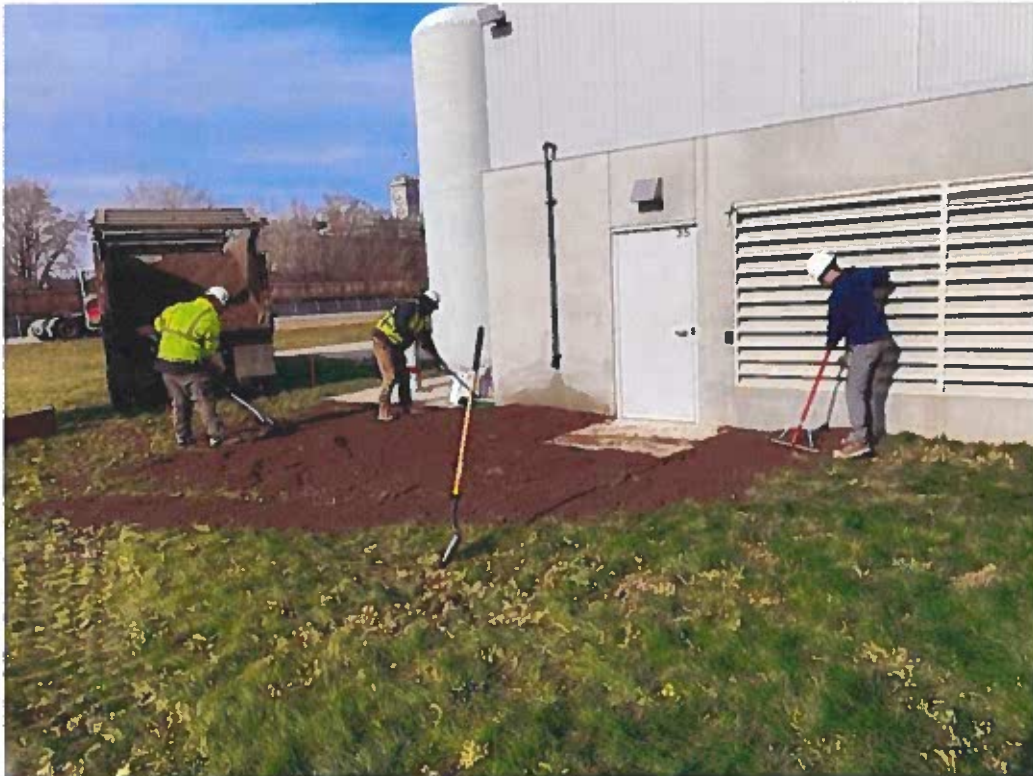
Mid-Project: Grading the backfilled topsoil following the excavation.

backfill was brought onsite and used to fill the excavated area back to level with the surrounding grade. The roll off bin was covered and was to remain onsite until the waste profile was completed, and the soil was accepted to a disposal facility.

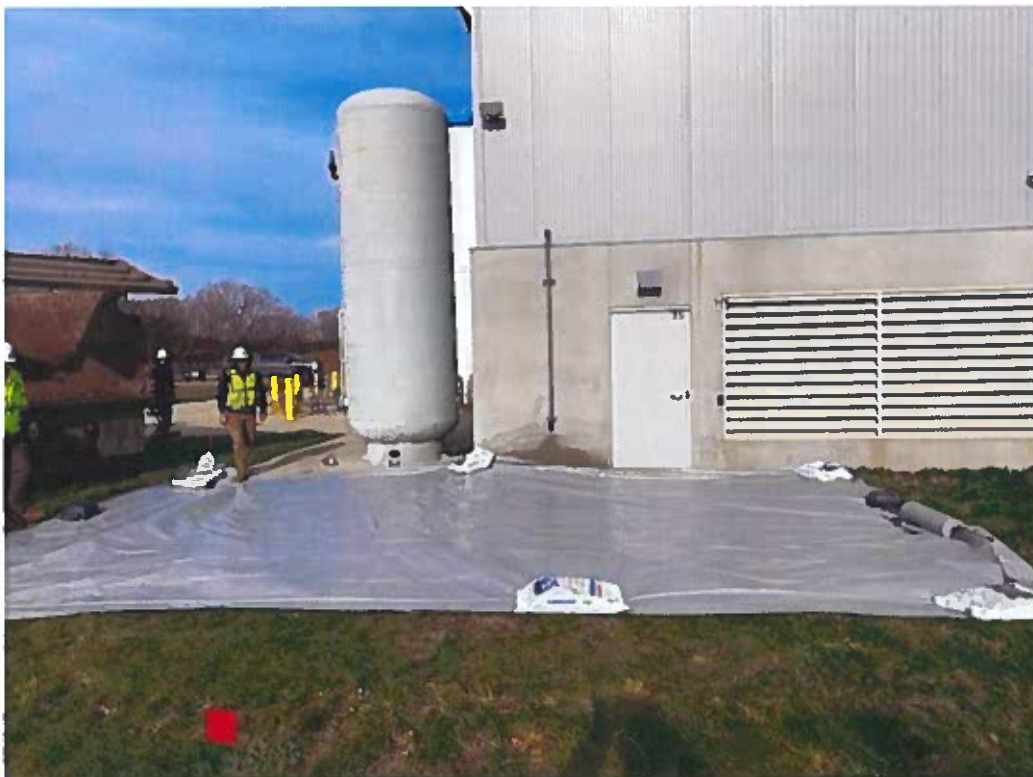
Post-Project: Covering the excavation area following the backfilling with topsoil.
