CORRESPONDENCE/MEMORANDUM

FILE REF: Former White and Lesperance Properties
BRRTS #s 02-36-096500 and 02-36-560273, respectively

SUBJECT: Meeting with lessee regarding status of the site investigation and discussion of redevelopment for the Former White and Lesperance Properties

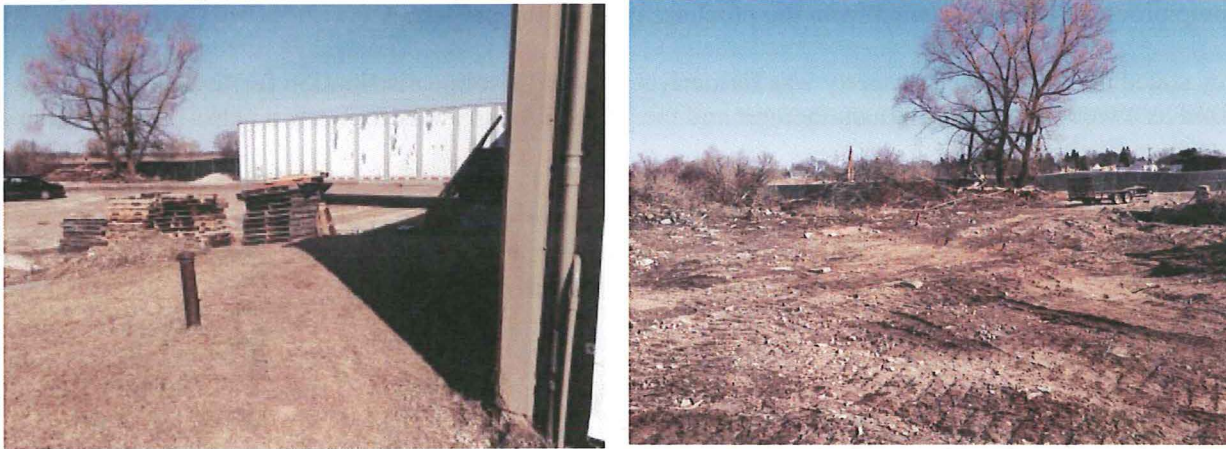
Photo Left: UST Area Location, looking NW. Note sawdust/woodchips in front of pallets. Photo Right: West end of property, looking NE. Note wooded area has been cleared and two monitoring wells in this area were abandoned. Painted wood stake marks one of the five MW locations.

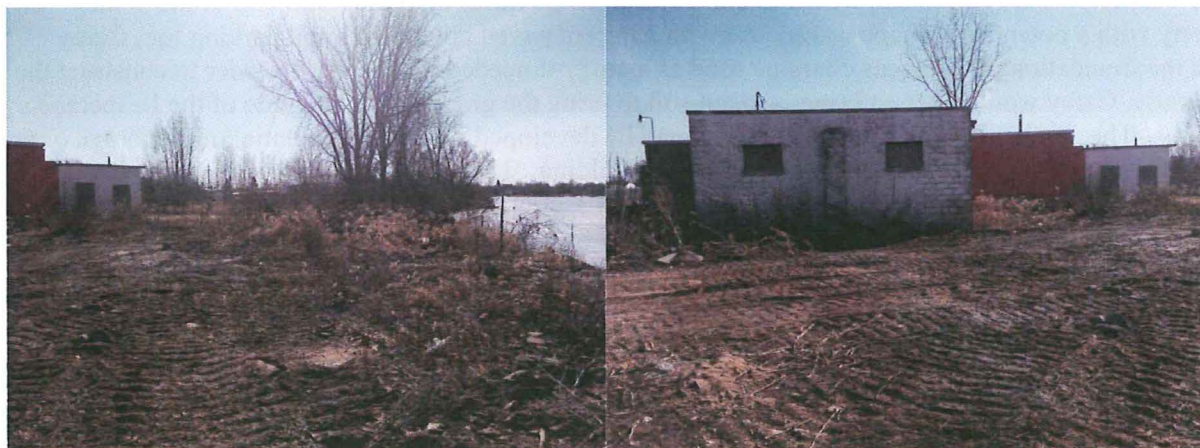
Photo Left: Area between the westernmost buildings and river, looking SSE. Photo Right: Historic Brick Building with historic steel warehouse and office building/warehouse behind, looking E. Note wood stake on left side of photo marks one of the five MW locations.

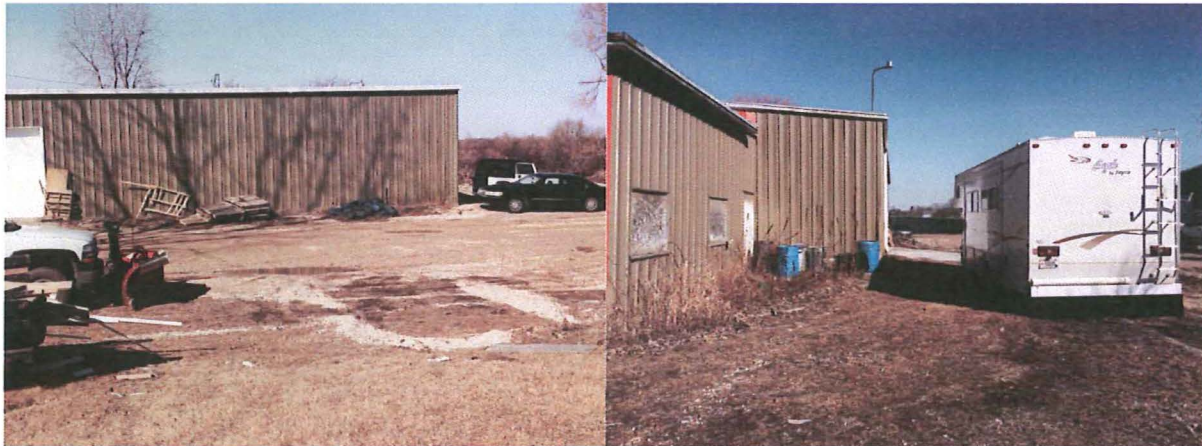
Photo Left: Between historic steel warehouse and office building/warehouse, looking west. Photo Right: Historic steel warehouse, looking north. Note the area between the warehouse and camper is the location of the abandoned underground US Oil pipeline that runs N-S.

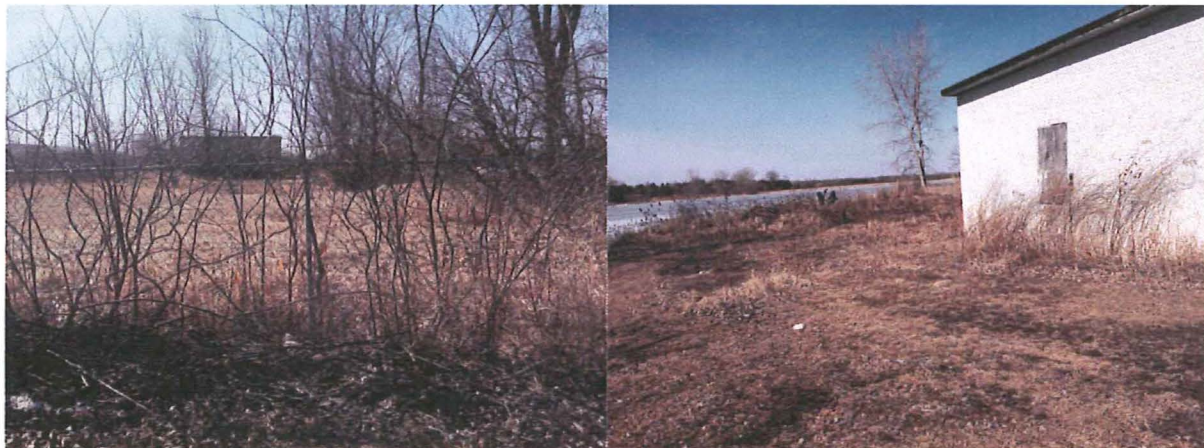
Photo Left: Approximate location at the Lesperance and White Property boundary where abandoned underground US Oil pipeline runs across N-S, looking south. Photo Right: Historic brick building with river in the background, looking NW.

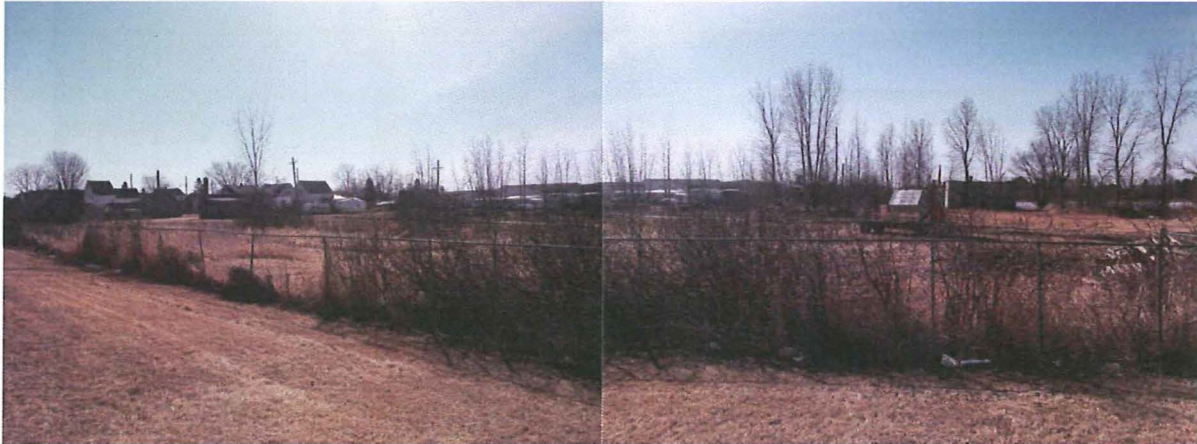
Photo Left: East half of White Property, looking SE. Photo Right: West half of White Property, looking SSW. Note the three original buildings associated with former petroleum storage and recycling facility operations. An unassociated trailer is temporarily parked on the property.

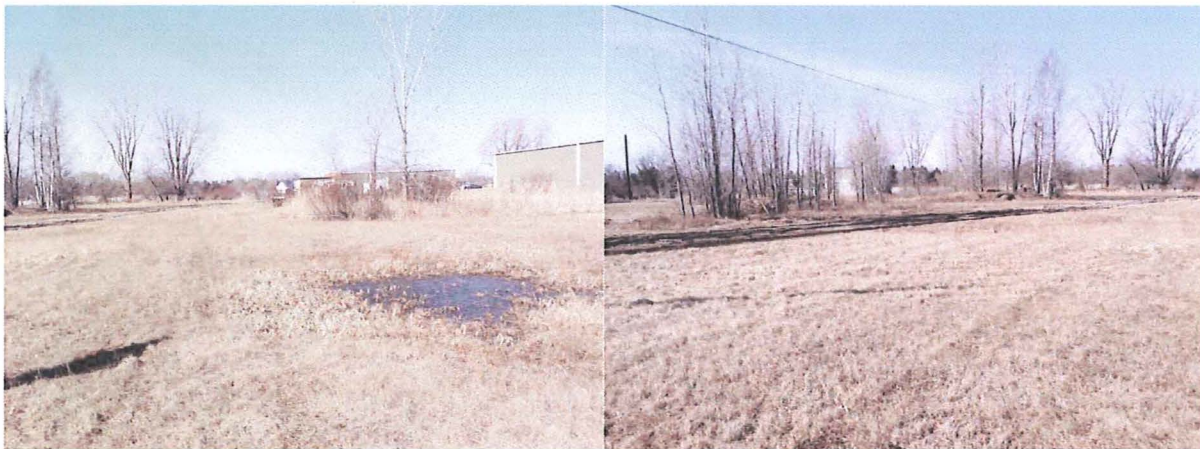
Photo Left: North half of White Property, looking W. Photo Right: South half of White Property looking WSW.

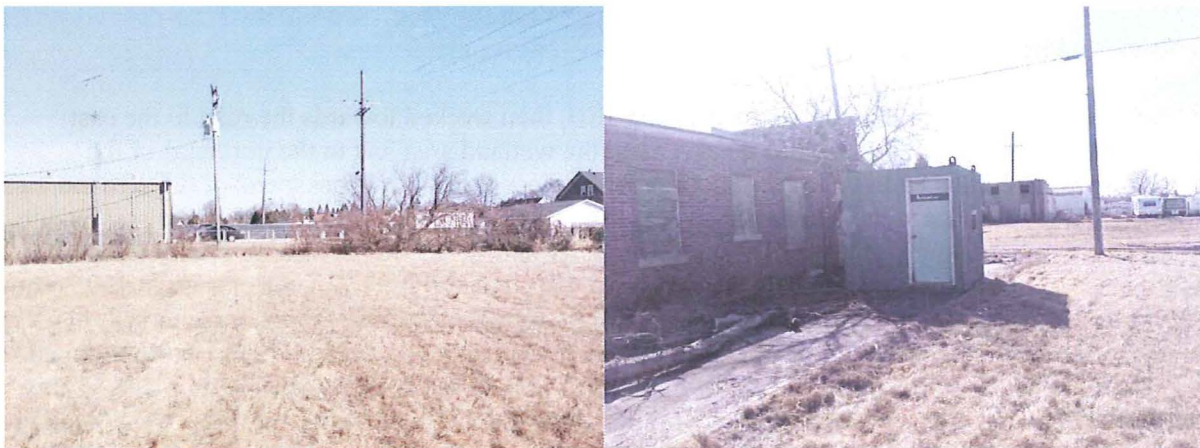
Photo Left: Northern Area for potential L-Warehouse expansion, looking N. Note grade is lower than Lesperance Property. Photo Right: Closer view of two buildings on east half of the White Property, looking SSE.

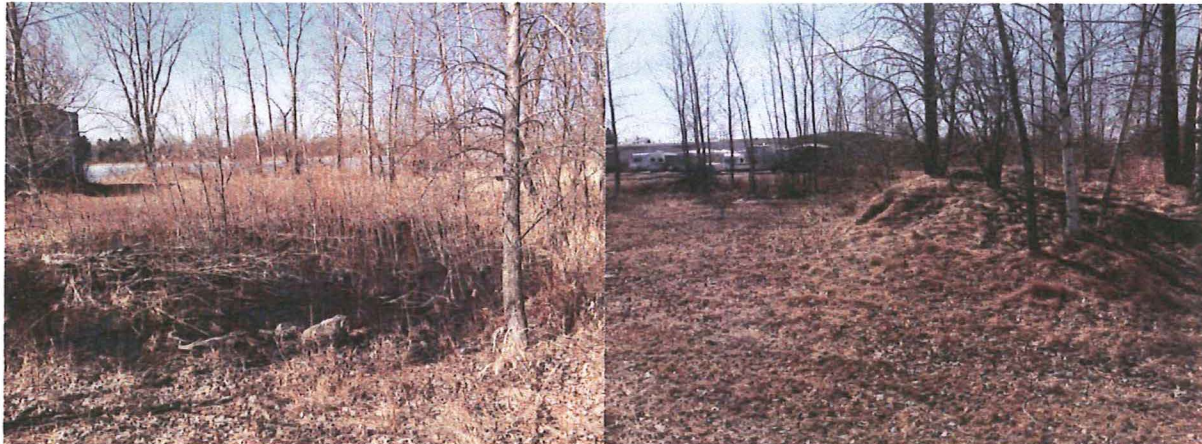
Photo Left: Wetland on the west portion of the property, looking W. Photo right: Carey believed that the mound was the original grade of the property. When the EPA conducted a removal in 1995 to remove the 18 ASTs on-site, they excavated a vast amount of contaminated soil as well.

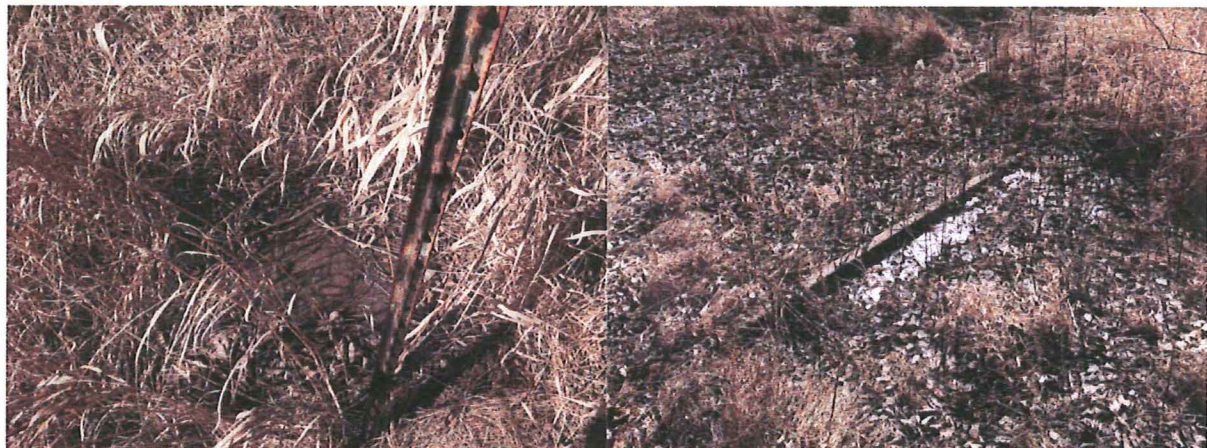
Photo Left: Access to US Oil Pipeline. Carey showed Beggs two access locations during the site walkthrough. Photo Right: Railroad Track on the south end of the property. Likely railroad access was from the south end of the property during former operations.
