January 7, 2020

SUBJECT: Final Case Closure with Continuing Obligations
910 Elm Grove, LLC., 910 Elm Grove Road, Elm Grove, WI 53122
DNR BRRTS Activity #: 02-68-097365
FID # 268503620

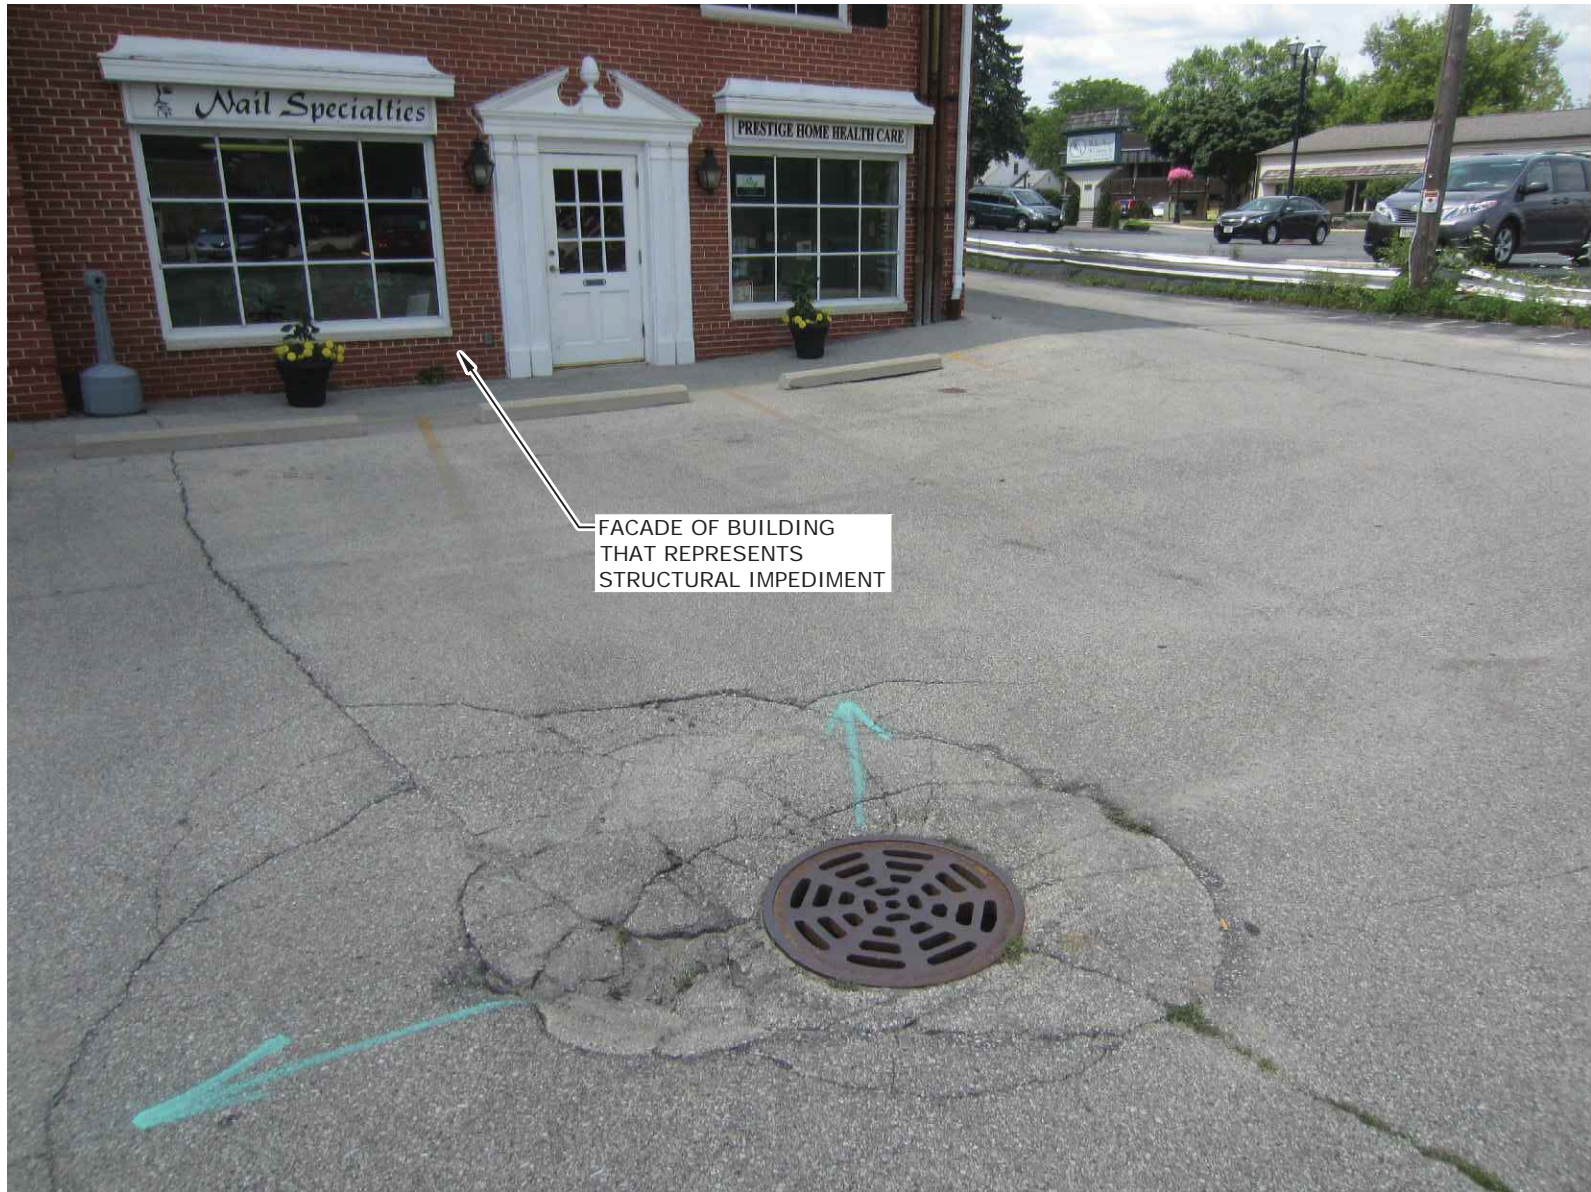
STRUCTURAL IMPEDIMENT PHOTO

FACADE OF BUILDING
THAT REPRESENTS
STRUCTURAL IMPEDIMENT

Structural Impediments (s. 292.12 (2) (b), Wis. Stats., s. NR 726.15, s. NR 727.07, Wis. Adm. Code)
The building as shown on the **attached map** Residual Soil Contamination, Figure B.2.b, May 16, 2019, made complete investigation and/or remediation of the soil contamination on this property impracticable. If the structural impediment is to be removed, the property owner shall notify the DNR at least 45 days before removal and conduct an investigation of the degree and extent of soil contamination below the structural impediment. If contamination is found at that time, the contamination shall be properly remediated in accordance with applicable statutes and rules.

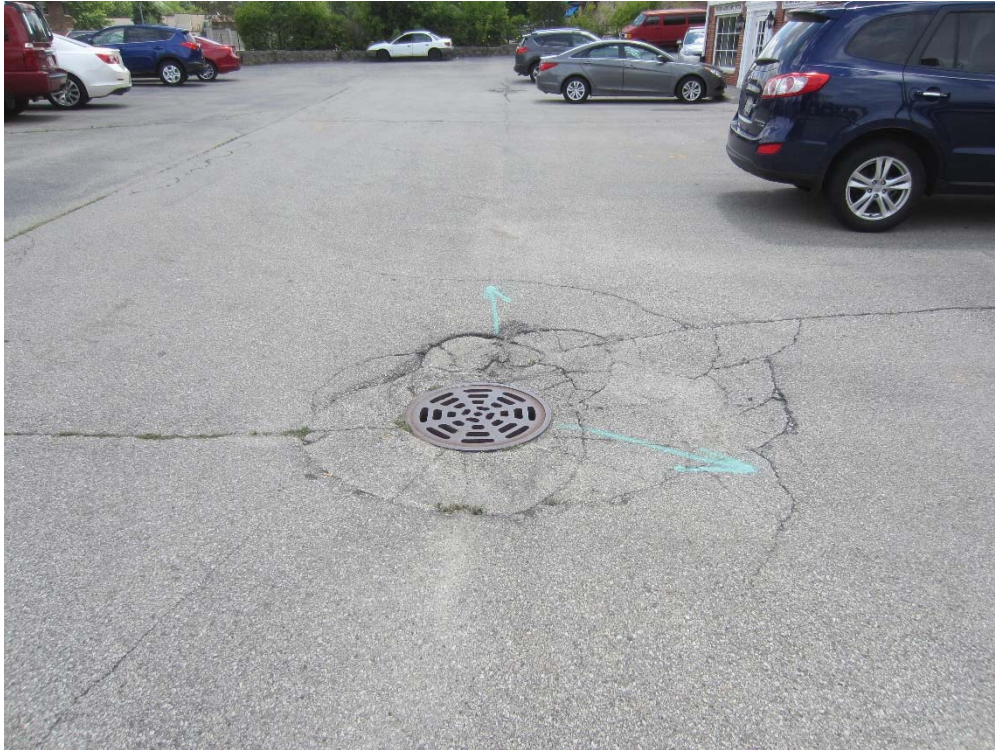
Photo 1: East parking lot facing south

The infiltration barrier overlying the contaminated soil and as depicted in Figure D.2 will be inspected once a year, normally in the spring after all snow and ice is gone, for deterioration, cracks and other potential problems that can cause additional infiltration into underlying soils. The inspections will be performed by the property owner or their designated representative. The inspections will be performed to evaluate damage due to settling, exposure to the weather, wear from traffic, increasing age and other factors. Any area where soils have become or are likely to become exposed and where infiltration from the surface will not be effectively minimized will be documented.

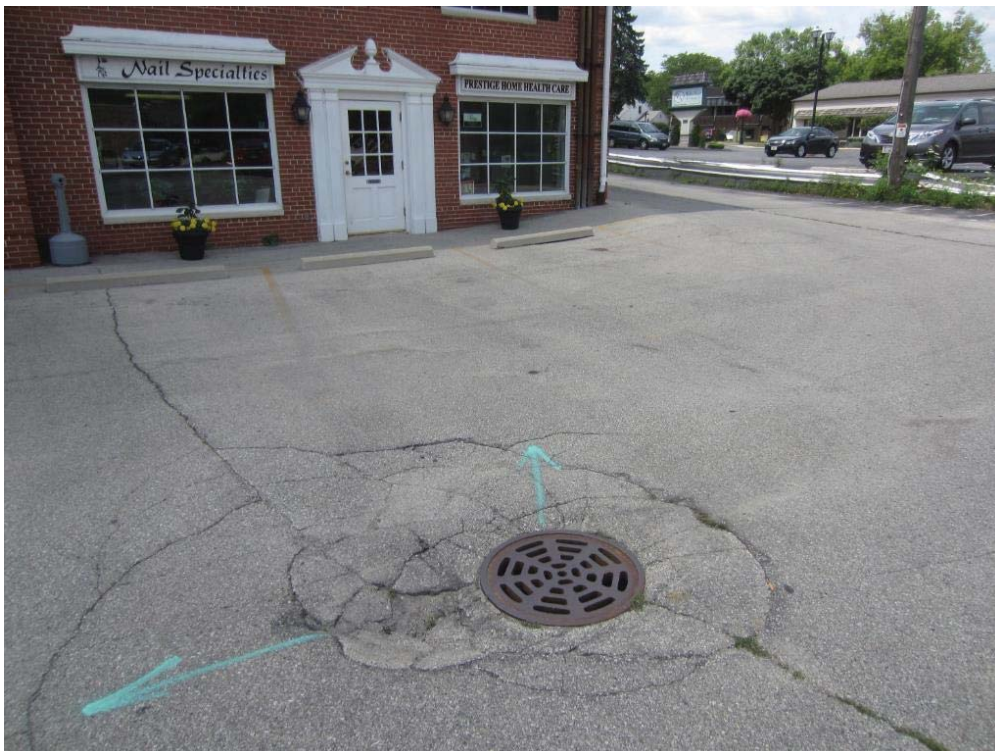
Photo 2: East parking lot facing northwest

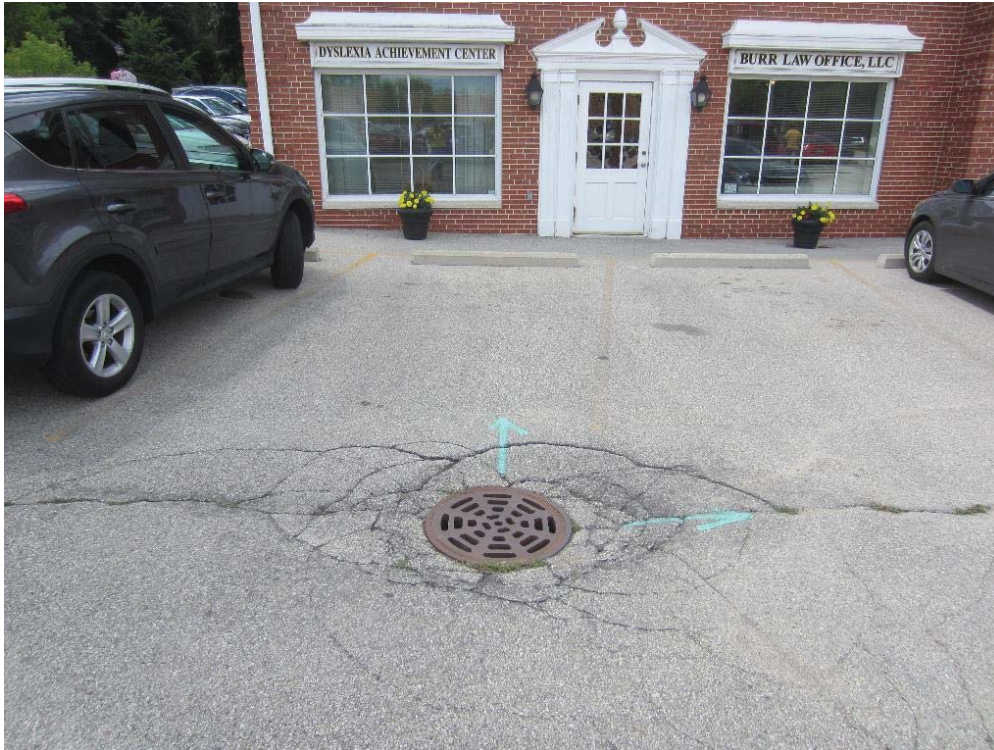
Photo 3: East parking lot facing west

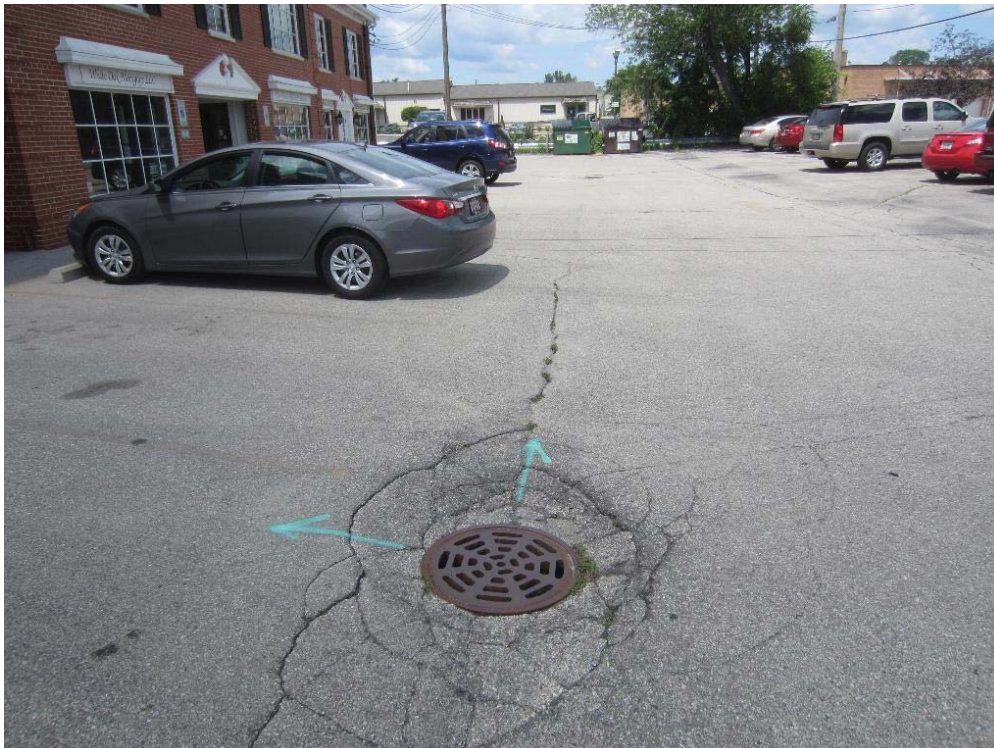
Photo 4: East parking lot facing north

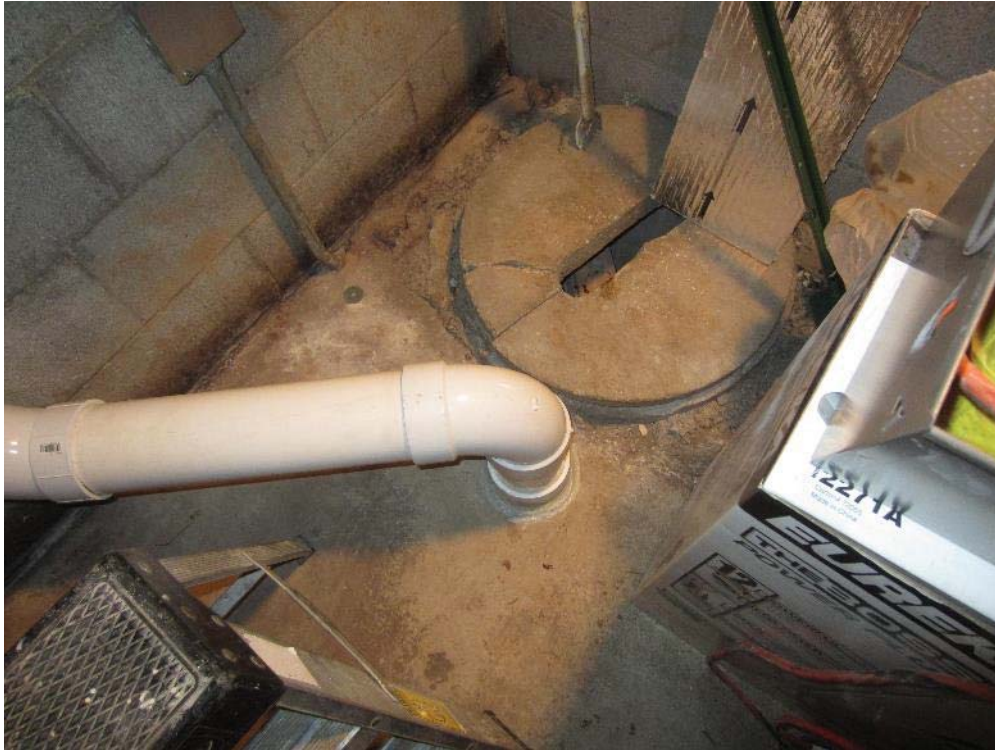
Photo 1: Northwest furnace room extraction point

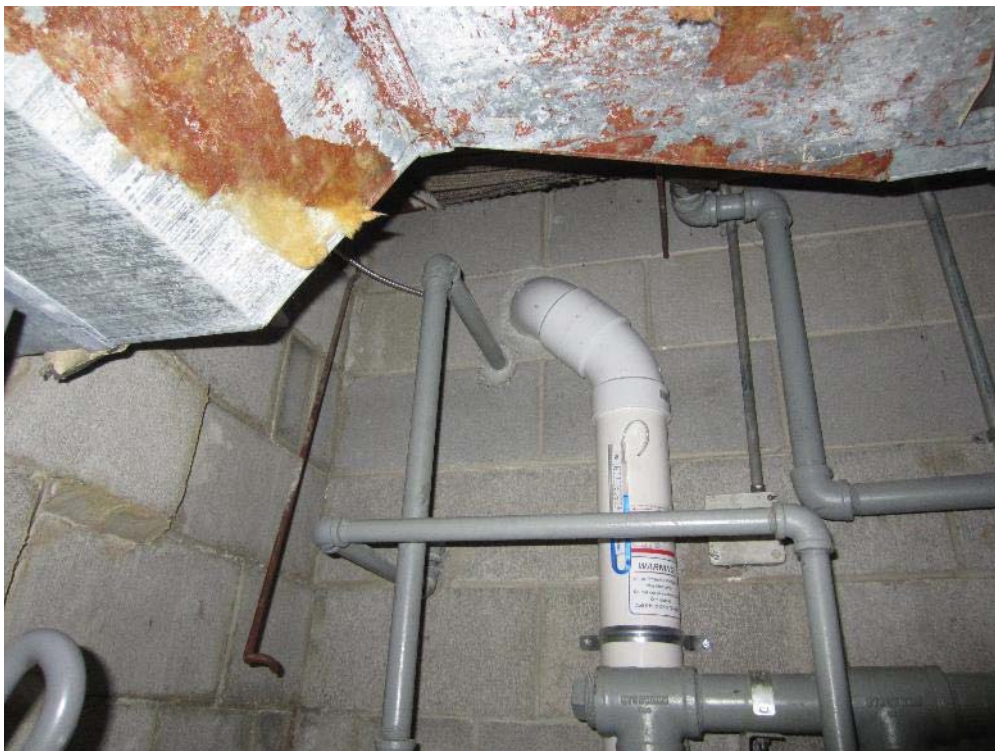
Photo 2: Northwest furnace room wall penetration and manometer

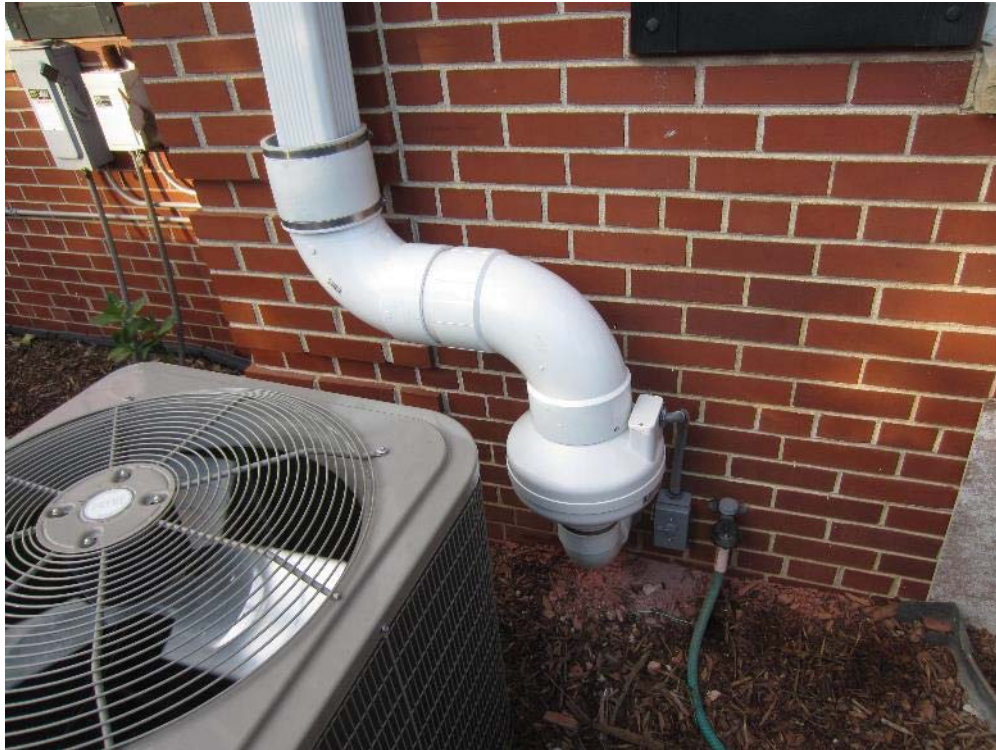
Photo 3: Northwest system fan

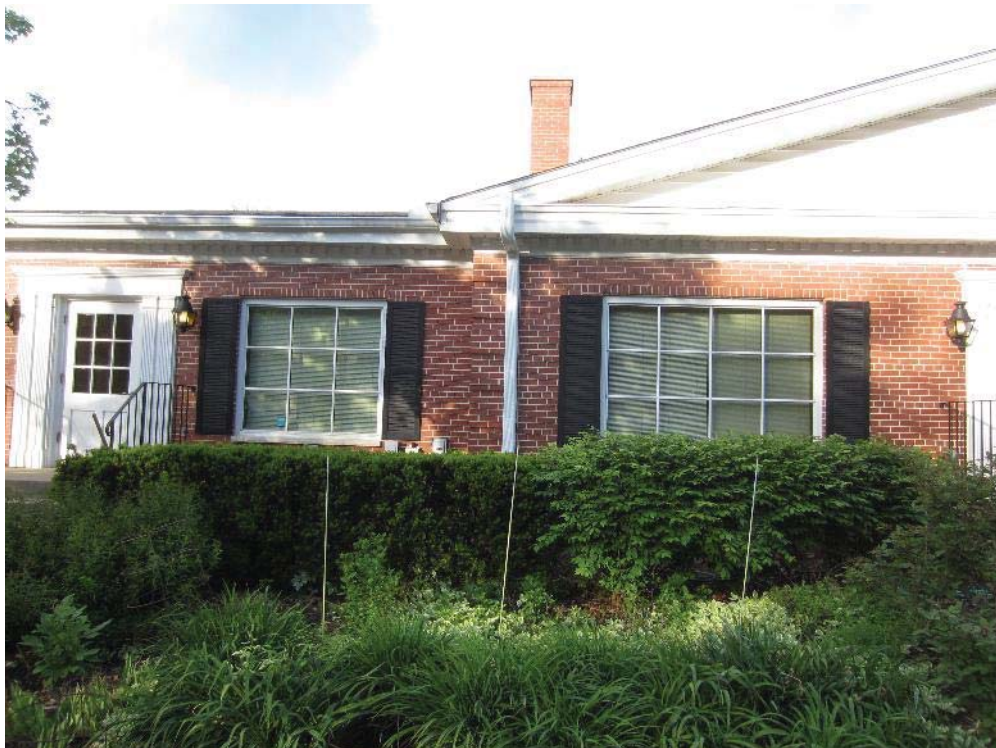
Photo 4: Northwest system exhaust

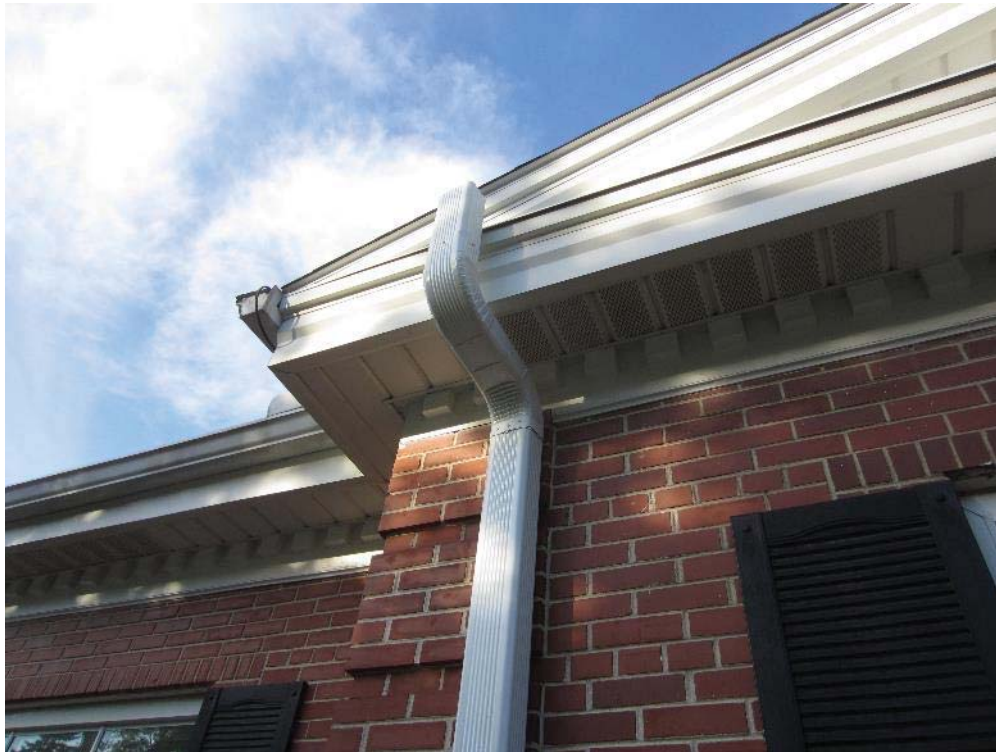
Photo 5: Northwest system exhaust location

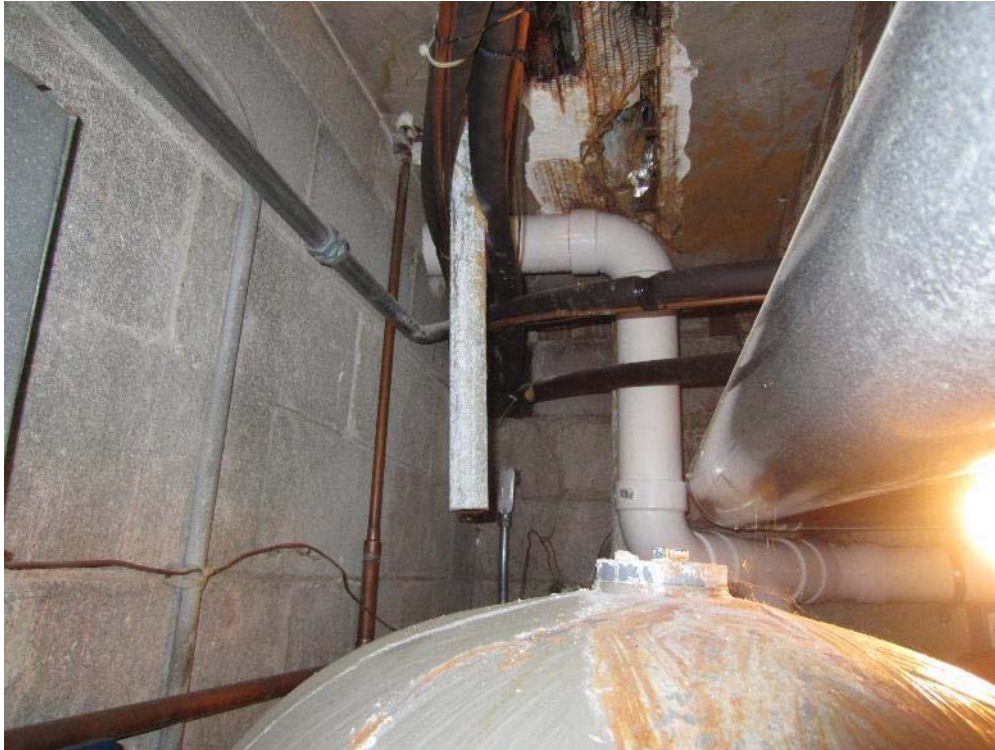
Photo 7: Southwest utility room wall penetration

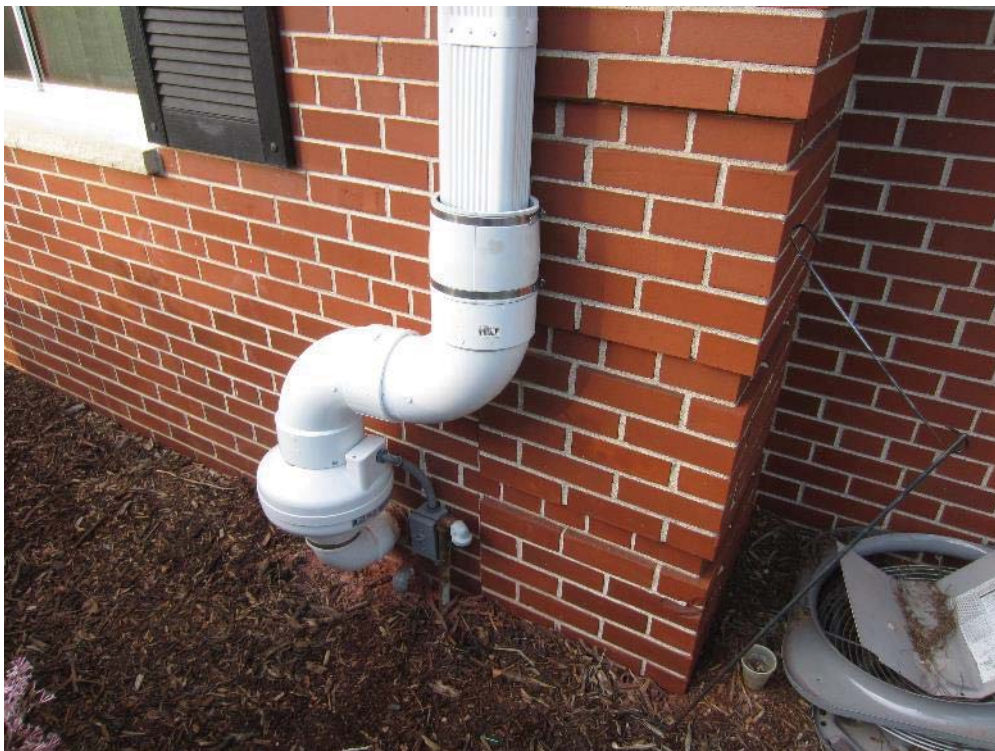
Photo 8: Southwest system fan

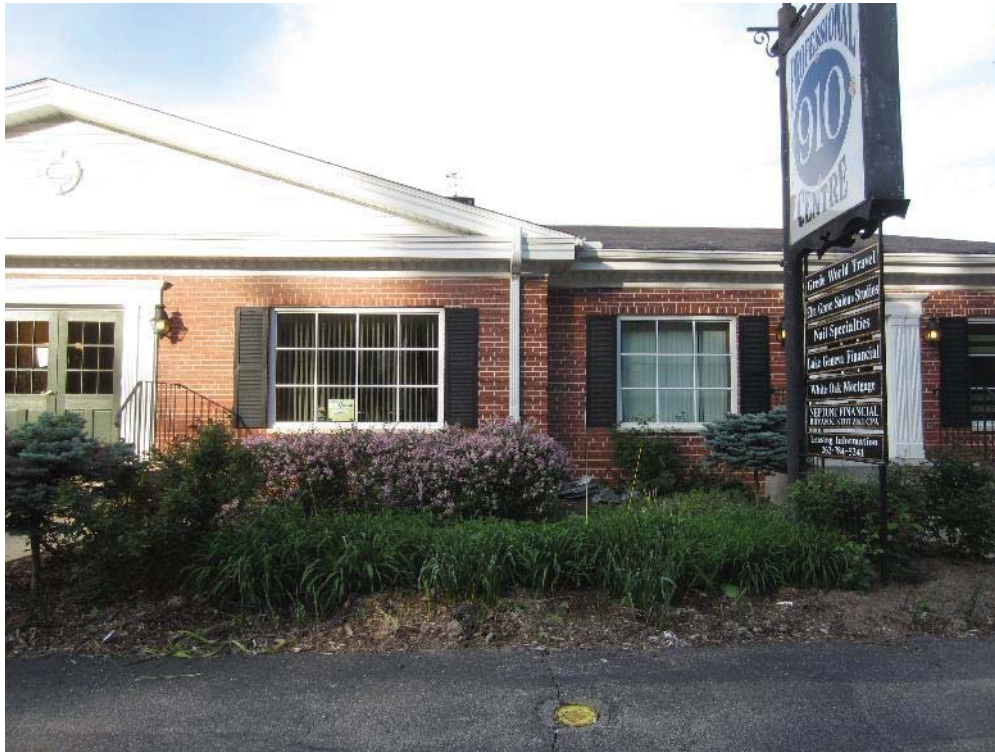
Photo 9: Southwest system exhaust

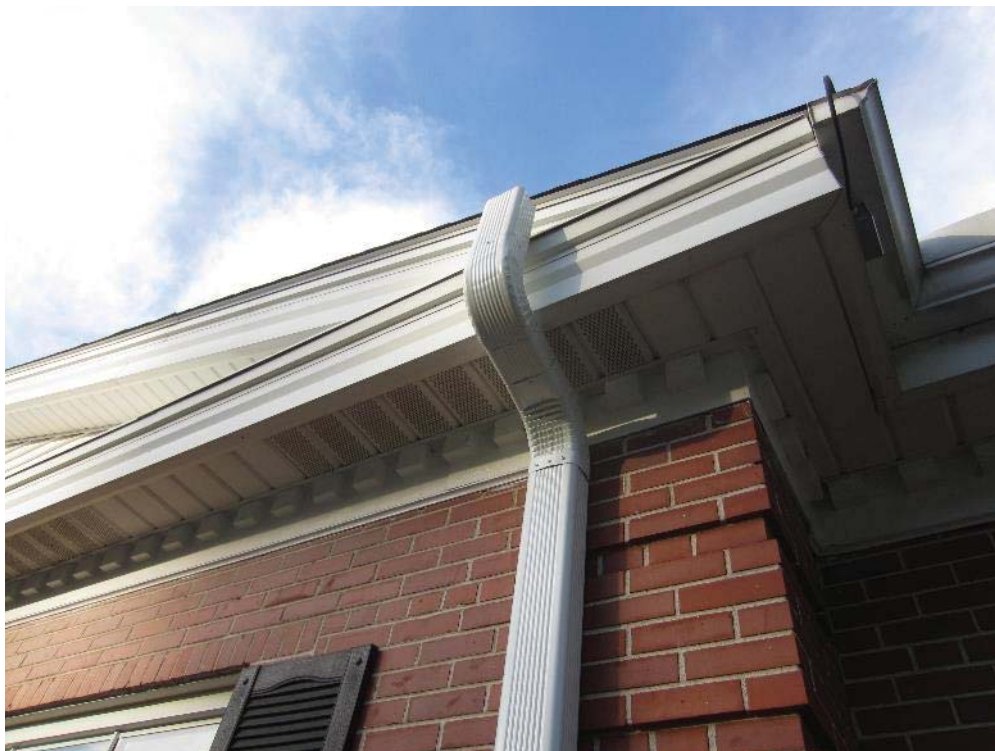
Photo 10: Southwest system exhaust location
