Site Name		DNR ID # (BRRTS #)	
Former Navistar/RMG Foundry		02-68-098404	
Address	City	State	ZIP Code
1401 Perkins Avenue	Waukesha	WI	53186

Site Investigation Sample Results Notification

SUBJECT: Vacant Lot Soil Vapor Probe Data Transmittal (0.43-acre, east side of White Rock Avenue, Waukesha, WI)

SUBJECT: Vacant Lot Soil Vapor Probe Data Transmittal (0.52-acre and 0.18-acre east side of White Rock Avenue and 0.69-acre west side of White Rock Avenue, Waukesha, WI)

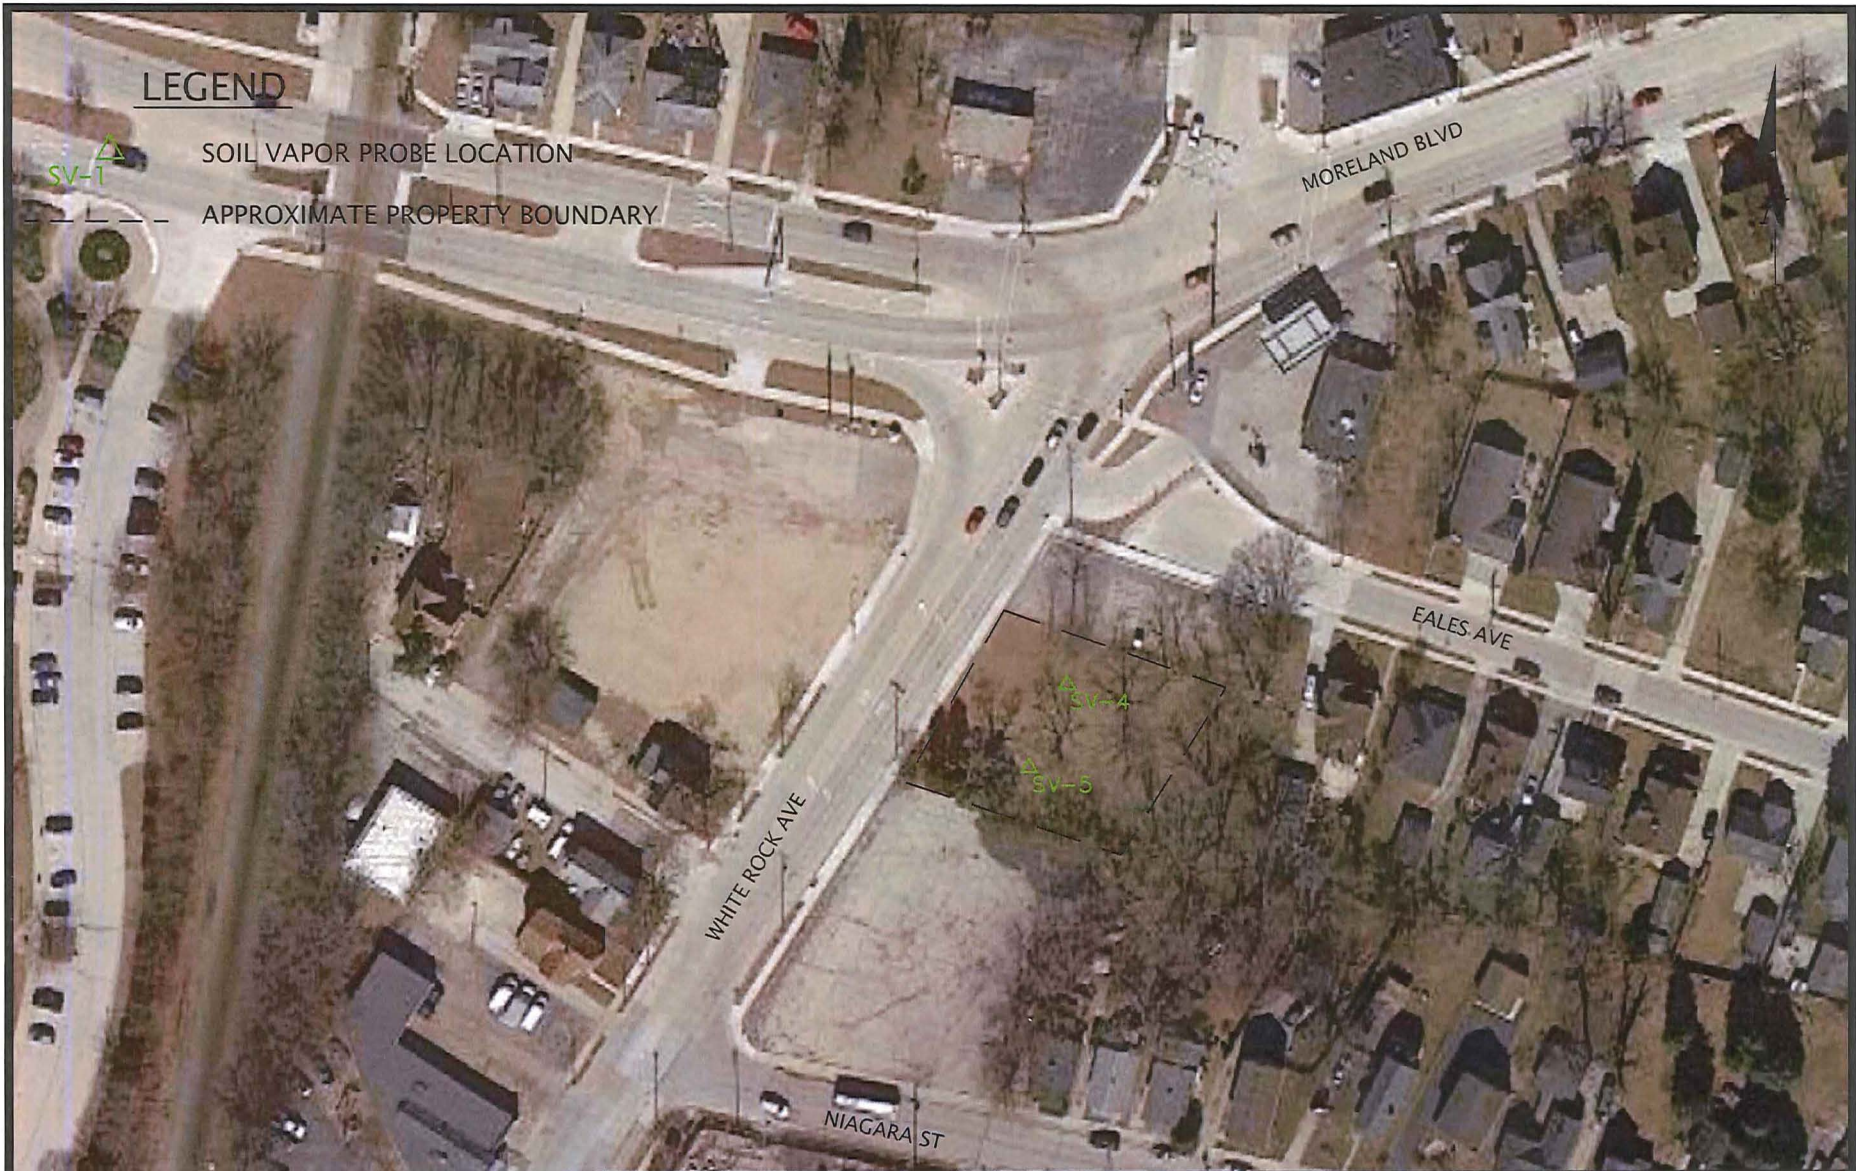
FIGURE 1

In accordance with the signed Access Agreement for these properties, on November 26, 2019, KPRG and Associates, Inc. (KPRG) installed two soil vapor probes (SV-4 and SV-5) on the 0.43acre vacant parcel in Waukesha, Wisconsin at approximate locations shown on Figure 1. The soil vapor probes are 0.75-inch inner diameter PVC, installed to a depth of approximately 8 feet and are completed flush with the ground surface. On December 4, 2019, KPRG then collected soil vapor samples, one from each vapor probe, for chemical analysis of trichloroethene (TCE). We recently received the analytical results from the laboratory for all of the samples. In accordance with our Access Agreement for this sampling, attached is Table 1 which summarizes the results along with some comparison criteria for your consideration. The subject property parcel is currently zoned B-1 Neighborhood Business with Property Tax Classification of Commercial Mercantile. Based on this zoning/classification, there are no deep soil Vapor Risk Screening Level (VRSL) exceedances. We will schedule another round of soil vapor sampling for the March-April 2020 timeframe (you will be provided access notification per the Access Agreement).

SOIL VAPOR PROBE LOCATIONS

Maria Sigala
Vacant Lot Parcel Waukesha, WI

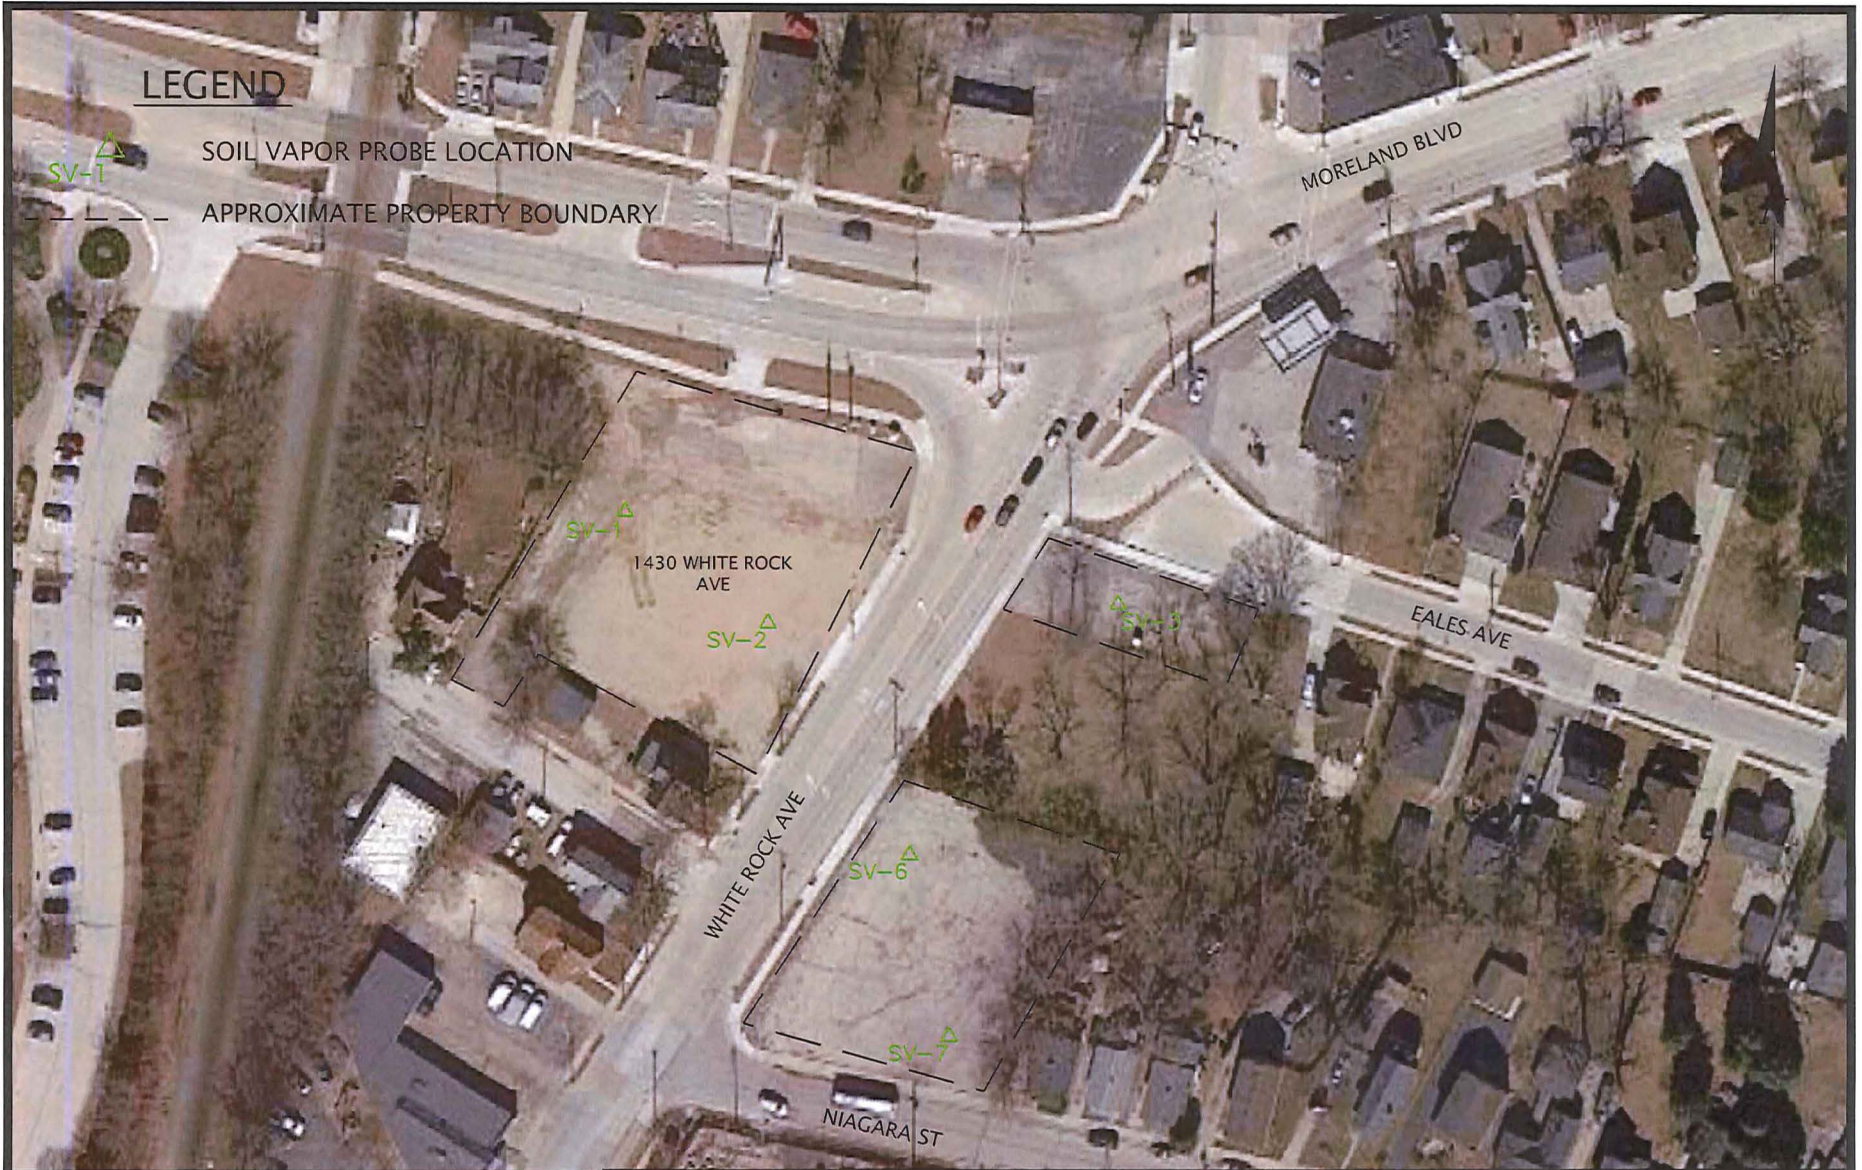
KPRG Project No. 11717 | **FIGURE 1**

In accordance with the signed Access Agreement for these properties, on November 26, 2019, KPRG and Associates, Inc. (KPRG) installed two soil vapor probes (SV-1 and SV-2) on the 0.69-acre parcel, two soil vapor probes (SV-6 and SV-7) on the 0.52-acre parcel and one soil vapor probe (SV-3) on the 0.18-acre parcel, all located in Waukesha, Wisconsin at approximate locations shown on Figure 1. The soil vapor probes are 0.75-inch inner diameter PVC, installed to a depth of approximately 8 feet and are completed flush with the ground surface. On December 4, 2019, KPRG then collected soil vapor samples, one from each vapor probe, for chemical analysis of trichloroethene (TCE). We recently received the analytical results from the laboratory for all of the samples. In accordance with our Access Agreement for this sampling, attached is Table 1 which summarizes the results along with some comparison criteria for your consideration. The subject property parcels are currently zoned B-1 Neighborhood Business with Property Tax Classifications of Commercial Mercantile. Based on this zoning/classification, there are no deep soil Vapor Risk Screening Level (VRSL) exceedances. We will schedule another round of soil vapor sampling for the March-April 2020 timeframe (you will be provided access notification per the Access Agreement).

SOIL VAPOR PROBE LOCATIONS

Hansen Brothers, LLC
Vacant Lot Parcels Waukesha, WI
