From: Iverson, Bruce
Sent: Wednesday, February 20, 2019 7:59 AM
To: 'Eric Lindman' <Eric.Lindman@ci.wausau.wi.us>
Cc: Thompson, Matthew A - DNR <MatthewA.Thompson@wisconsin.gov>
Subject: 1996 Sanitary Sewer Inspections and Sealing Communications

Re: Wauleco Operations and Possible Relationship to Occasional Elevated
Pentachlorophenol Concentrations in Wausau Wastewater Treatment Plant Effluent

Starting in March 1996, the wastewater treatment plant recorded four consecutive monthly effluent discharge violations for pentachlorophenol (PCP). The standard is based on the effluent pH. The general pH range of the effluent stream is between 6.0 and 7.0 pH which correlates to a PCP discharge standard of 12 ug/L. A copy of Wausau's monthly PCP discharge values are shown in table A.

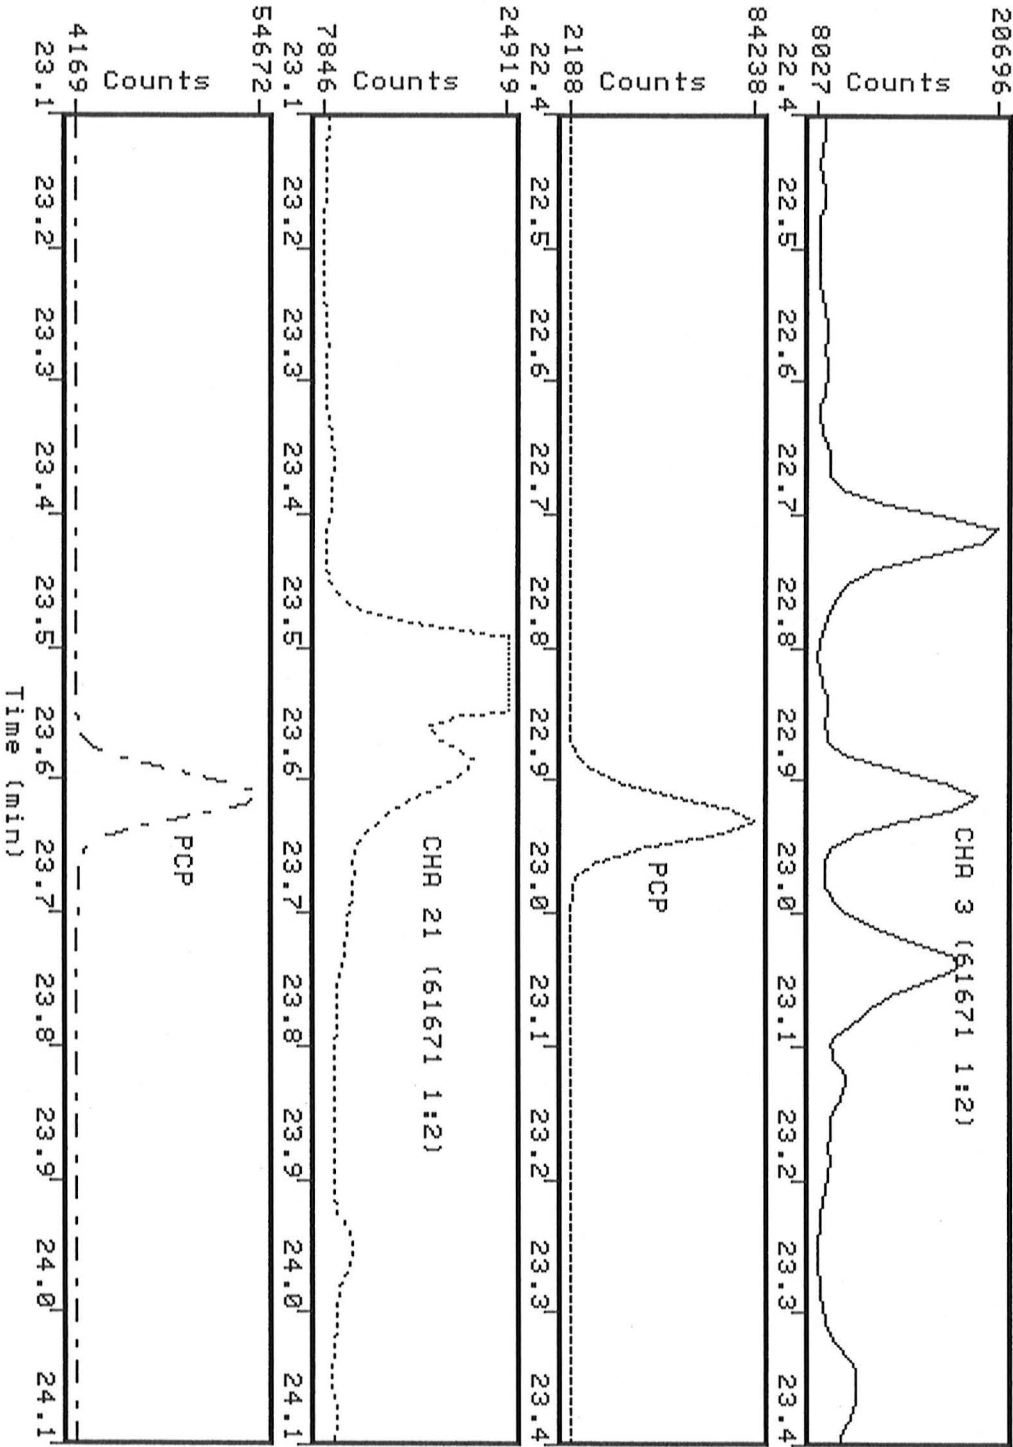
96-2026 (61671)1:2 WRAUSAU

The sample was analyzed twice, once straight and once with a two fold dilution. The sample was diluted because confirmation of the PCP on the second column was not distinct due to the presence of interfering compounds. On the straight sample, a result of 13.2 ug/l was calculated using the information from the one column. The diluted sample concentration produced a result of 13.9 ug/l on the same channel. The second channel in both cases was used for confirmation of the PCP and not quantitation.

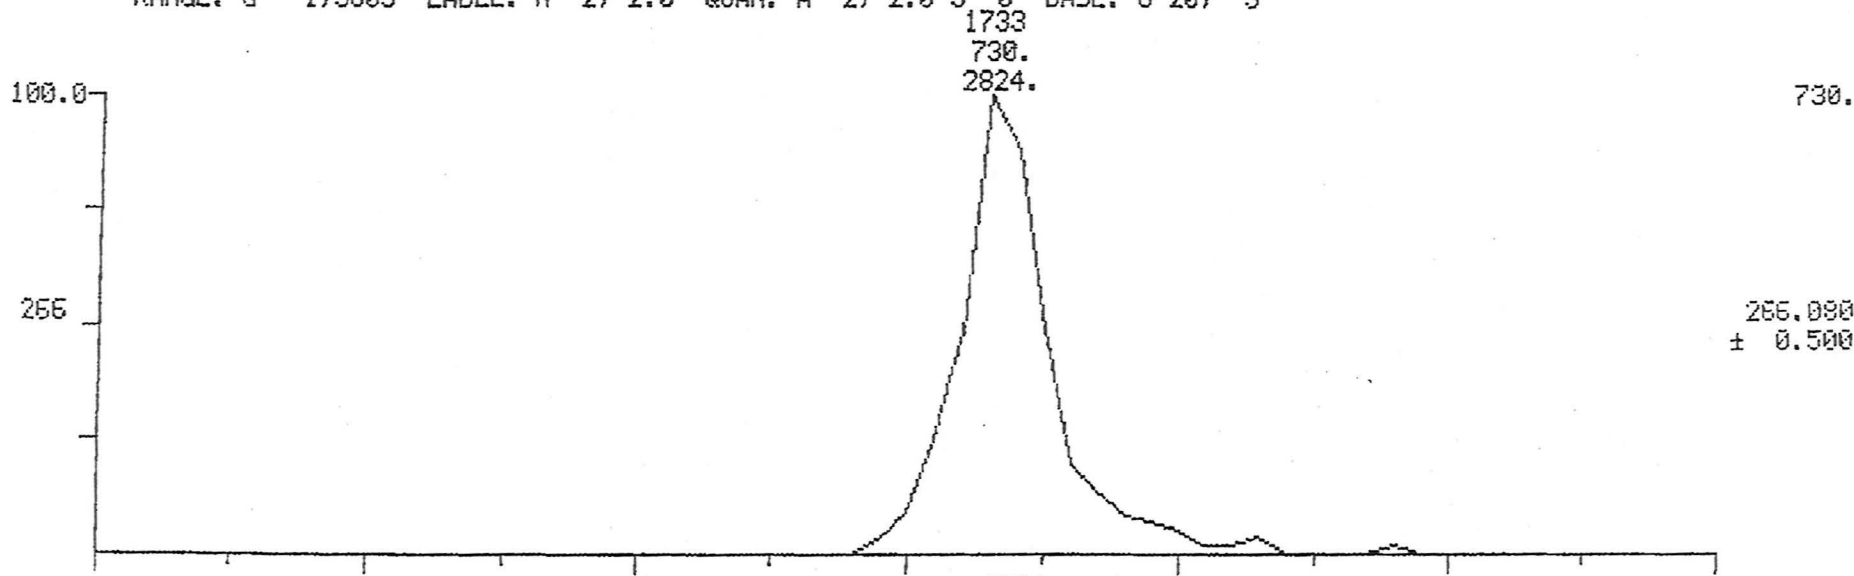
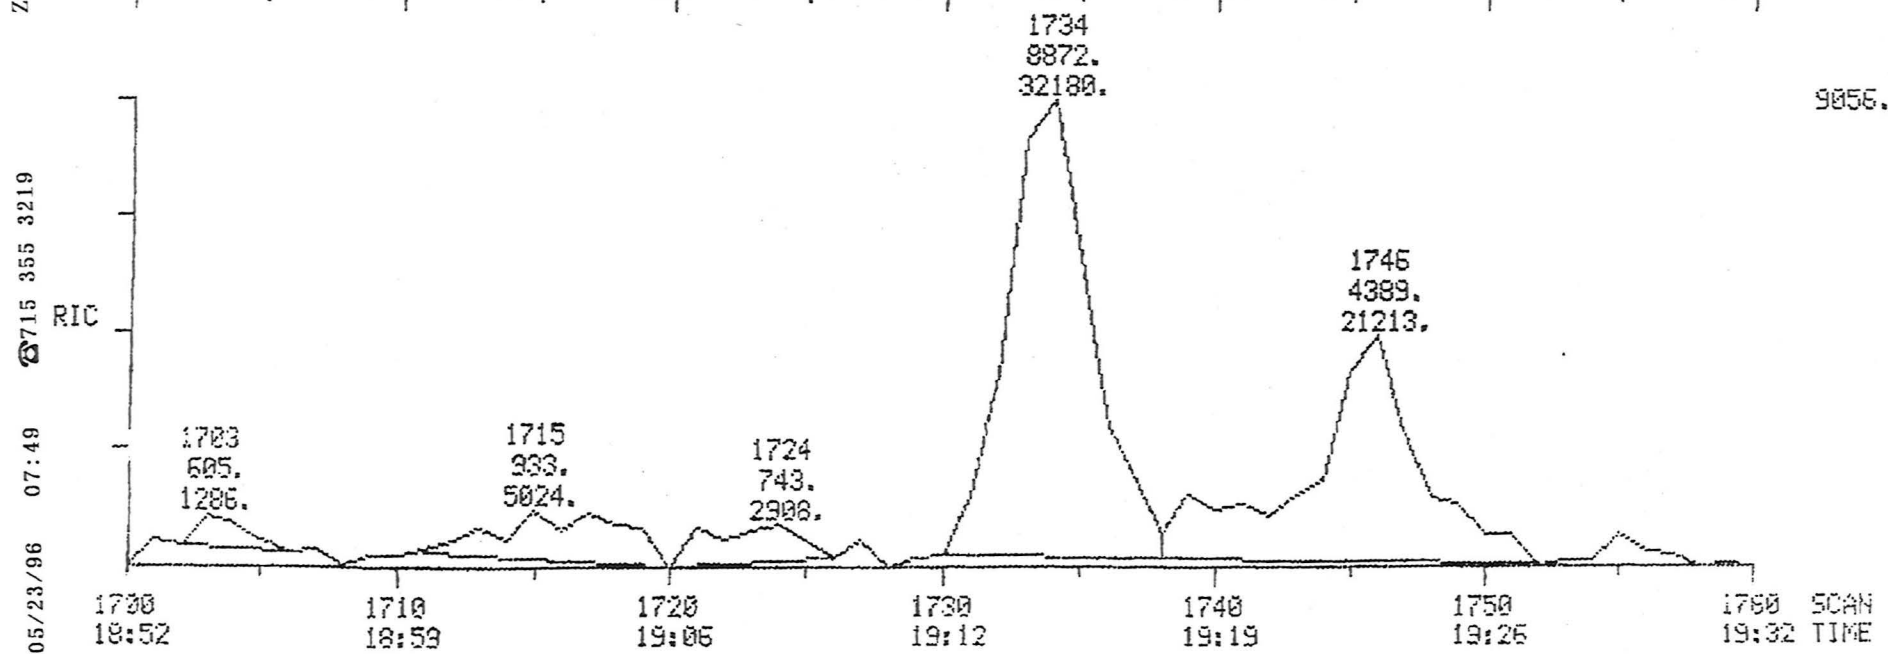
RIC+MASS CHROMATOGRAM

Due to the interference, the analyst also had the sample confirmed by GC/MS. All three major ions matched for the identification of PCP. The peak fit was 99.1% positive for PCP. The quantitation for PCP from the GC/MS data was 11.5 ug/l. (The MDL for PCP by GC/MS is 2.1 ug/l).

CONDS.: 30 M X 0.32 MM ID DB-5.625, 1.0 UL SPLITLESS AUTO INJECTION
