RE: Results of the Additional Environmental Services for the DB Oak Property (former Thomas Industries) Located at 700-710 Oak Street in Fort Atkinson, Wisconsin — FEC Project No. 170503, DNR BRRTS No. 02-28-176509

Friess Environmental Consulting (FEC) has prepared this letter to present the results of additional environmental services, including limited soil removal, sub-slab vapor testing of the on-site building, soil gas sampling on the adjacent properties, and additional groundwater sampling. The project background and results are presented below.

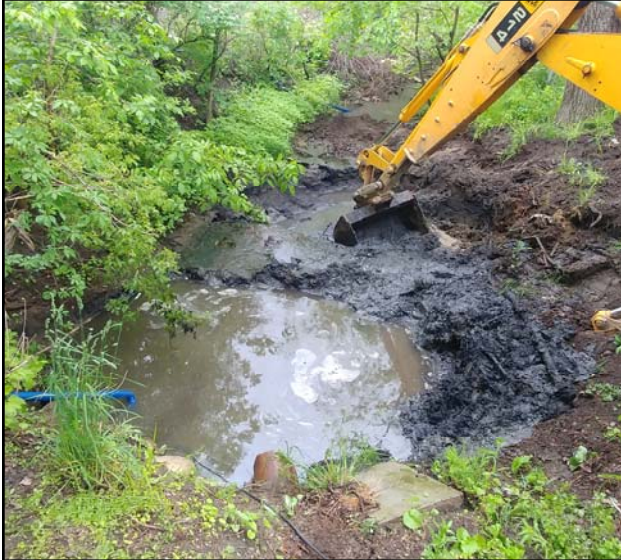
Photograph 1 - Drainage swale during limited soil removal.

FEC coordinated the removal and disposal of approximately 18.9 tons of CVOC impacted soil from the drainage swale. The final excavation was approximately 4 feet wide and extended from the outfall to approximately 45 feet south along the drainage swale at a depth of approximately 2 feet below grade. Large rip rap was placed in the drainage swale to minimize future sediment migration and eliminate risk of direct contact. No soil samples were collected from the base of the final excavation as the sampling conducted in 2016 had characterized the sediments to be removed and what is now left in-place along the drainage swale. The area of soil removal is shown on Figure 3 in Appendix B. The soil disposal manifests and photographs of the soil removal area are presented in Appendix D.

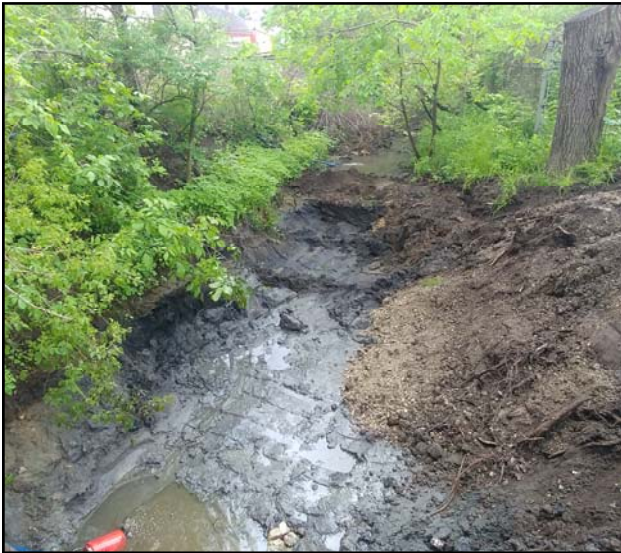
Photograph 2 - Drainage swale after soil was removed

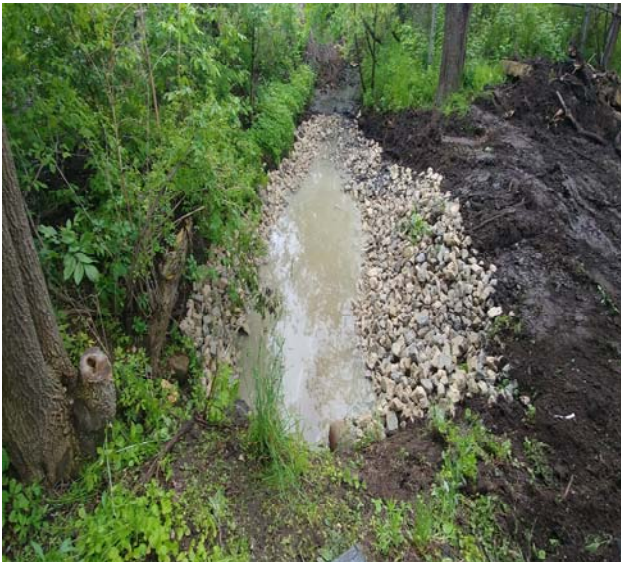
Photograph 3 - Drainage swale after limited soil removal and placement of stone.

Based on the field observations and previous sediment sampling results, the excavation effectively removed the direct contact risk and greatly reduced the residual impacts present above RCLs for the protection of groundwater within the drainage swale. This will limit storm water infiltrating the ground surface within the drainage swale resulting in potential partitioning of residual soil contamination to the groundwater.
