Technical Assistance, Environmental Liability Clarification or Post-Closure Modification Request

Attachment 1. Foam Observation Photographs

Tyco Fire Products LP
Marinette, WI

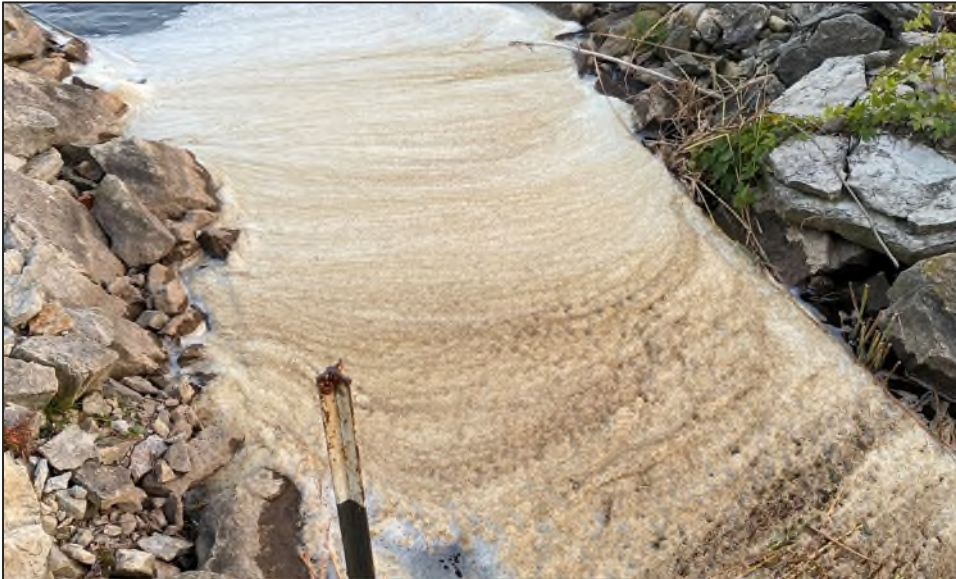
Photo: 1

Description:
White/tan, frothy

Location:
Southeast side of Ditch C
(SW branch) and West Bay
Shore St crossing

No foam accumulation was observed on Ditches A, B, D, and E during daily inspections throughout the monitoring period. Foam was observed twice on Ditch C (October 11, 2020 and October 12, 2020). A summary of the daily inspection logs for Ditches A, B, C, D, and E are provide as **Tables 1, 2, 3, 4, and 5**, respectively. A 3rd party oil release was observed in Ditch B on September 17, 2020 upstream of the Ditch B Interim Action Treatment System. As a result, sheen was observed in Ditch B during daily inspections conducted September 25 and September 28, 2020.

All foam was collected into a single drum to allow the foam to naturally collapse into a liquid. Approximately 1 gallon of collapsed foam and approximately 2.2 gallons of collapsed foam from the previous reporting period (April 24, 2020 to July 3, 2020) were consolidated into a sealable, UN rated 5-gallon bucket and shipped as a non-hazardous material to Clarkson University in Potsdam, New York (Clarkson) on January 11, 2021. Clarkson used the condensed foam for a research project, where nonthermal plasma technology is used to destroy the condensed foam. Documentation of destruction will be provided in a subsequent foam monitoring report.

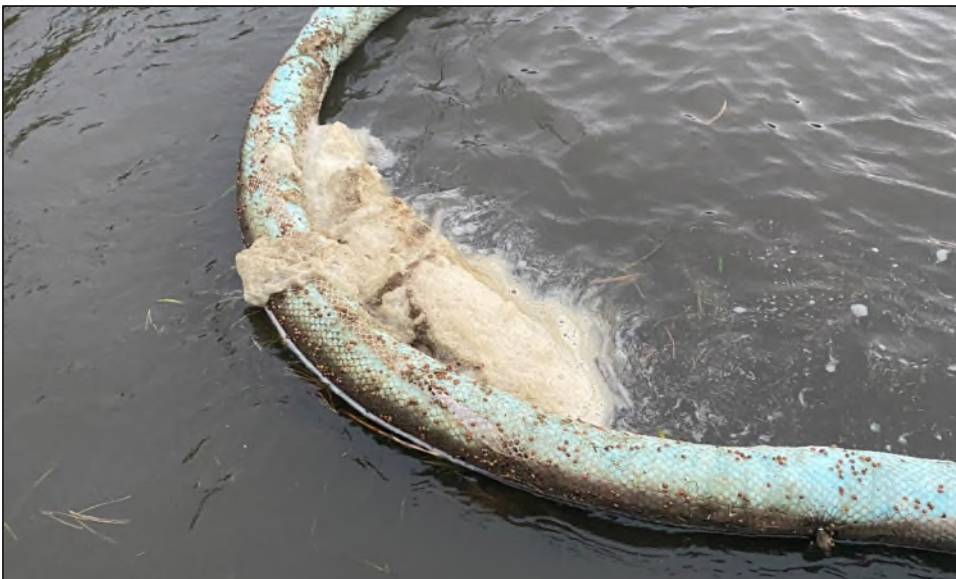
Photo: 2

Date:
10/12/20
