Technical Assistance, Environmental Liability Clarification or Post-Closure Modification Request

Phase I Environmental Site Assessment for Identifying Recognized Environmental Conditions

*Phase I Environmental Site Assessment for
Identifying Recognized Environmental Conditions
2346 Clear View Road
Christiana, Dane County, Wisconsin*

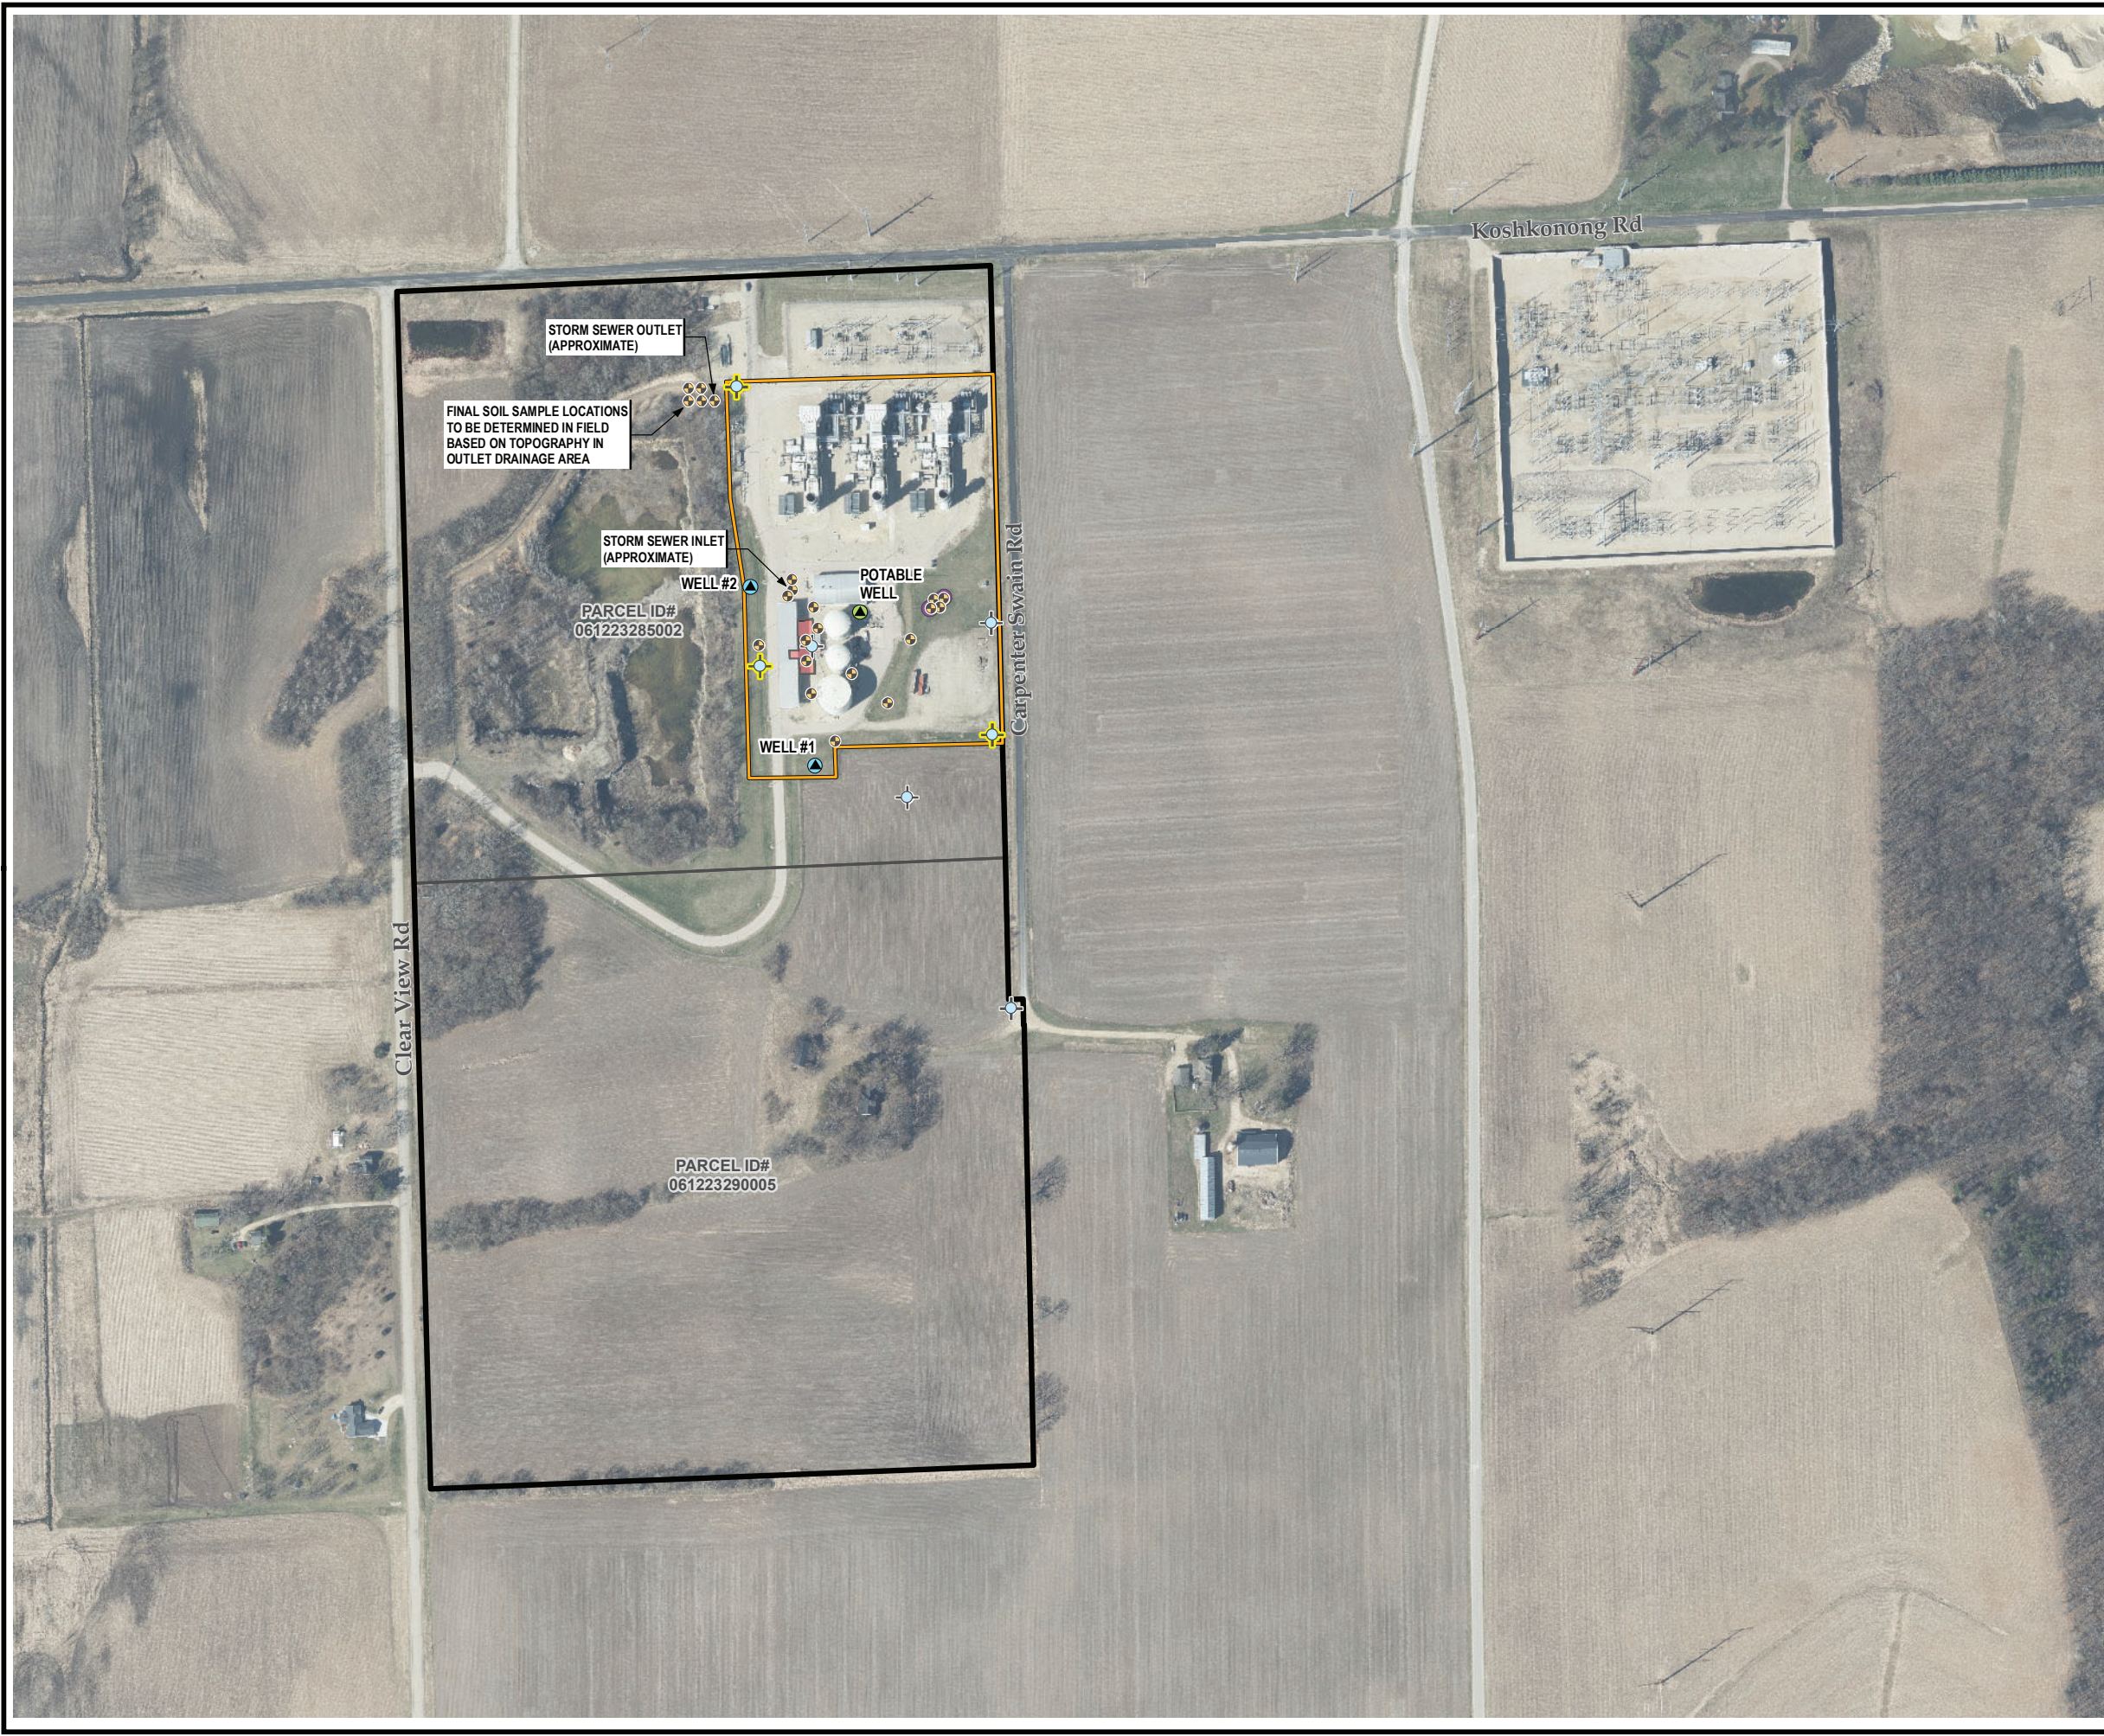
- PROPOSED MONITORING WELL
- PROPOSED SOIL BORING
- MONITORING WELL TO BE INSTALLED FIRST AND USED TO DETERMINE PRELIMINARY GROUNDWATER FLOW DIRECTION
- POTABLE WELL
- DEEP PRODUCTION WELL
- APPROXIMATE AREA OF AFFF INSPECTION TESTING
- APPROXIMATE EXTENT OF SEPTIC MOUND
- PROPERTY BOUNDARY
- PARCEL BOUNDARY
- SITE EXTENT FOR PURPOSE OF INVESTIGATION

- Installation and development of monitoring wells will be in accordance with NR 141. The wells will extend to 7 feet below the water level observed during drilling (estimated to be approximately 70 feet bgs). Monitoring wells will be constructed of 2-inch diameter PVC and 10-foot screens and will be completed with stick-up covers.

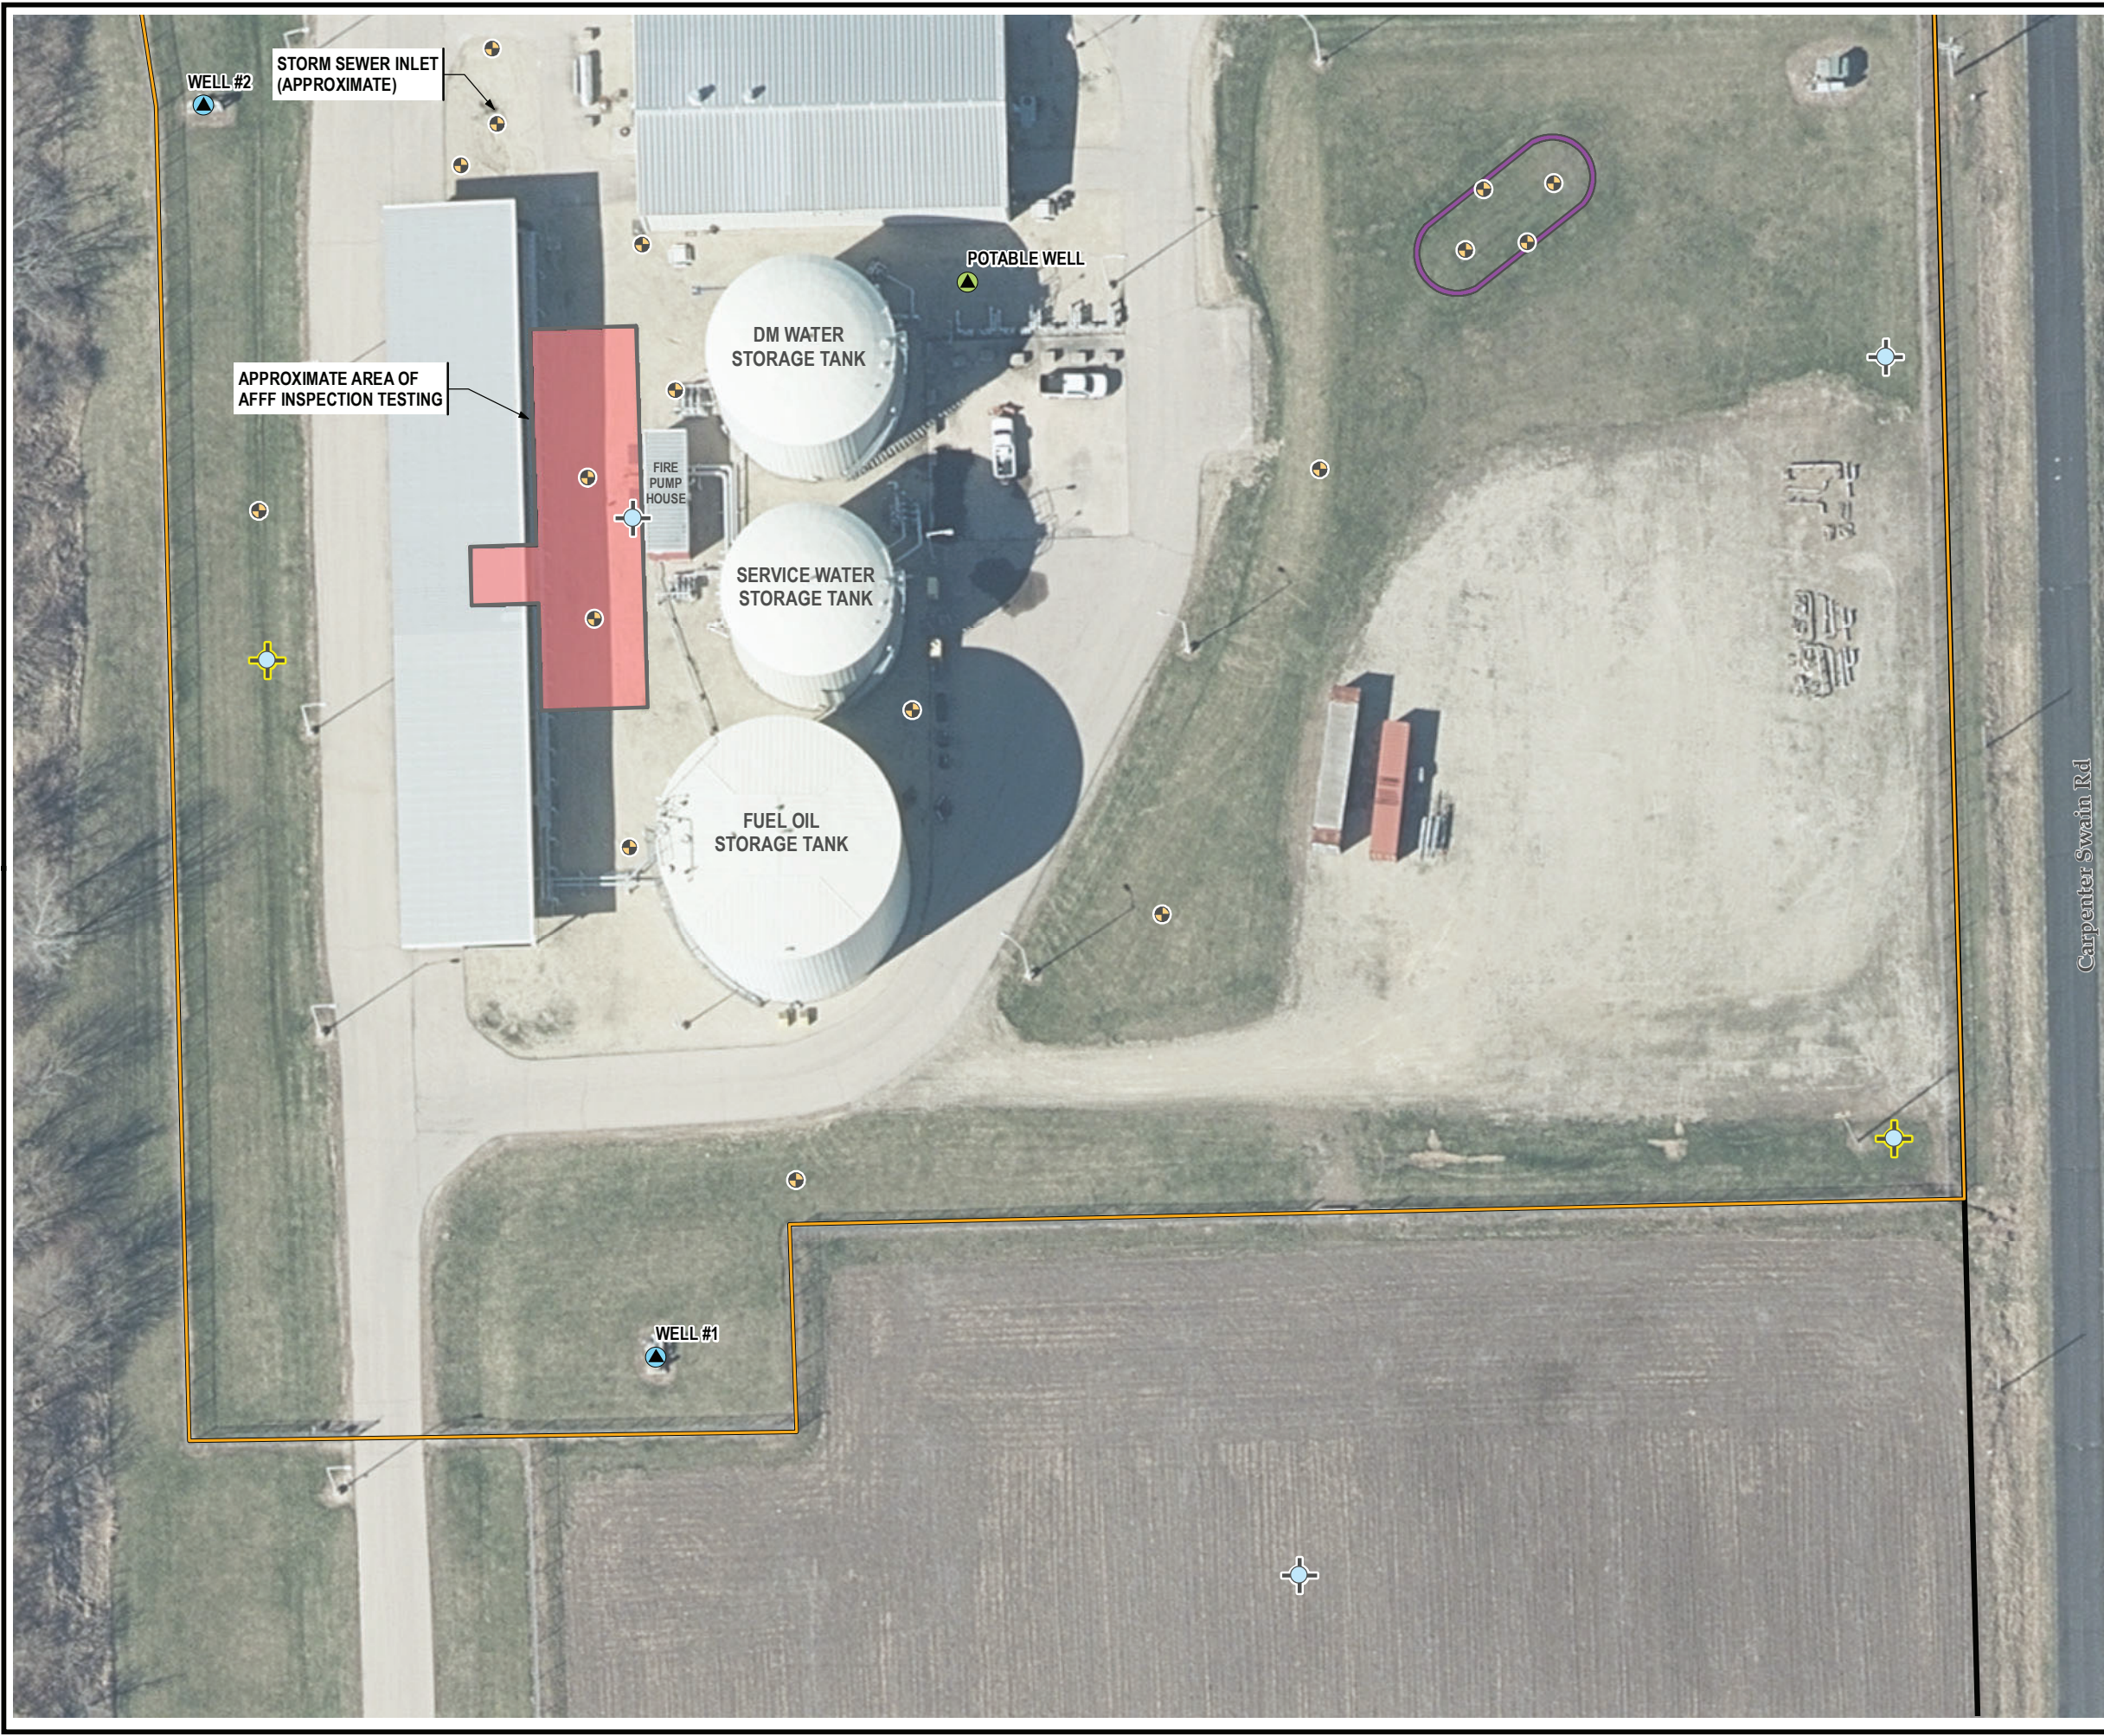
- PROPOSED MONITORING WELL
- PROPOSED SOIL BORING
- MONITORING WELL TO BE INSTALLED FIRST AND USED TO DETERMINE PRELIMINARY GROUNDWATER FLOW DIRECTION
- POTABLE WELL
- DEEP PRODUCTION WELL
- APPROXIMATE AREA OF AFFF INSPECTION TESTING
- APPROXIMATE EXTENT OF SEPTIC MOUND
- PROPERTY BOUNDARY
- SITE EXTENT FOR PURPOSE OF INVESTIGATION

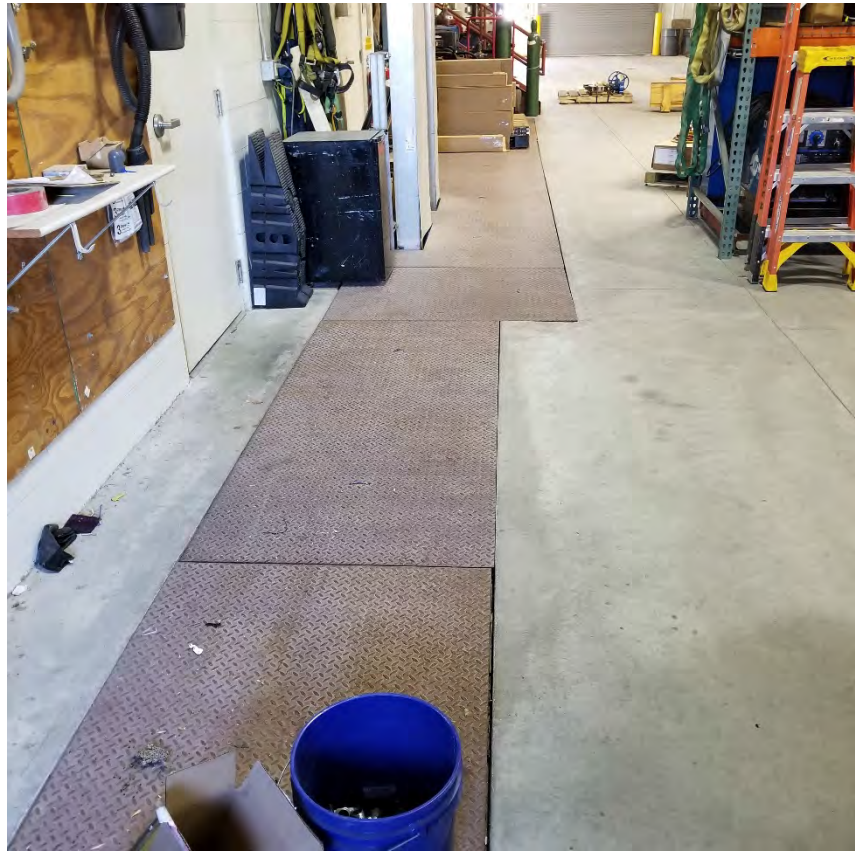
Photograph 11:

Pictured is the concrete trench containing cables and circuitry leading to the control room.

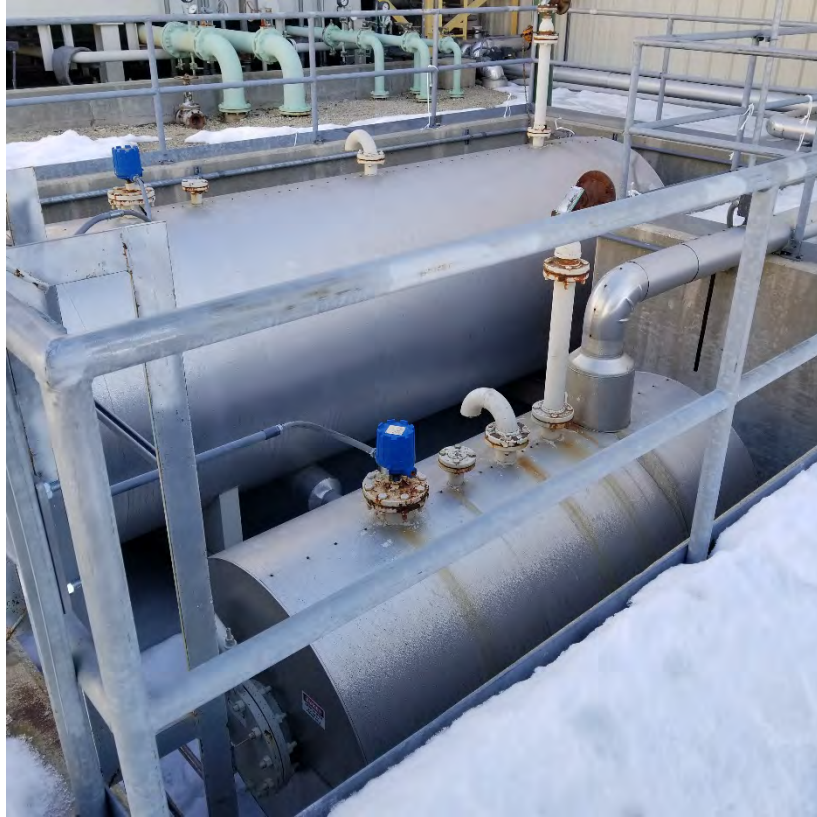
Photograph 13:

Pictured are two of the power plant's process drain tanks.

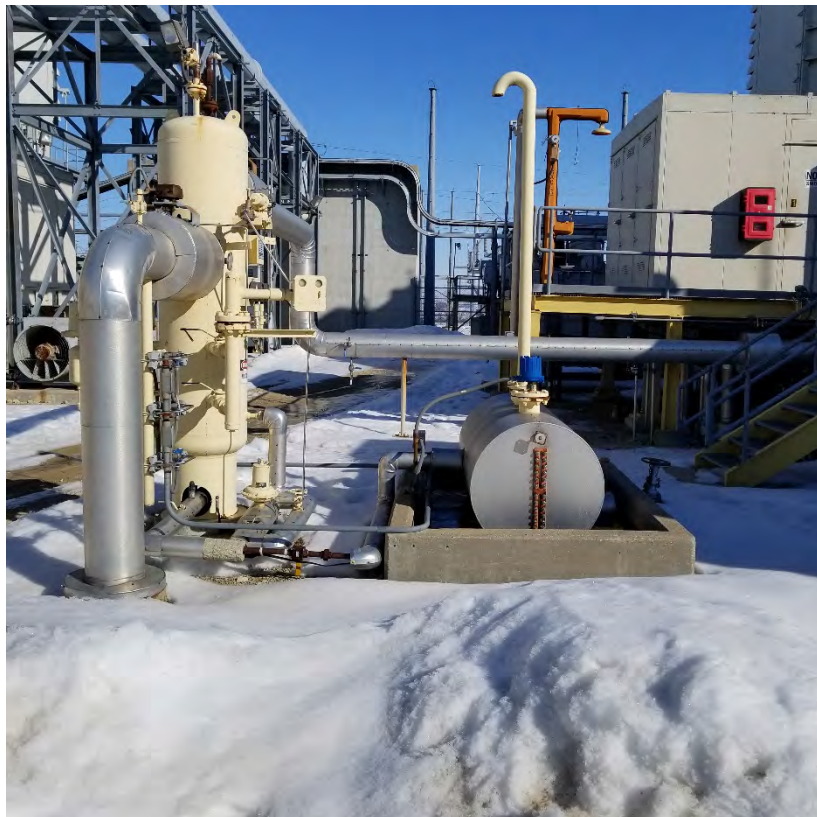
Photograph 14:

Pictured is one of the power plant's fuel gas conditioning tanks.

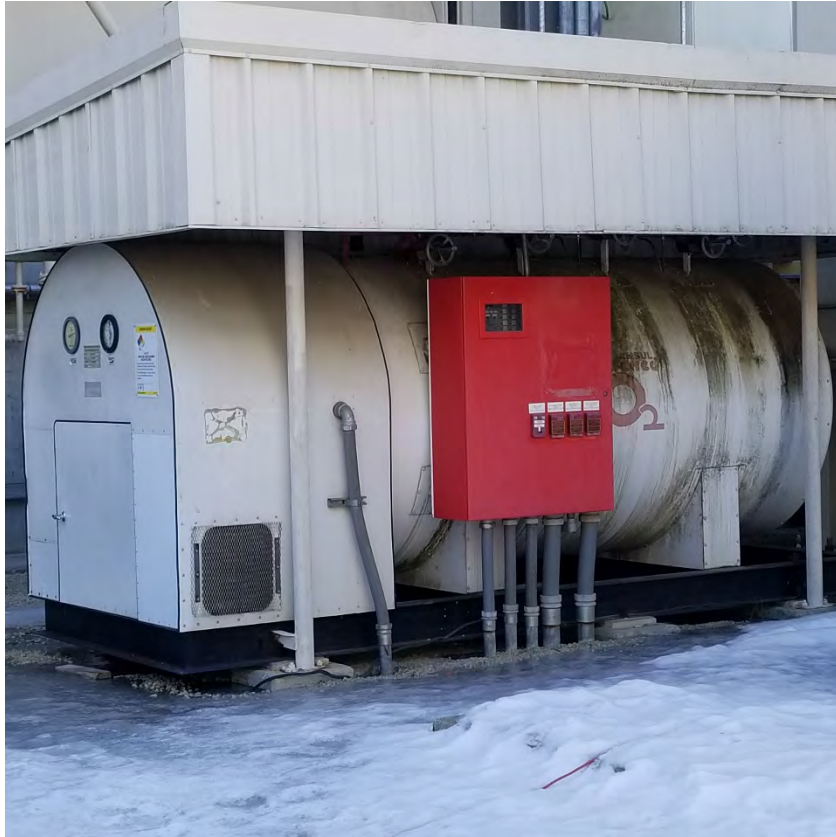
Photograph 17:

Pictured is one the power plant's carbon dioxide fire protection skids.

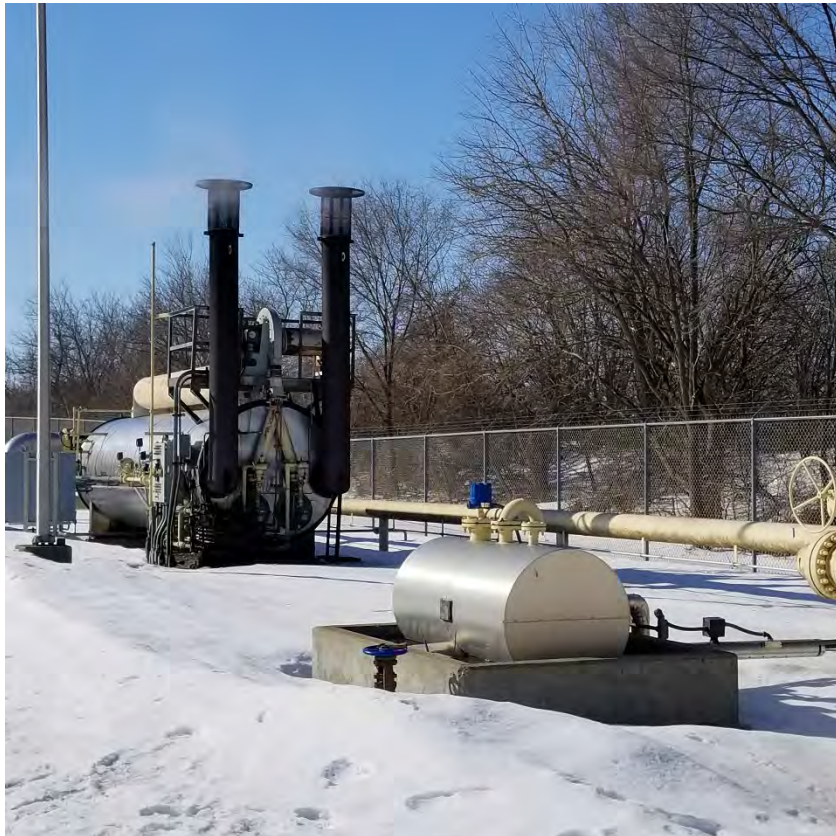
Photograph 18:

Pictured is the fuel gas separating drain tank.

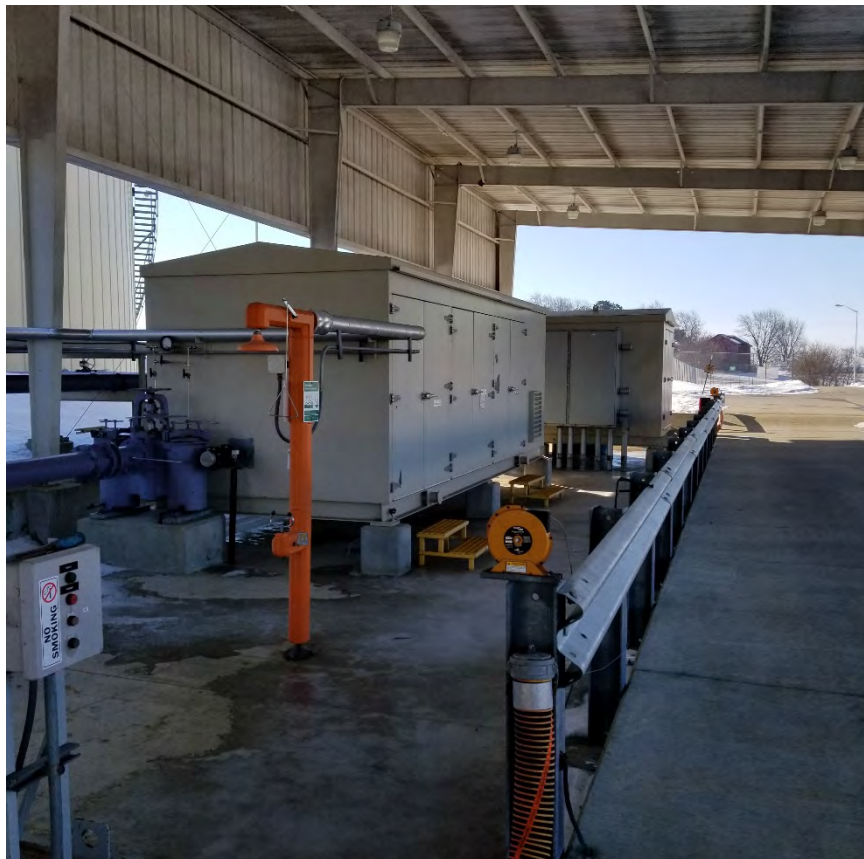
Photograph 22:

Pictured are the two fuel oil forwarding skids located in the unloading area.

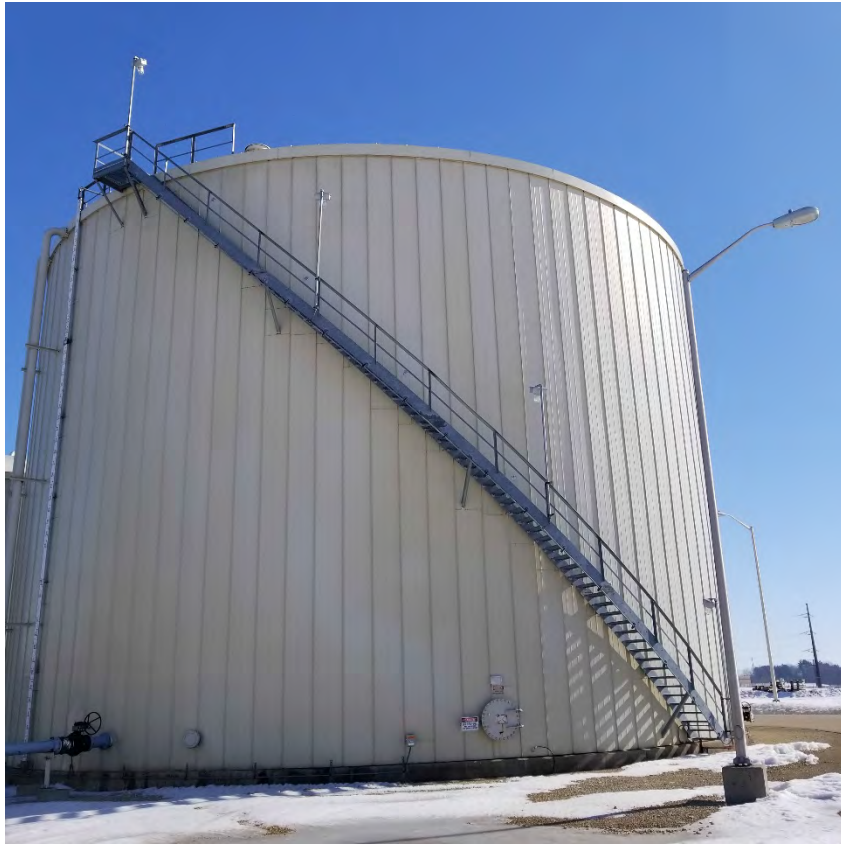
Photograph 25:

Pictured is the 1.2 million gallon fuel oil tank.

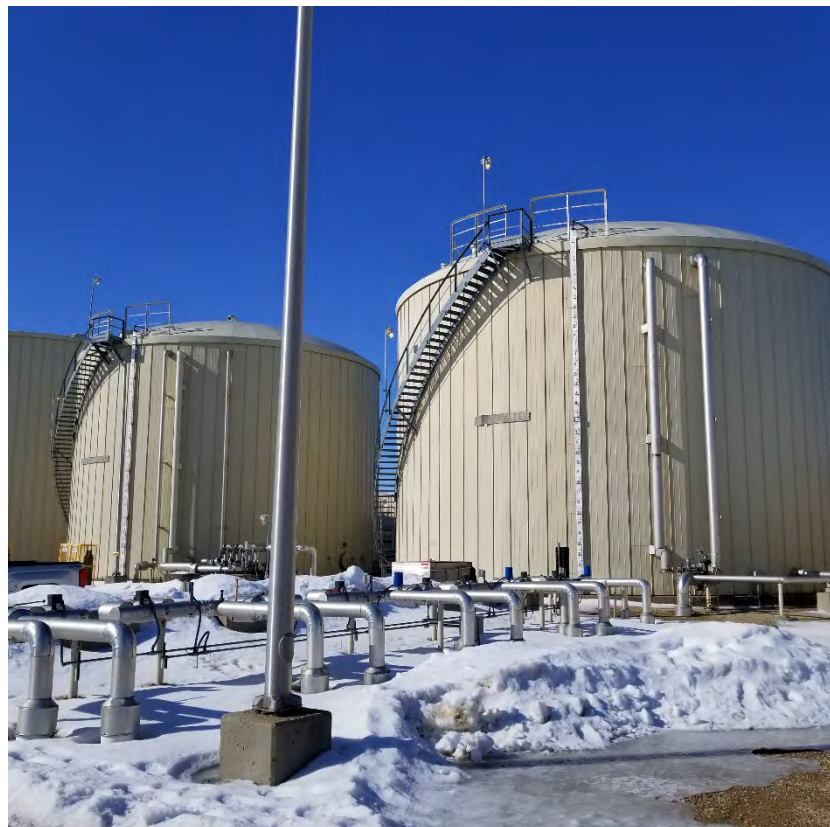
Photograph 26:

Pictured is the 500,000 gallon demineralized tank and the 600,000 raw water tank.

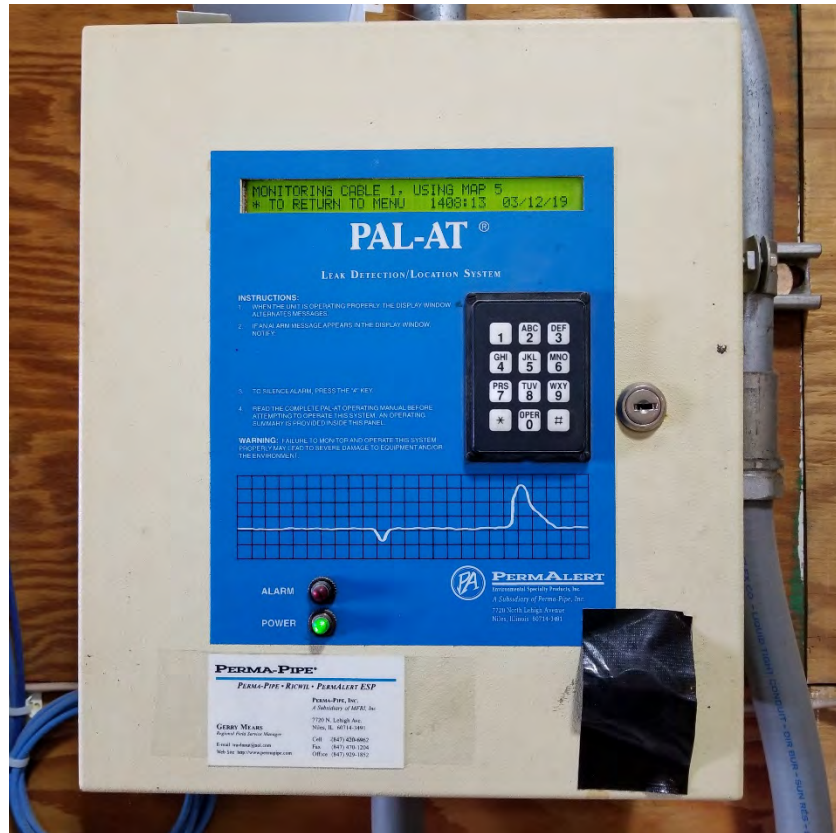
Photograph 29:

Pictured is the digital leak detection system that monitors underground piping at the facility.

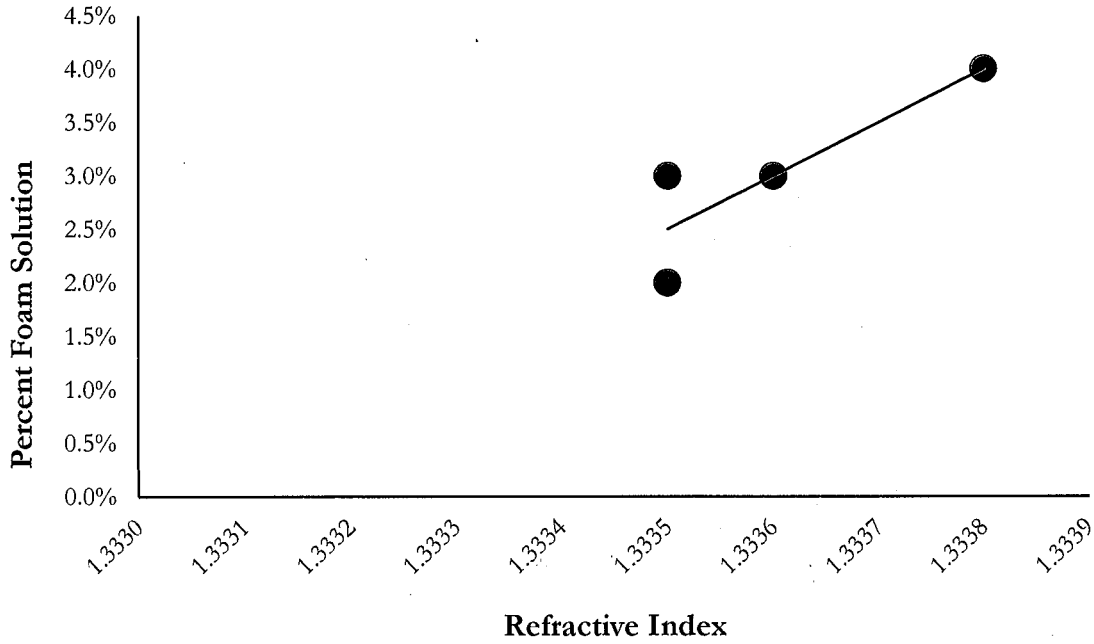
System: Fuel Oil Tank

System	Foam Concentrate	Water	Premix #1 2	Premix #2 3	Premix #3 4	Foam-Water Test Sample
Fuel Oil Tank	1.3511	1.3330	1.3335 / 2.0 %	1.3336 / 3.0 %	1.3338 / 4.0 %	1.3335 / 3.0 %
