RE: Results of Additional Environmental Services for the DB Oak Property (former Thomas Industries) Located at 700-710 Oak Street in Fort Atkinson, Wisconsin — FEC Project No. 170503: DNR BRRTS # 02-28-176509

Vapor Mitigation Install Report: 700 Oak Street, Fort Atkinson, WI 53538 Phase 1: Central Building

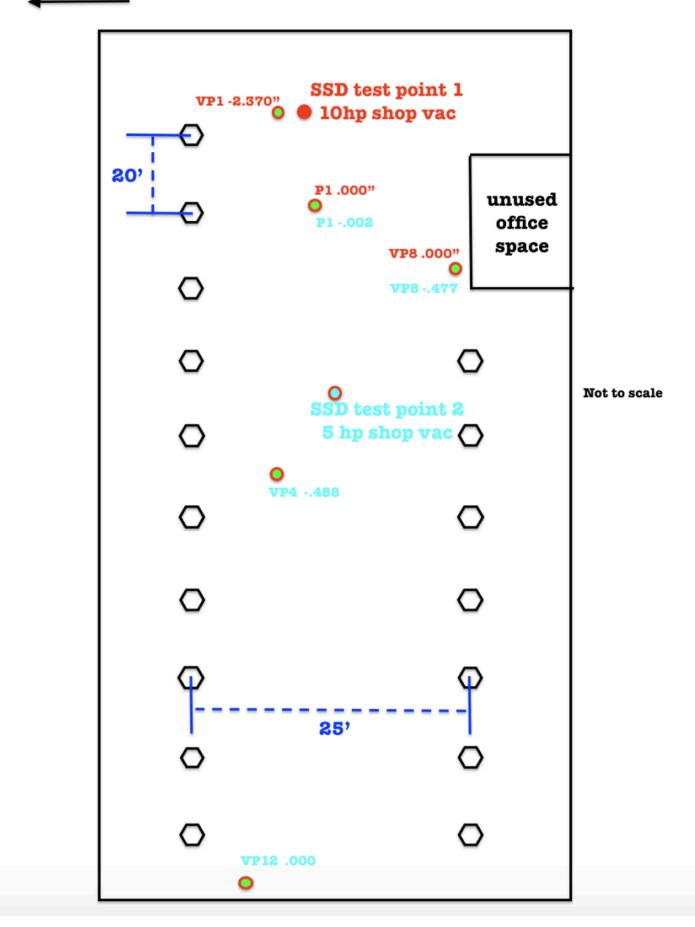
Results: The PFET results show there are multiple areas with communication blockage throughout the slab area of concern. There were three different large pressure points created and tested, all with different communication abilities. The first sub-slab depressurization (SSD) test point was created near VP1, this pressure point had little to no communication through the slab in any direction. There were 2-5hp shop vacs connected creating near absolute vacuum (about 120" negative pressure) and just three feet away at VP1 there was less than 2.5" of negative pressure left. A pressure test point was created about 20 feet away to the west and there was no measurable negative pressure left. SSD test point 2 was created about 70 feet to the west of SSD test point 1 were communication was found to be considerably better than test point 1 but still would not reach most of the area needed to be mitigated. SSD test point three was created about 70 feet to the North East of SSD 2. Here it was found to have decent communication to the south and west but could not communicate well to north or east. Due to time constraint and costs, it was determined that it would be best to stop and analyzed the data that was collected to best decide what type of mitigation systems would be able to handle the large footprint with such extremely variable sub-slab soils and conditions. Based on the information gathered it was determined the best way to mitigate would be to burry large perforated vent pipe in long horizontal trenches with large custom built blowers that could handle the possibility of extremely high volumes and/ or create the extremely high negative pressures that are required for the tighter sub slab soil areas. The first diagram located on the next page is for the South Bay Area and the second on the following page is for the rest of the building area of concern located to the north of the south bay.

As one can see, based upon the initial PFET and the high variance in sub-slab material, a more robust active soil depressurization system is needed to create proper communication throughout the areas of concern. Further, it is also noted that trenching (or laying large sections of piping under the sub-slab to create lengthy stretches of uninterrupted depressurization) would be the most effective means of mitigation. That is, since the sub-slab soil conditions range from relatively porous to virtually no porosity at all, creating long stretches of uninterrupted communication increases the likelihood of establishing negative pressure in areas potentially unreached by other means of mitigation.

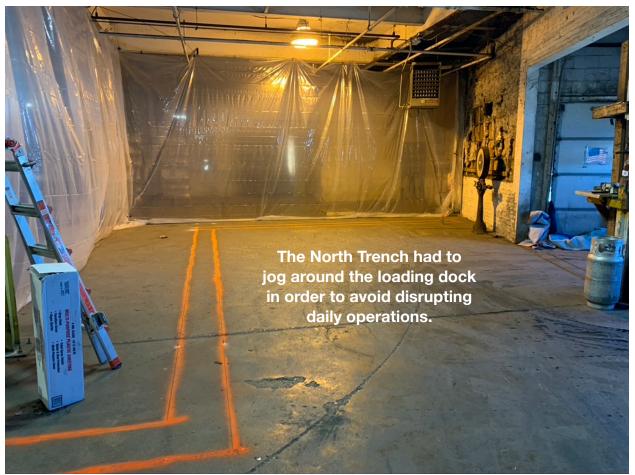
North Trench

As one can see by the figures above, marking paint was used to identify where the trenching should take place, at what width the trenches should be cut, and where the sections should be cut horizontally to ultimately remove the concrete blocks. Ground penetrating radar was used prior to marking to ensure the trenching pathway was clear of plumbing lines, other sub-slab utilities or any obstructions. Further, a temporary tunnel around the trench pathway was constructed with plastic sheeting, and held down tightly with furring strips, in order to control concrete dust and soil vapors as cutting and removal took place. Large portable air handlers were placed on the far west end of the tunnel directing the air through the tunnel and ultimately outside of the loading dock doors on the far east side of the building.

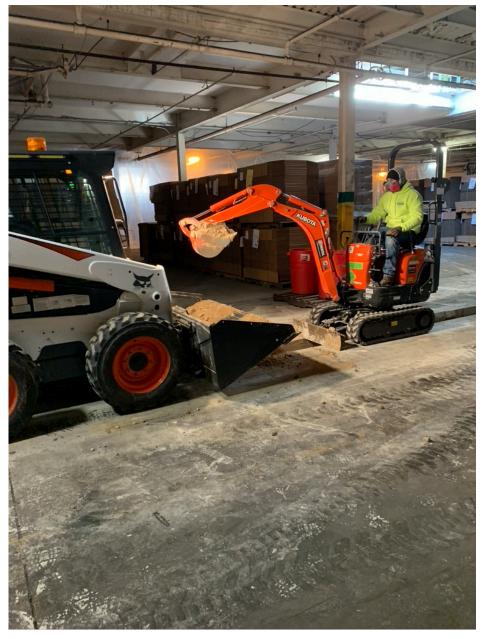
## FIGURE 10

The trench was dug approximately 14" deep to leave enough room for a proper aggregate bed, the 6-inch stainless steel piping, and final backfill. Moreover, midway through the south trench it was discovered that almost exactly 14" beneath the current slab was a second, older slab. The second slab was only present for a smaller, approximate 20-foot section of the trench.

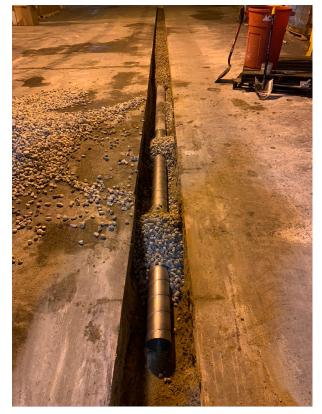
**FIGURE 13**

**Backfilling Underground Pipe**

After all of the piping is laid in the trench, the technicians continue to backfill around, and slightly above, the underground piping with the 1" washed stone previously mentioned. The

technicians were extremely diligent in ensuring that any portion of the existing slab that was slightly undermined during the excavation process was properly backfilled and compressed with the aforementioned aggregate. After the stone fill was added and properly compressed, the onsite project manager checked the depth between the existing slab and the backfill to ensure at least 8-inches of space was left for an even, sturdy 8" concrete pour. If the depths of any areas were greater or less than 8-inches, the proper adjustments were made and regraded. Additionally, after the stone was properly graded, the 6-mil vapor barrier was added to the trench to prep for the final concrete pour.

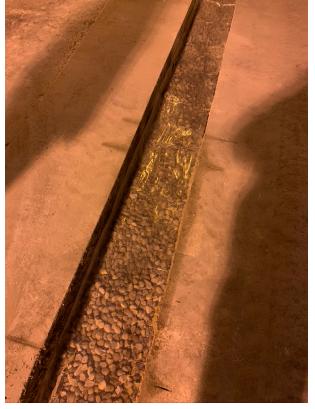
Final Grade of Underground Pipe w/ Vapor Barrier

The 6-mil vapor barrier was placed over the 1" washed stone backfill and overlapped by at least 12-inches where two separate pieces are joined. This is important to ensure the vapor barrier helps create a better vacuum under the slab while the soil is being depressurized. To be absolutely clear, the vapor barrier does not fully ensure that a perfect vacuum is achieved but rather it helps to create a better vacuum than if it were not present and/or not overlapped where two separate sections are joined.

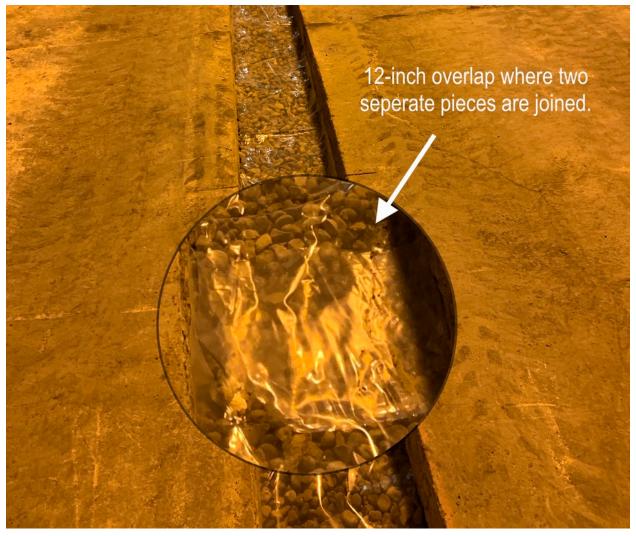
(See Figure 14 below illustrating the vapor barrier and the overlap present)

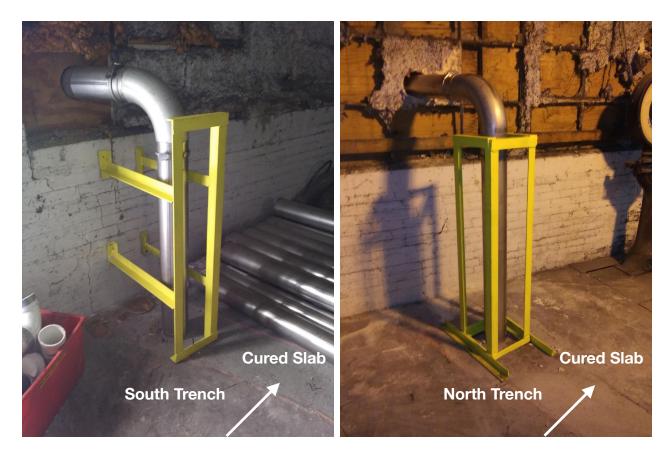
## FIGURE 16

One important consideration for the above ground piping on this particular project was protecting the vertical piping in the industrial setting. That is, ensuring that fork lifts and other industrial equipment do not damage the piping during the course of normal operations or in the event of an accidental collision. With that being said, the technicians designed and welded a protective barrier to enclose the vertical piping and ultimately protect the vapor piping from the aforementioned concerns. Further, to improve visibility of the vertical piping and barrier, the technicians painted the protective barrier yellow.

As one can see in the figures above, the above grade piping comes out at about 4-feet above the slab and has a 90-degree, long radius elbow exiting to the exterior of the building. Utilizing a long radius elbow is important to help maximize both pressure and airflow of the system. That is, long radius elbows provide less friction and resistance than short radius fittings.

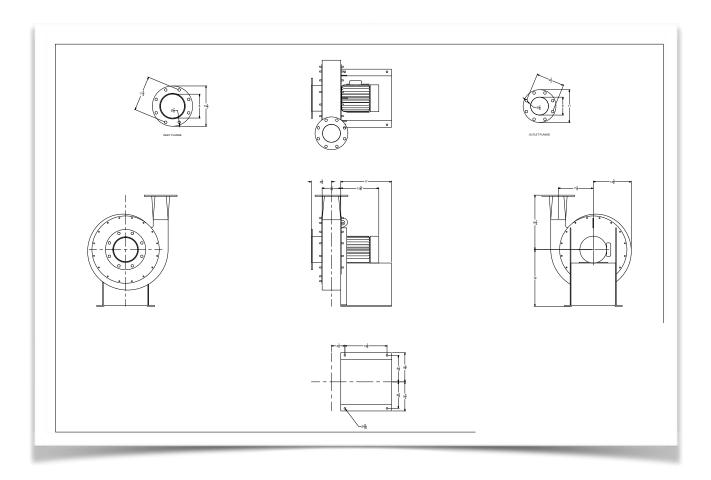
## Performance Curve

Once the pipe exits the structure, the custom blowers are connected and mounted to the vapor mitigation system. The blowers used for both the North Trench and South Trench of the Central Building are custom blowers manufactured by New York Blower Company. The design specifications of the fans can be found in figure 17, 18, and 19 below.

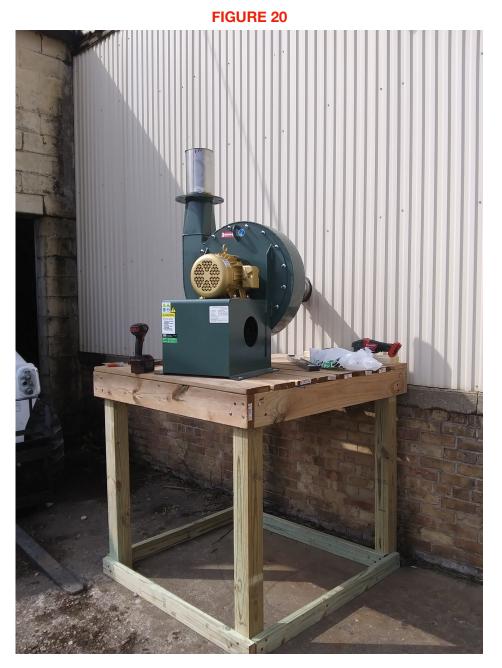
Because of the height at which the above ground piping is exiting the structure and due to the condition of the exterior slab, a platform to hold, stabilize and ultimately mount the fan was built. Figure 20 below briefly illustrates the platform built for the fan.

The blower was of course bolted to the wooden platform shown above. Further, the platform was then also bolted to the exterior slab beneath the fan for extra support and stability. Once the blower was fully mounted and secured, the technicians began building the exterior, exhaust portion of the system. Similar to the importance of the long radius, 90-degree elbows previously mentioned (on the intake portion of the system), it is equally important to reduce friction and resistance on the output side of the blower as well. Therefore, when building out

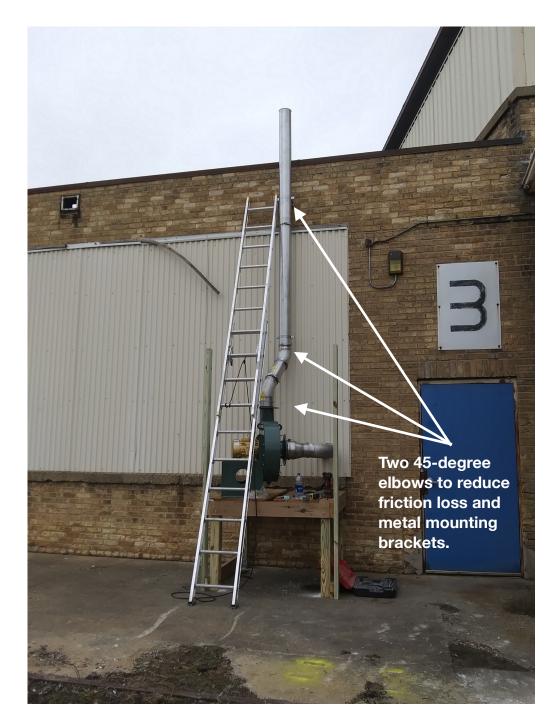
## (Please see Figure 21 for a visual representation of the fittings and brackets used)

the output portion of the system, the technicians used two, long radius 45-degree elbows rather than two, 90-degree elbows—thus reducing friction loss and resistance substantially. This offset is important to properly mount the system to the building and the fittings chosen are equally as important for maximum system effectiveness. Once the system was properly offset back to the structure, metal brackets further secured the vapor piping to the structure.

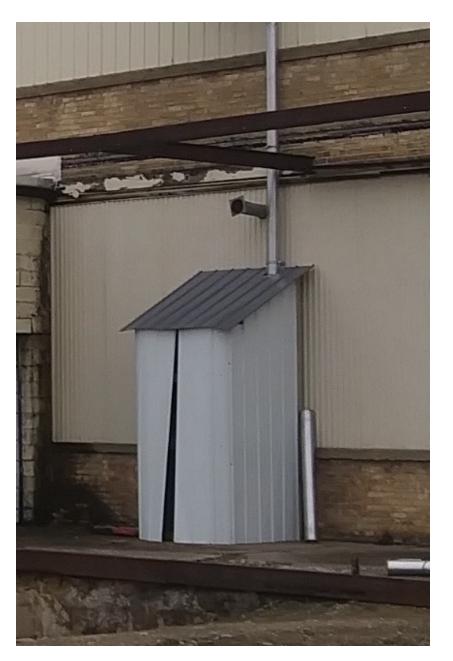
## FIGURE 22

In order to protect the blower motor and vapor mitigation system from tampering, vandals and weathering, a protective "shed-like" housing was also built around the blower. This housing is illustrated in figure 22.

The protective housing is of course complete and properly enclosed. The above illustration shows the housing while technicians were still making blower adjustments. The design was built so the front of the enclosure can bolt apart and technicians can access for any potential maintenance or service down the road.

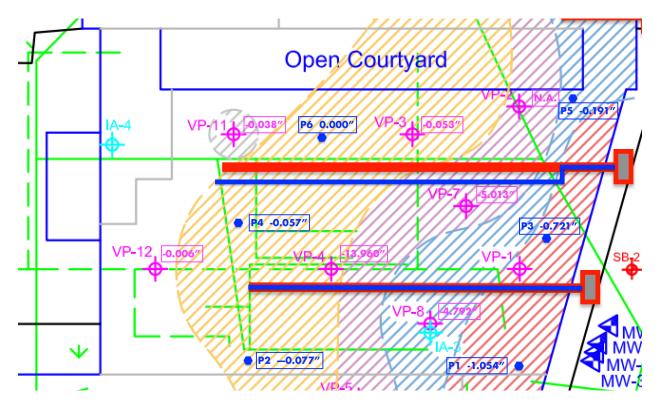
After the exploration phase of the post mitigation diagnostic process, the lead technician measured the negative pressure of the mitigation system (in w.c.) as well as the airflow at the discharge (in CFM). The negative pressure of the system is measured with the Magnehelic Differential Pressure Gauge mounted on the system. This pressure gauge shows the pressure underneath the slab and is mounted on the interior vertical piping for maximum visibility and functionality. The North Trench (North System) was pulling a negative pressure of 19" w.c. and the South Trench (South System) was also pulling a negative pressure of 19" w.c. Moreover, the North System was moving 834 CFM and the South System was moving 767 CFM. After the pressure and airflow readings were taken, the lead technician began doing his post mitigation PFE testing. The results of the post mitigation PFET can be found below in Figure 23.

The post mitigation PFE Test results below show the sub-slab pressure readings after the vapor mitigation system installation. As one can see, nearly all of the sub-slab pressure readings indicate that a negative pressure is taking place. This means the system is working and extending through the soil as it should. The only point that did not show a negative pressure reading was P6. With that being said, vapor mitigation system PFET readings tend to change over time—that change is of course dependent on many factors, including but not limited to moisture content in the soil, wind, HVAC usage or barometric pressure changes, etc. Further, it is not unusual for negative pressure readings to improve (over time) as the vapor mitigation system extracts water vapor from the soil, ultimately drying out the sub-slab material. Drying out the sub-slab can create cracks, crevasses, and separation below grade that improves porosity and ultimately negative pressure field extension.
