**Subject: Site Investigation Work Plan
Community Within the Corridor Limited Partnership – East Block
2748 N. 32nd Street, Milwaukee, WI 53210
BRRTS #: 02-41-263675; FID #: 241025400**

SITE INVESTIGATION WORK PLAN
COMMUNITY WITHIN THE CORRIDOR LIMITED PARTNERSHIP - EAST BLOCK
2748 S. 32ND ST.
MILWAUKEE, WI 53210
BRRTS #: 02-41-263675 FID #: 241025400

APRIL 14, 2021

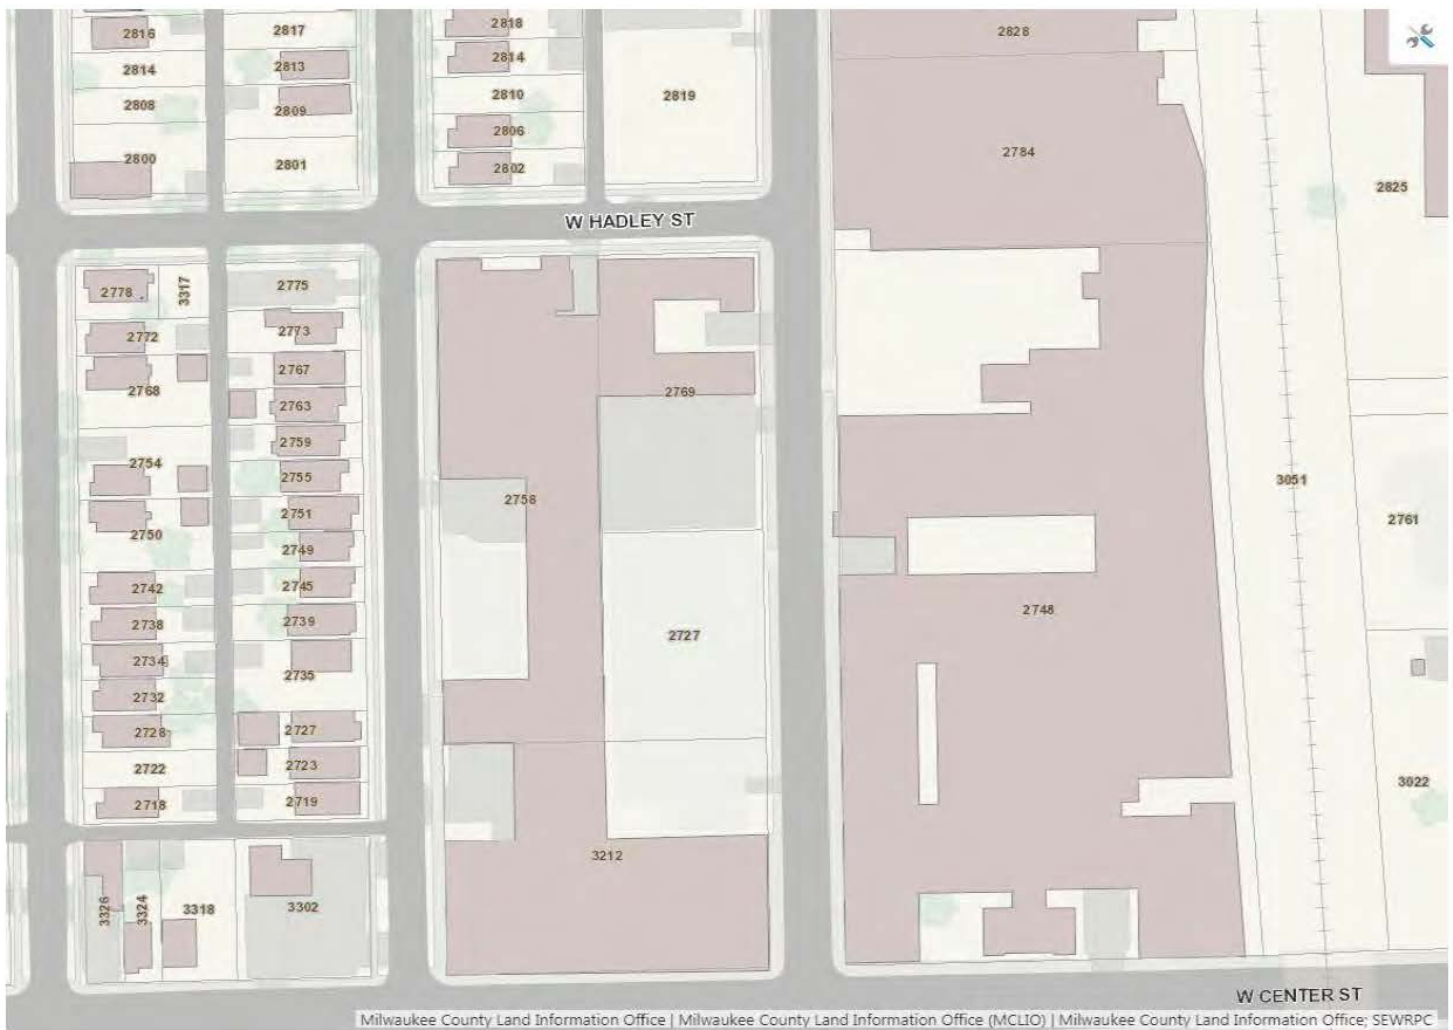
Figure 3: Milwaukee County Parcel Map

The plant is composed of five parcels, four of which contain buildings and one which has always remained open (Figure 3). For the purposes of this nomination and ease of understanding, this section will first provide individual descriptions of each of the properties which compose the plant, and will then assess the appearance and integrity of the plant as a whole.

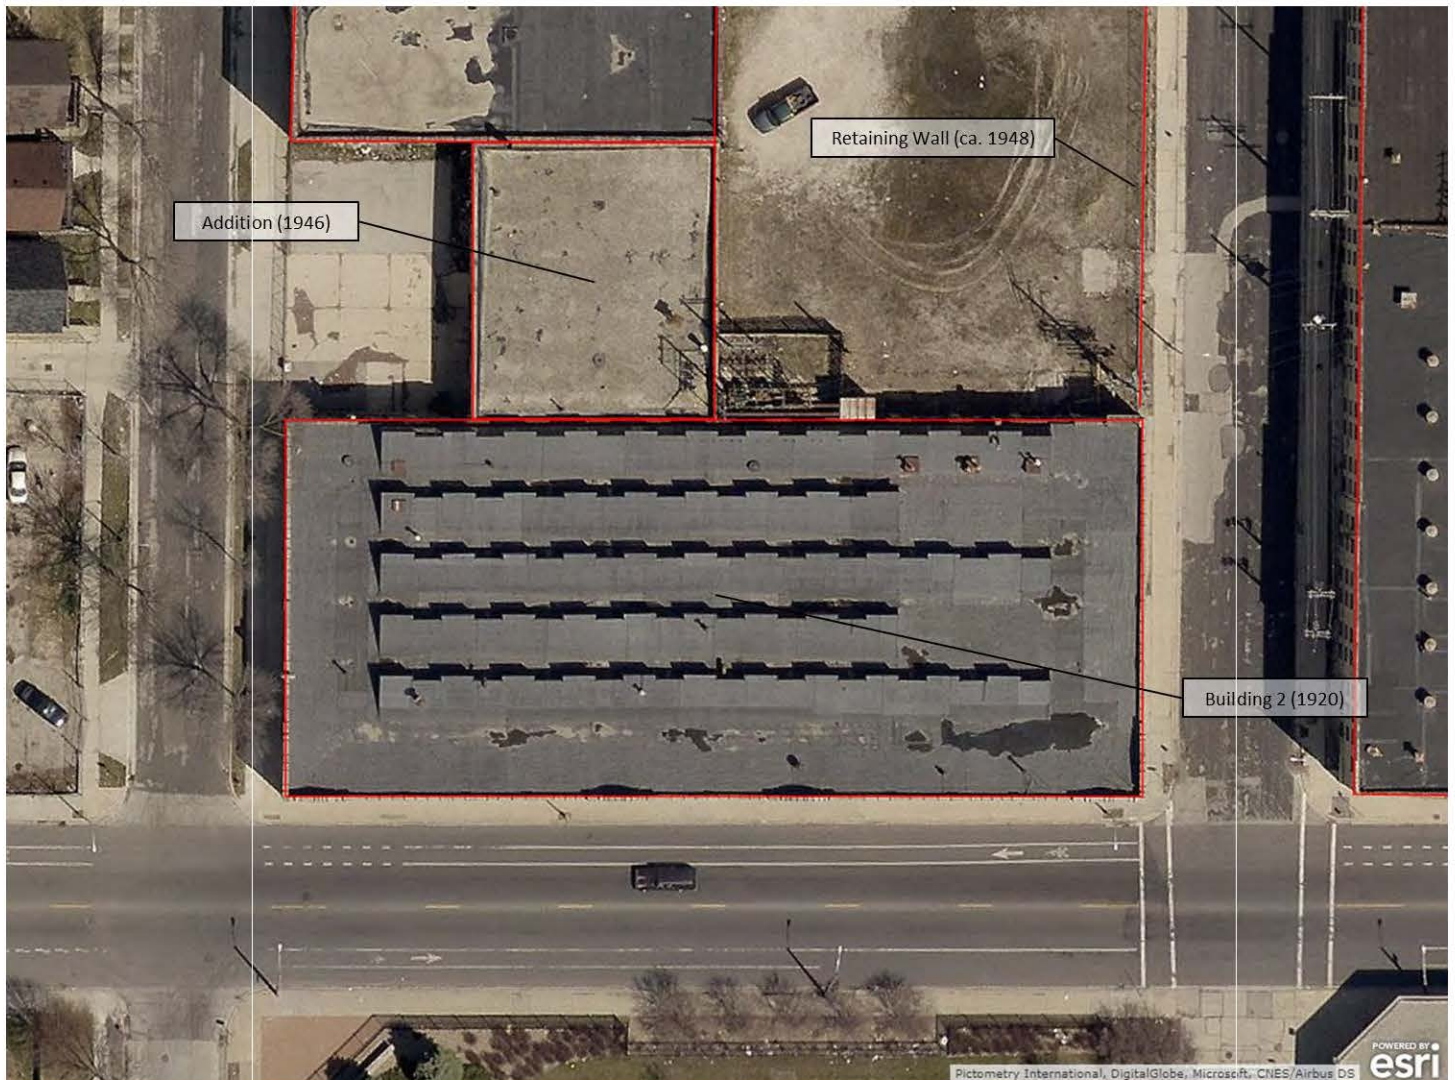
Figure 5: 3212 W Center Street (Parcel #309-1205), Site Map

The 3212 W Center Street parcel contains one building (constructed 1920) with one addition, built 1946 (Figure 5). When Briggs and Stratton Corporation purchased the property directly north of 3212 W Center Street, they cut a passage through the north wall of the 1946 addition to connect to the southern-most addition of Building 3 (2758 N 33rd Street).

On June 2, 1950, Briggs and Stratton purchased the building at 3212 W Center Street (parcel #309-1208) from the Harley Davidson Motor Company for use as its “service and distribution warehouse and headquarters.”⁵ This facility functioned as a highly modernized warehouse, and was primarily used for stocking, packaging and shipping replacement parts, and was “one of the first of its kind in the country.”⁶ This building (building 2) had originally been built in 1920 for the Columbia Knitting and Manufacturing Company, who sold the property to the Holeproof Hosiery Company in 1926.⁷ That company, in turn, sold the property to the Harley Davidson Motor Company in February 1942.⁸ They built a single-story trucking and distribution addition (building 2, addition 1) to the rear of the building in 1946 (Figure 17). Harley Davidson only occupied the building for eight years, and sold the property to Briggs & Stratton in 1950. Briggs & Stratton modernized the building for their purposes, and after they purchased the neighboring property (2758 N 33rd Street) in 1972, they cut a door through the northern wall of the addition to join the two properties.

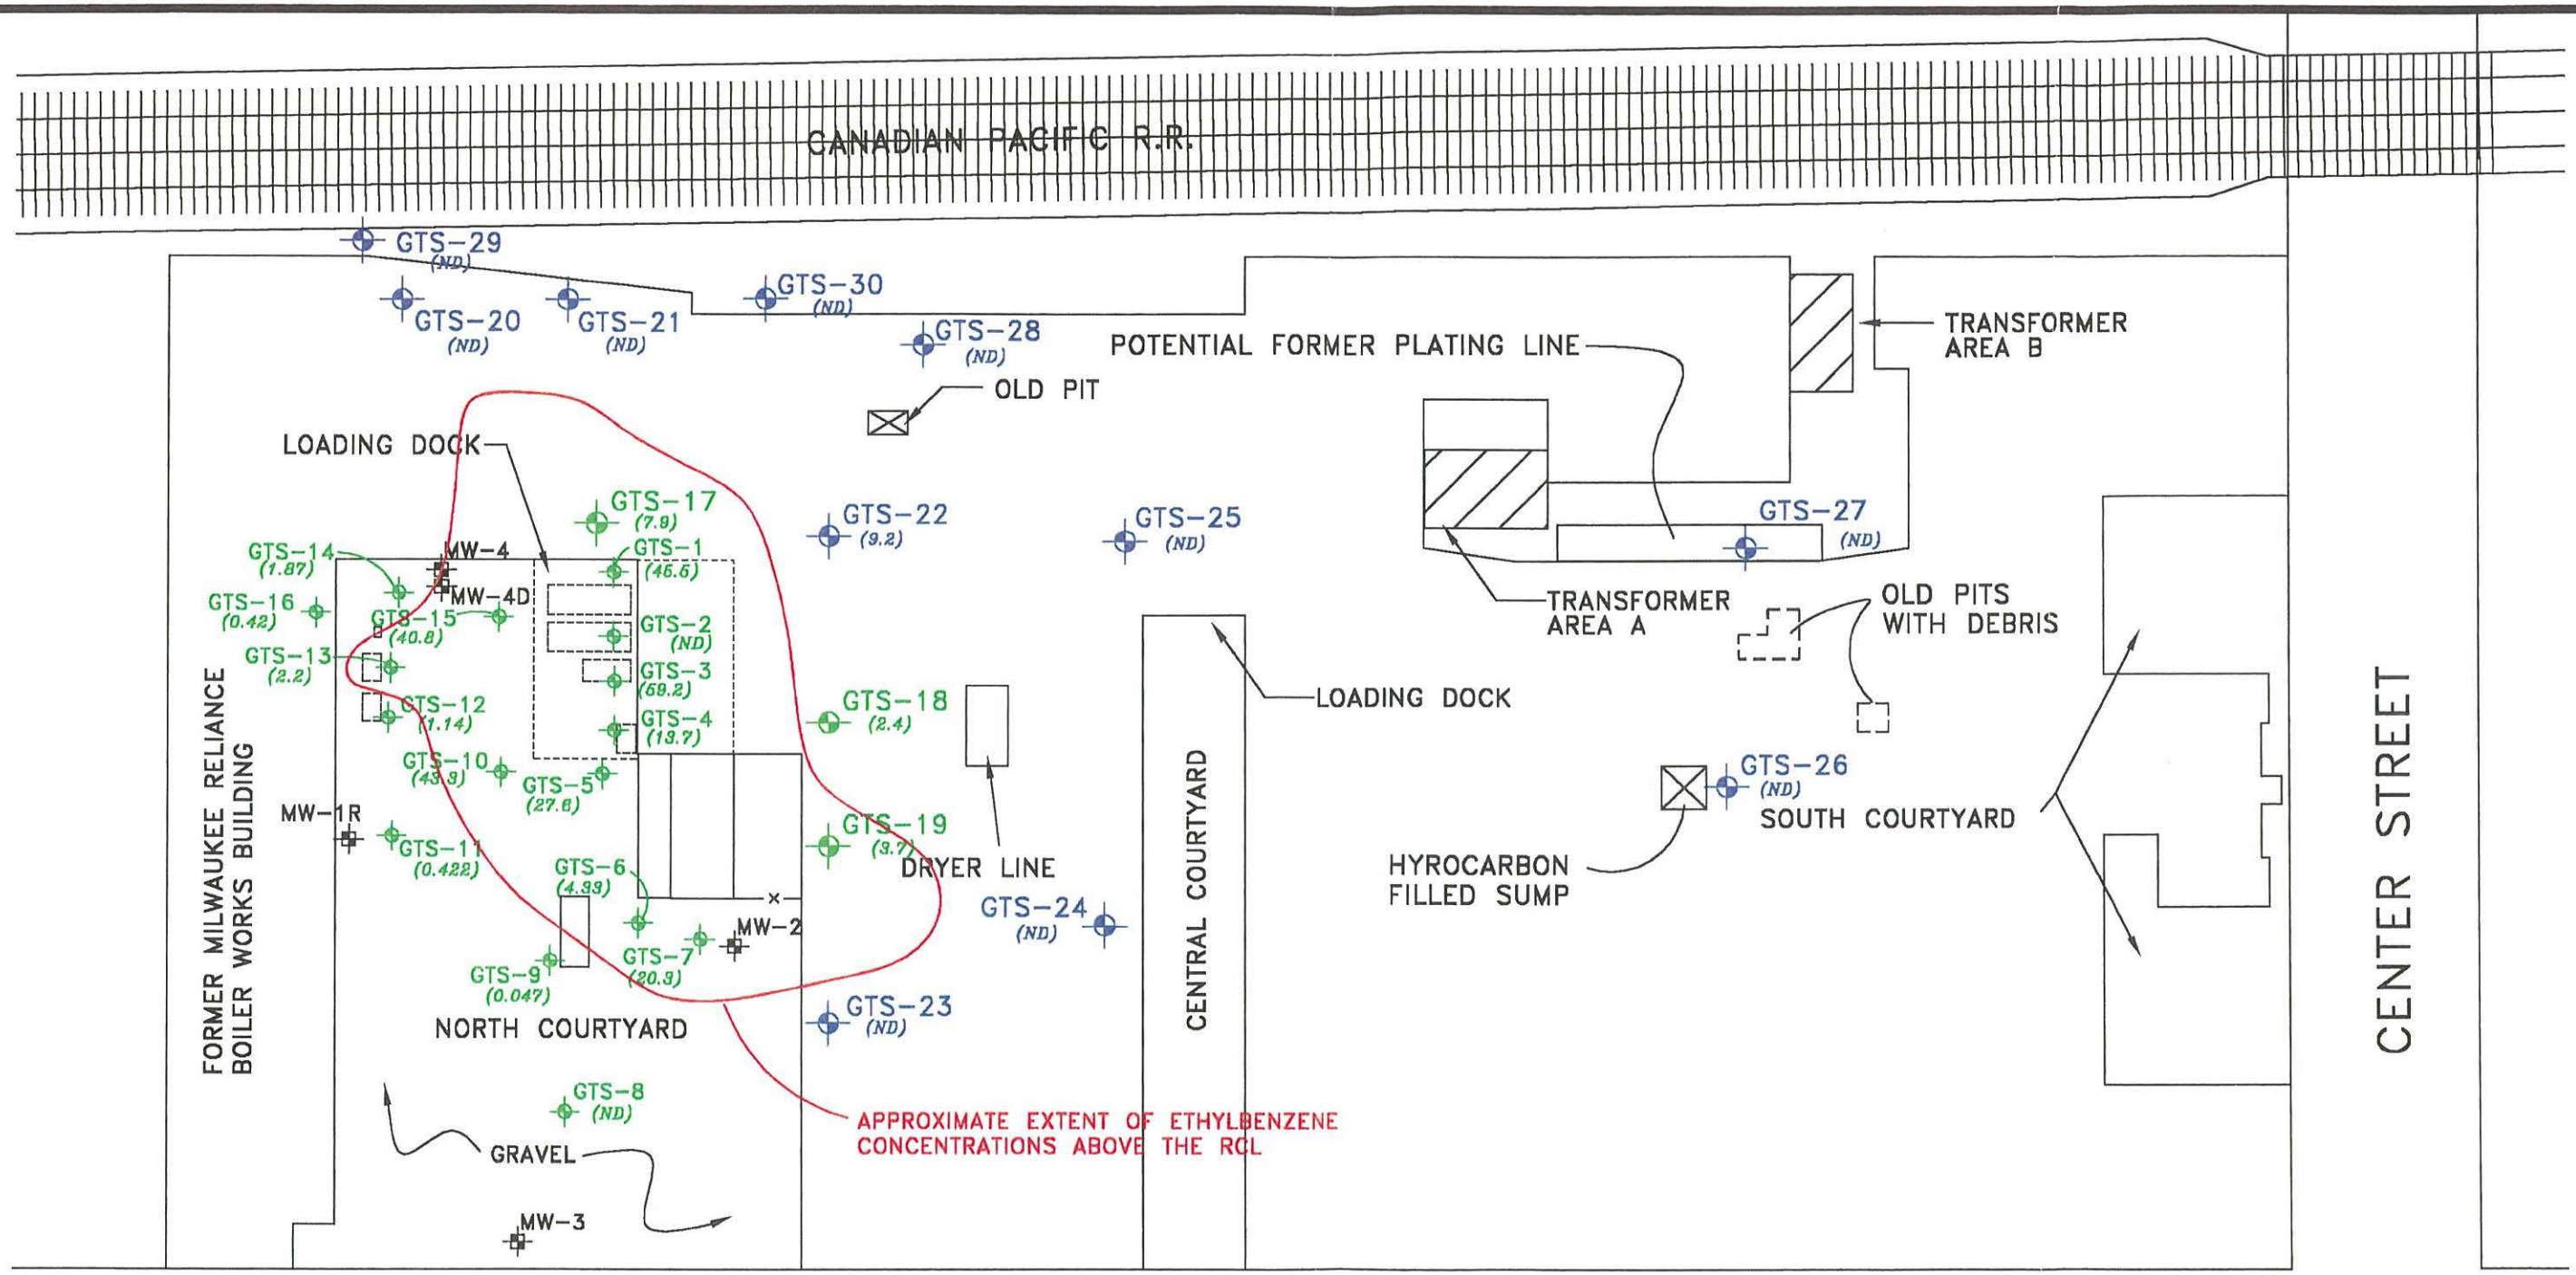
EXTENT OF ETHYLBENZENE SOIL IMPACT ABOVE RCL	
Phase II Site Investigation 2748 North 32nd Street Milwaukee, Wisconsin	
Scale: 1" = 50'	Date: May 15, 2002
KPR Project No. 11102	FIGURE 3-3

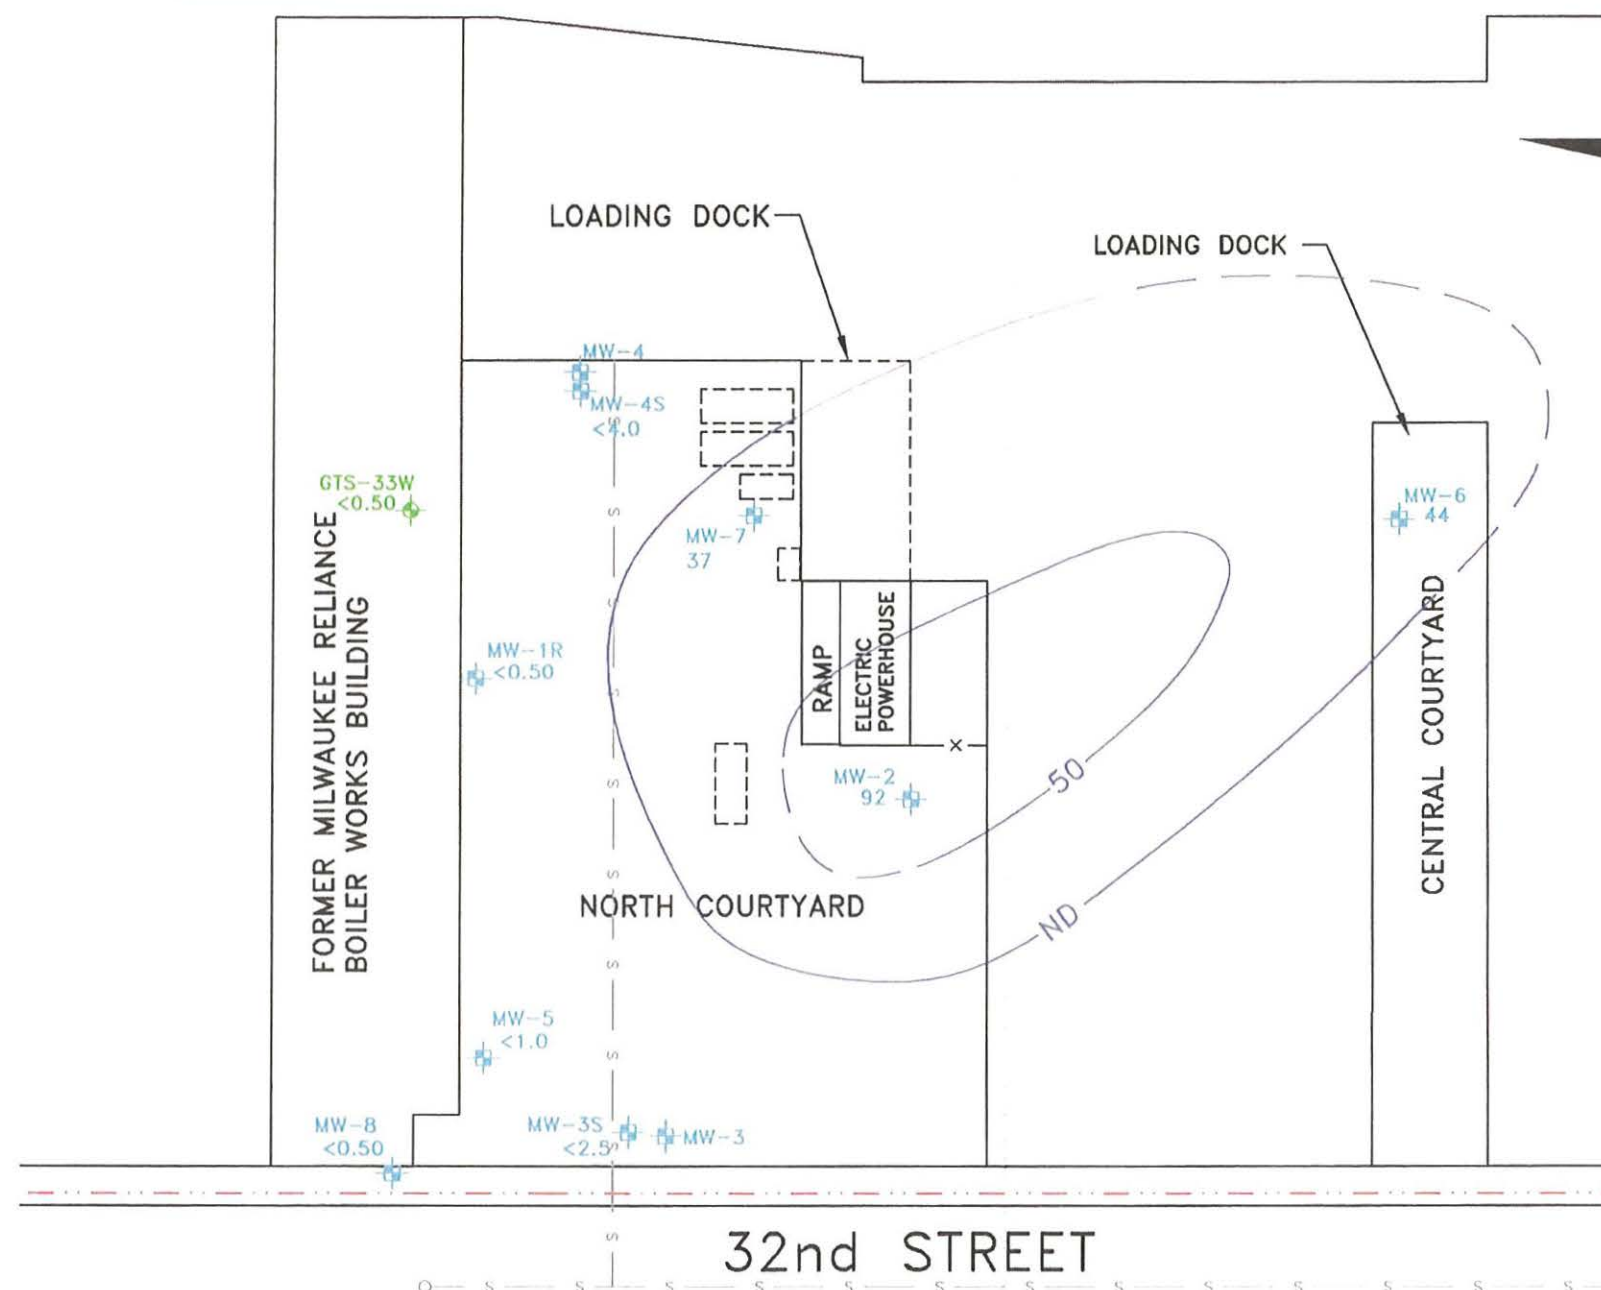
ENVIRONMENTAL CONSULTATION & REMEDIATION <h1 style="margin: 0;">K P R G</h1> <small>KPRG and Associates, Inc.</small>	GROUNDWATER ISOCONCENTRATION MAP VINYL CHLORIDE APRIL 2007	
	Former Briggs & Stratton Facility 2748 North 32nd Street Milwaukee, Wisconsin	
<small>414 Plaza Drive, Suite 106 Westmont, Illinois 60559 Telephone 630-325-1300 Facsimile 630-325-1593</small> <small>14665 West Lisbon Road, Suite 28 Brookfield, Wisconsin 53005 Telephone 262-781-0478 Facsimile 262-781-0478</small>	Scale: See Bar	Date: July 2, 2007
	KPRG Project No. 12703	FIGURE A10

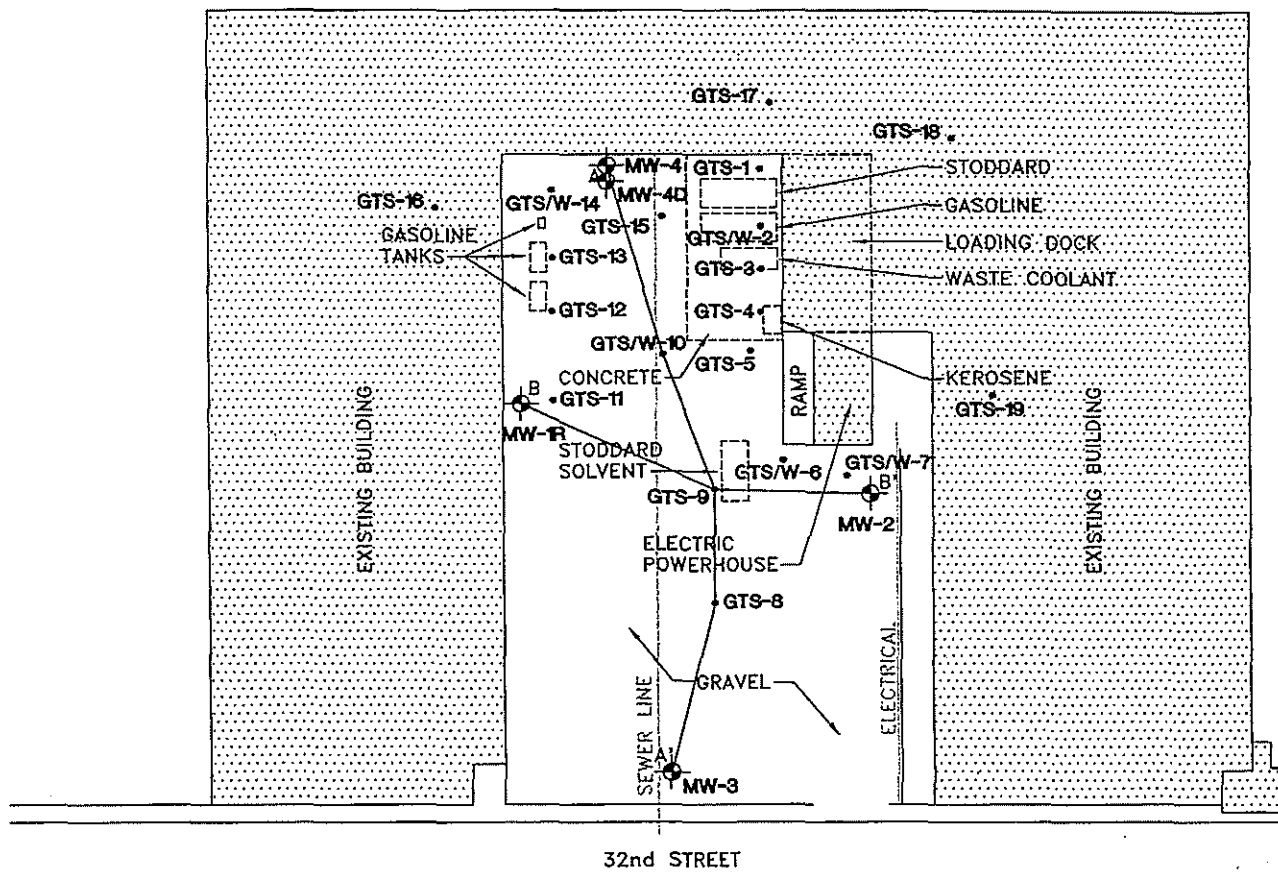
FORMER BRIGGS & STRATTON PLANT NORTH COURTYARD	DATE: 11/15/01
SITE LAYOUT NORTH COURTYARD	DESIGNED: RR
	CHECKED: RR
	APPROVED: RR
	DRAWN: HJU
	PROJ.: P625
