MEMORANDUM

SUBJECT : Weekly Progress Report for Week Ending 4/29/2023
Community Within the Corridor - East Block

COPY TO : Que El-Amin / Scott Crawford, Inc., Robert Reineke, PE, Robert Fedorchak, PE,
Project #40441B

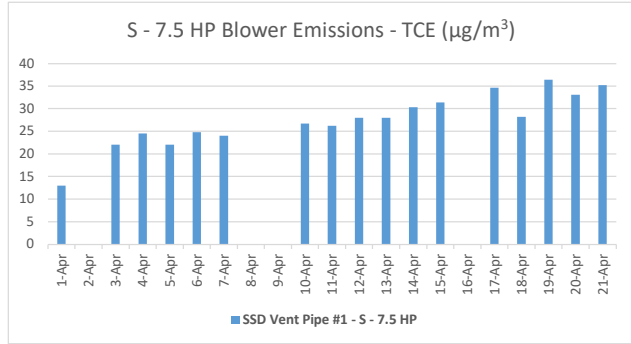
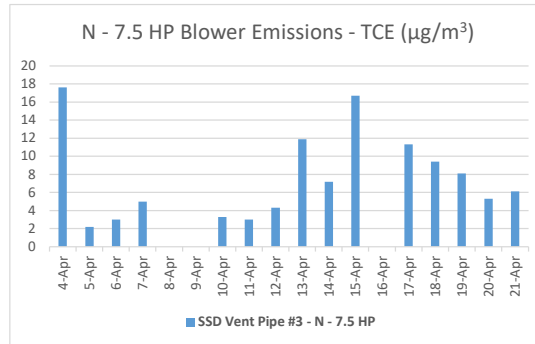
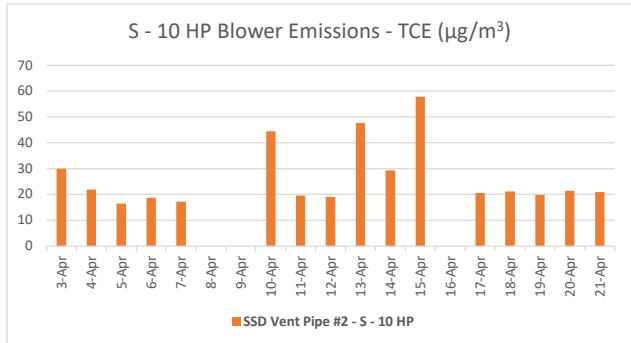
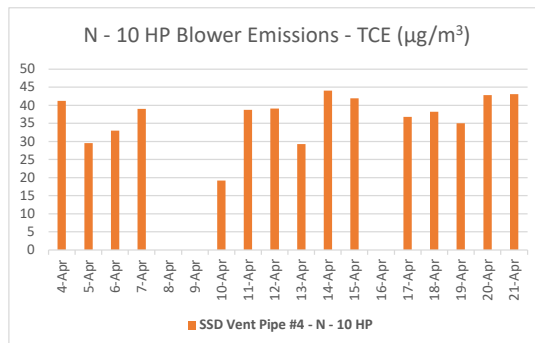
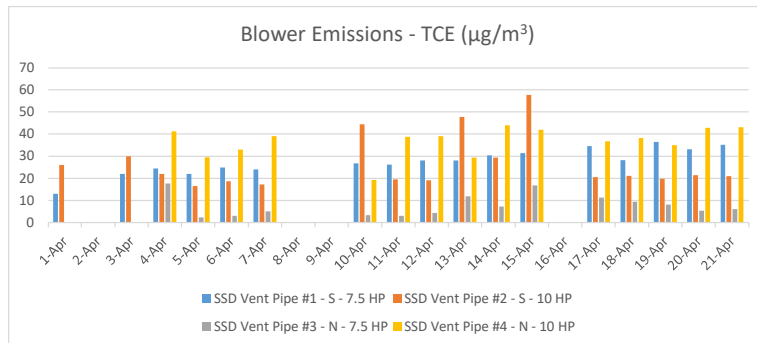
Table 8 - Comparative Blower Emissions

Sample Location	1-Apr	3-Apr	4-Apr	5-Apr	6-Apr	7-Apr	10-Apr	11-Apr	12-Apr	13-Apr	14-Apr	15-Apr	17-Apr	18-Apr	19-Apr	20-Apr	21-Apr
SSD Vent Pipe #1 - S - 7.5 HP	13	22	24.5	22	24.8	24	26.7	26.2	28	28	30.3	31.4	34.6	28.2	36.4	33.1	35.2
SSD Vent Pipe #2 - S - 10 HP	26	30	21.9	16.4	18.7	17.2	44.4	19.5	19	47.7	29.3	57.8	20.5	21.1	19.8	21.4	20.9
SSD Vent Pipe #3 - N - 7.5 HP			17.6	2.2	3	5	3.3	3	4.3	11.9	7.17	16.7	11.3	9.4	8.1	5.3	6.1
SSD Vent Pipe #4 - N - 10 HP			41.2	29.5	33	39	19.2	38.7	39.1	29.3	44	41.9	36.8	38.2	35	42.8	43.1

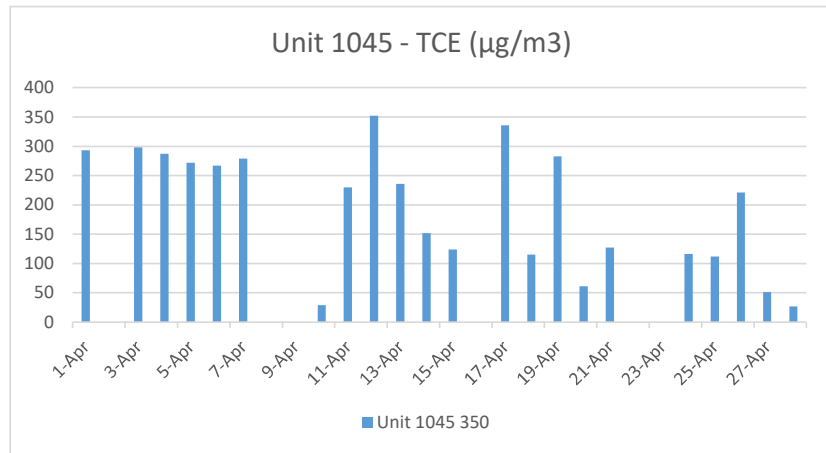
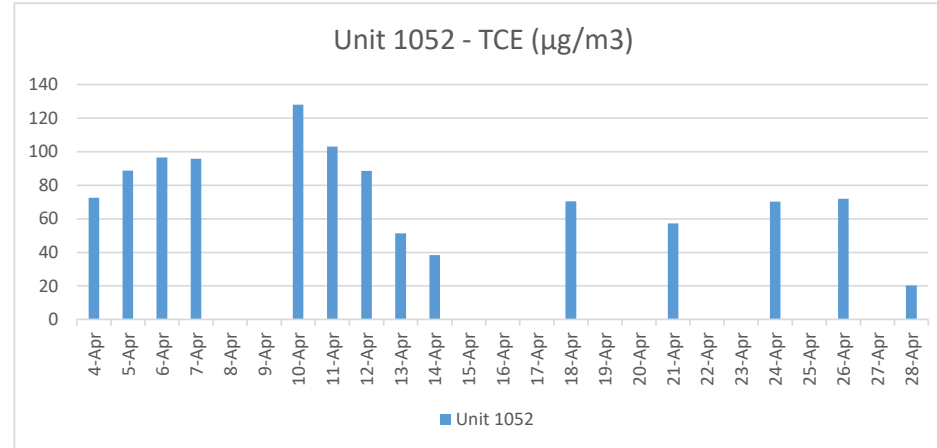
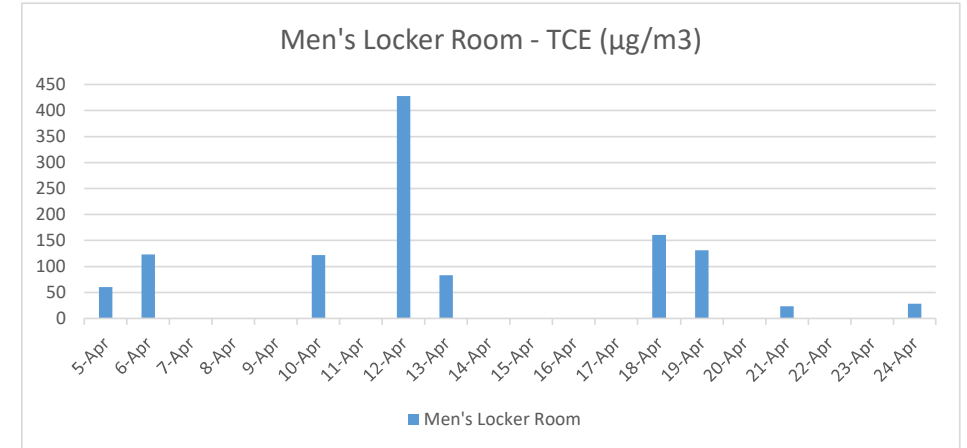
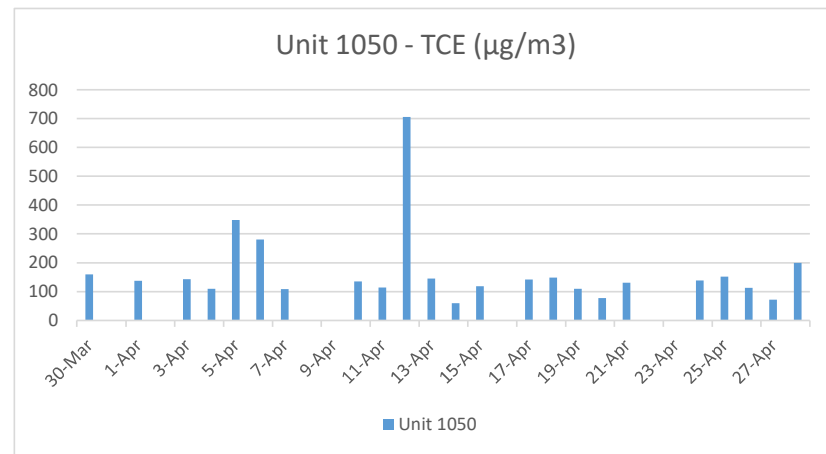
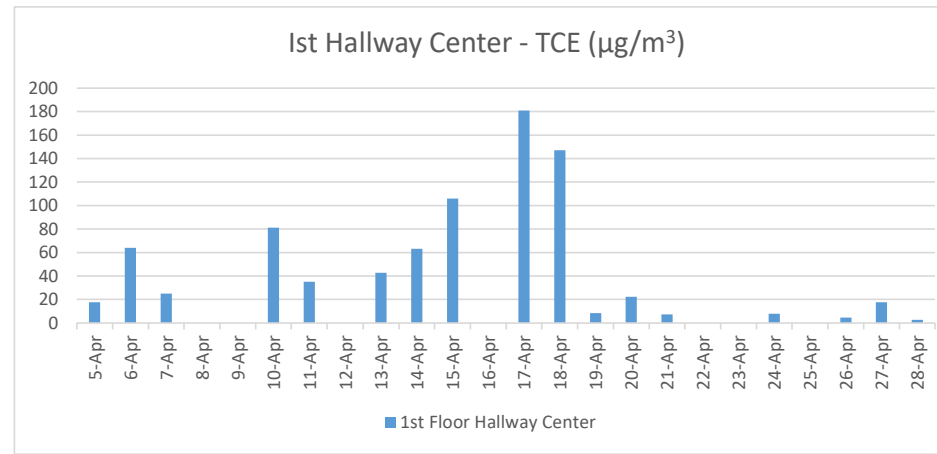
Table 9 - Comparative TCE Concentrations in Impacted Units

Sample Location	30-Mar	31-Mar	1-Apr	3-Apr	4-Apr	5-Apr	6-Apr	7-Apr	10-Apr	11-Apr	12-Apr	13-Apr	14-Apr	15-Apr	17-Apr	18-Apr	19-Apr	20-Apr	21-Apr	24-Apr	25-Apr	26-Apr	27-Apr	28-Apr
Unit 1045	350		293	298	287	272	267	279	28.9	230	352	236	151.5	124	336	115	283	61	127	116	112	221	51.3	26.6
Unit 1050	160		137	143	110	348	280	108	135	114	706	145	60	118	142	149	110	77.8	131	138	152	113	71.7	199
Unit 1052					72.5	88.7	96.6	95.7	128	103	88.6	51.4	38.4			70.5			57.2	70.3		72		20.2
1st Floor Hallway Center						17.7	64	25	81.1	35		42.7	63.3	106	181	147	8.5	22.4	7.4	7.8		4.7	17.7	2.7
Men's Locker Room						60.7	123		122		428	82.9				161	131		23.7	28.3
