## MEMORANDUM

SUBJECT : Weekly Progress Report for Week Ending 05/06/2023  
Community Within the Corridor - East Block

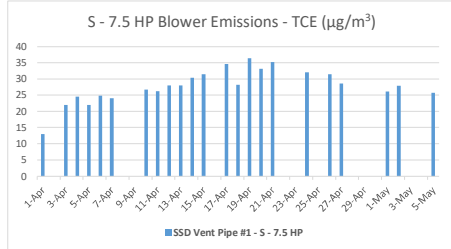
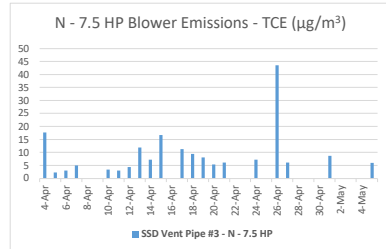
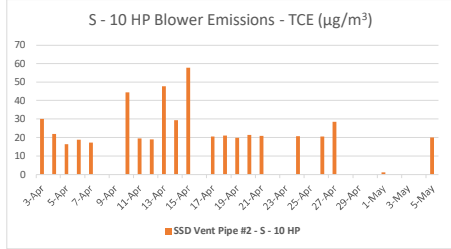
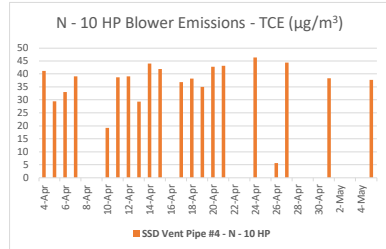
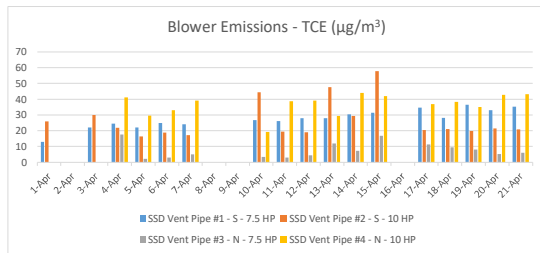
Table 8 - Comparative Blower Emissions

Sample Location	1-Apr	3-Apr	4-Apr	5-Apr	6-Apr	7-Apr	10-Apr	11-Apr	12-Apr	13-Apr	14-Apr	15-Apr	17-Apr	18-Apr	19-Apr	20-Apr	21-Apr	24-Apr	25-Apr	26-Apr	27-Apr	28-Apr	1-May	2-May	3-May	4-May	5-May
SSD Vent Pipe #1 - S - 7.5 HP	13	22	24.5	22	24.8	24	26.7	26.2	28	28	30.3	31.4	34.6	28.2	36.4	33.1	35.2	32		31.4	28.6		26.1	27.9			25.7
SSD Vent Pipe #2 - S - 10 HP	26	30	21.9	16.4	18.7	17.2	44.4	19.5	19	47.7	29.3	57.8	20.5	21.1	19.8	21.4	20.9	20.7		20.6	28.5		1.2				20
SSD Vent Pipe #3 - N - 7.5 HP			17.6	2.2	3	5	3.3	3	4.3	11.9	7.17	16.7	11.3	9.4	8.1	5.3	6.1	7.2		43.5	6.1		8.6				5.9
SSD Vent Pipe #4 - N - 10 HP			41.2	29.5	33	39	19.2	38.7	39.1	29.3	44	41.9	36.8	38.2	35	42.8	43.1	46.3		5.7	44.4		38.3				37.7

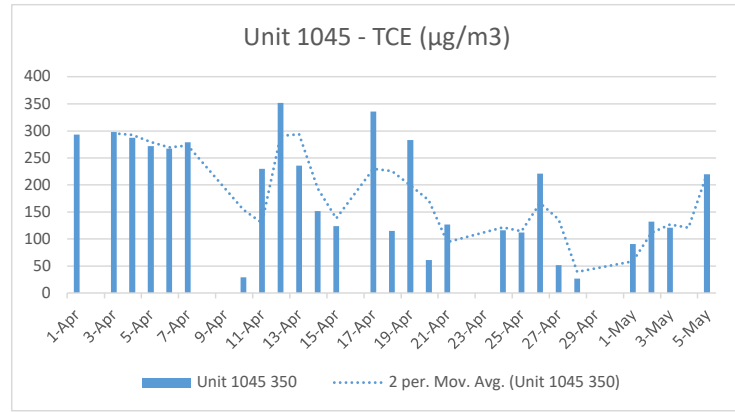
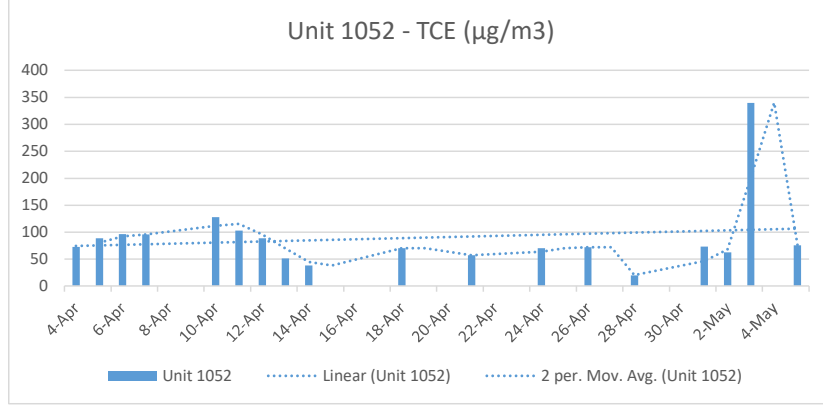
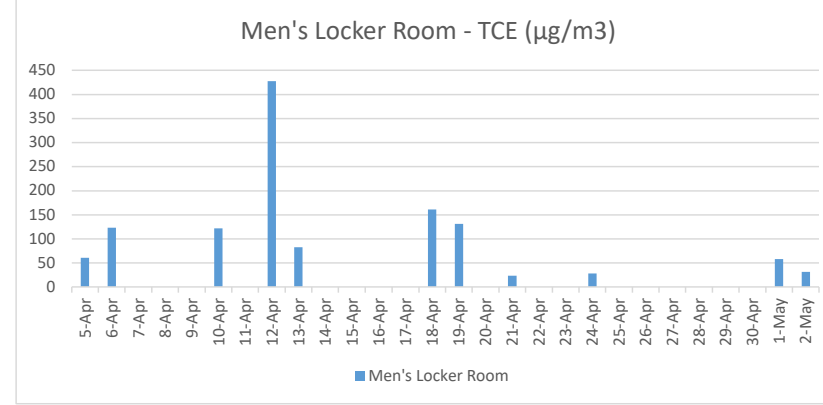
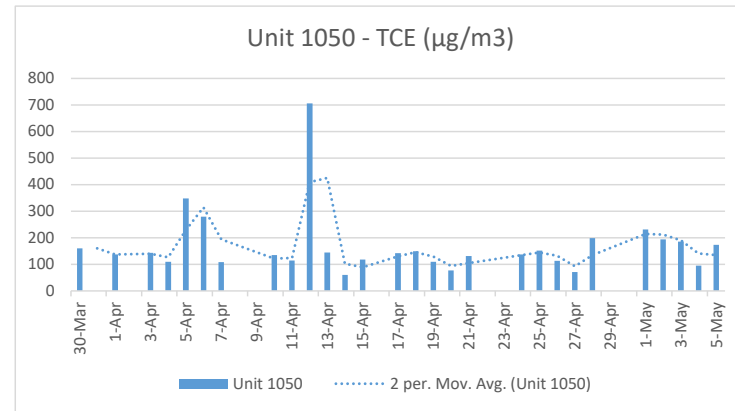
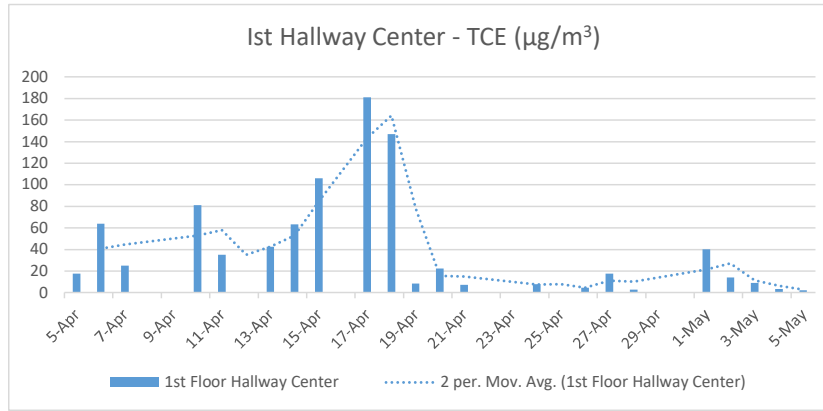
Table 9 - Comparative TCE Concentrations in Impacted Units

Sample Location	30-Mar	31-Mar	1-Apr	3-Apr	4-Apr	5-Apr	6-Apr	7-Apr	10-Apr	11-Apr	12-Apr	13-Apr	14-Apr	15-Apr	17-Apr	18-Apr	19-Apr	20-Apr	21-Apr	24-Apr	25-Apr	26-Apr	27-Apr	28-Apr	1-May	2-May	3-May	4-May	5-May	
Unit 1045	350		293	298	287	272	267	279	28.9	230	352	236	151.5	124	336	115	283	61	127	116	112	221	283	51.3	26.6	90.3	132	121	4-May	220
Unit 1050	160		137	143	110	348	280	108	135	114	706	145	60	118	142	149	110	77.8	131	138	152	113	71.7	199	231	194	186	95.5	174	
Unit 1052					72.5	88.7	96.6	95.7	128	103	88.6	51.4	38.4							57.2	70.3		72		20.2	73.6	62.6	340	76	
1st Floor Hallway Center						17.7	64	25	81.1	35		42.7	63.3	106	181	147	8.5	22.4	7.4	7.8		4.7	17.7	2.7	40.3	14	9	3.5	2.3	
Men's Locker Room						60.7	123		122		428	82.9				161	131		23.7	28.3					58	31.6
