From: Chase Kresl <ckresl@reiengineering.com>
Sent: Thursday, May 11, 2023 4:14 PM
To: Schrank, Jayson S - DNR
Subject: RE: BRRTS #02-37-589640 Former Mall Parking Facility #1 Remaining Actions Needed
Attachments: B.2.b.pdf; B.3.a.pdf; MW-1A.pdf; MW-2A.pdf; 4400-202 printed.pdf; B.2.a.pdf
Follow Up Flag: Follow up
Flag Status: Flagged

Site Information			
BRRTS No.	VPLE No.		
02-37-589640			
Parcel ID No.	291-2907-362-0284, 291-2907-362-0243		
FID No.	WTM Coordinates		
737258060	X 549,231	Y 498,311	
BRRTS Activity (Site) Name	WTM Coordinates Represent:		
Former Mall Parking Facility #1	<input checked="" type="checkbox"/> Source Area <input checked="" type="checkbox"/> Parcel Center		
Site Address	City	State	ZIP Code
120 Forest Street	Wausau	WI	54403
Acres Ready For Use	0.5

FORMER MALL PARKING FACILITY #
102 FOREST STREET
WAUSAU, WI 54403

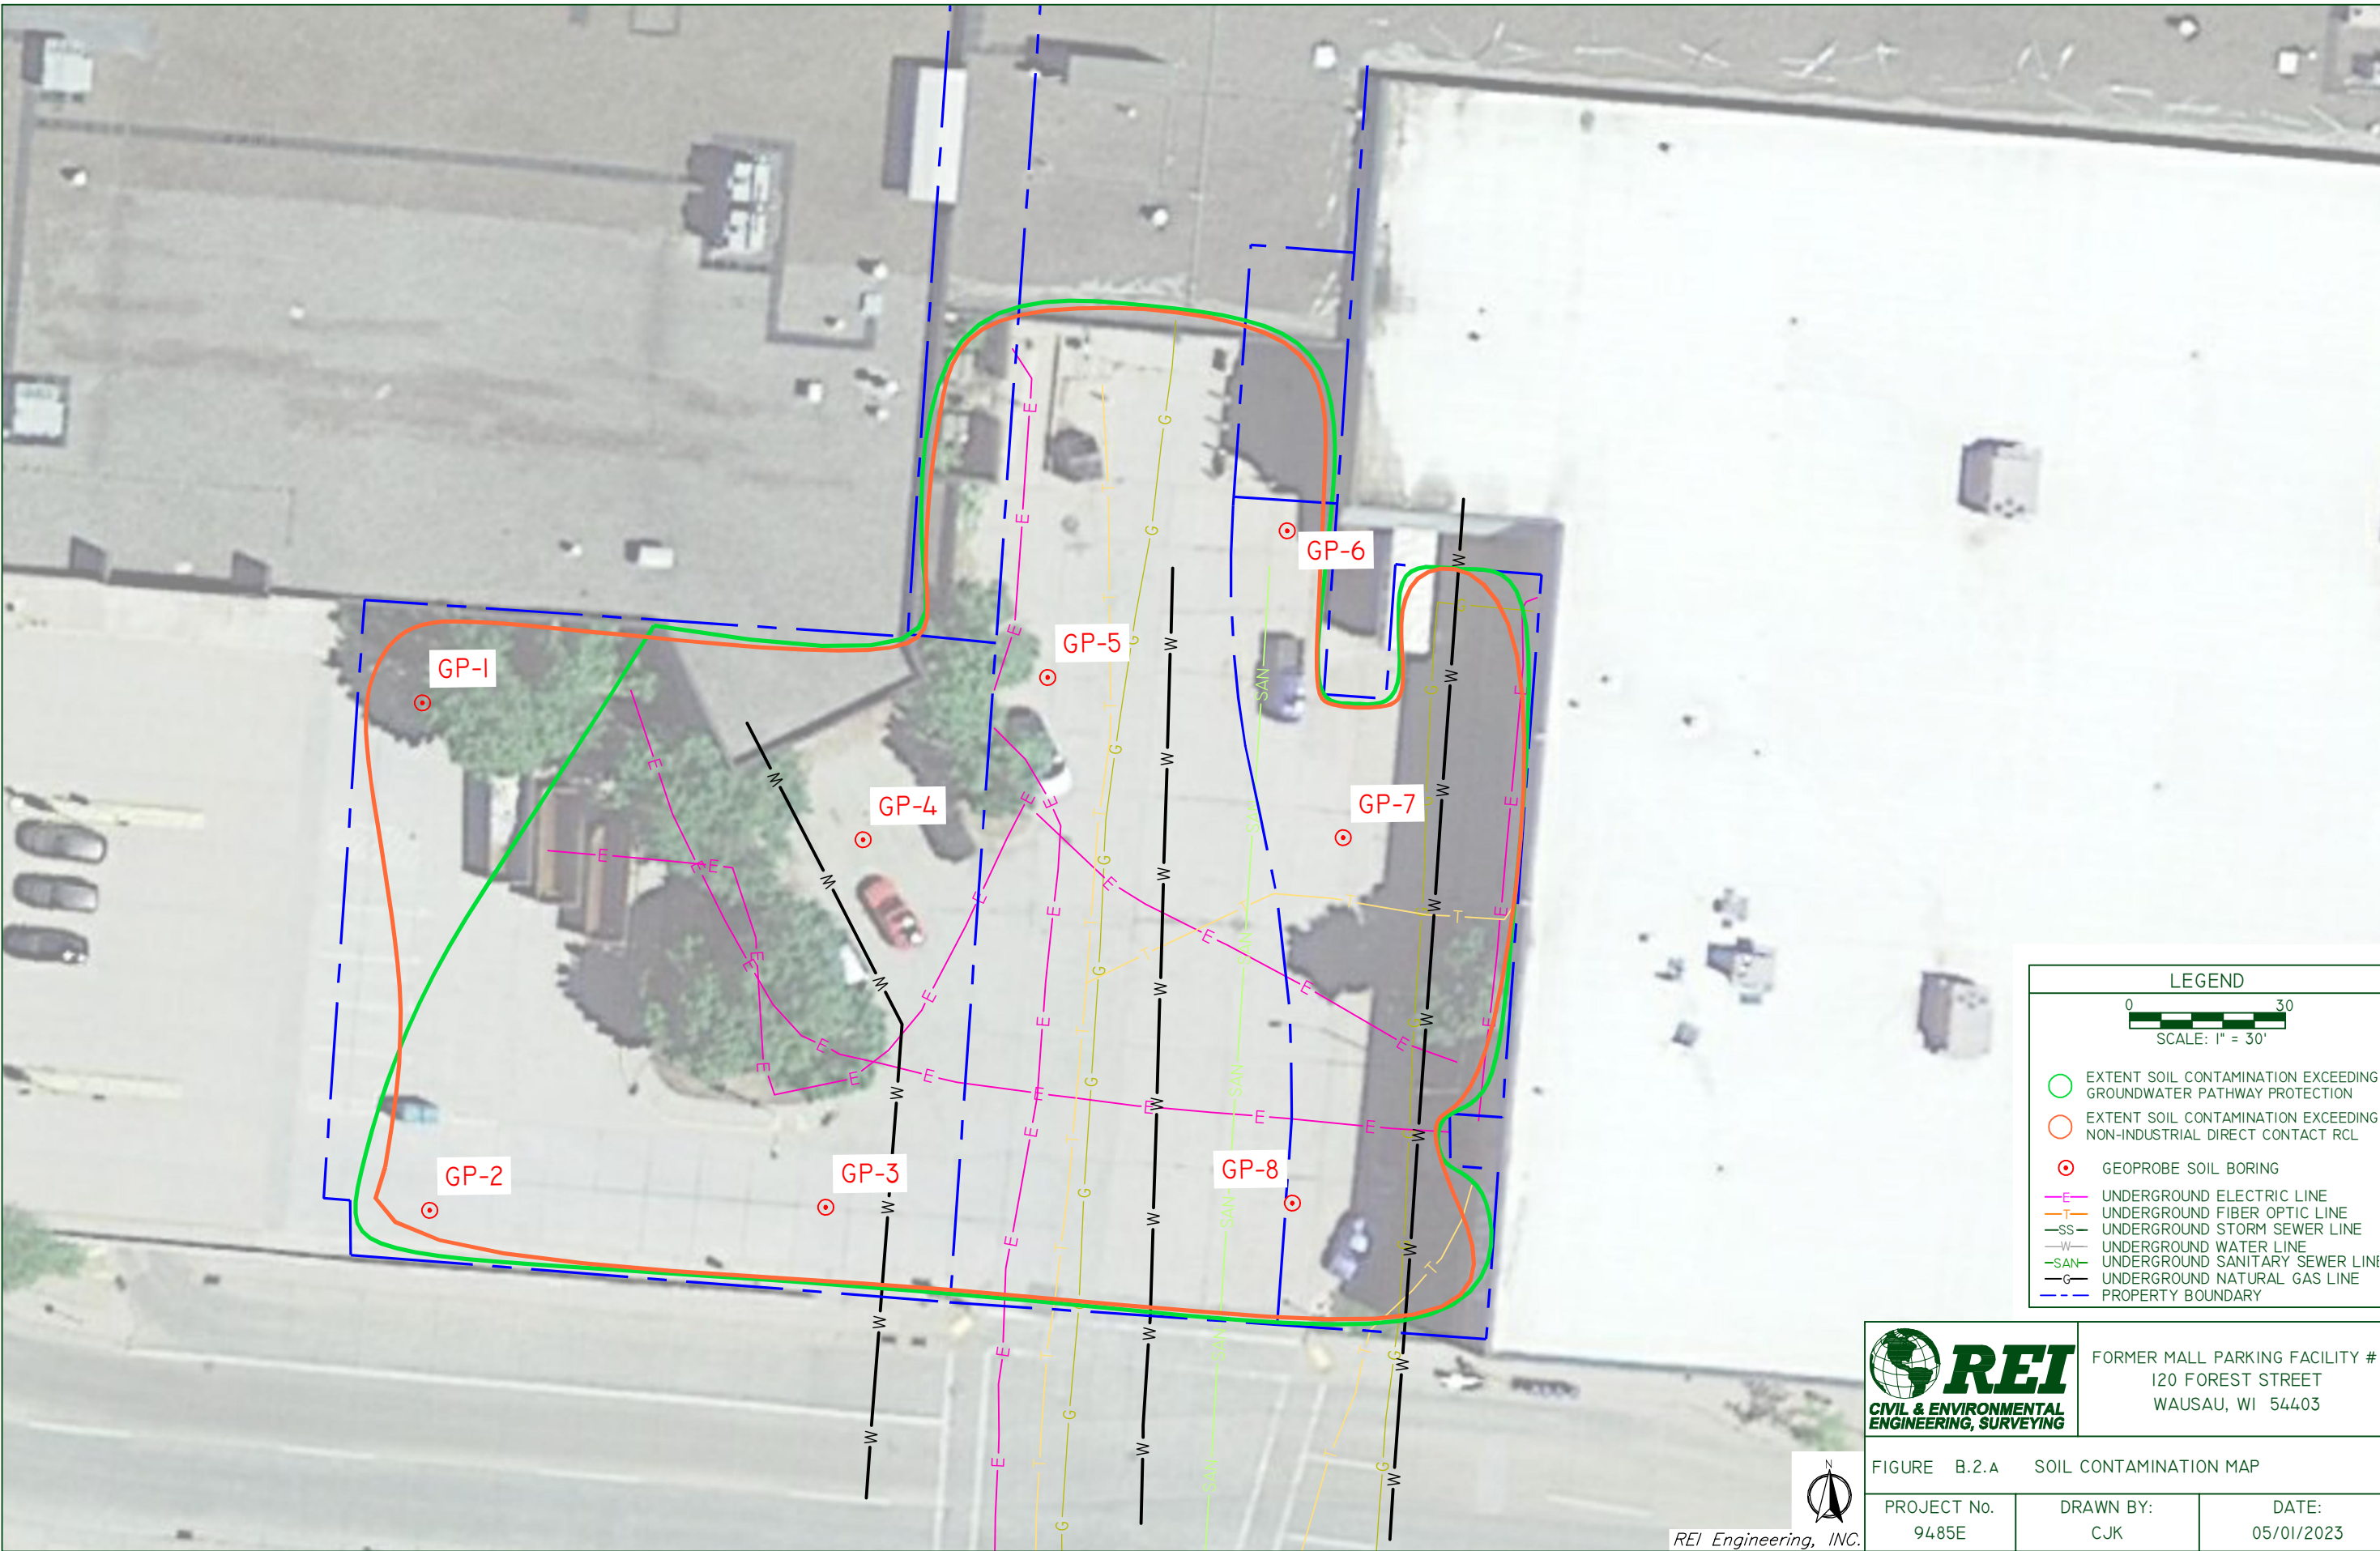
DRAWING FILE: P:\194,00-9499\19485E - WAUSAU MALL\Drawings\194,85E-Boring Location Map.DWG LAYOUT: OUTLOT SOIL PLOTTED BY: CHASEK MAY 01, 2023 - 2:03PM

0 30
SCALE: 1" = 30'

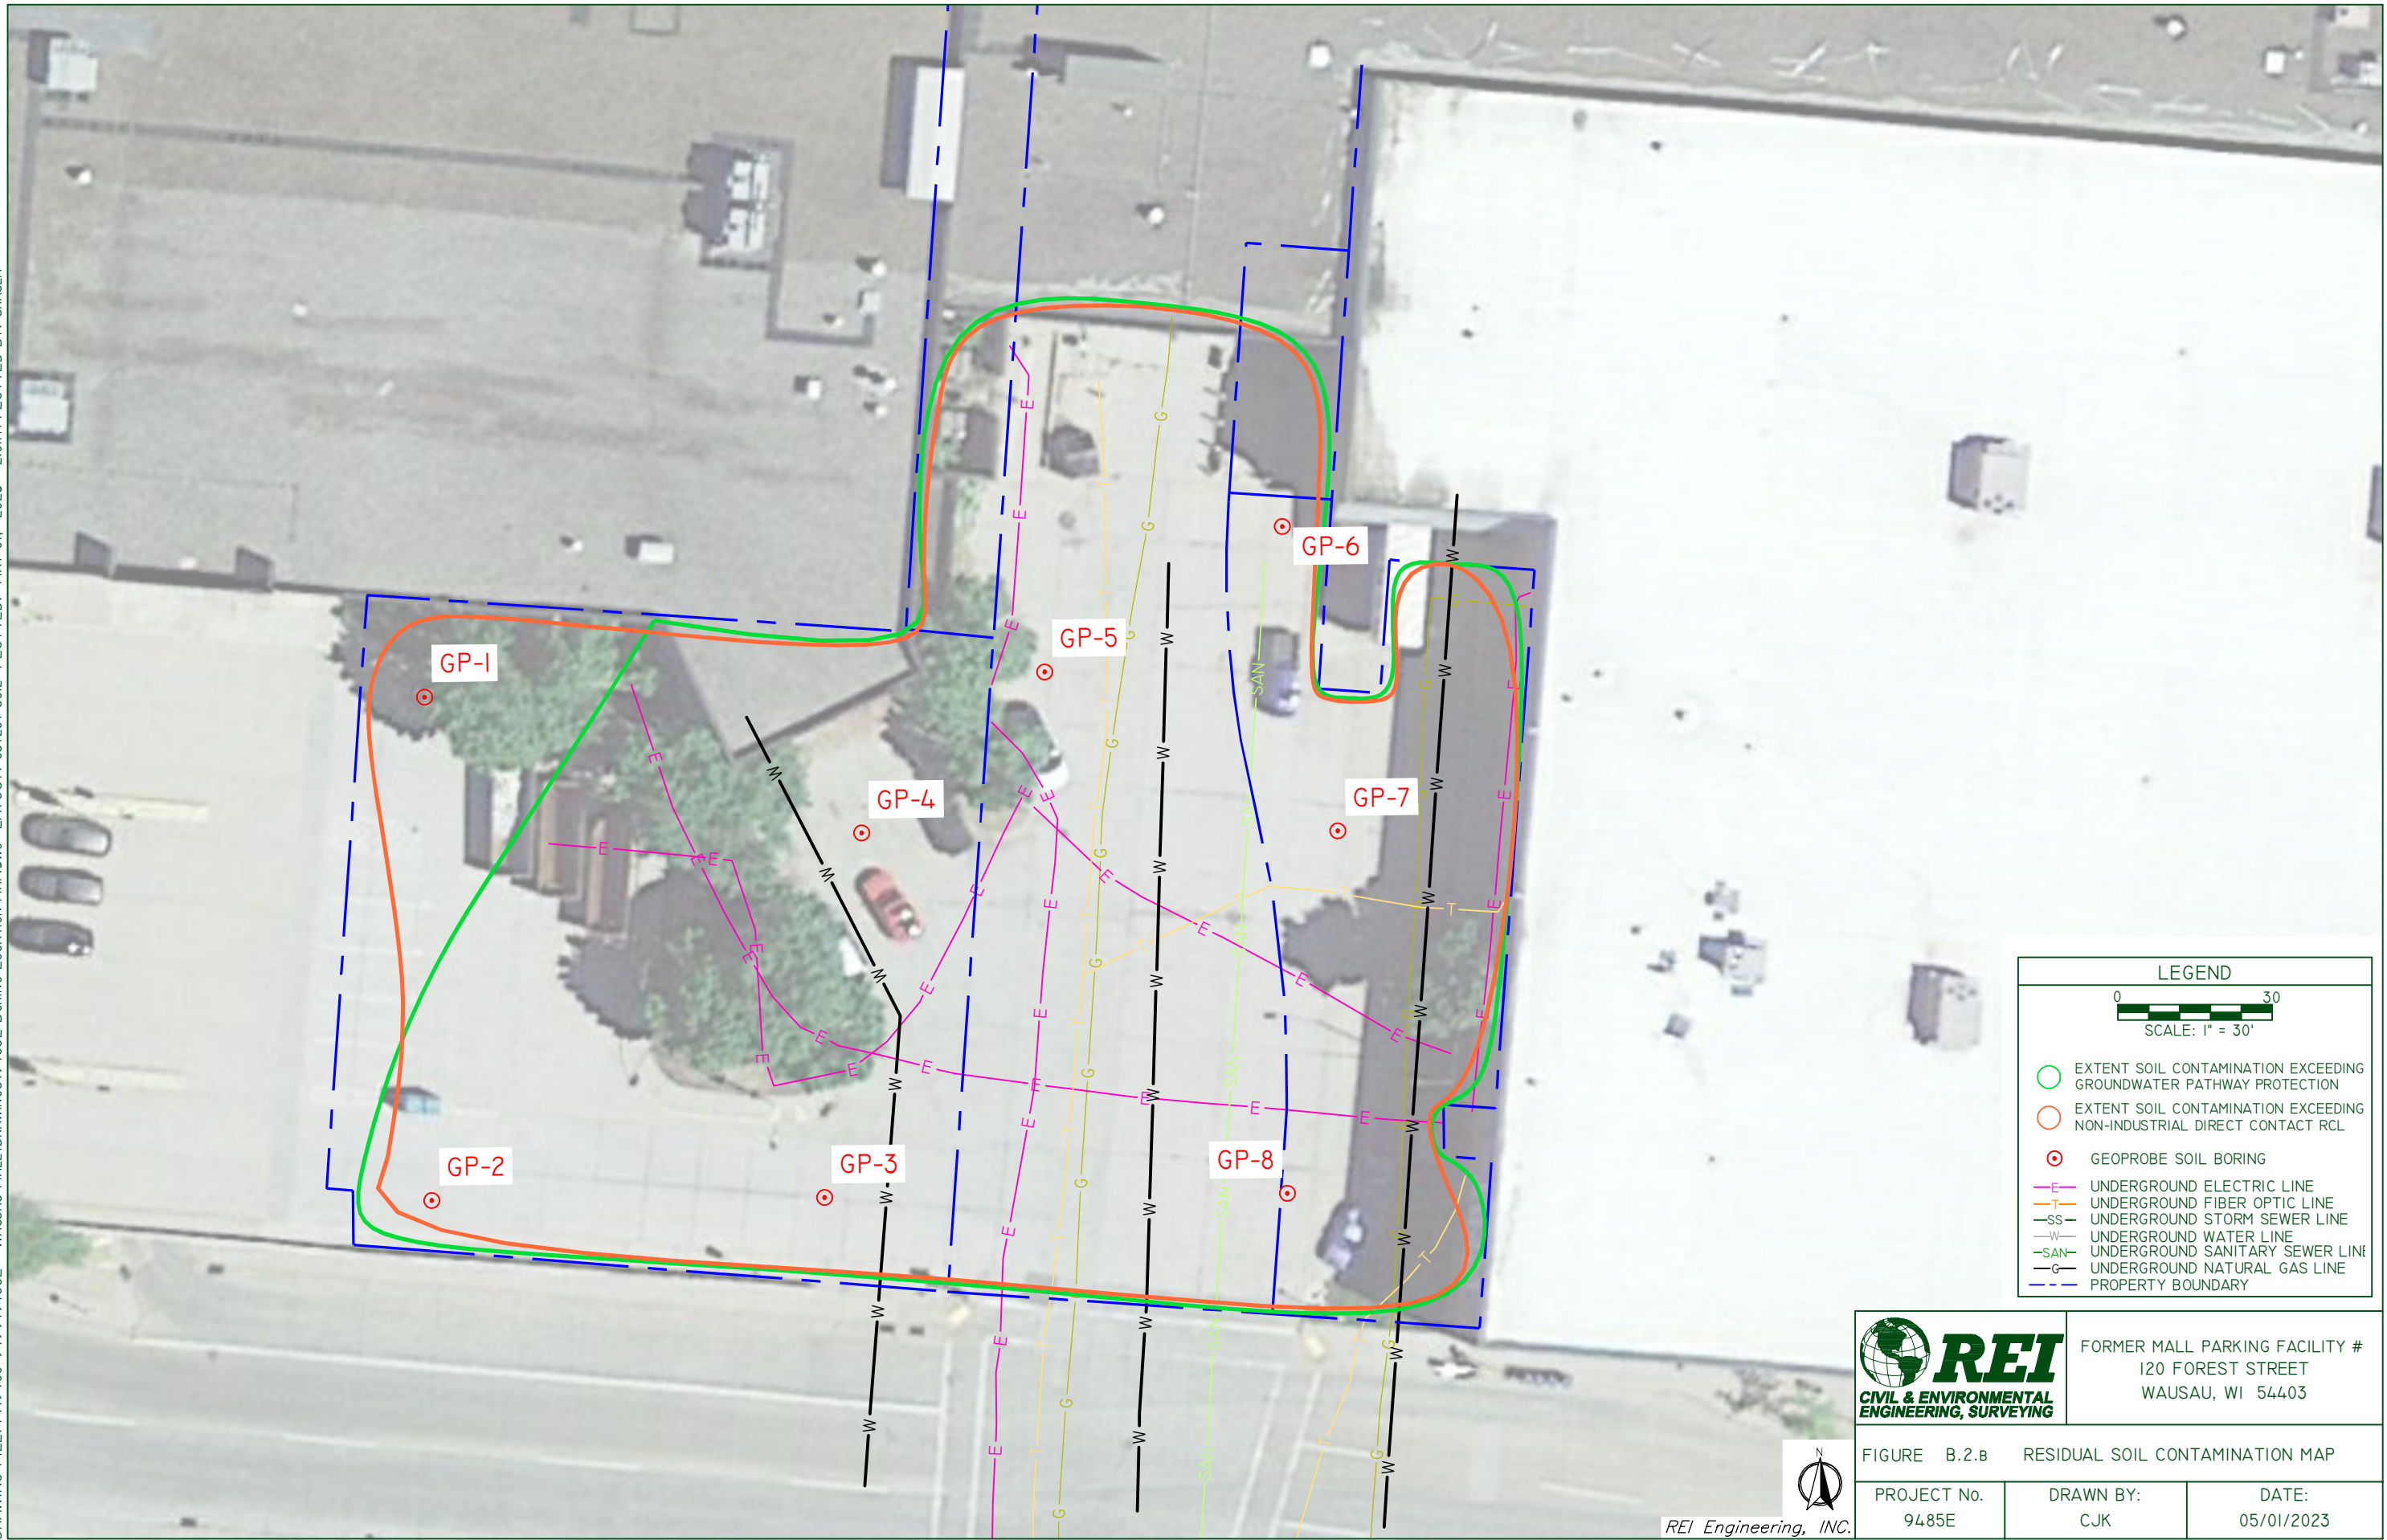
DRAWING FILE: P:\94.00-9499\9485E - WAUSAU MALL\Drawings\94.85E-Boring Location Map.DWG LAYOUT: OUTLOT SOIL PLOTTED BY: CHASEK

0 30
SCALE: 1" = 30'
