SUBJECT: Case Closure with Continuing Obligations
Former Mall Parking Facility #1, 120 Forest Street, Wausau, WI 54403
BRRTS #: 02-37-589640

FIGURE B.2.B RESIDUAL SOIL CONTAMINATION MAP		
PROJECT No. 9485E	DRAWN BY: CJK	DATE: 05/01/2023

FIGURE B.3.B GROUNDWATER ISOCONCENTRATION MAP

COVER or BARRIER MAINTENANCE PLAN
(to be included in Form 4400-202, as Attachment D)

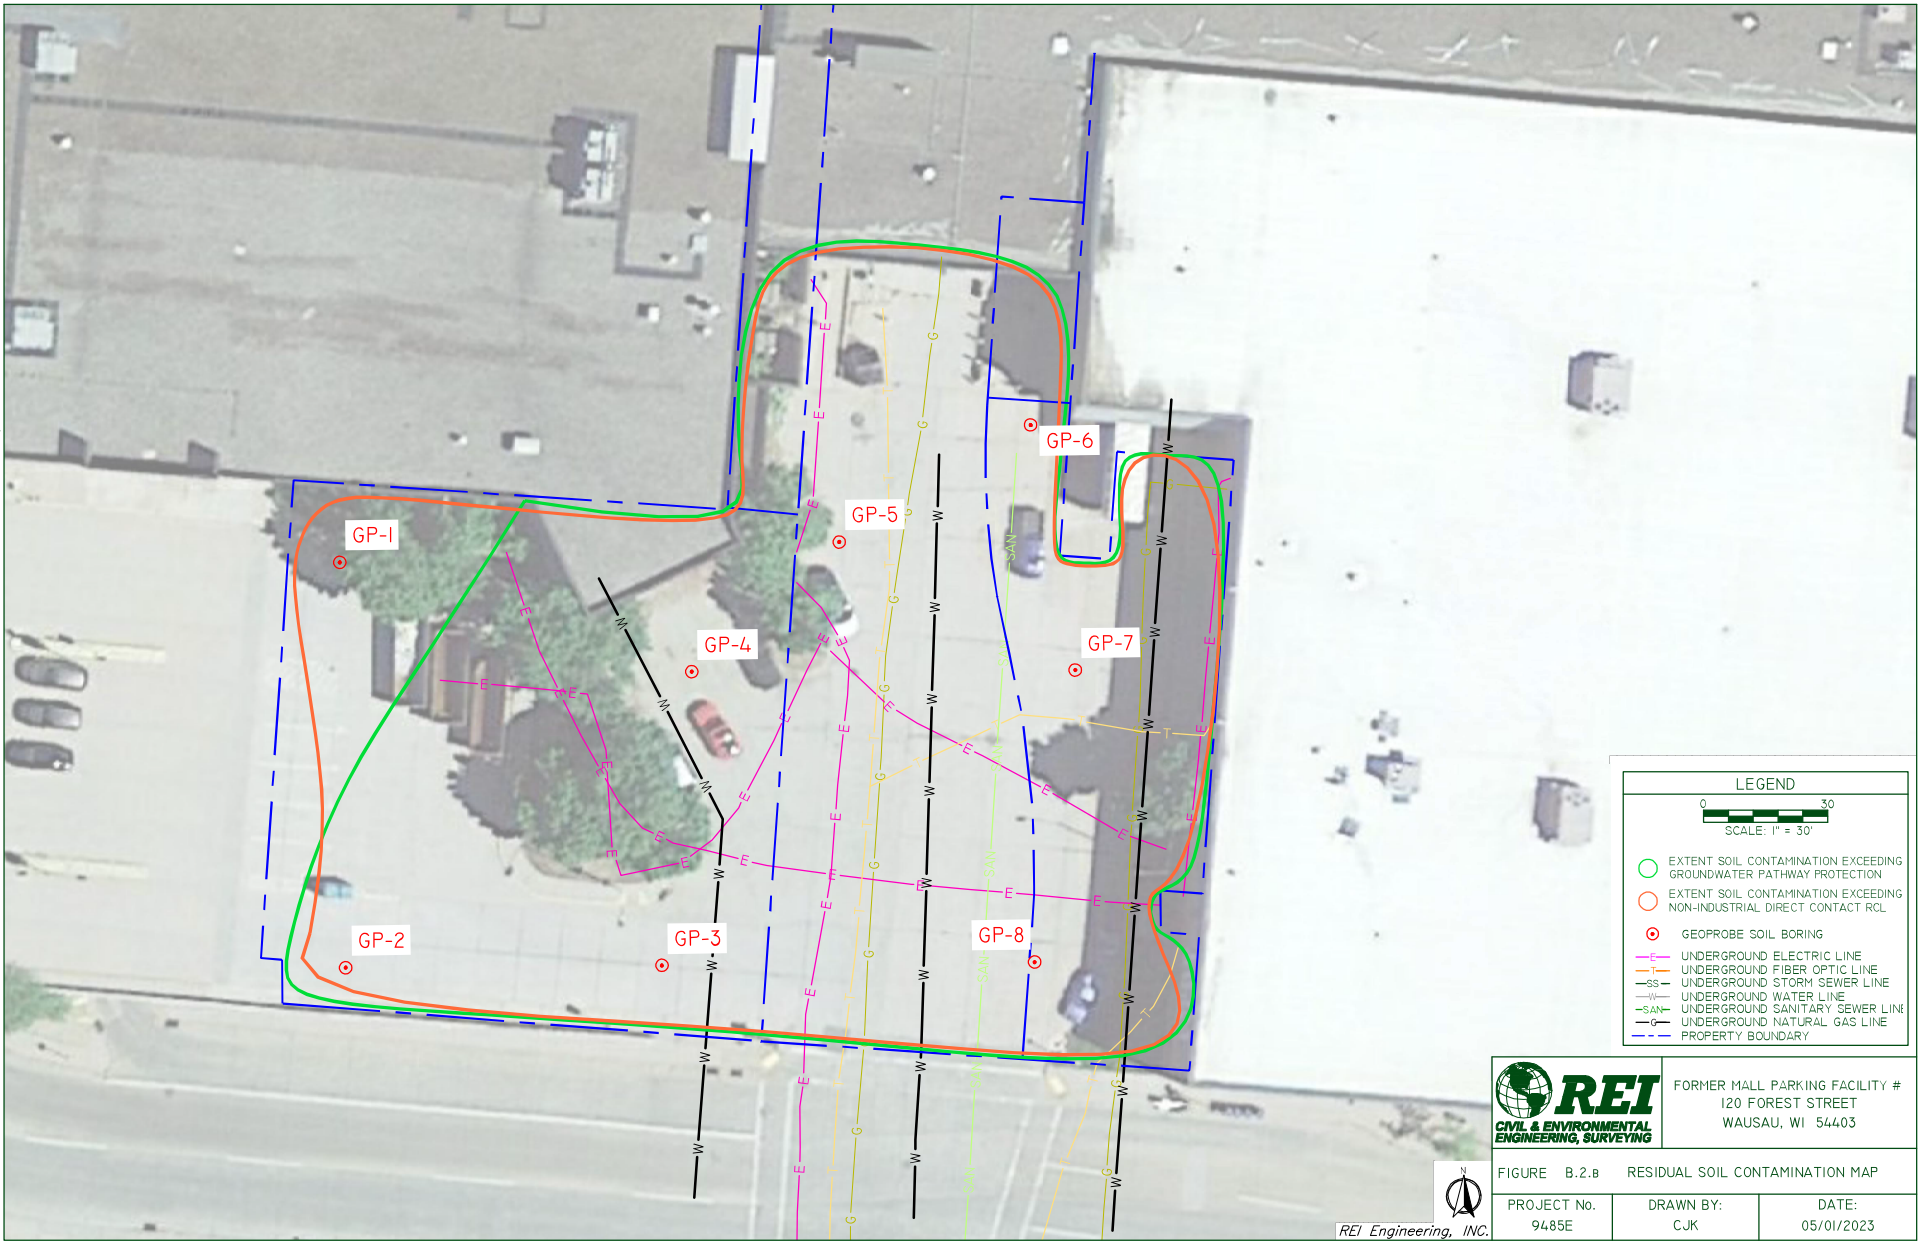
- EXTENT SOIL CONTAMINATION EXCEEDING GROUNDWATER PATHWAY PROTECTION
- EXTENT SOIL CONTAMINATION EXCEEDING NON-INDUSTRIAL DIRECT CONTACT RCL
- ⊙ GEOPROBE SOIL BORING
- E— UNDERGROUND ELECTRIC LINE
- T— UNDERGROUND FIBER OPTIC LINE
- SS— UNDERGROUND STORM SEWER LINE
- W— UNDERGROUND WATER LINE
- SAN— UNDERGROUND SANITARY SEWER LINE
- G— UNDERGROUND NATURAL GAS LINE
- PROPERTY BOUNDARY

Soil contamination remains as indicated on the enclosed map (Figure B.2.b., Residual Soil Contamination, 5/1/23). If soil in the location(s) shown on the map is excavated in the future, the property owner or right of way holder at the time of excavation must sample and analyze the excavated soil. If sampling confirms that contamination is present, the property owner or right of way holder at the time of excavation will need to determine if the material is considered solid waste and ensure that any storage, treatment or disposal complies with applicable standards and rules. Contaminated soil may be managed under Wis. Admin. Code ch. NR 718 with prior DNR approval.

Laboratory analytical results revealed detections of several compounds in exceedance of NR720 Direct Contact and Groundwater Pathway Protection RCLs in site soil. Compounds exceeding Direct Contact standards were all PAHs, with Benzo(a)anthracene, Benzo(a)pyrene, Benzo(b)fluoranthene, Dibenz(a,h)anthracene, and Indeno(1,2,3-cd)pyrene commonly detected in the borings. In total, the Non-Industrial Direct Contact RCL was exceeded in eleven (11) of the collected samples from all eight (8) of the advanced geoprobe borings. Non-Industrial Direct Contact RCL exceedances were noted within four (4) feet of the ground surface in all boring locations except GP-2, which was advanced near the southwest corner of the site.

Dibenz(a,h)anthracene exceeded the Direct Contact RCL in two (2) locations, naphthalene exceeded the Direct Contact RCL in one (1) location, and lead exceeded the Direct Contact RCL in one (1) location. Exceedances of the Direct Contact RCL were noted primarily in borings advanced near the center and west side of the property.

Exceedances of NR720 Groundwater Pathway Protection RCLs were also primarily PAHs. Benzo(a)pyrene, Benzo(b)fluoranthene, and Chrysene were detected in exceedance of the Groundwater Pathway Protection RCL each of the borings except GP-1, which was advanced near the northwest corner of the site. These exceedances were also preferentially noted in shallower sample locations. Tetrachloroethene was the only non-PAH compound detected above state standards. Tetrachloroethene was reported above the Groundwater Pathway Protection RCL in three (3) sample locations which were collected from two (2) borings. The samples were collected within six (6) feet of the ground surface from borings GP-7 and GP-8, which were advanced on the east side of the site.

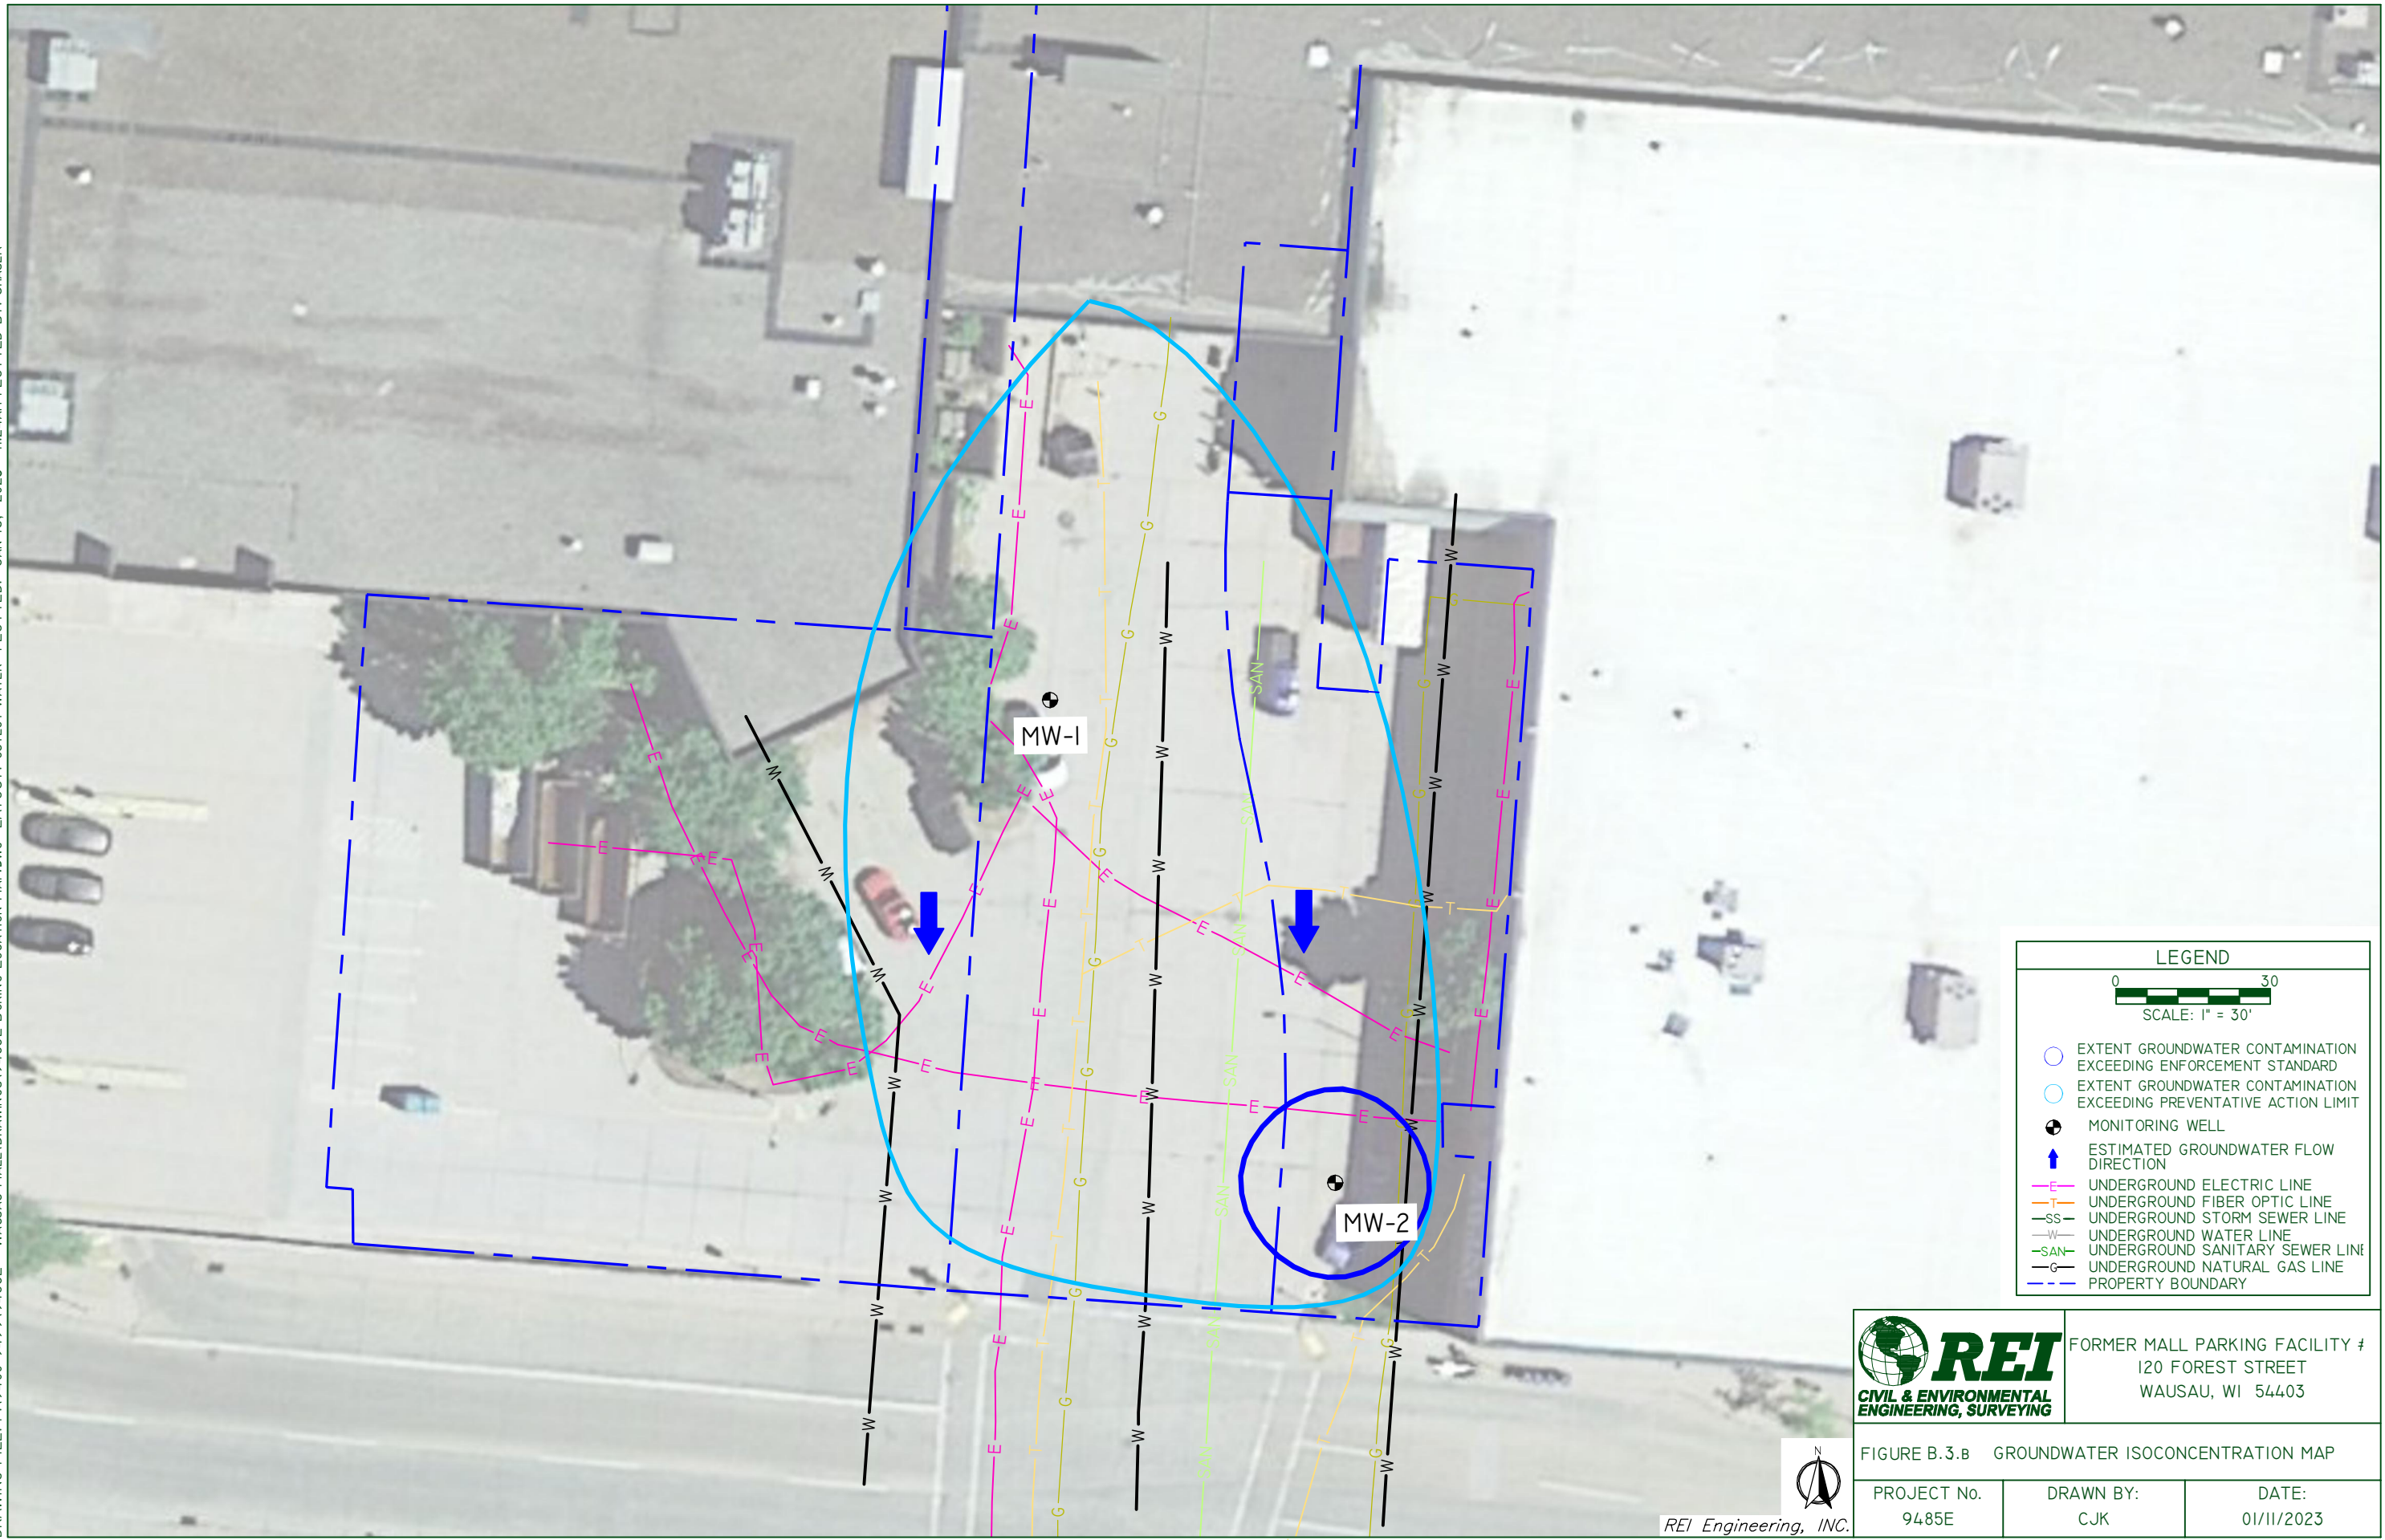
- EXTENT GROUNDWATER CONTAMINATION EXCEEDING ENFORCEMENT STANDARD
- EXTENT GROUNDWATER CONTAMINATION EXCEEDING PREVENTATIVE ACTION LIMIT
- MONITORING WELL
- ESTIMATED GROUNDWATER FLOW DIRECTION
- UNDERGROUND ELECTRIC LINE
- UNDERGROUND FIBER OPTIC LINE
- UNDERGROUND STORM SEWER LINE
- UNDERGROUND WATER LINE
- UNDERGROUND SANITARY SEWER LINE
- UNDERGROUND NATURAL GAS LINE
- PROPERTY BOUNDARY

Groundwater contamination which equals or exceeds the enforcement standards for VOCs, PAHs and RCRA metals is present as shown on the enclosed map (Figure B.3.b., Groundwater Isoconcentration Map, 01/11/2023). To construct a new well or reconstruct an existing well, the property owner must obtain prior DNR approval. Additional casing may be necessary to prevent contamination of the well.

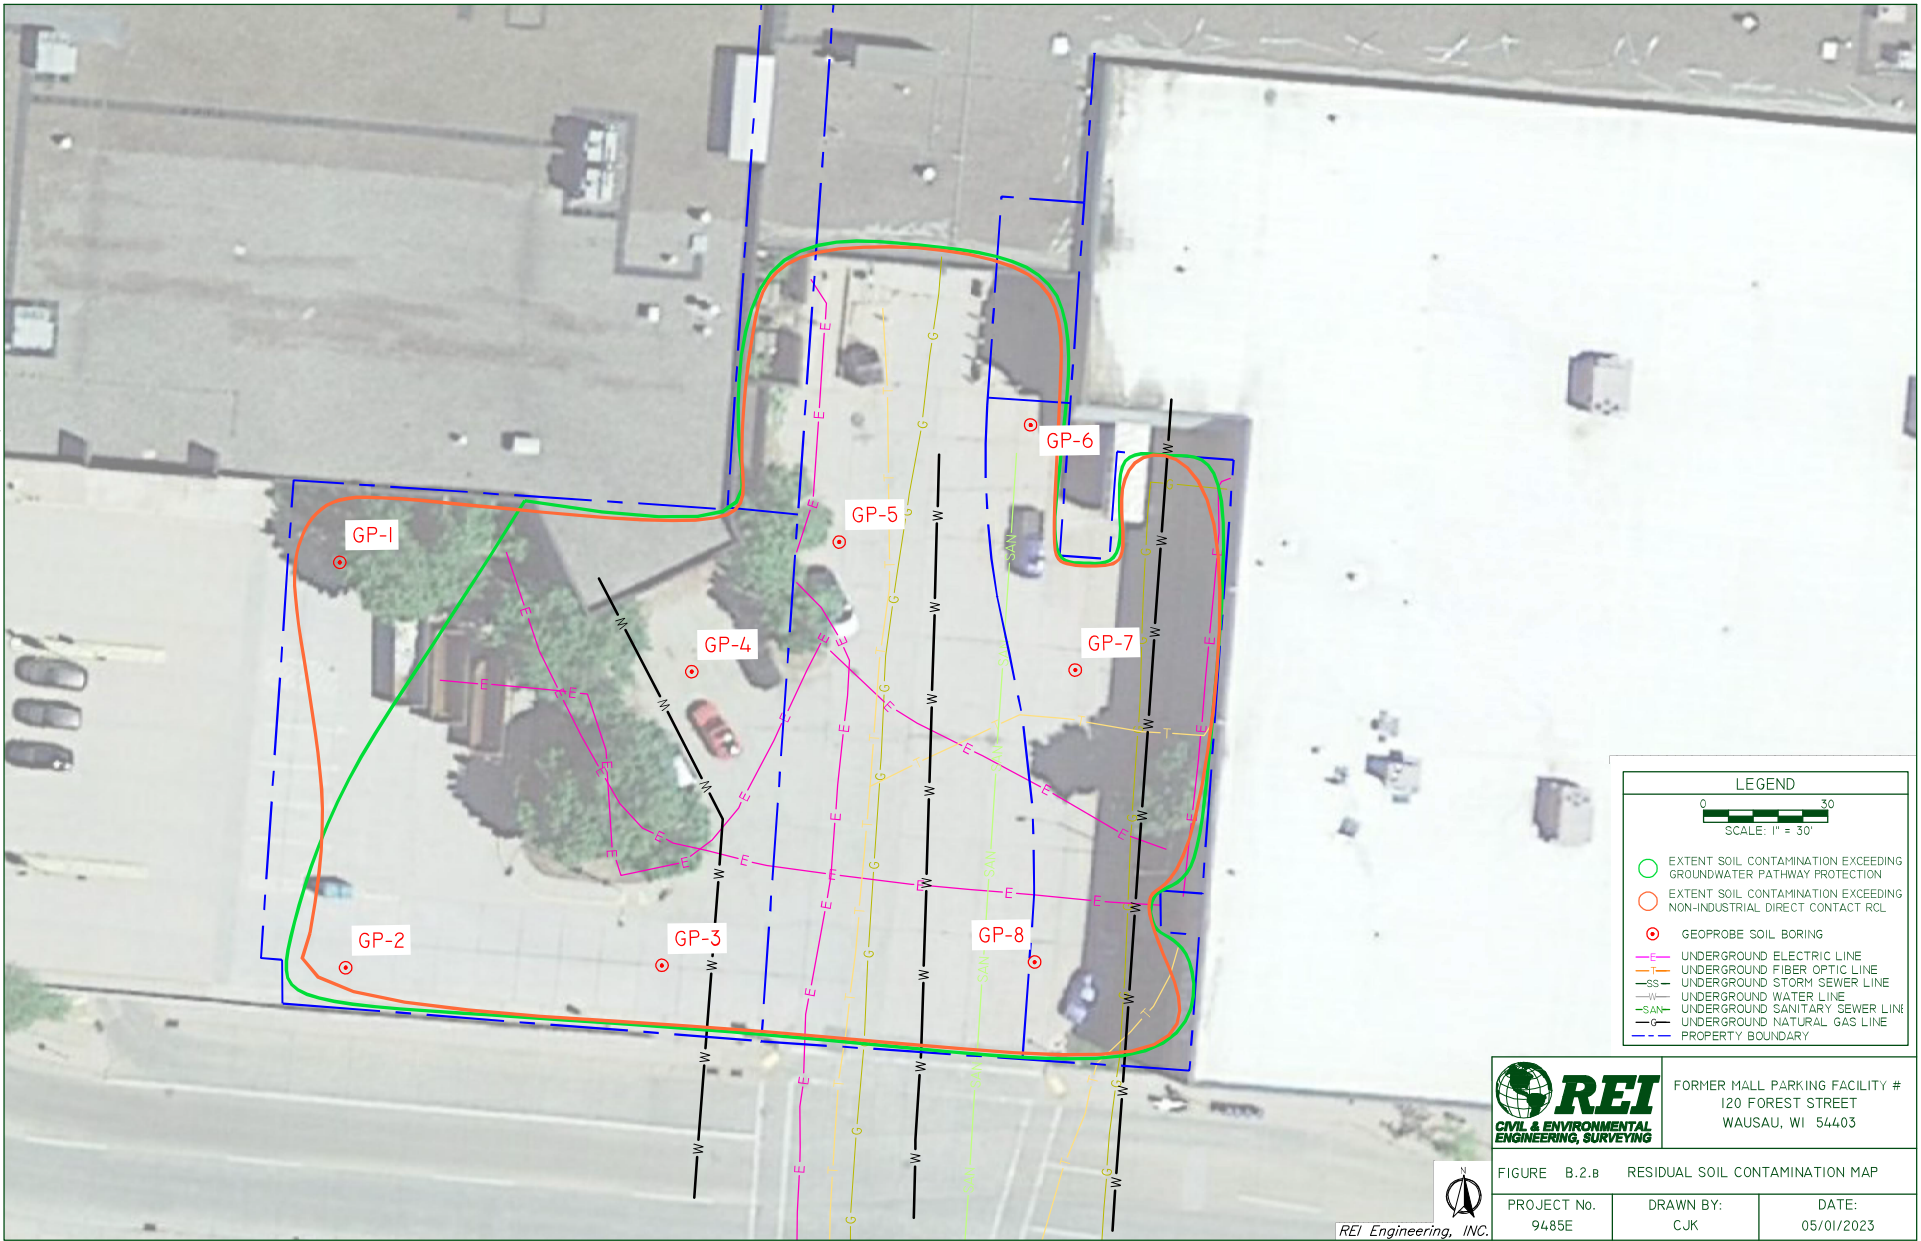
FIGURE B.2.B RESIDUAL SOIL CONTAMINATION MAP		
PROJECT No. 9485E	DRAWN BY: CJK	DATE: 05/01/2023

- EXTENT SOIL CONTAMINATION EXCEEDING GROUNDWATER PATHWAY PROTECTION
- EXTENT SOIL CONTAMINATION EXCEEDING NON-INDUSTRIAL DIRECT CONTACT RCL
- ⊙ GEOPROBE SOIL BORING
- UNDERGROUND ELECTRIC LINE
- UNDERGROUND FIBER OPTIC LINE
- SS— UNDERGROUND STORM SEWER LINE
- W— UNDERGROUND WATER LINE
- SAN— UNDERGROUND SANITARY SEWER LINE
- G— UNDERGROUND NATURAL GAS LINE
- - - PROPERTY BOUNDARY

Due to observations of subsurface materials, the lack of apparent source, and generally similar contaminant signature noted in samples across the site it is apparent that contamination across the site is resultant from historical fill placed on the site rather than a single point source. Contaminated fill was evidently placed preferentially on the east side of the property as opposed to the west. Low-level tetrachloroethene contamination may be resultant from a historical laundry facility located on/near the eastern portion of the property. The extent of soil and groundwater contamination is depicted on Figure D.2.

The concrete cap consists of several inches of concrete parking/driving area which is currently existing. The concrete cap encompasses nearly the entirety of the property. Small areas of the property which are not concrete covered contain raised landscaped beds. The area of cover to be maintained includes the majority of the site and is depicted on Figure D.2.

The concrete cap overlying the contaminated soil and groundwater and as depicted in Figure D.2 will be inspected once a year, normally in the spring after all snow and ice is gone, for deterioration, cracks and other potential problems that can cause additional infiltration into or exposure to underlying soils. The inspections will be performed by the property owner or their designated representative. The inspections will be performed to evaluate damage due to settling, exposure to the weather, wear from traffic, increasing age and other factors. Any area where soils have become or are likely to become exposed and where infiltration from the surface will not be effectively minimized will be documented.

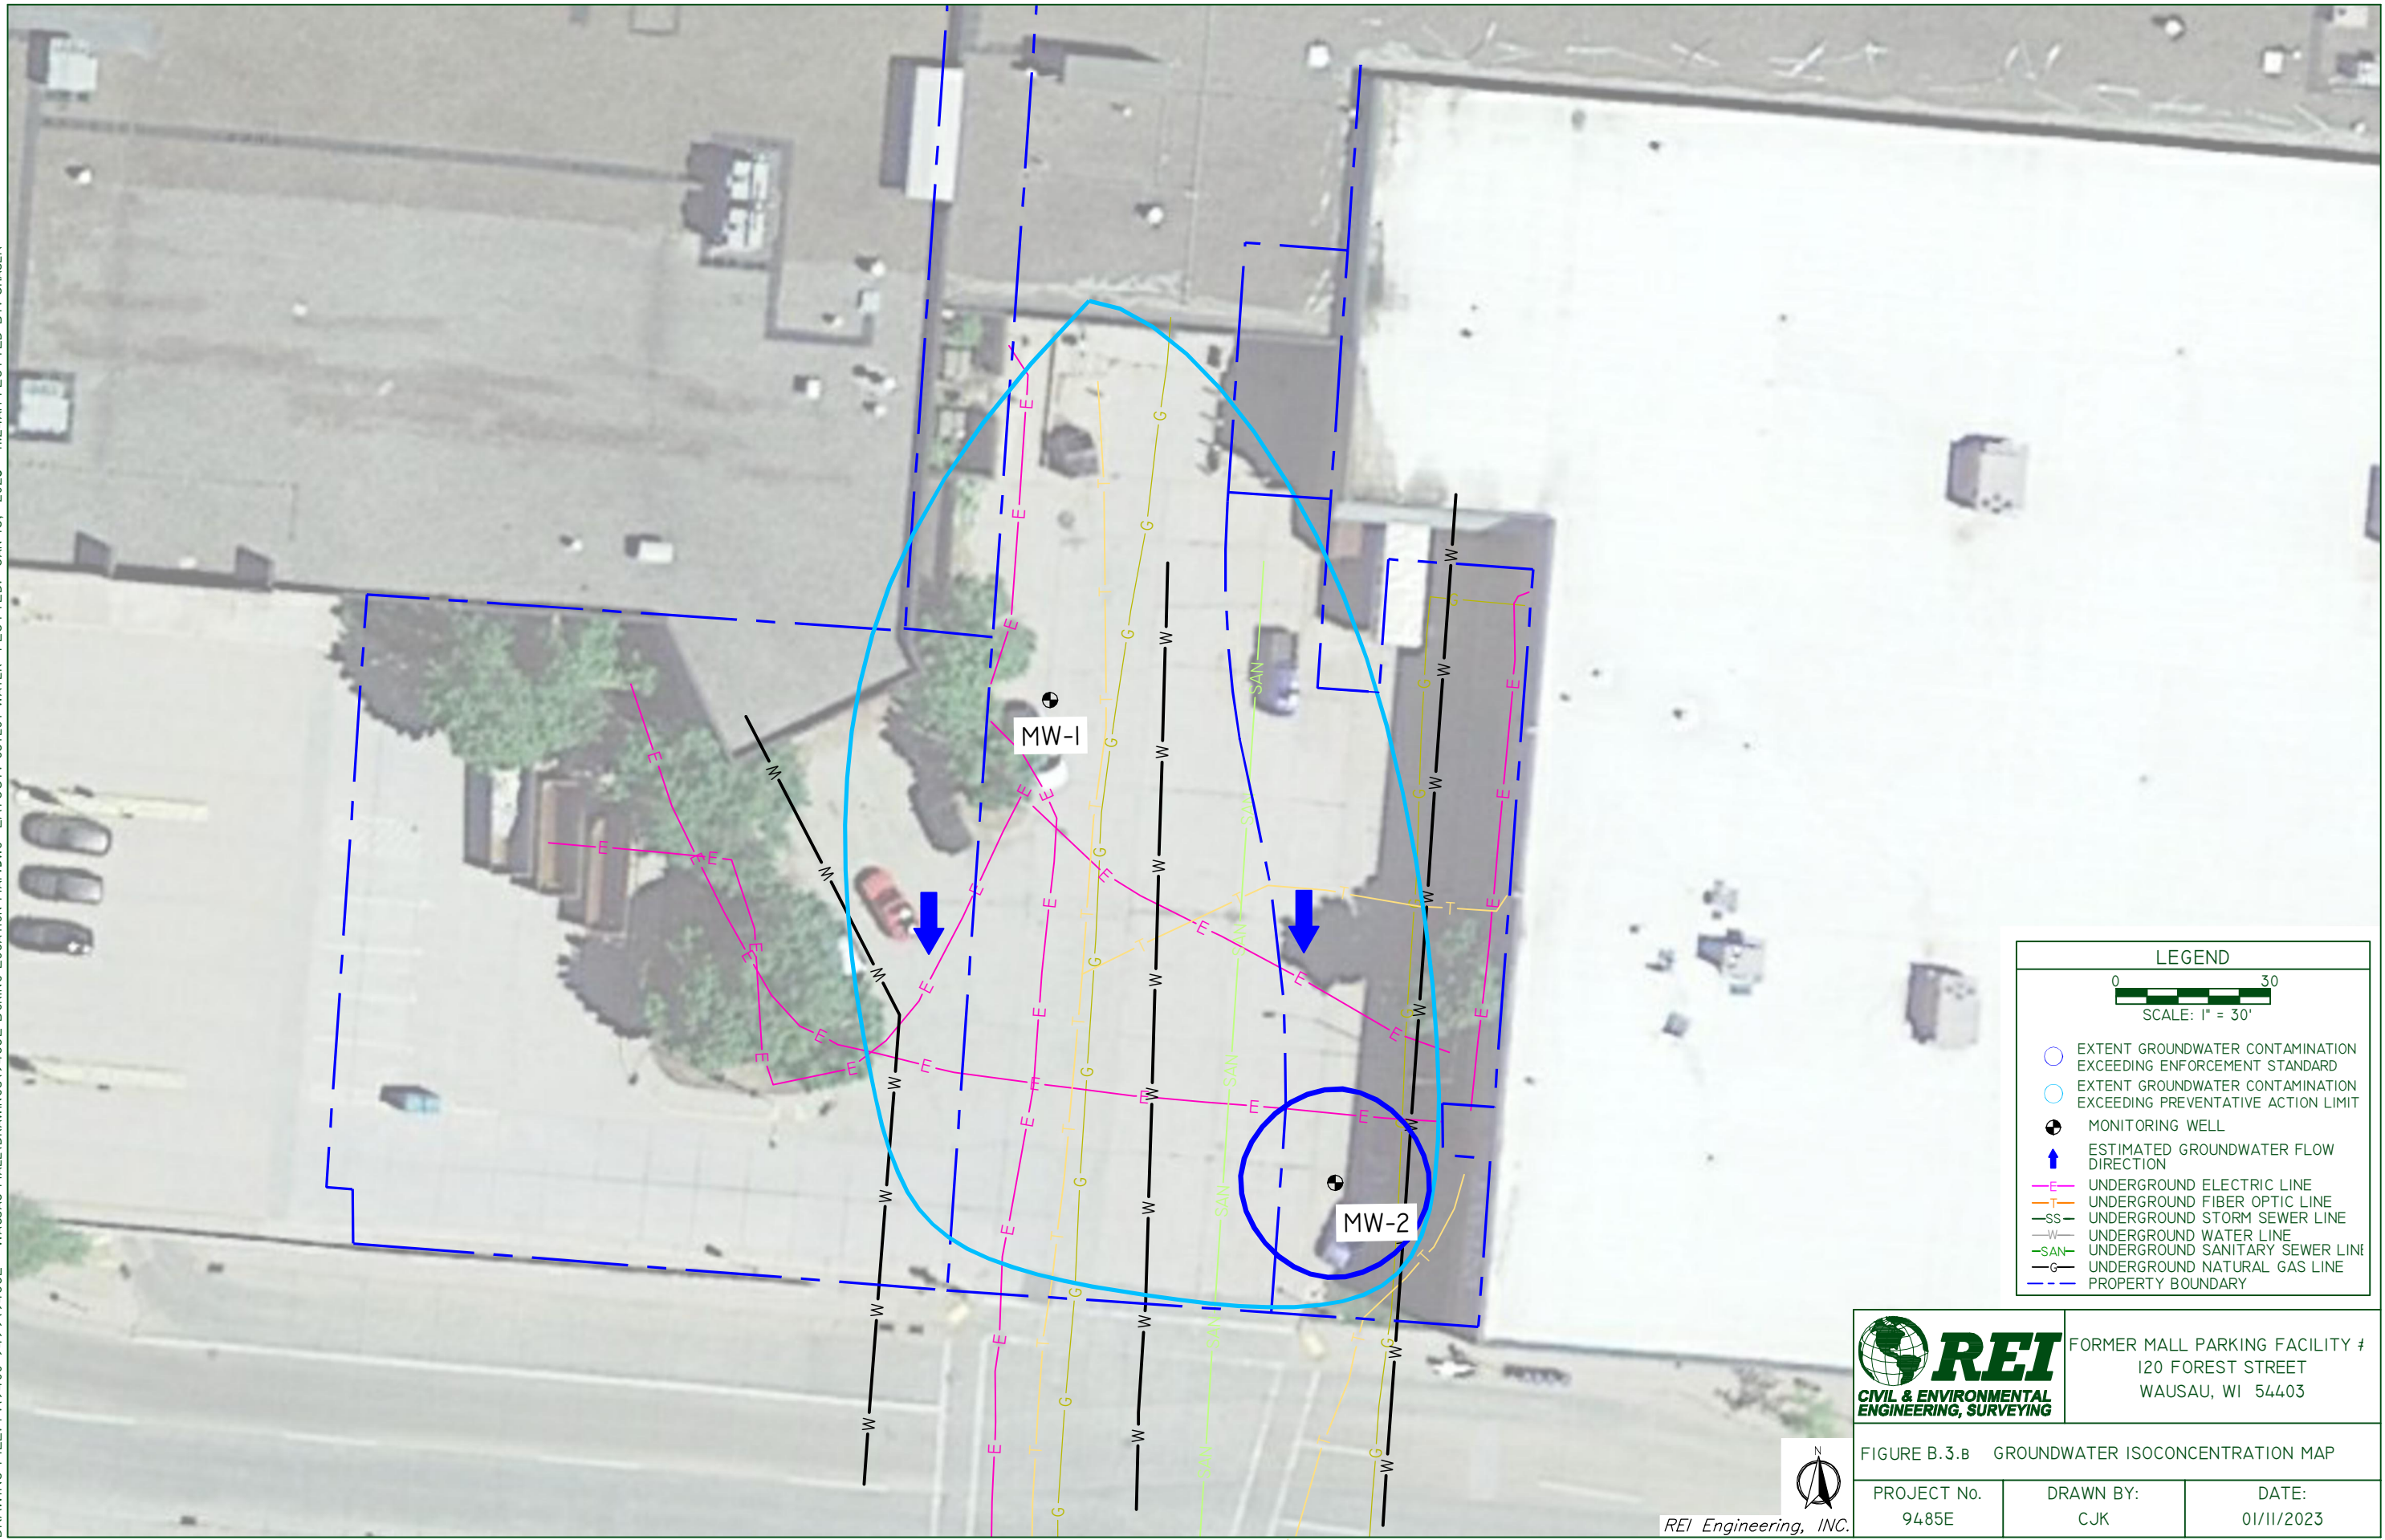
FIGURE B.3.B GROUNDWATER ISOCONCENTRATION MAP

- EXTENT GROUNDWATER CONTAMINATION EXCEEDING ENFORCEMENT STANDARD
- EXTENT GROUNDWATER CONTAMINATION EXCEEDING PREVENTATIVE ACTION LIMIT
- MONITORING WELL
- ESTIMATED GROUNDWATER FLOW DIRECTION
- UNDERGROUND ELECTRIC LINE
- UNDERGROUND FIBER OPTIC LINE
- UNDERGROUND STORM SEWER LINE
- UNDERGROUND WATER LINE
- UNDERGROUND SANITARY SEWER LINE
- UNDERGROUND NATURAL GAS LINE
- PROPERTY BOUNDARY

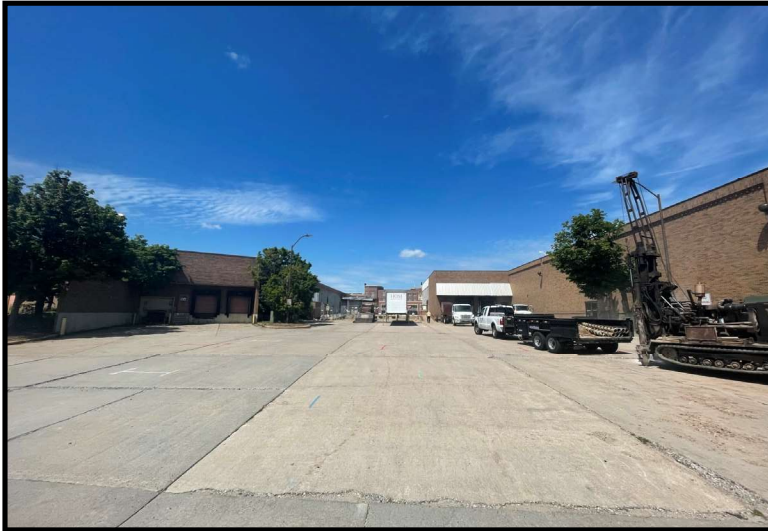
Concrete cap on 2nd Street right-of-way and Outlot 3
(07/26/2022)

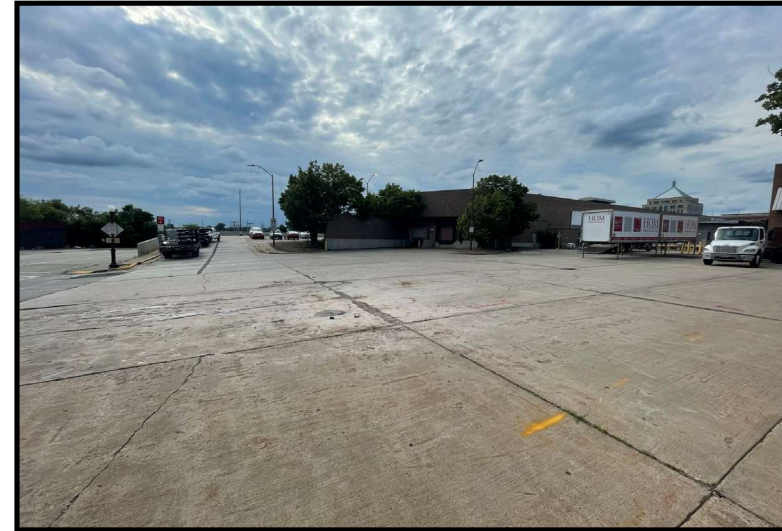
Concrete cap on 2nd Street right-of-way and Lot 1
(07/26/2022)

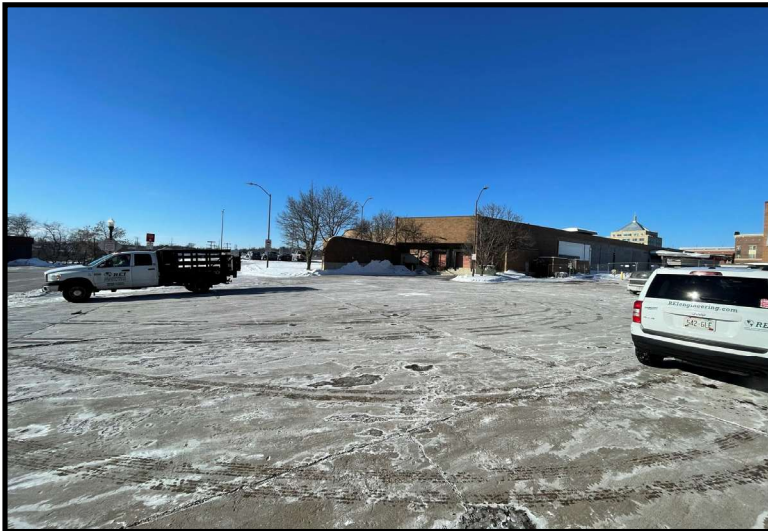
Concrete cap on 2nd Street right-of-way and Lot 1
(01/31/2023)

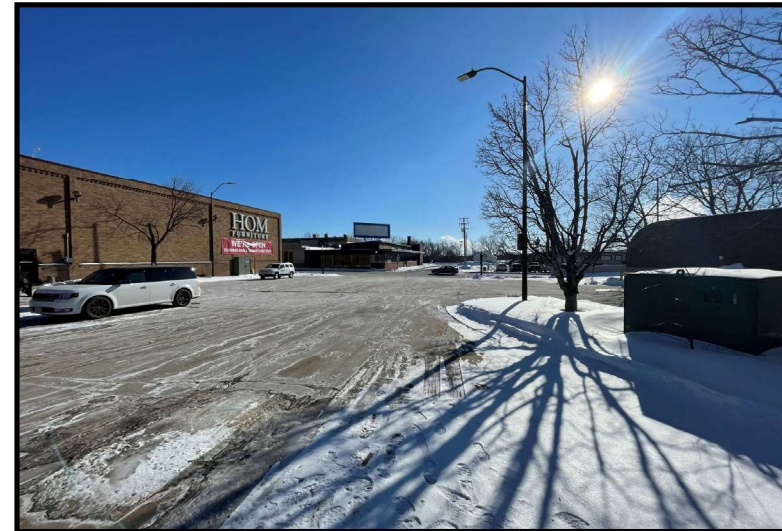
Concrete cap on 2nd Street right-of-way and Outlot 3
(01/31/2023)

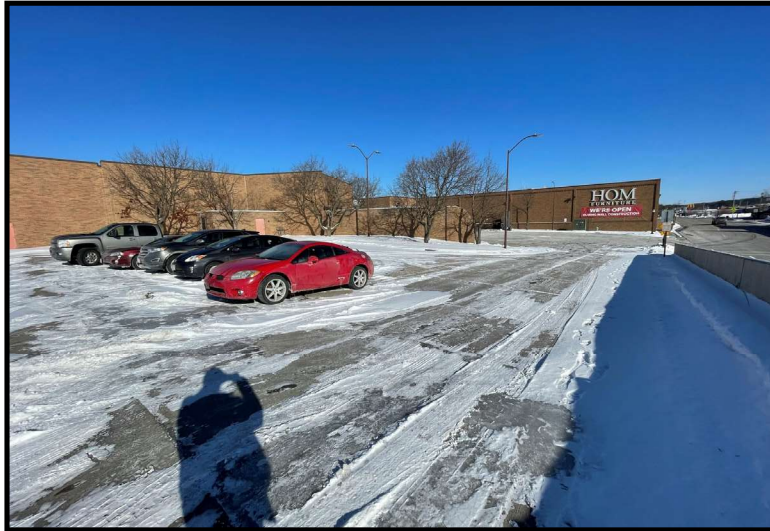
Concrete cap on Lot 1 (01/31/2023)

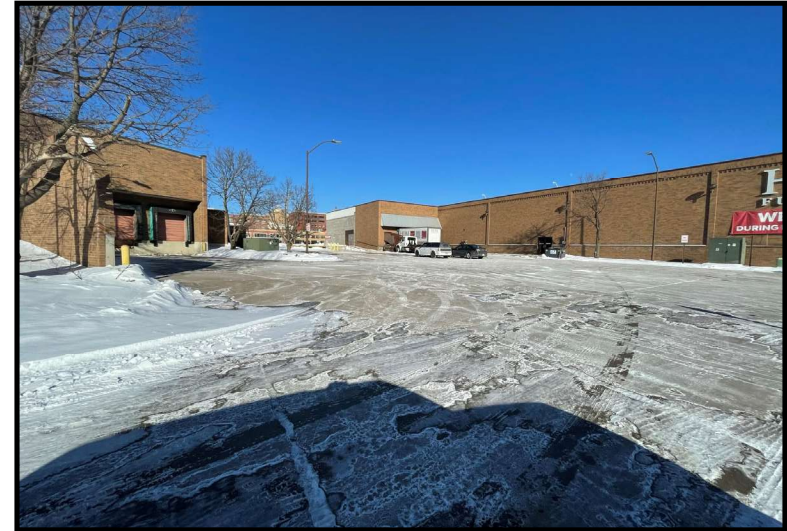
Concrete cap on 2nd Street right-of-way and Outlot 3
(01/31/2023)
