## MEMORANDUM

SUBJECT : Weekly Test Results for the Week Ending 11/04/2023  
Community Within the Corridor - East Block

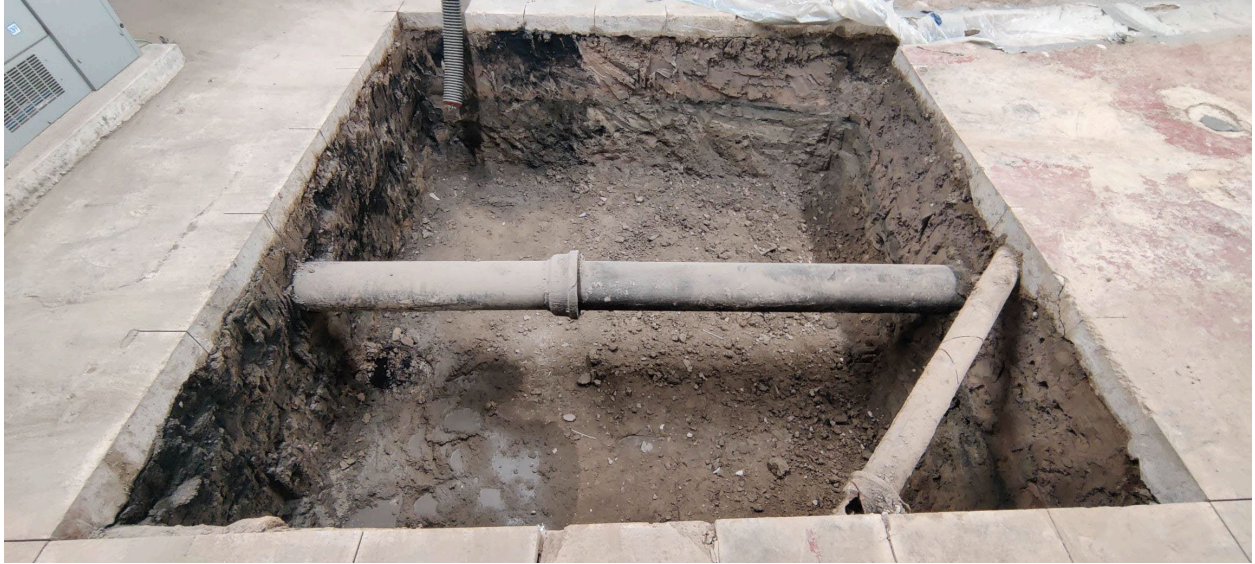
Excavation work commenced in the North Mechanical Room on 10/30/2023 and was completed on 11/02/2023. Approximately 13 cu. yards of soil was recovered from the area. Upon completion of excavation in N Mechanical Room, excavation commenced in the SW Garage area in Building 1B-NW. Approximately 75% of the area was excavated in two days with over 40 cu. yards being excavated. 4 soil borings were conducted in the hallway outside the storage room and the laundry room to determine the hazardous characteristics of the soil. The pictures from the excavation activity and the corresponding air quality readings can be found in Attachment A.

**Picture 1 – N Mechanical Room Excavated Area**

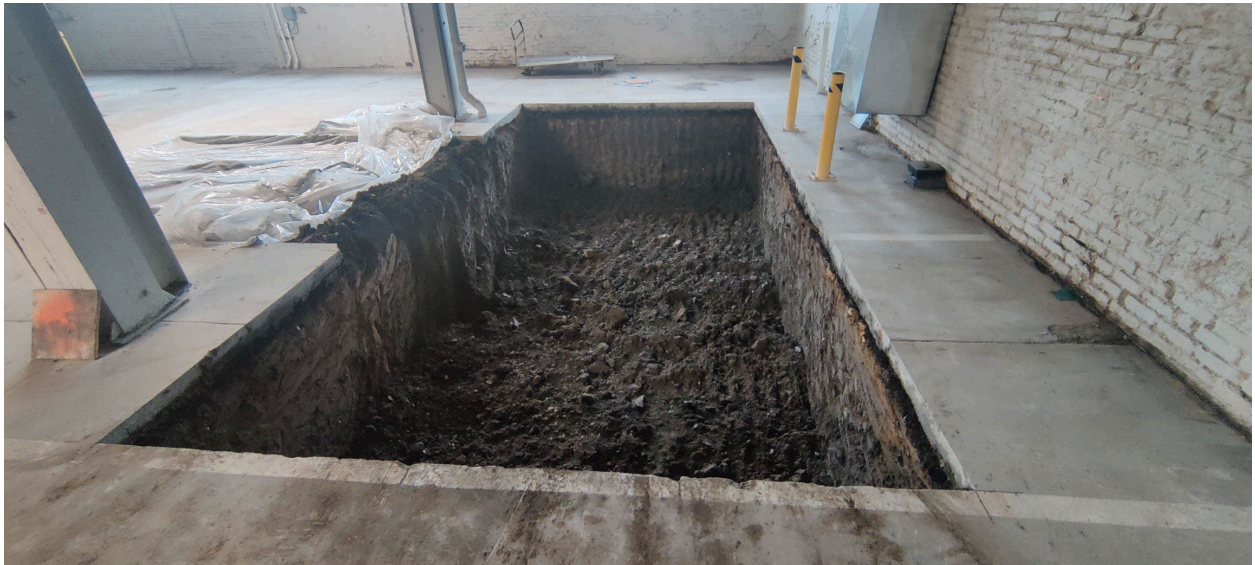
**Picture 2 – SW Garage Excavated Area**
