**King Lake Management Report  
Polk County, Wisconsin  
2007  
(MWBIC: 2472300)**

**Brian W. Spangler, Sr.  
Advanced Fisheries Technician  
Wisconsin Department of Natural Resources  
Northern Region-Barron  
March 2009**

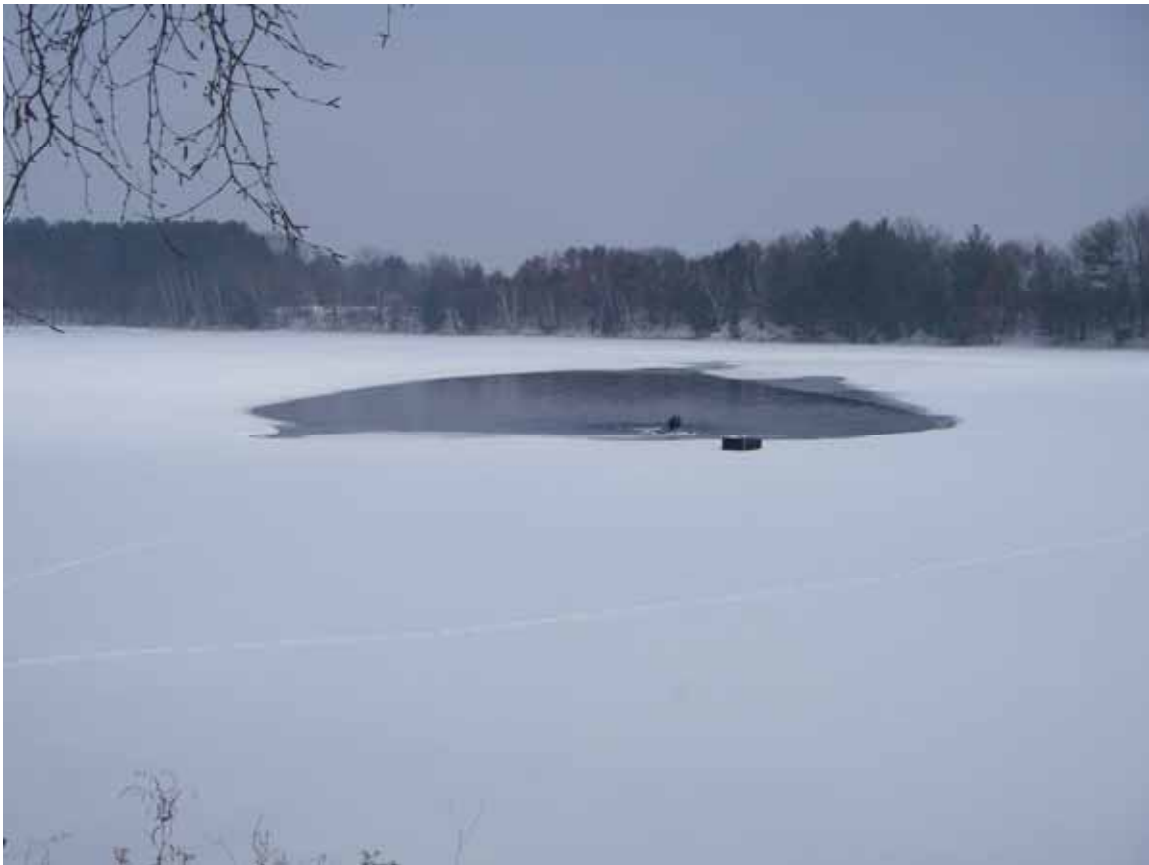
Aeration project implementation consisted of installation of electrical power, circuit breaker box and 230 volt 25 amp twist lock plug. The aerator was a 3 hp surface aspirator supported by a 30 in by 60 in poly float and moored by 3 cement filled blocks attached by rope, 2 in front and 1 in the rear (see cover photo). Aerator installation involved laying out approximately 200 ft. of water proof power cord with waterproof connections on the ice to locate the aerator. The ice is removed by cutting a rectangular hole in the ice with chain saws once the ice is approximately 8 - 12 in thick and pushing the cut blocks under the ice. The aerator is assembled on the float, power cord is attached, and placed in the hole with the anchors attached and stretched out to anchor the aerator with the thrust going in the desired direction. Mooring of the unit is achieved during the course of operation as the anchors fall on their own through the open water created by the unit to the bottom of the lake. Power is turned on and several holes are drilled with an ice auger at various distances from 2 ft to 6 ft in front of the aerator to relieve water pressure and back spray and facilitate the opening of the open water hole. The resultant open water created by aeration was barricaded according to instructions in Wisconsin State Statue 167.26. The open water barricade in King lake was constructed from 5/8 in by 5 ft fiberglass electric fence posts that have 3M reflective tape attached for visibility. Two 3 in by 3 in foam net floats are attached to the bottom of the posts which serves two purposes; to help stand up the post, and float the post after the ice goes out.

The rope was 10 mm black "niteline", which has a reflective filament running throughout the rope making it highly visible. The barricade was installed by laying out the rope in the desired shape in sufficient size to completely encompass the open-water hole. Posts are spaced approximately 25 feet apart and holes are drilled, in the ice, approximately 6 in deep with an electric drill and 3/4 in auger bit. The posts are placed upright in the holes and the rope is attached to the posts with metal clips and electrical zip ties approximately 3 ft above the surface of the ice. Every 5<sup>th</sup> post receives an 8 in by 12 in black coroplast plastic placard attached to the top of the posts to provide daytime visibility. A warning sign is placed at the public boat landing to inform people about the aerator in operation and open water. The unit is operated until all ice has left the lake to prevent blowing ice from damaging the blower unit. Immediately upon ice out the aerator and all components are removed by boat and stored at the Town of Black Brook maintenance shop.
