2003-2004 Door Peninsula Baseline Monitoring Report

By Steve Hogler, Steve Surendonk and Mary Gansberg

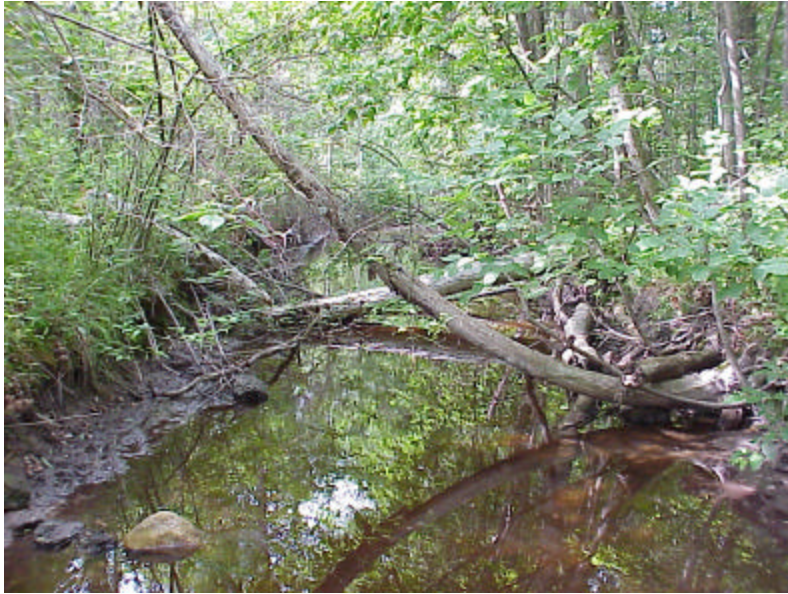
The survey site was located just upstream of State Highway 42 above a wooden bridge in a village park (N45.1246, W-087.2387 to N45.1236, W-087.2389). The survey section averaged 3.3 meters in width and was 102 meters in length. Fish Creek has a gradient of 2.8 meters per kilometer and a sinuosity of 1 to 1.12. The study reach of the river ran through 100 percent wooded parkland (Figure 2).

Figure 2. An upstream view from the start of the survey site on Fish Creek. This view was what was observed throughout the entire survey site.

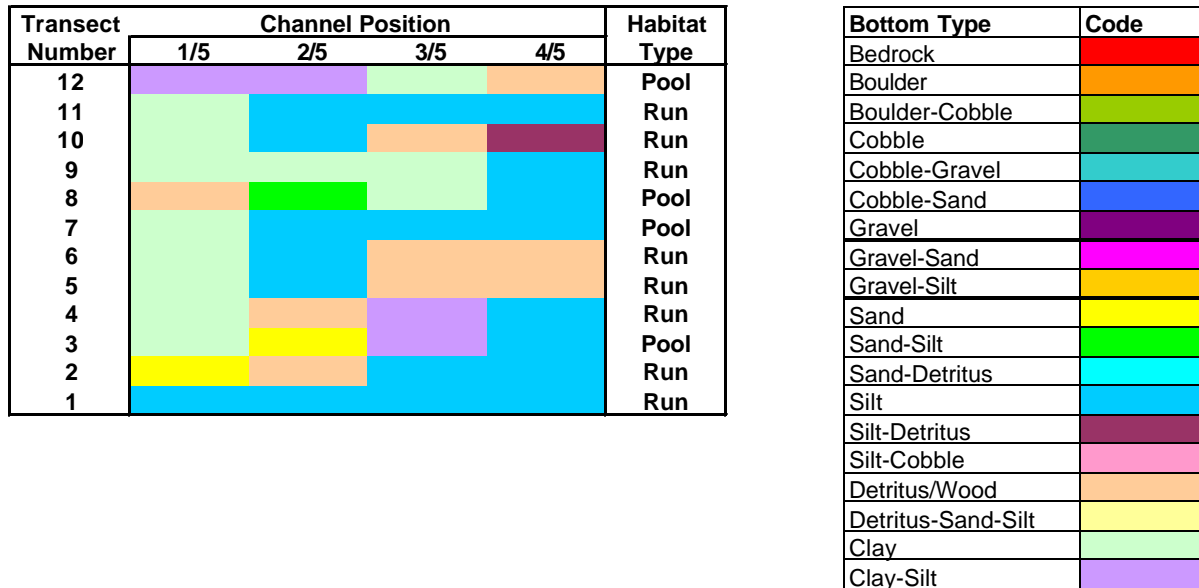
The bottom sediments were dominated by silt and clay although large areas of detritus and wood were encountered (Figure 3). The soft sediments found at this location were indicative of the bank erosion and channelization that was observed at this site.

Figure 3. Bottom sediment map and key for the survey site upstream of Highway 42 on Fish Creek. Transect 1 is the furthest downstream sampling location.

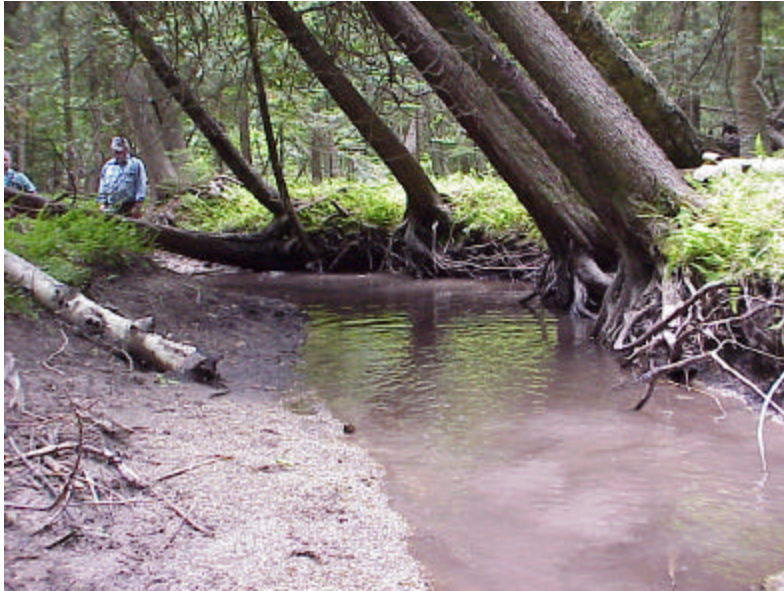
meters in length. The creek has a gradient of 0.4 meters per kilometer and a sinuosity of 1 to 1.26 (Door County SWD 2000). The study reach of the river ran through 100 percent wooded land (Figure 4).

Figure 4. Looking upstream from the start of the survey site on Ephraim Creek. Note the clay sediment in the water caused by waders in the stream.

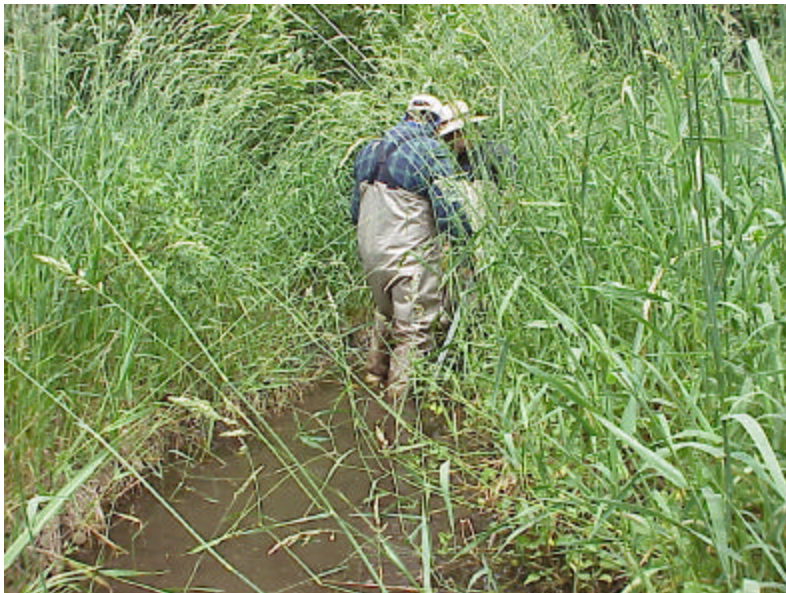
The survey site was upstream of Highway ZZ (N45.1856, W-087.0782 to N45.1869 W-087.0787). Mean stream width was not calculated for this stream because low flow caused the stream to have a stream width that varied in width from 0.015 m to 0.9 m. Many of the runs in the stream were dry when surveyed. The survey section was 92 meters in length. This 1st. order stream had a gradient of 2.1 meters per kilometer and a sinuosity of 1 to 1.12 (Door County SWD 2000). The study reach of the river ran through a landscape of meadows, shrubs and forest (Figure 6).

Figure 6. Looking upstream on Three Springs Creek. Grassland was replaced by shrubs and trees as one proceeded upstream. The stream channel upstream was dry in many places.

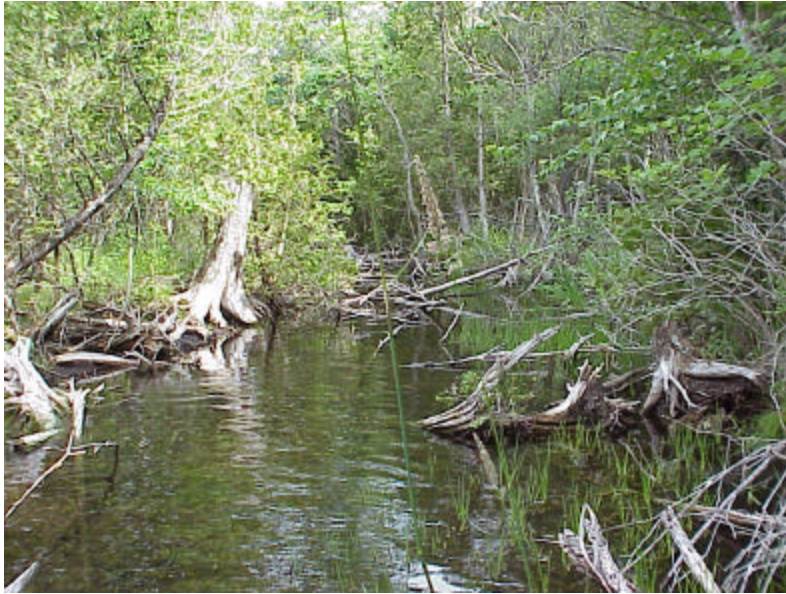
The survey location on Piel Creek was upstream of County Highway EE (N45.0692, W-087.1683 to N45.0701, W-087.1699), averaged 5.0 meters in width, and was 170 meters in length. The gradient was 1.2 meters per kilometer and the stream sinuosity was 1 to 1.2 (Door County SWD 2000). The study reach of the river ran through nearly 100 percent woodland with the remainder wetland (Figure 8).

Figure 8. An upstream view of Piel Creek from the start of the survey station. Note the large amount of woody debris in the stream.

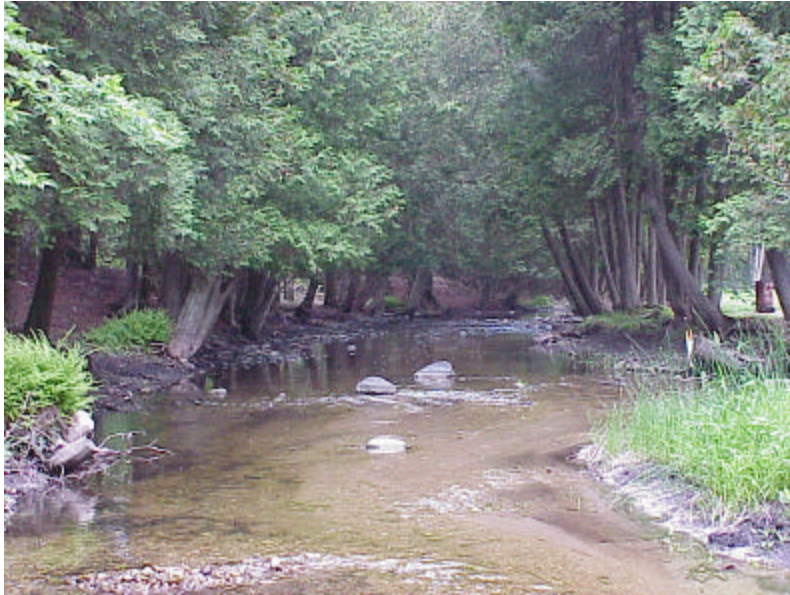
kilometer and a sinuosity of 1 to 1.15 (Door County SWD 2000). The study reach of the river ran through nearly 100 percent woodland with the remainder wetland and lawn (Figure 10).

Figure 10. An upstream view of Hibbards Creek above County Highway A.

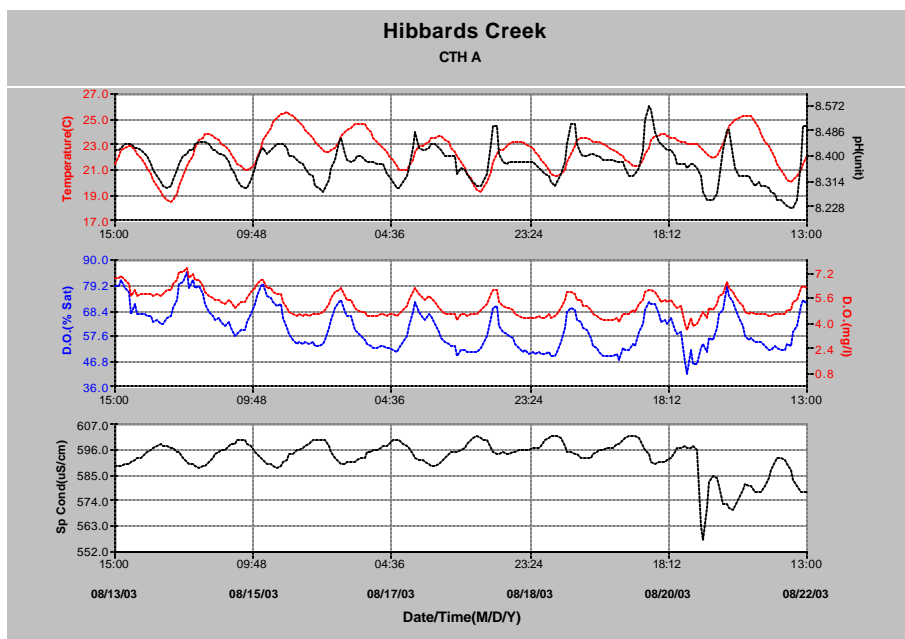
The continuous monitor at this location showed daily dissolved oxygen problems (Figure 12). In fact, dissolved oxygen levels were depressed throughout the sampling period except for short periods in the middle of the day when photosynthesis brought levels to slightly above the 6 mg/l water quality standard. Dissolved oxygen levels were as low as 4.0 and as high as 7.6 mg/l. These daily fluctuations put tremendous stress on the aquatic organisms that may inhabit the stream. Water temperatures ranged from 18 to 26 degrees C with a mean temperature of 22.6 degrees C. pH was normal with a mean of 8.4. Specific conductivity values ranged from 557 to 602 uS/cm.

Figure 12. Continuous monitor data collected at County Highway A on Hibbard's Creek.

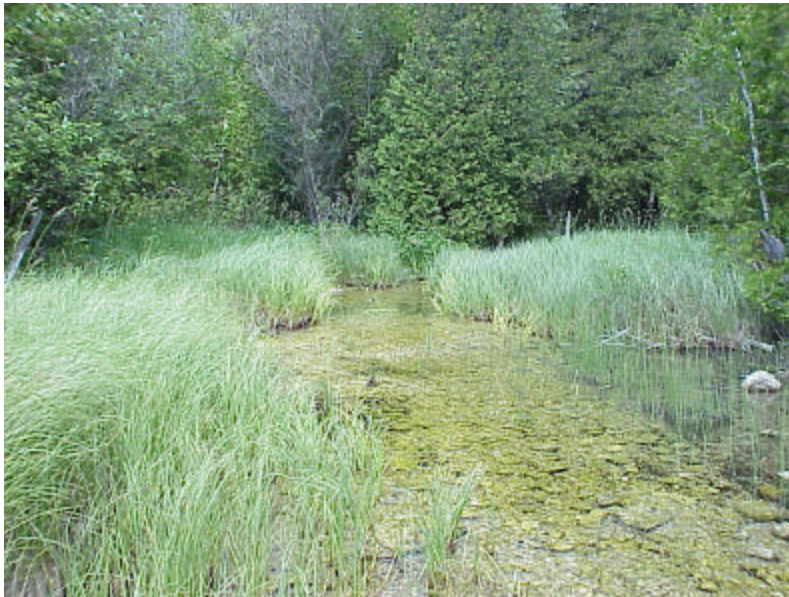
This survey location on Hibbards Creek was upstream of Fairview Road (N45.0326, W-087.2036 to N45.0331, W-087.2039). The study section averaged 2.8 meters in width, and was 92 meters in length. The stream had a gradient of 4.2 meters per kilometer and a sinuosity of 1 to 1.19 (Door County SWD 2000). The study reach of the river ran through a woodland, shrub and grassland corridor (Figure 13).

Figure 13. An upstream view of Hibbards creek at Fairview Road. Note in the foreground water cress (*Rorippa nasturtium aquaticum*) and that at the tree line the stream splits with the major channel on the right.

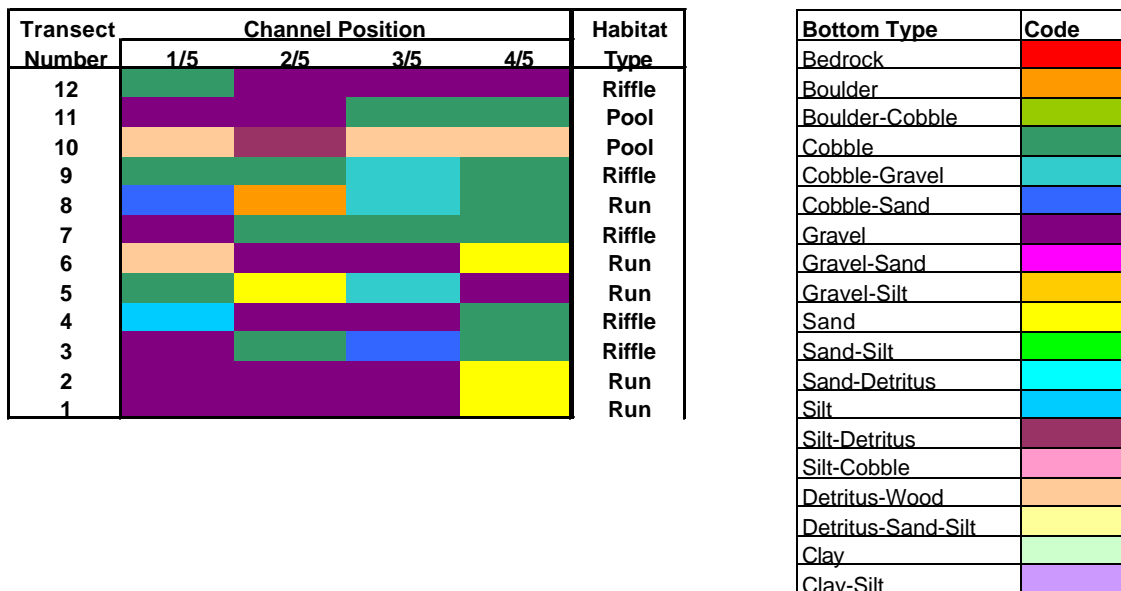
Gravel and cobble were the dominant bottom sediment types observed in this section of Hibbards Creek (Figure 14). Small, scattered patches of sand or detritus/wood were encountered across transects that were adjacent to logged areas of the streambank.

Figure 14. Bottom sediment map and key for the survey site upstream of Fairview Road on Hibbards Creek. Transect 1 is the furthest downstream sampling location.

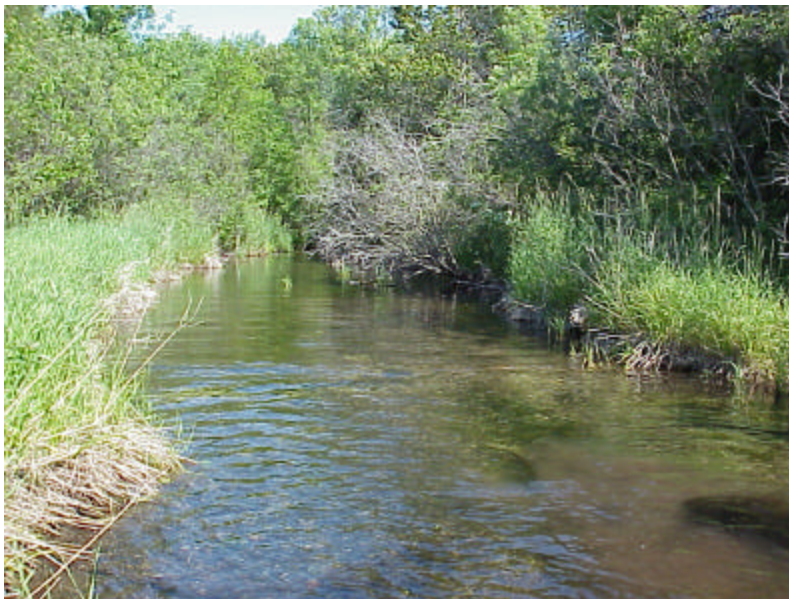
This survey location on Logan Creek was upstream of State Highway 57 (N44.9579, W-087.2181 to N44.9596, W-087.2192), averaged 5.9 meters in width and was 204 meters in length. Logan Creek drains a 31.1 km² watershed. The gradient was 3.4 meters per kilometer, and the sinuosity was 1 to 1.31 (Door County SWD 2000). The study reach of the river ran through meadow-shrub habitat in lower sections and was all woodland by the end of the study section (Figure 16).

Figure 16. Looking upstream on Logan Creek just above State Highway 57.

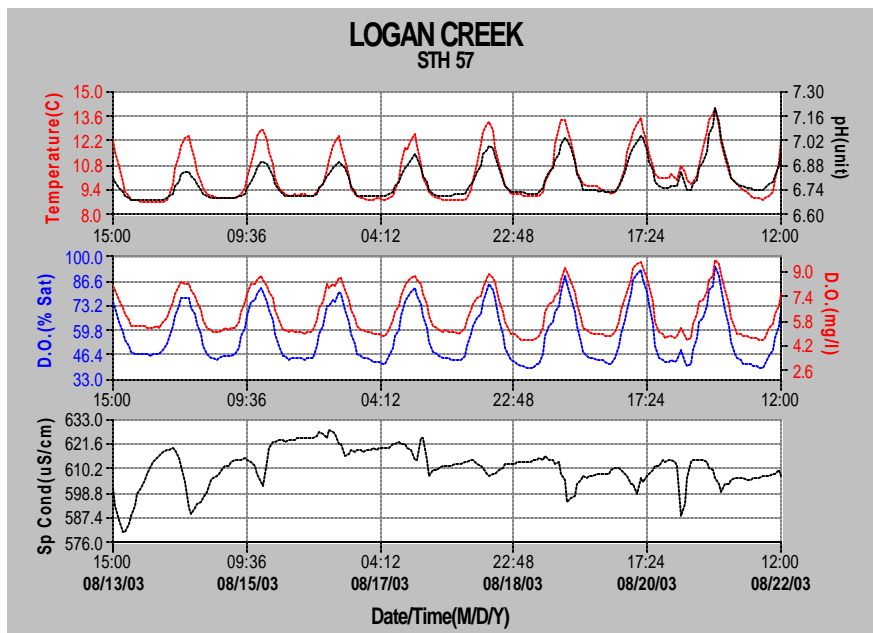
Figure 18. Continuous monitoring data collected on Logan Creek at State Highway 57.

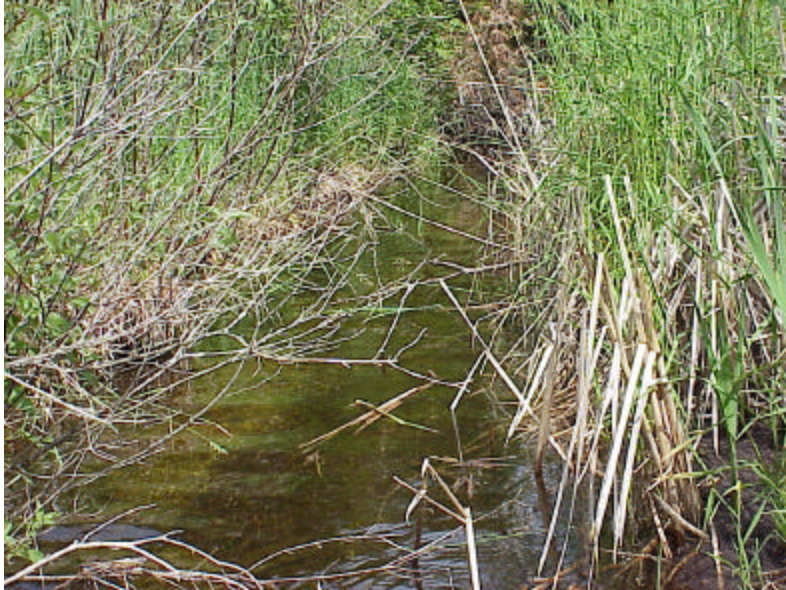
in length. The gradient was 2.4 meters per kilometer, and the sinuosity was 1 to 1.4 (Door County SWD 2000). The study reach of the river ran through meadow-wetland habitat in lower sections and was all woodland by the end of the study section (Figure 19).

Figure 19. Looking upstream of Highway T on Logan Creek. Note the wetland plants in the foregrounds that give way to woodland upstream.

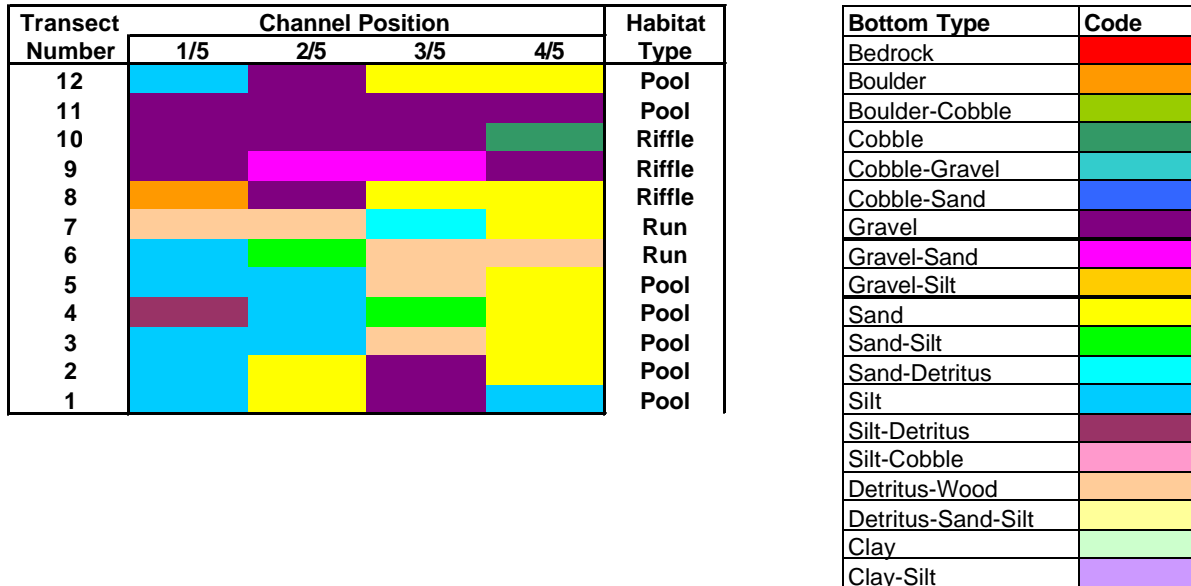
Figure 20. Bottom sediment map and key for the survey site upstream of Highway T on Logan Creek. Transect 1 is the furthest downstream sampling location.

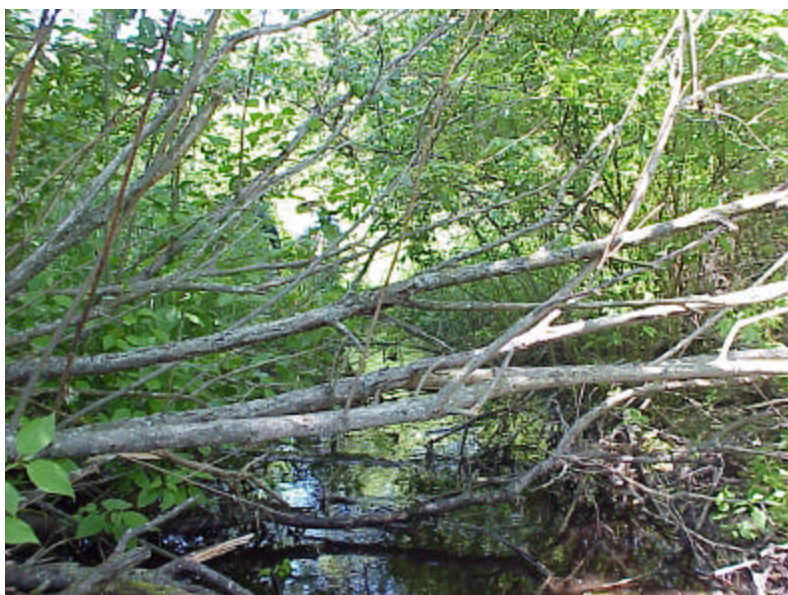
The survey location on Geisel Creek was upstream of Dunn Road (N44.8939, W-087.2656 to N44.8947, W-087.2658), averaged 1.92 meters in width and was 92 meters in length. The stream had a gradient of 1.8 meters per kilometer, and a sinuosity of 1 to 1.16 at this location (Door County SWD 2000). The study reach of the river ran through meadow and shrub land (Figure 21).

Figure 21. Looking upstream at the abundant shrub cover on Geisel Creek above Dunn Road.

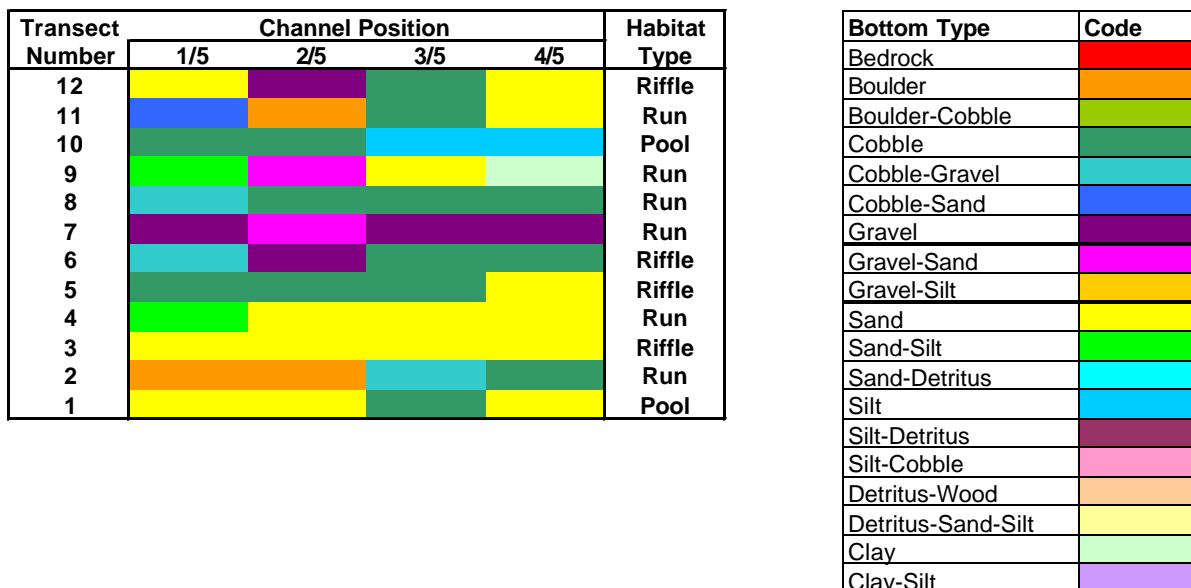
Figure 22. Bottom sediment map and key for the survey site upstream of Dunn Road on Geisel Creek. Transect 1 is the furthest downstream sampling location.

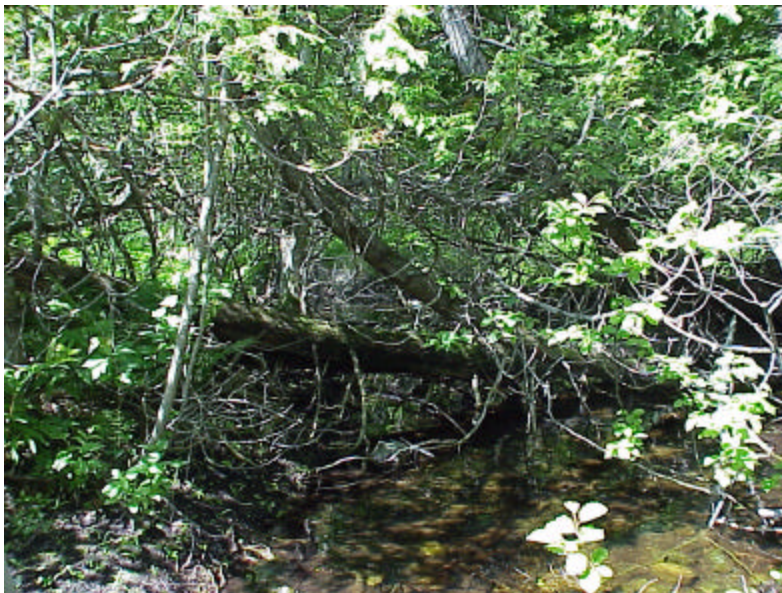
Figure 23. Looking upstream at the downed cedar that was common throughout the survey site on Lilly Bay Creek.

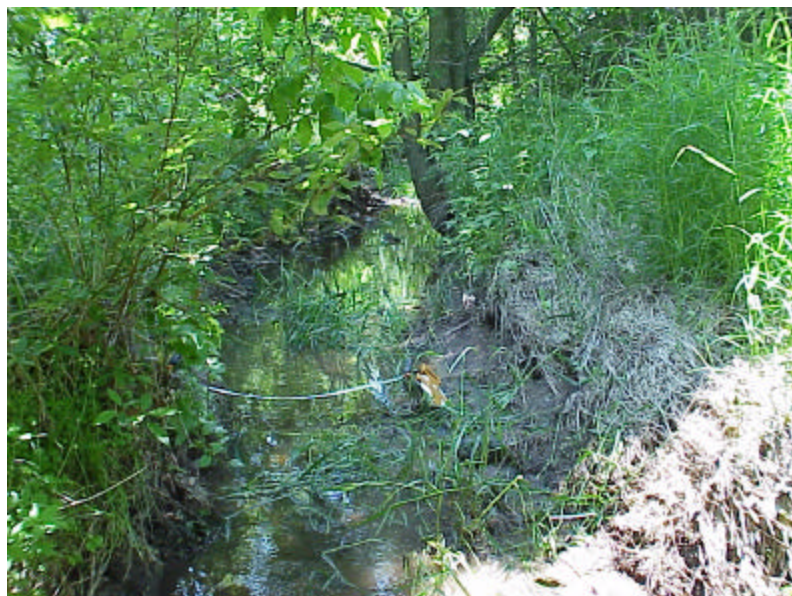
The survey location on Smith Creek was upstream of Town Hall Road (N44.6323, W-087.7587 to N44.6318, W-087.7592), averaged 1.42 meters in width and was 94 meters in length. The stream had a gradient of 2.1 meters per kilometer, and a sinuosity of 1 to 1.27. The study reach of the river ran through meadow and woodland (Figure 25).

Figure 25. An upstream view of Smith Creek that was typical of the habitat along the stream corridor.

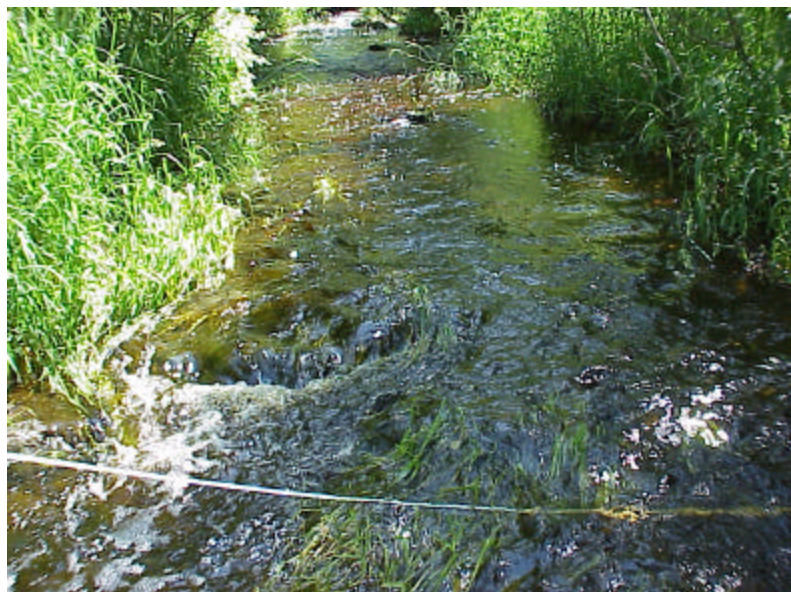
The survey location on Red River was upstream of County Highway A (N44.6594, W-087.7280 to N44.6591, W-087.7271), averaged 3.1 meters in width and was 105 meters in length. The gradient was 3.68 meters per kilometer, and had a sinuosity of 1 to 1.27 at this survey site. The study reach of the river ran through meadow and shrubs (Figure 27).

Figure 27. Looking upstream at Red River from above County Highway A. Just upstream of this location is a small waterfall.

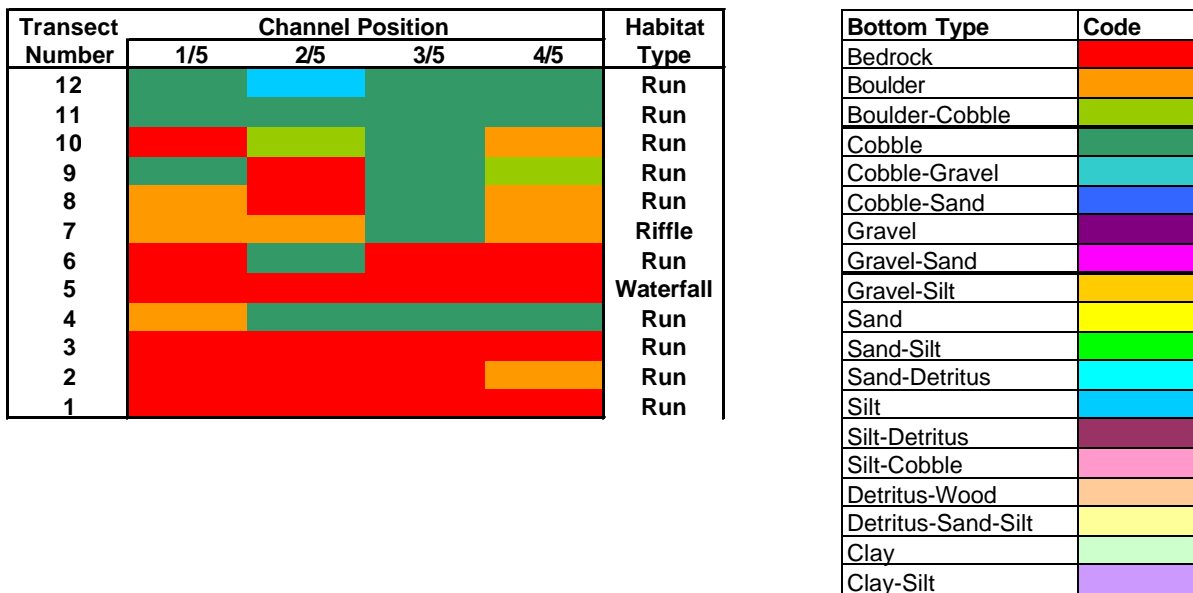
Figure 28. Bottom sediment map and key for the survey site upstream of County Highway A on Red River. Transect 1 is the furthest downstream sampling location.

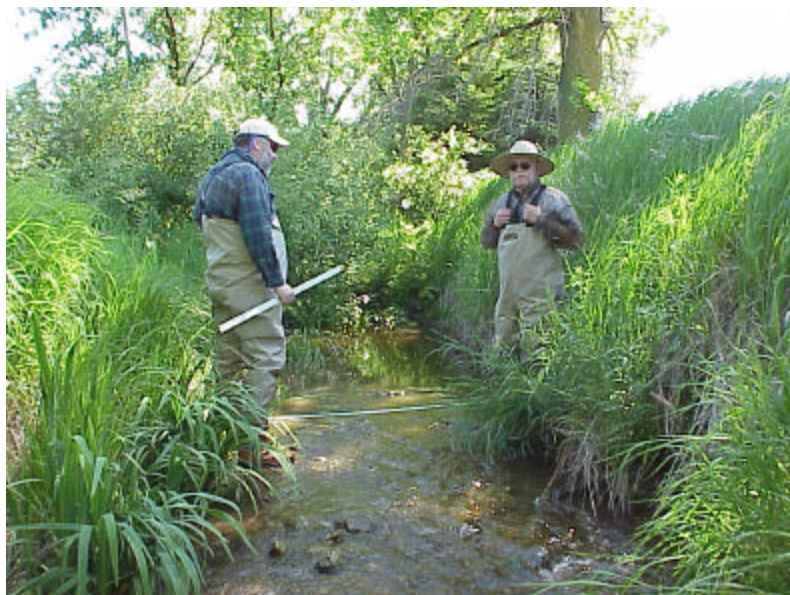
Figure 29. Stream width being measured on Renard Creek.

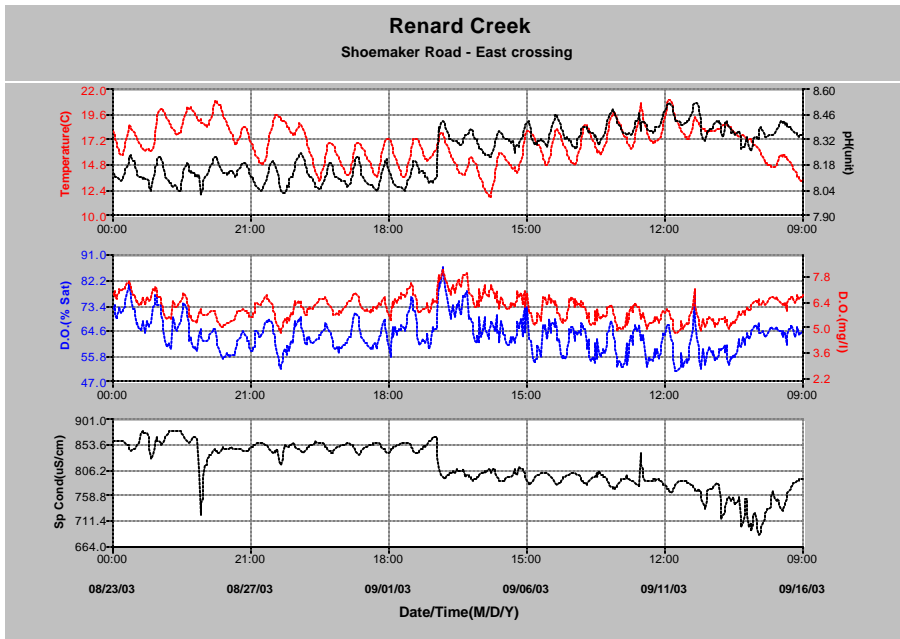
Figure 31. Continuous monitoring data collected at Shoemaker Road on Renard Creek.

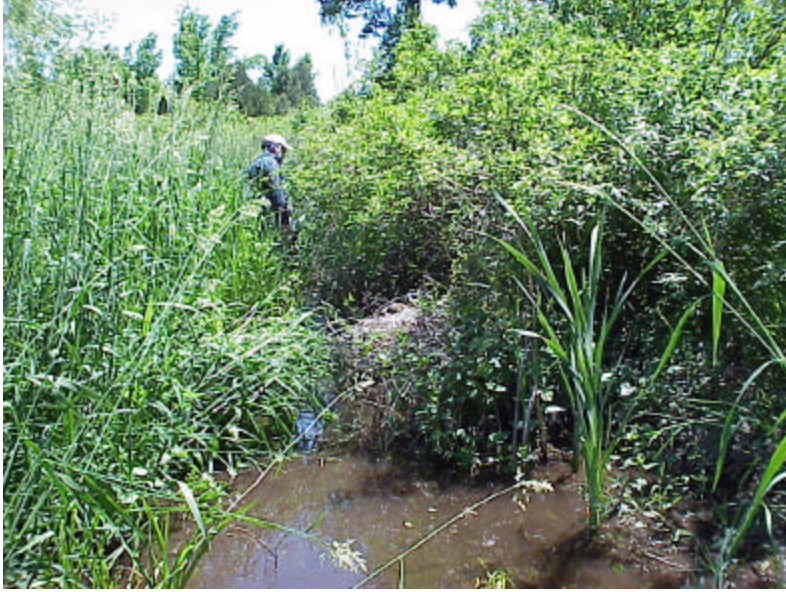
The survey location on Sugar Creek was upstream of Gardner Road (N44.7633, W-087.6616 to N44.7586, W-087.6594). The Sugar Creek survey section averaged 2.7 meters in width although some transects reached 10 meters width in wetland areas. Through the 95 meter study section, the creek had a gradient of 3.4 meters per kilometer, and a sinuosity of 1 to 1.33. The study reach of the river ran through a shrub-meadow-wetland complex (Figure 32).

Figure 32. Looking upstream at the thick wetland and shrub vegetation that was common throughout the study site on Sugar Creek above Gardner Road.

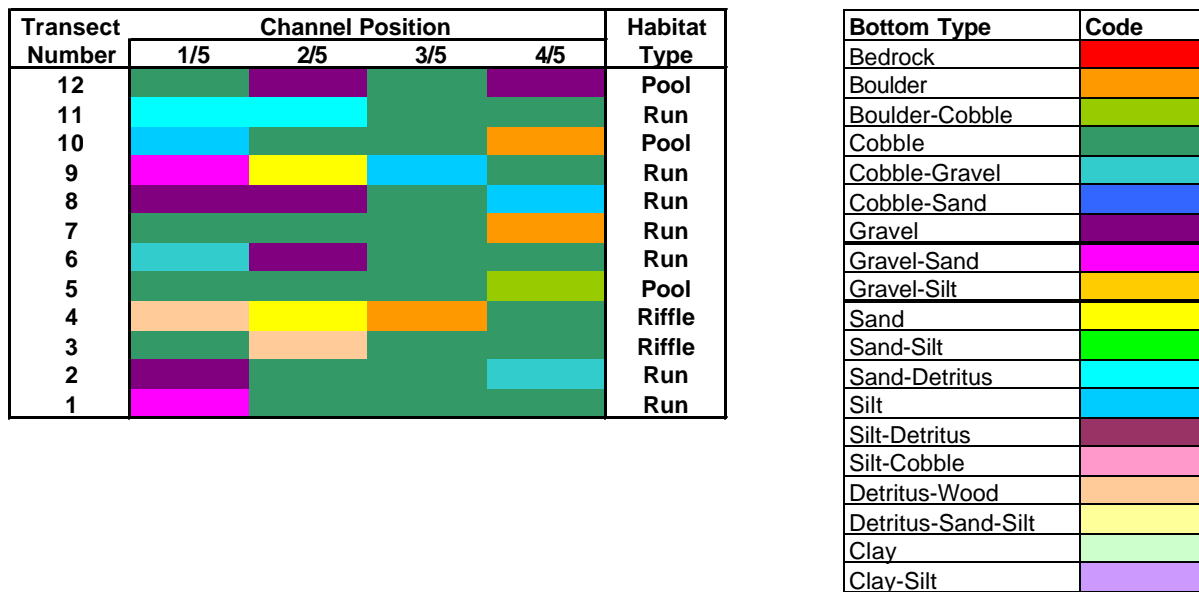
Figure 33. Bottom sediment map and key for the survey site upstream of Gardner Road on Sugar Creek. Transect 1 is the furthest downstream sampling location.

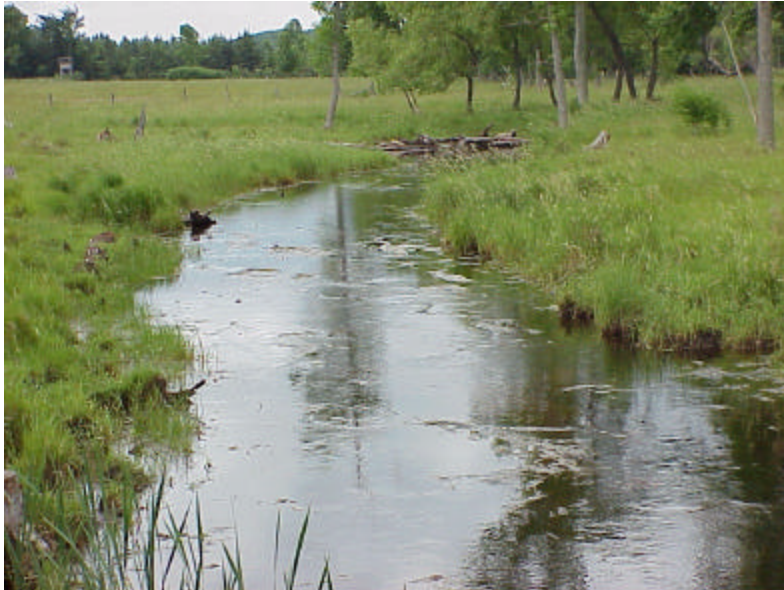
The survey location on Kayes Creek was upstream of Fox Lane (N44.8092, W-087.5866 to N44.8083, W-087.5869). The Kayes Creek survey section averaged 6.2 meters in width and was 225 meters in length. Kayes Creek has a gradient of 1.5 meters per kilometer, and a sinuosity of 1 to 1.28 at this location. The study reach of the river ran through meadow and pasture (Figure 35).

Figure 35. Looking upstream at the meadow-pasture that was common throughout the survey site on Kayes Creek.

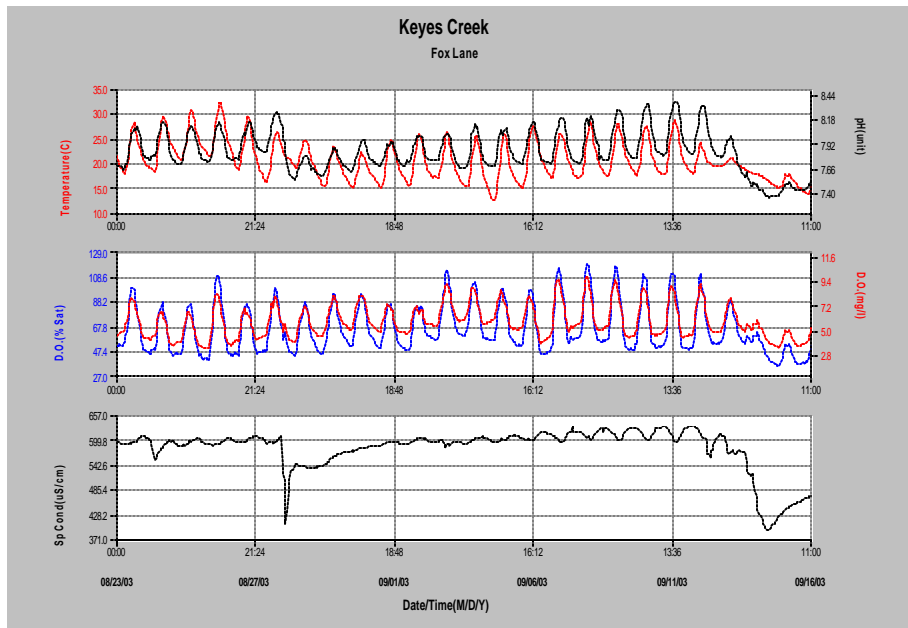
Figure 37. Continuous monitoring data collected at Fox Road on Kayes Creek.

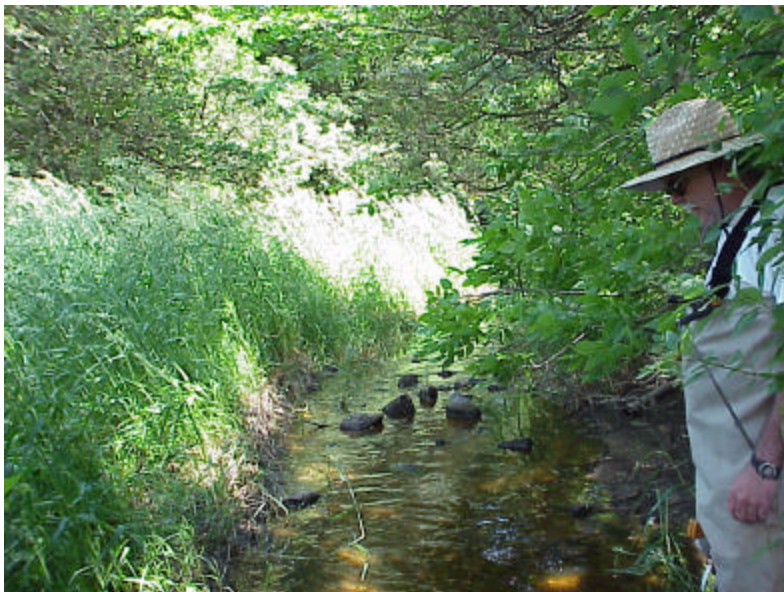
Figure 38. A typical view of Malvitz Creek looking upstream above County Highway C.

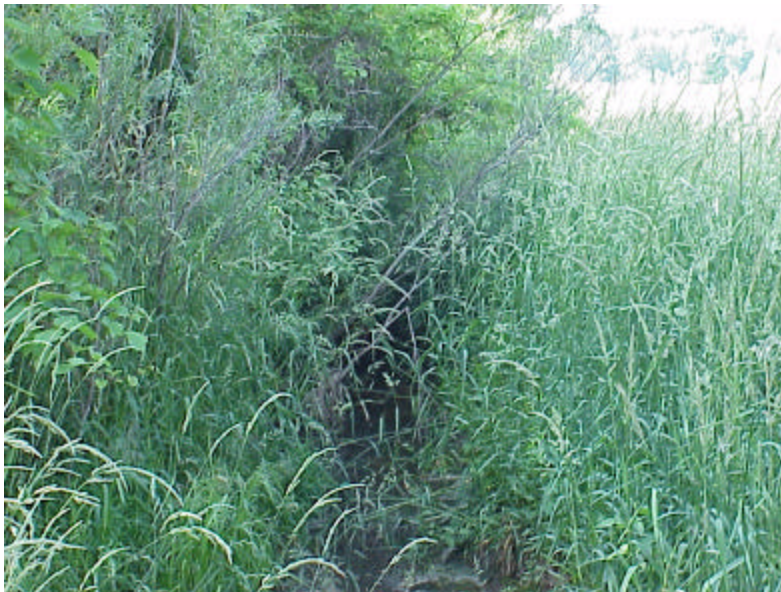
Figure 40. Thick, overhanging grass was common throughout the survey site on Larson Creek.

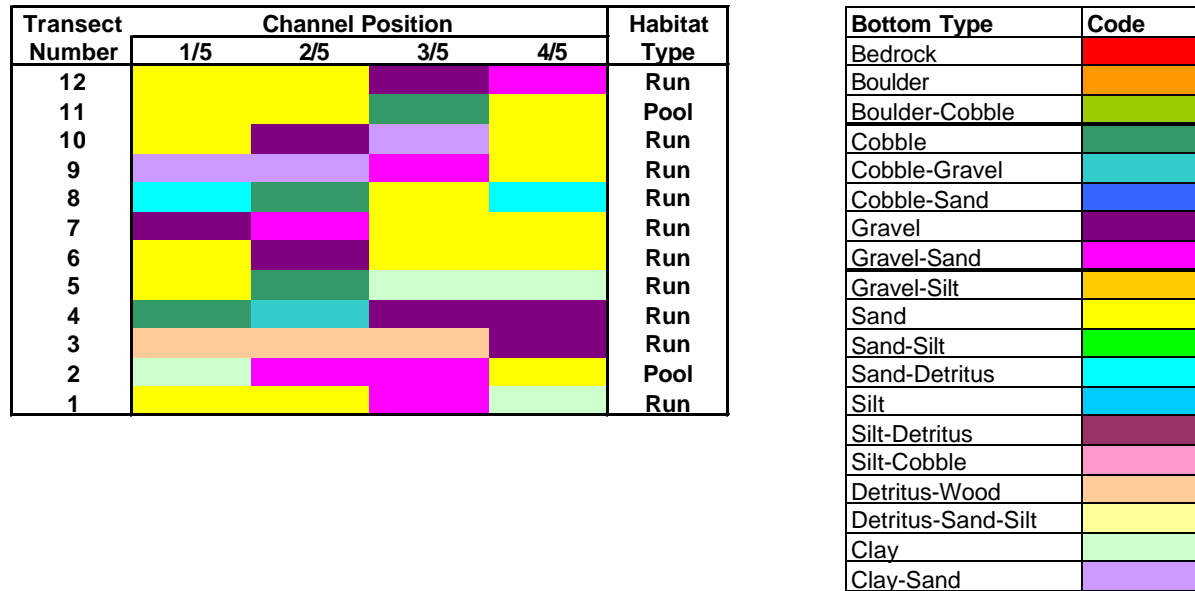
Figure 41. Bottom sediment map and key for the survey site upstream of Eliason Road on Larson Creek. Transect 1 is the furthest downstream sampling location.

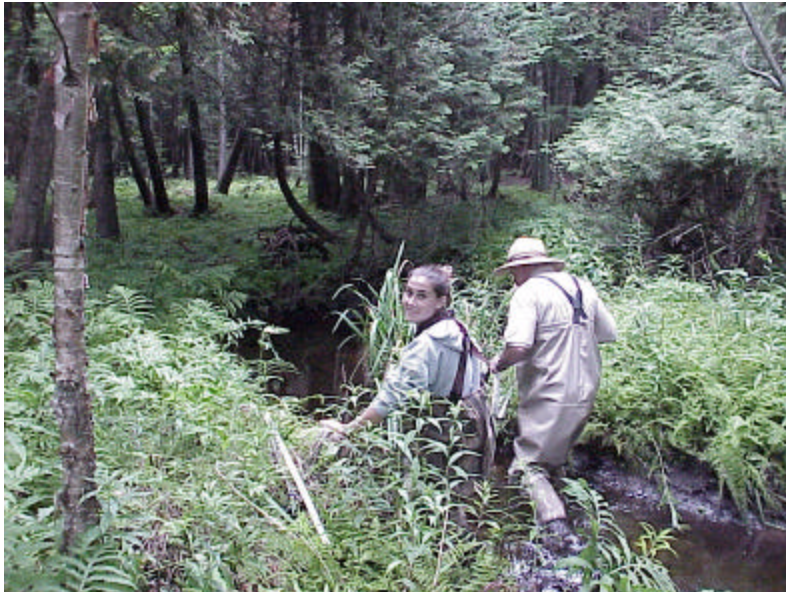
Figure 42. Field staff measuring habitat on Clay Banks Creek. The bare soil banks that can be seen in this picture were common throughout the site.

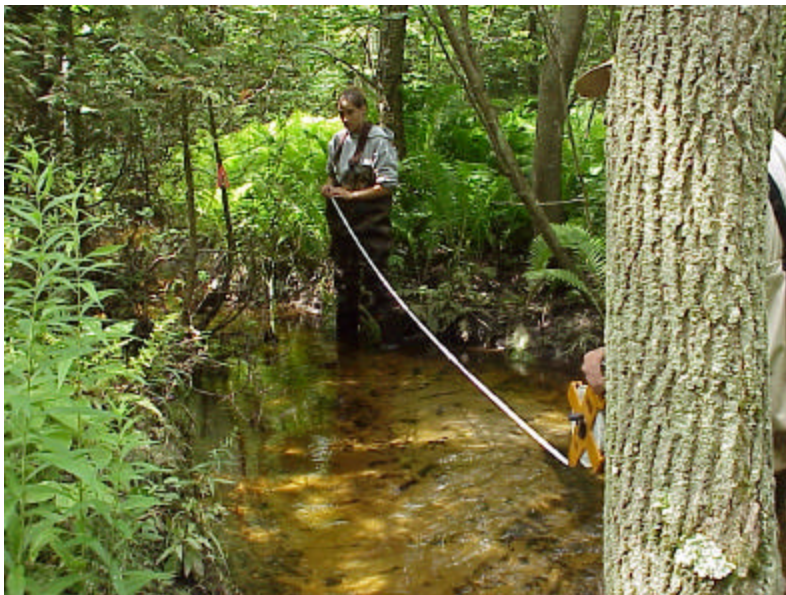
Figure 44. Field staff measuring feature length on Woodward Creek.

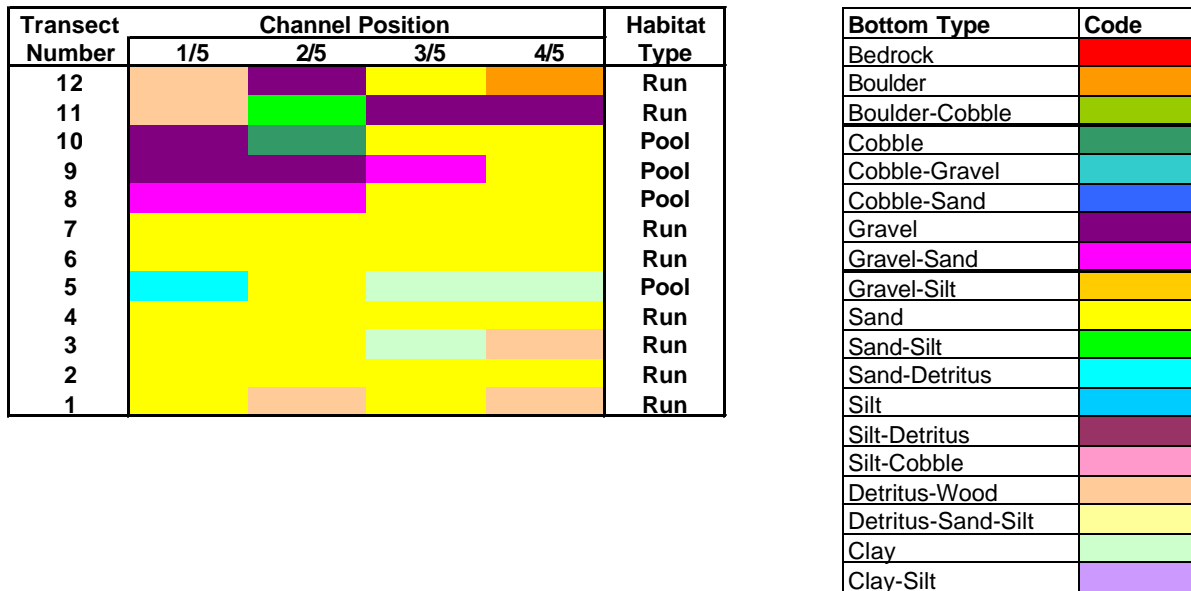
Figure 45. Bottom sediment map and key for the survey site upstream of County U on Woodward Creek. Transect 1 is the furthest downstream sampling location.

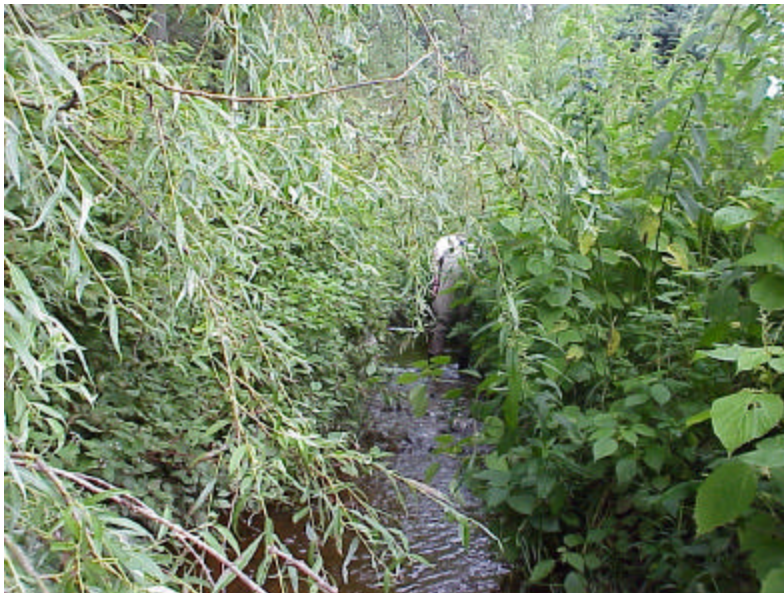
Figure 46. Field staff measuring stream width on Schuyler Creek. Dense vegetation was common throughout the survey site.

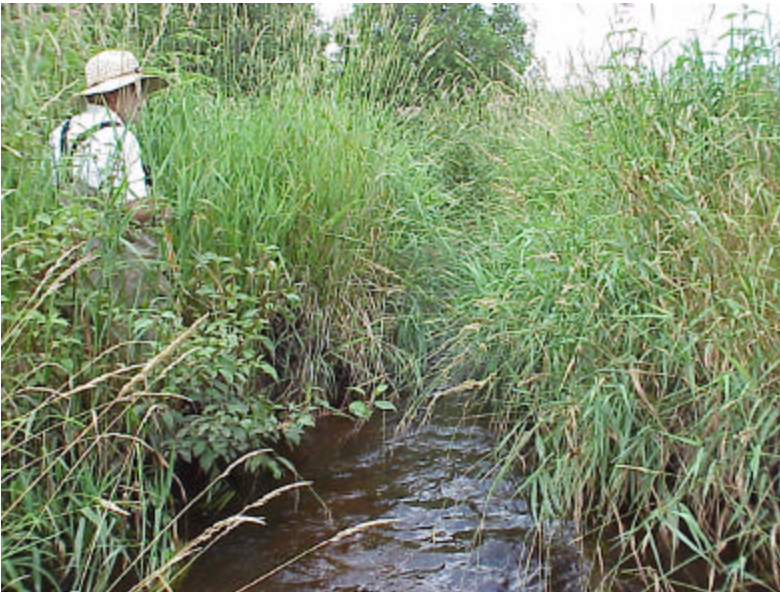
Figure 48. Thick meadow vegetation was common in lower reaches of the study site on Bear Creek before giving way to shrubs in upper reaches.

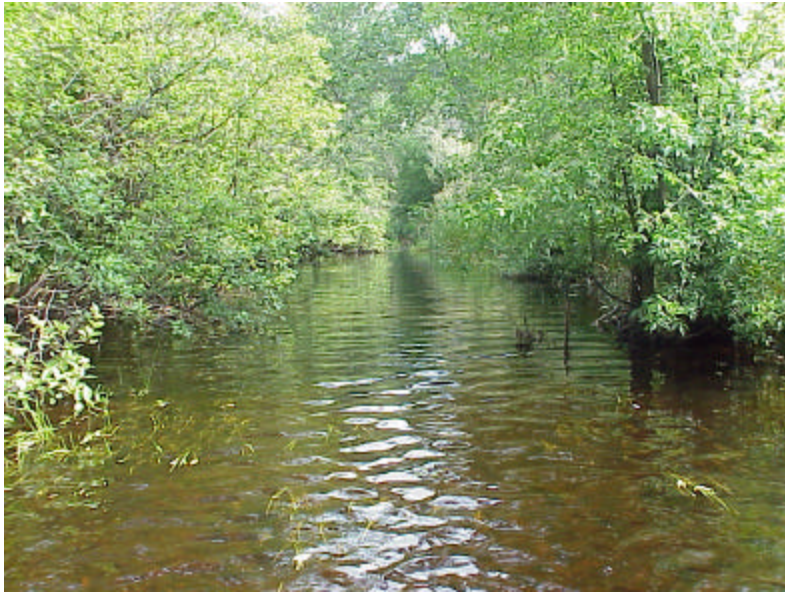
Figure 50. An upstream look at Stony Creek from above Rosewood Road showing the wooded stream bank and stained water.

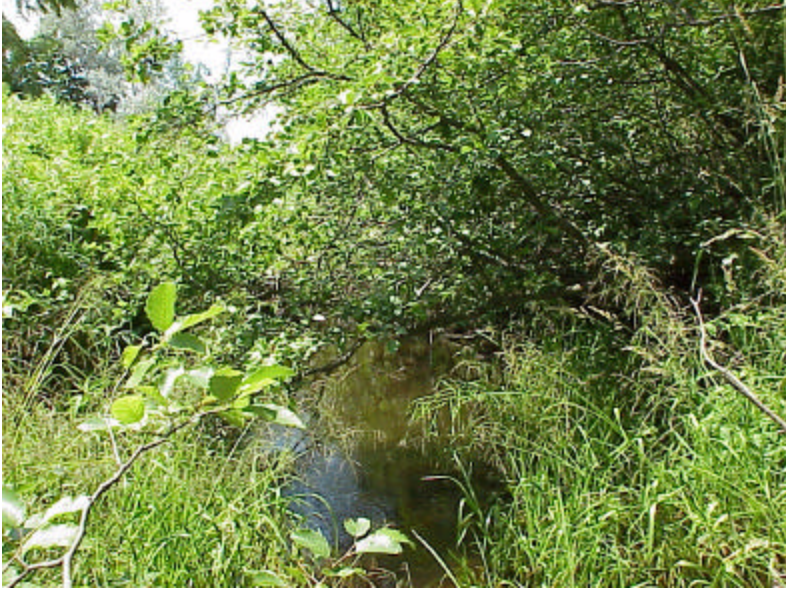
Figure 54. An upstream look at Stony Creek from above Maplewood Road showing the dense shrub cover encountered at the lower end of the survey location.

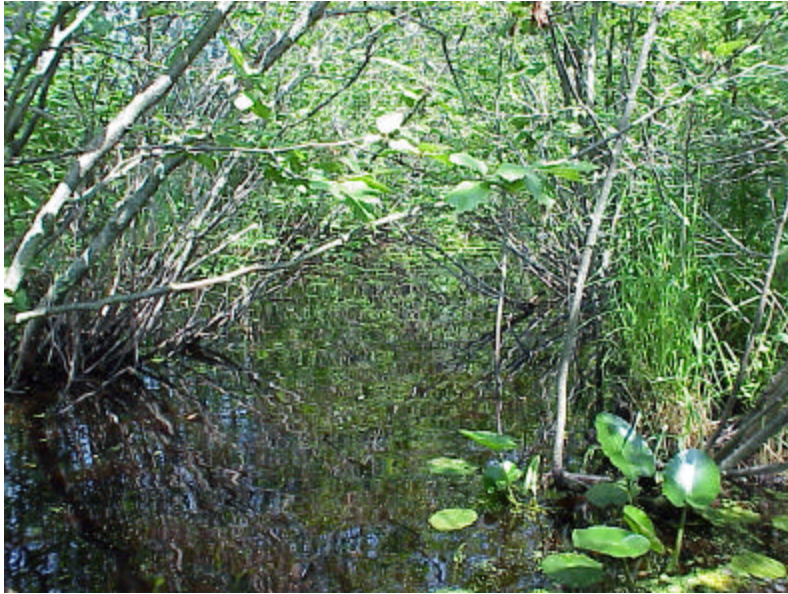
Figure 57. Looking upstream on Kolstad Creek at the shrub/wetland complex that was common throughout the survey station.

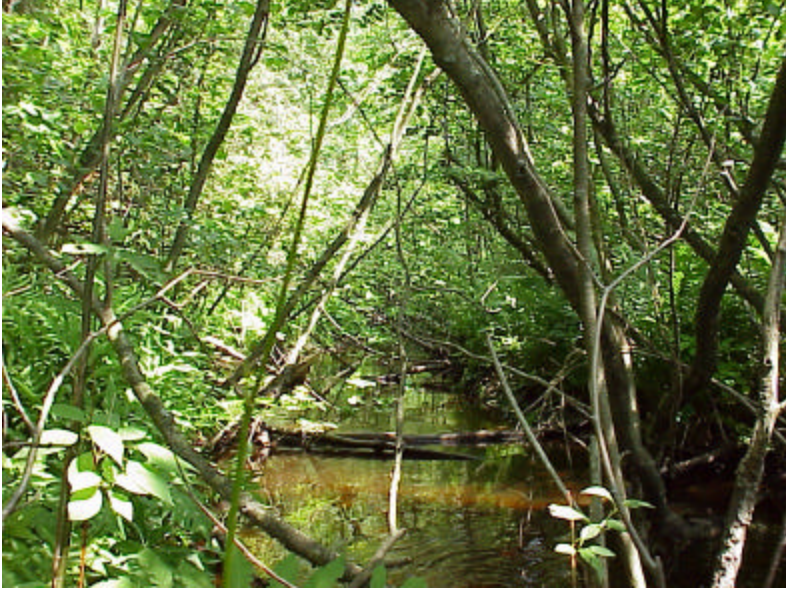
Figure 59. Looking upstream on a wooded section of Kramer Creek.

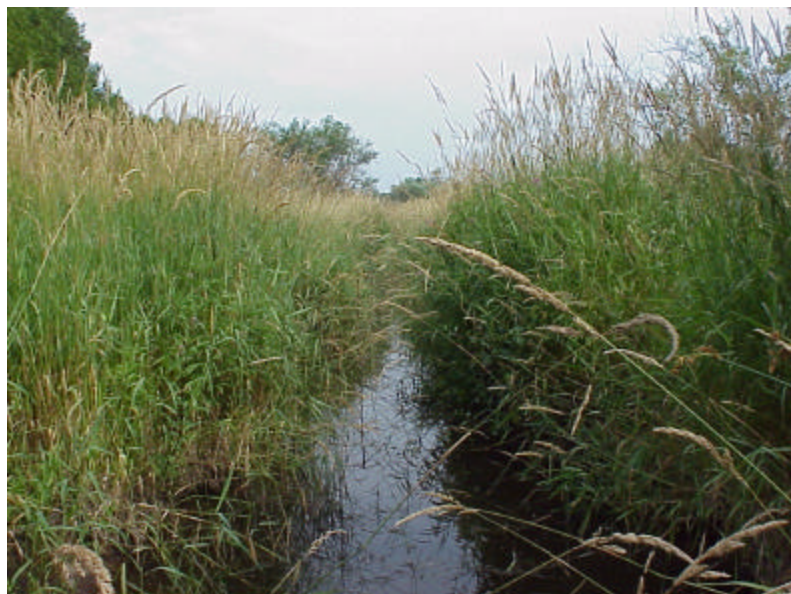
Figure 61. The dense meadow was common throughout the survey station upstream of Jackson Road on Silver Creek.
