2003-2004 Door Peninsula Baseline Monitoring Report

By Steve Hogler, Steve Surendonk and Mary Gansberg

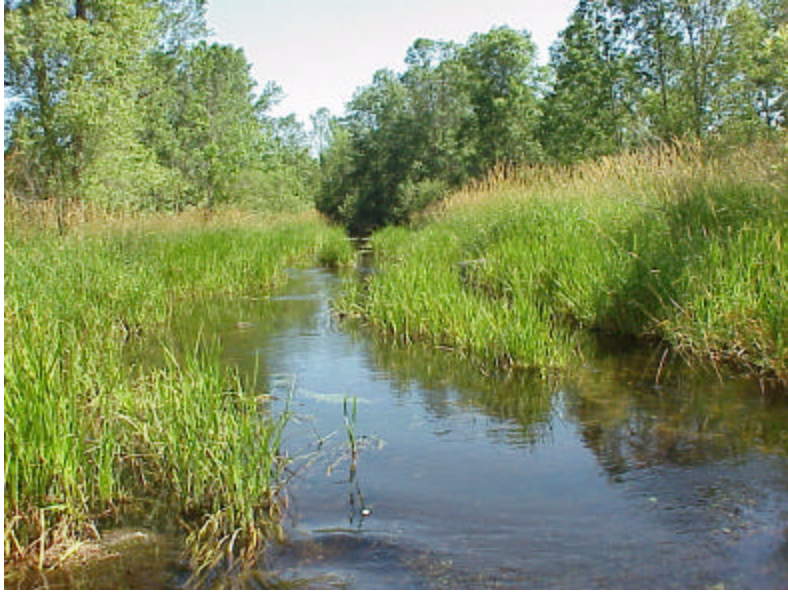
The survey location on the Ahnapee Rivers was upstream of Door County Highway H (N44.7482, W-087.5366 to N44.7505, W-087.5354). The survey section on the Ahnapee River averaged 8.54 meters in width resulting in a survey station that was 306 meters in length. The Ahnapee River has a gradient of 1.08 meters per kilometer, and a sinuosity of 1 to 1.27. The study reach of the river ran through a meadow-woodland-shrub landscape (Figure 64).

Figure 64. This upstream facing photo on the Ahnapee River shows the typical meadow-woodland-shrub landscape found at this survey site.

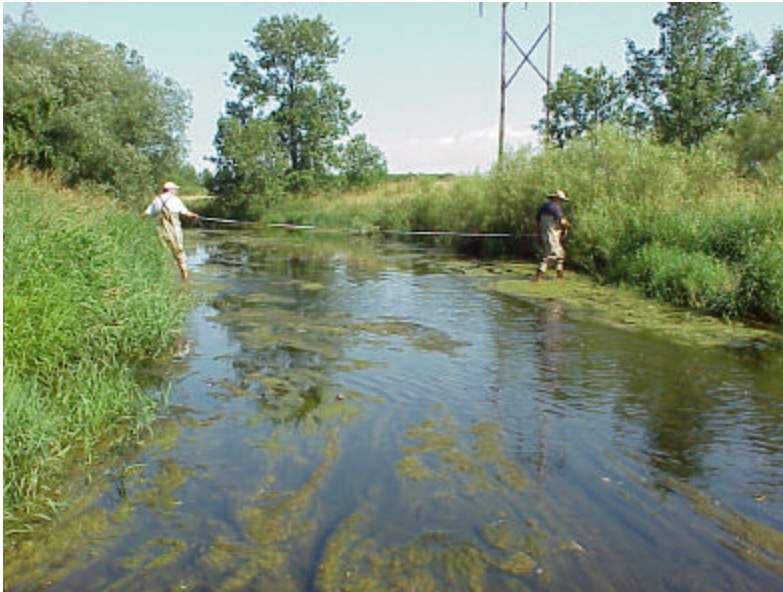
The survey location at this site on Silver Creek was upstream of Kewaunee County Highway S (N44.6179, W-087.4890 to N44.6199, W-087.4910). The survey section on Silver Creek averaged 9.2 meters in width resulting in a survey station that was 306 meters in length. Silver Creek has a gradient of 0.36 meters per kilometer, and a sinuosity of 1 to 1.20. The study reach of the river ran through either a meadow-woodland or a meadow-shrub landscape (Figure 67).

Figure 67. Measuring stream width on Silver Creek upstream of Highway S.

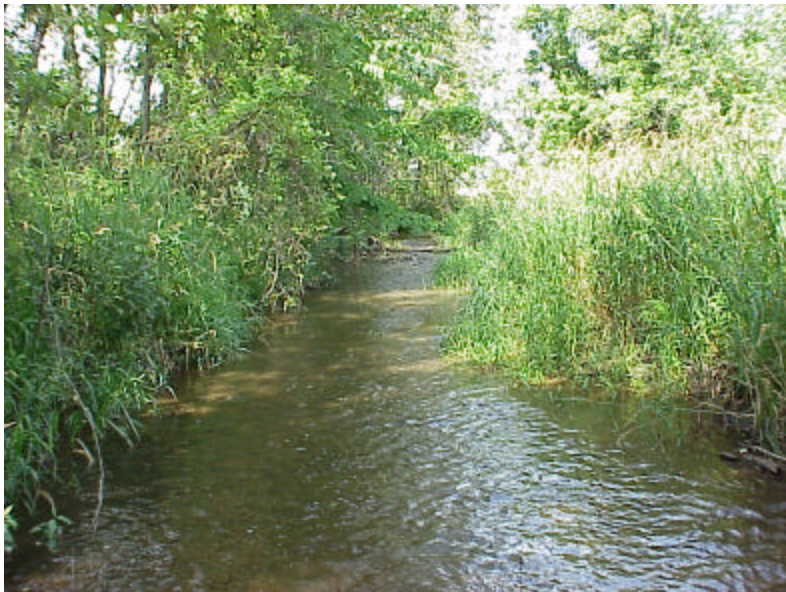
The survey location at this site on Silver Creek was upstream of Black Ash Road (N44.6358, W-087.5463 to N44.6365, W-087.5470). The survey section on Silver Creek averaged 3.5 meters in width resulting in a survey station that was 92 meters in length. Silver Creek has a gradient of 1.83 meters per kilometer, and a sinuosity of 1 to 1.29. The study reach of the river ran through a meadow-woodland landscape (Figure 69).

Figure 69. Looking upstream on Silver Creek at Black Ash Road.

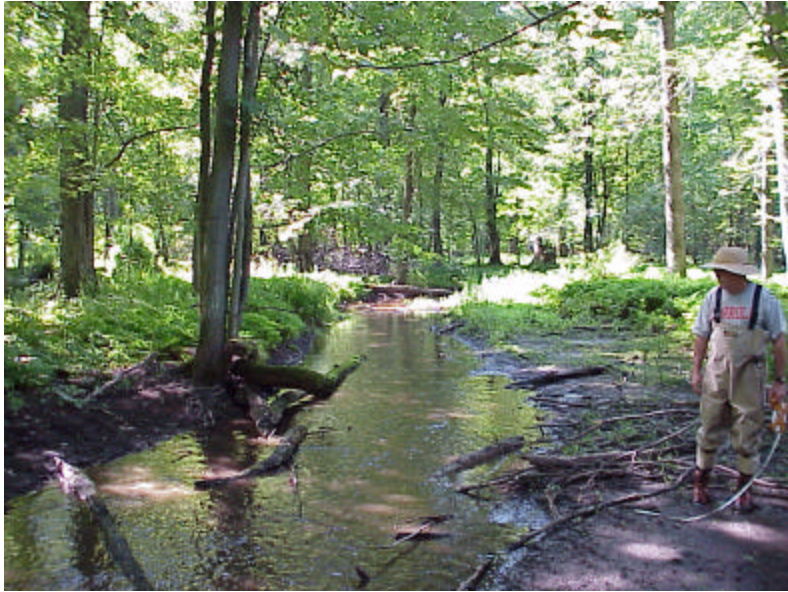
The survey location on Rio Creek was upstream of Kewaunee County Highway S (N44.6181, W-087.5244 to N44.6168, W-087.5703). The survey section on Rio Creek averaged 3.1 meters in width resulting in a survey station that was 92 meters in length. Rio Creek has a gradient of 0.34 meters per kilometer, and a sinuosity of 1 to 1.16. The study reach of the river ran through 100 percent woodland (Figure 71).

Figure 71. Upstream of Highway S, Rio Creek flows through woodland that shades the stream and adds wood to the stream .

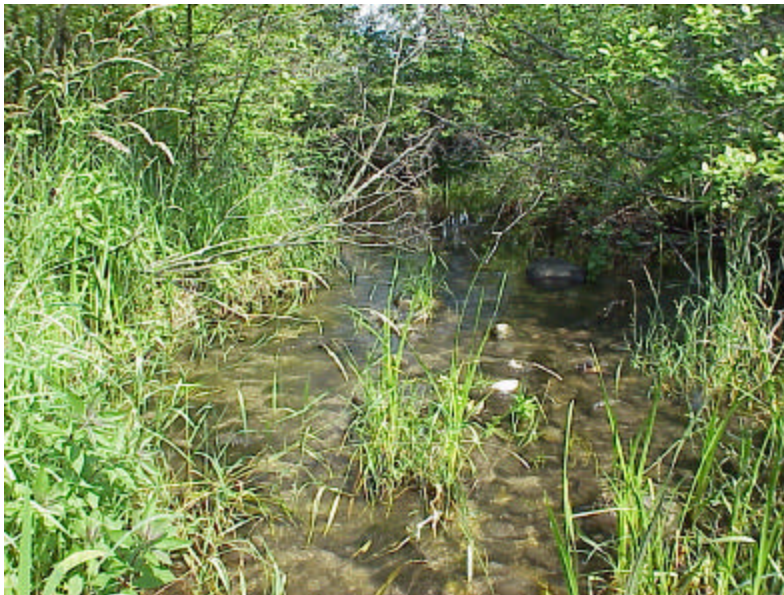
The survey location on Silver Creek was upstream of Stevenson Pier Road (N44.7601, W-087.5400 to N44.7593, W-087.5413). The survey section on Silver Creek averaged 5.74 meters in width resulting in a survey station that was 204 meters in length. Silver Creek has a gradient of 1.01 meters per kilometer, and a sinuosity of 1 to 1.33. The study reach of the river ran through a meadow-shrub-woodland complex (Figure 73).

Figure 73. Looking upstream of Stevenson Pier Road on Silver Creek.

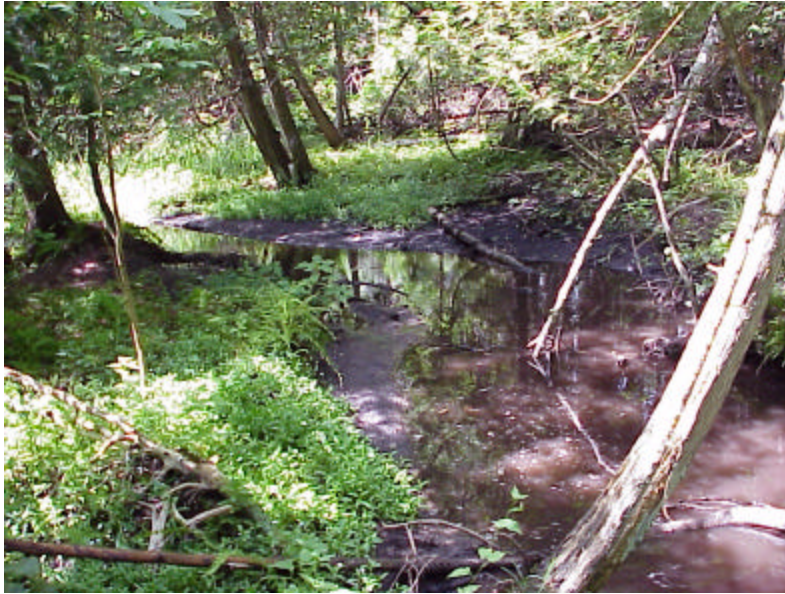
The survey location on Three Mile Creek was upstream of Longfellow Road (N44.5854, W-087.4642 to N44.5850, W-087.4653). The survey section on Three Mile Creek averaged 2.7 meters in width resulting in a survey station that was 92 meters in length. Three Mile Creek has a gradient of 14.5 meters per kilometer, and a sinuosity of 1 to 1.16. The study reach of the river ran through a cedar woodland (Figure 76).

Figure 76. A view of the wooded Three Mile Creek upstream of Longfellow Road.

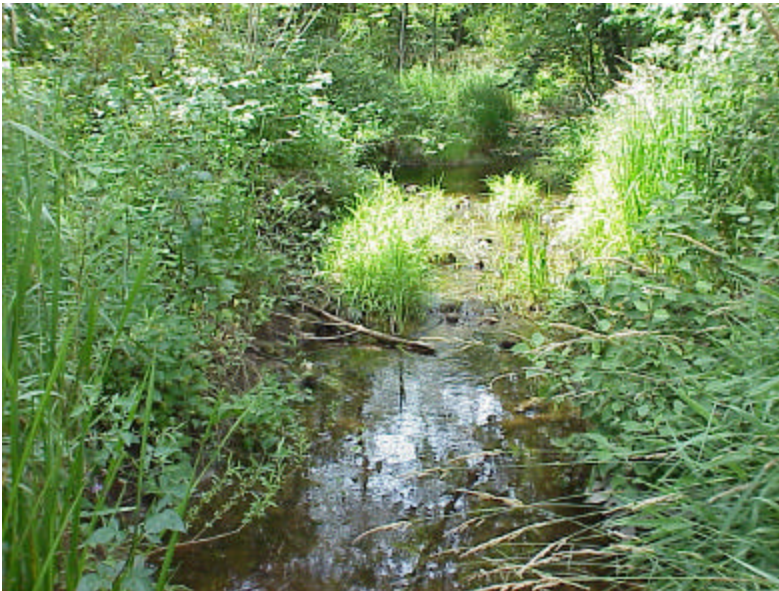
The survey location on Mashek Creek was upstream of Lakeshore Drive (N44.5032, W-087.4868 to N44.5029, W-087.4882). The survey section on Mashek Creek averaged 3.3 meters in width resulting in a survey station that was 92 meters in length. Mashek Creek has a gradient of 10.09 meters per kilometer, and a sinuosity of 1 to 1.16. The study reach of the river ran through shrub-woodland (Figure 78).

Figure 78. An upstream view of Mashek Creek upstream of Lakeshore Drive.

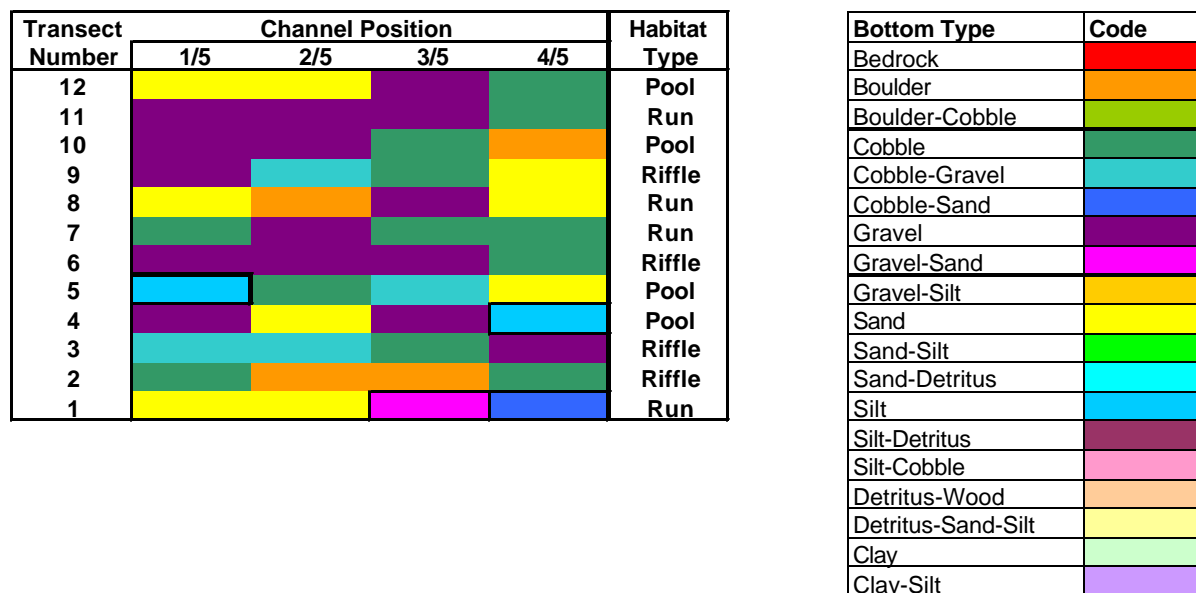
Figure 79. Bottom sediment map and key for the survey site upstream Lakeshore Drive on Mashek Creek. Transect 1 is the furthest downstream sampling location.
