# **An Aquatic Plant Management Plan for Townsend Flowage, Oconto County, Wisconsin**

**Townsend Flowage Lake Association  
c/o John Brantmeier  
17643 Bennett Lane  
Townsend, WI, 54175**

**December 19, 2006**

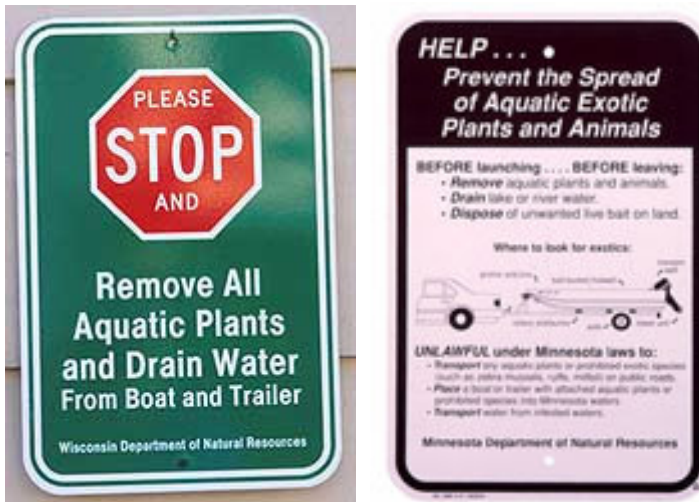
**Figure 14. Exotic species prevention signs available through the Wisconsin DNR.**

It is important that the boat landings on Townsend Flowage be posted with exotic species prevention signs. There are signs available through the Wisconsin DNR (see **Figure 14**). These signs should be posted and maintained at all access points to Townsend Flowage including boat launches and walk-ins. Many lake organizations choose to design and erect larger signs designed to call attention to specific concerns related to their lake.

Since exotic species have not yet been found in Townsend Flowage, the focus of these signs should be education and prevention.

It is recommended that all signs posted around the Flowage encourage boaters entering or leaving the lake to remove any plant or animal material from their watercrafts.

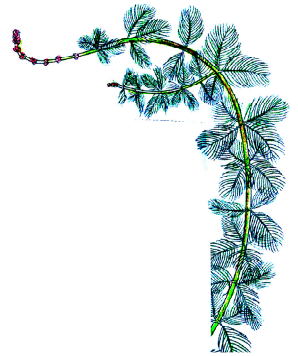
Eurasian watermilfoil (*Myriophyllum spicatum*) produces long spaghetti-like stems that often grow up to the water's surface. Leaves are feather-like and resemble bones on a fish. 3-5 leaves are arranged in whorls around the stem, and each leaf contains 12-21 pairs of leaflets. At mid-summer small reddish flower spikes may emerge above the water's surface. Perhaps the most distinguishing characteristic though, is the plant's ability to form dense, impenetrable beds that inhibit boating, swimming, fishing, and hunting.

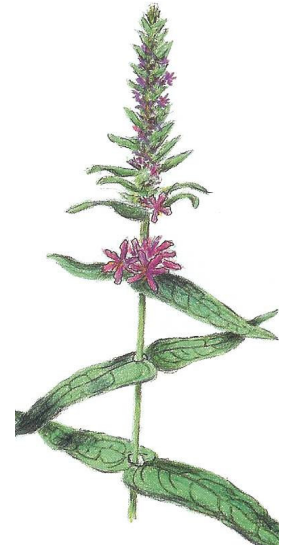
Purple loosestrife (*Lythrum salicaria*) forms bright purple flowers in a spike atop stems that reach 2 to 7 feet in height. Lance-shaped leaves are arranged oppositely along the stem. Purple loosestrife can be found in a wide variety of habitats from shallow water to moist soils. Like Eurasian watermilfoil it is a very aggressive plant that can displace many native wetland plants including cattails (*Typha spp.*). Purple loosestrife plants produce hundreds of thousands of tiny seeds. When purple loosestrife is cut, seeds stick to mowing equipment and are spread to new locations. This invasive plant causes significant economic damage by clogging waterways and irrigation canals. Unlike cattails, purple loosestrife has little food or cover value for wildlife (Borman et. al. 1997).

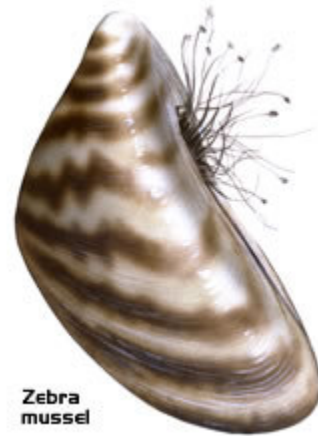
Zebra mussels (*Dreissena polymorpha*) are small (1/4" to 2") mollusks with elongated shells marked by alternating light and dark markings. They produce dense elastic strands, called byssal threads, by which they can securely attach to nearly any surface, often forming barnacle-like incrustations. Mussels spawn in the early spring when water temperatures reach 54° F. Fertilized eggs develop into microscopic free-swimming larvae called veligers. After three to four weeks, the surviving veligers settle onto firm objects where they quickly attach themselves. Within a year the young grow into adults that can live four to six years.

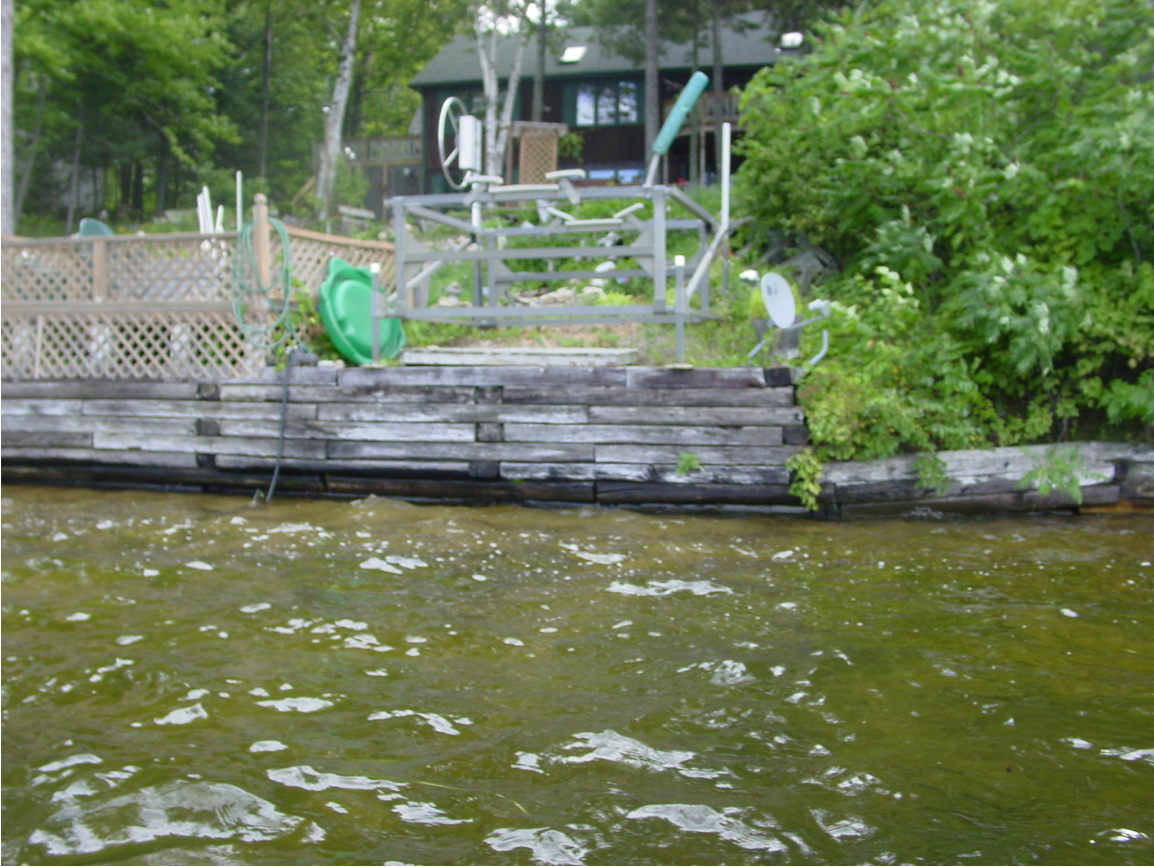
An example of this can be seen in the picture on the next page. These structures, often referred to as sea walls can provide some shoreline stabilization, but are detrimental to a number of plant and animal species. In particular, species such as reptiles and amphibians move frequently to and from the water. These sea walls deny the level of access these species require. Benefits to lake water quality, fishery and wildlife could be achieved by restoring shoreline plants in Townsend Flowage. Lakefront habitat improvement is often done on a property-by-property basis. In recent years many new techniques have been developed for restoring lakefronts. This type of work often
