ALPINE LAKE

WAUSHARA COUNTY, WISCONSIN

AQUATIC PLANT MANAGEMENT PLAN & PRELIMINARY WATERSHED INVESTIGATION

June 2003

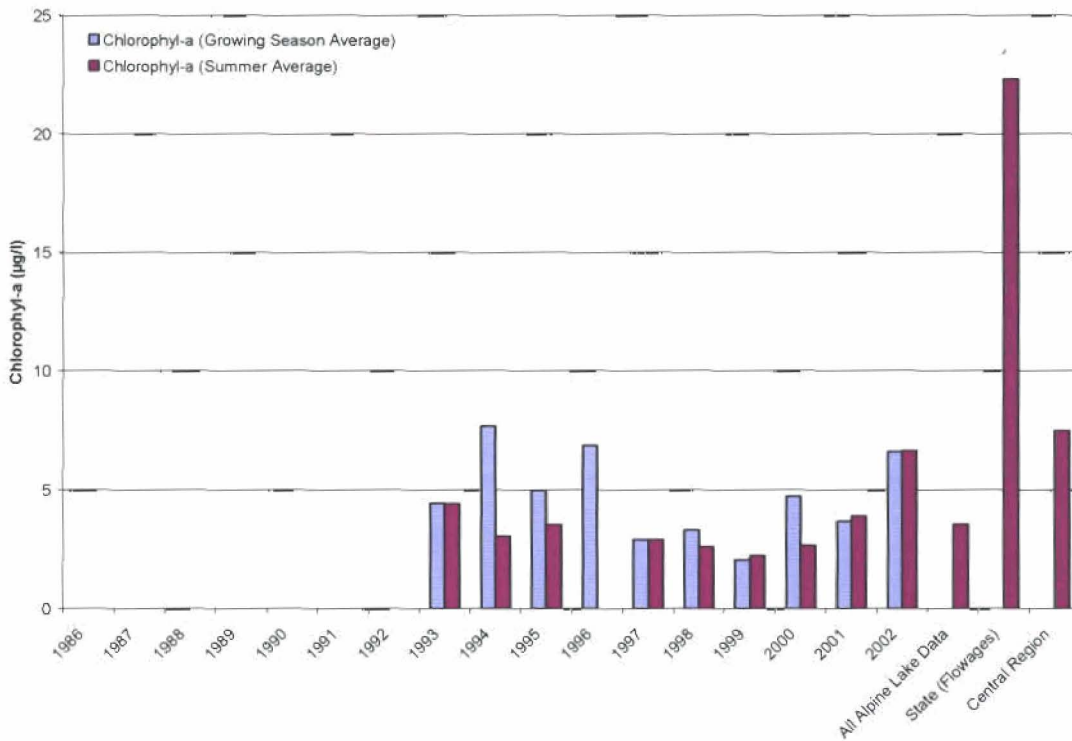
Figure 3. Mean chlorophyll-a concentrations from Alpine Lake, state and central region. All means were calculated from summer samples.

As indicated in Figure 2, the phosphorus levels within Alpine Lake vary from year to year and do not indicate apparent trends. Chlorophyll-*a* levels (Figure 3) and Secchi disk transparency (Figure 4) follow the same suit of variability from year to year. Interestingly, the two years with the highest summer phosphorus levels of the past decade, 1997 and 1998, exhibited some of the lowest chlorophyll-*a* concentrations over the same time period. It is unclear why this occurred, but one explanation may be that concentrations of total phosphorus (as reported here) include all forms of phosphorus found in lake water including particulate and dissolved forms and the phosphorus bound in *phytoplankton* and *zooplankton*. The only form that is readily available to algae is the dissolved phosphorus. Therefore, even though the total phosphorus concentrations were higher at that time, the dissolved form may have been low and did not spur higher algal abundance. This phenomenon was not apparent during the summer of 2002 when both total phosphorus and chlorophyll-*a* concentrations were higher than normal. The higher algal abundance resulted in reduced water clarity as indicated by the shallower Secchi disk depths found during the same time period. It is very likely that the elevated total phosphorus concentrations were brought on by higher than normal precipitation levels during the spring and early summer as increased runoff washed sediment and phosphorus into the lake from its drainage basin.

Figures 2-4 also indicate that Alpine Lake's water quality is much better than other flowages within the state and it is equal or better than average findings for lakes within the central region. Comparisons with the central region lakes are particularly interesting because 73% of the lakes sampled in the region were of natural origin (Lillie and Mason 1983). Natural lakes generally have better water quality than impoundments, so it would be expected that the water quality of Alpine Lake, an impoundment, would not compare well with the regional data. On the contrary, it compares very well, indicating that Alpine Lake has good water quality when these three parameters are considered. This is also the case when the data contained in Figures 2-4 are compared with the Water Quality Index (WQI) for Wisconsin lakes found in Table 1. These comparisons show, that for the most part, the WQI for Alpine Lake chlorophyll-*a* and water clarity levels fall within the good to very good categories and the total phosphorus levels fall with in the good classification.

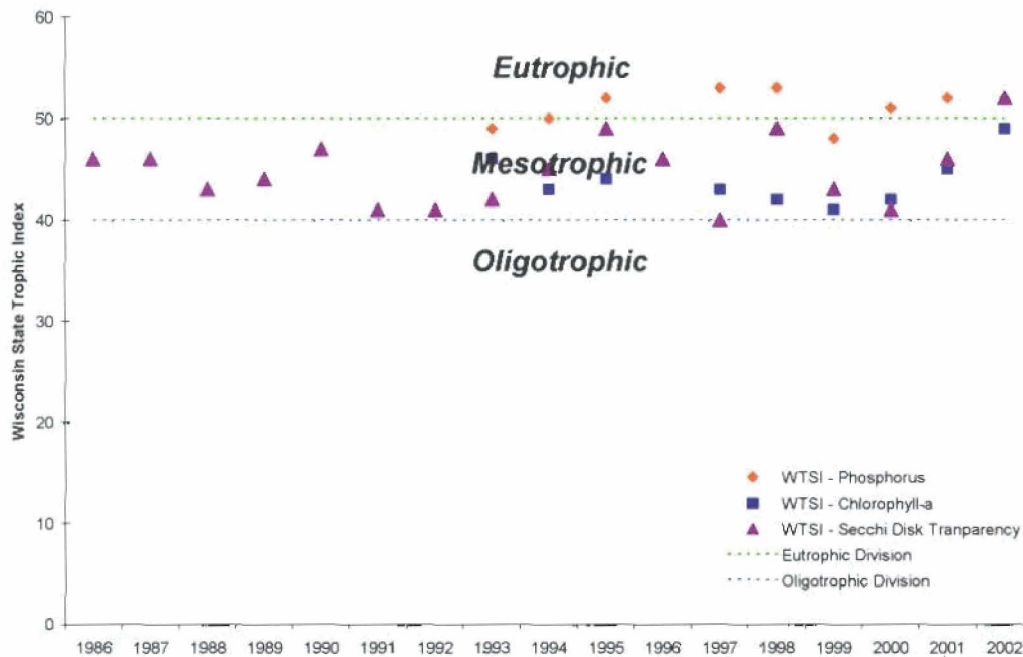
Figure 5. Wisconsin State Trophic Index values for Alpine Lake.

Figure 5 contains the Wisconsin Trophic State Index (WTSI) (Lillie, et al. 1993) values calculated from average surface levels of chlorophyll-*a*, total phosphorus, and Secchi disk transparencies measured during the summer months in Alpine Lake. The WTSI is based upon the widely used Carlson Trophic State Index (TSI) (Carlson 1977), but is specific to Wisconsin lakes. The WTSI is used extensively by the Wisconsin Department of Natural Resources (WDNR) and is reported along with lake data collected by Self-Help Volunteers. For the most part, the chlorophyll-*a* and Secchi disk data indicate that Alpine Lake fluctuates within the mesotrophic state, while the total phosphorus levels indicate the lake is closer to a mesotrophic-eutrophic state. As with the WQI, the WTSI analysis indicates that the Alpine Lake is in

relatively good health. Remember, values that fall into the mesotrophic or eutrophic categories are not indicative of poor lake health. There are benefits associated with the higher rates of productivity found in these lakes. For instance, lakes that are not as productive are unable to support a large fishery.

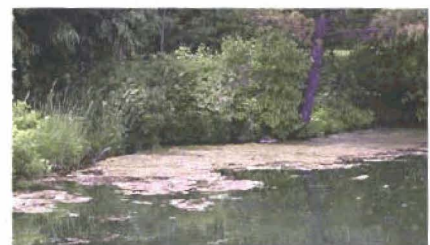
Photo 1. Filamentous algae at Alpine Lake during June 2002.

Algal analysis beyond that of chlorophyll-*a* determinations was outside the scope of this project; nevertheless, it is obvious that filamentous algae play an important role in the ecology, aesthetic value, and nutrient dynamics of Alpine Lake. Like macrophytes, filamentous algae production is not normally accounted for in conventional methods of determining lake water quality and trophic state. The fact of the matter is that most lake samples used for these determinations are collected in open water near the deepest part of the lake in order to obtain a sample indicative of the majority of the lake. In most lakes, filamentous algae are not found in these open water areas, but are instead found tangled in macrophytes or clumped on the windward side of the lake (Photo 1). As a result, this type of algae is not included in the water quality analyses.

During our sampling runs, it was quite obvious that Alpine Lake has an overabundance of filamentous algae, especially in the small bays near the inflow and in the main arm as a whole. The same nutrient loads fueling the macrophyte population in the lake are also fueling these filamentous algae blooms. Additionally, it is likely that these algae are acting somewhat like a filter by removing some the phosphorus that enters the lake through the inlet before it reaches the sample site located near the dam; further supporting the fact that the WTSI is underestimating the trophic state of Alpine Lake.

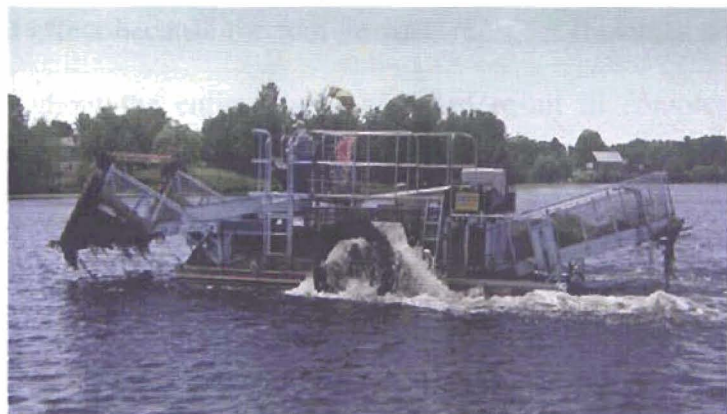
Aquatic plant harvesting is frequently used in Wisconsin and involves the cutting and removal of plants much like mowing and bagging a lawn. Harvesters are produced in many sizes that can cut to depths ranging from 3 to 10 feet with cutting widths of 4 to 10 feet. Plant harvesting speeds vary with the size of the harvester, density and types of plants, and the distance to the off-loading area. Equipment requirements do not end with the harvester. In addition to the harvester, a shore-conveyor would be required to transfer plant material from the harvester to a dump truck for transport to a landfill or compost site. Furthermore, if off-loading sites are limited and/or the lake is large, a transport barge may be needed to move the harvested plants from the harvester to the shore in order to cut back on the time that the harvester spends traveling to the shore conveyor.

Equipment costs vary with the size and features of the harvester, but in general, standard harvesters range between \$45,000 and \$100,000. Larger harvesters or stainless steel models may cost as much as \$200,000. Shore conveyors cost approximately \$20,000 and trailers range from \$7,000 to \$20,000. Storage, maintenance, insurance, and operator salaries vary greatly.
