2004 Lake Lorraine Aquatic Plant Survey Technical Report

June 2008

By J. E. Britton¹ and The Limnological Institute²

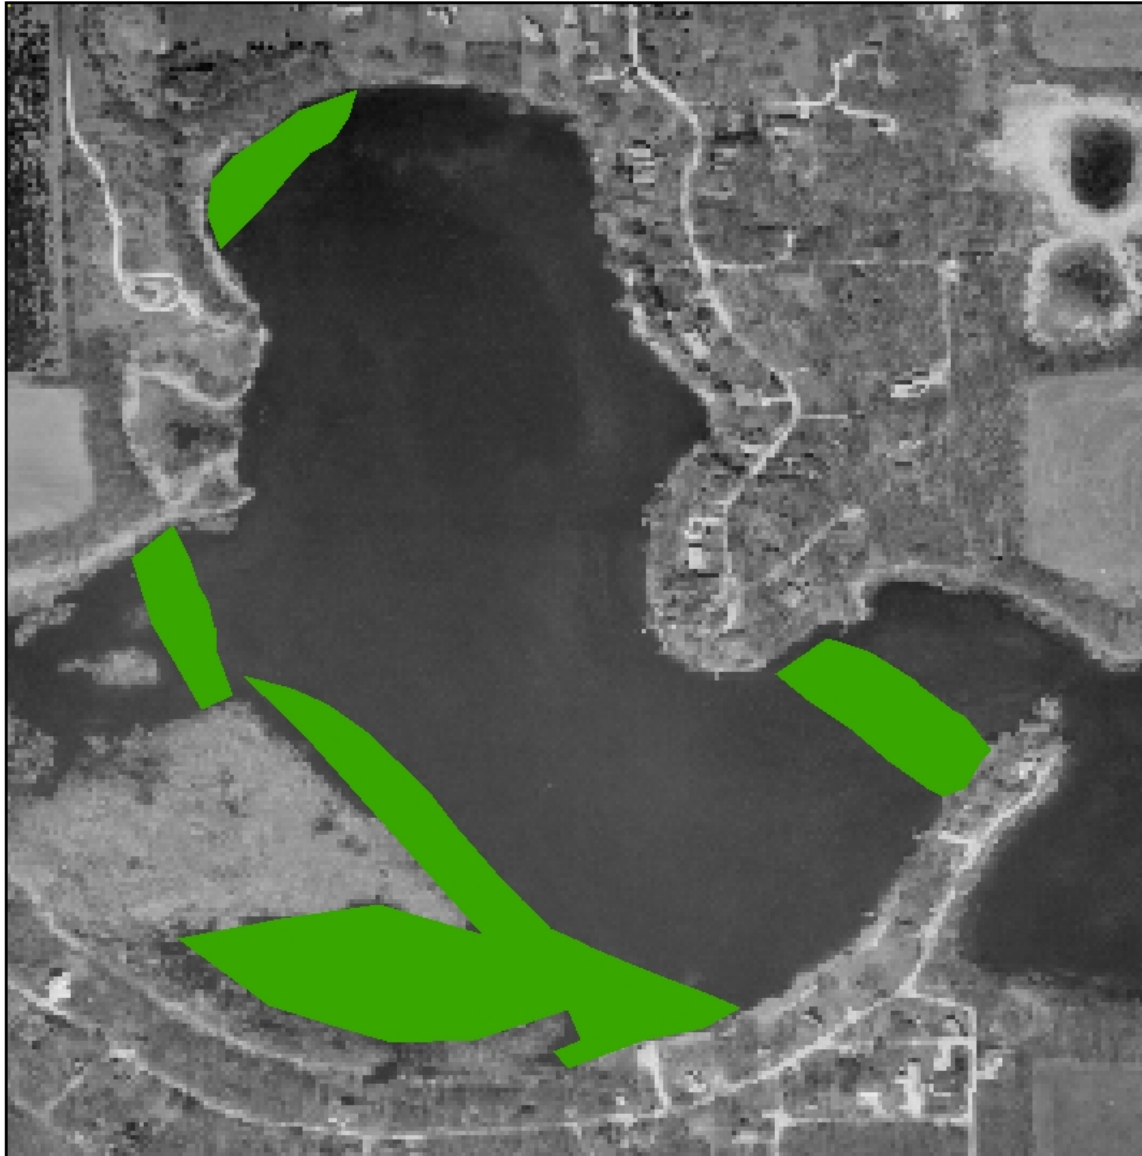
Figure E-5. Total area of floating leaf vegetation within Lake Lorraine (Walworth County, Wisconsin) June, 2004.

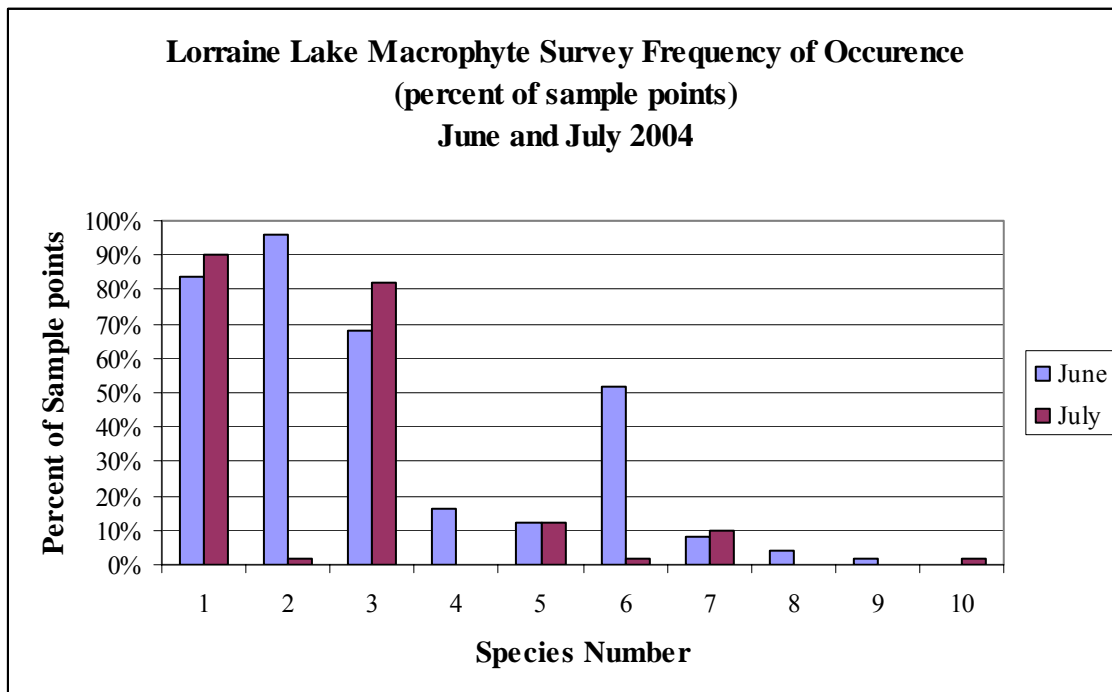
Figure 3. Lake Lorraine macrophyte frequency of occurrence as a percent of sample points during June and July surveys of Lake Lorraine (Walworth County, WI).

The three most common species during the spring survey were Eurasian water-milfoil, curly-leaf pondweed, and coontail. Coontail and EWM were also the most common species found during the summer survey. Of these three species, two are non-native invasive species (EWM and CLP) and were found at nearly every sample site. CLP is a non-native cold water specialist that germinates in late fall, over-winters as an evergreen, reproduces both sexually and asexually, and senesces in the late spring and early summer. The reason for CLP's success is that it has a growth cycle that naturally reduces competition for resources such as nutrients and space.
