# Lake Management Plan for Muskellunge Lake, Vilas County, Wisconsin

July 2005

Prepared by **Steve McComas, Blue Water Science**  
with contributions from **Wisconsin Department of Natural Resources**  
and the **Muskellunge Lake Association**

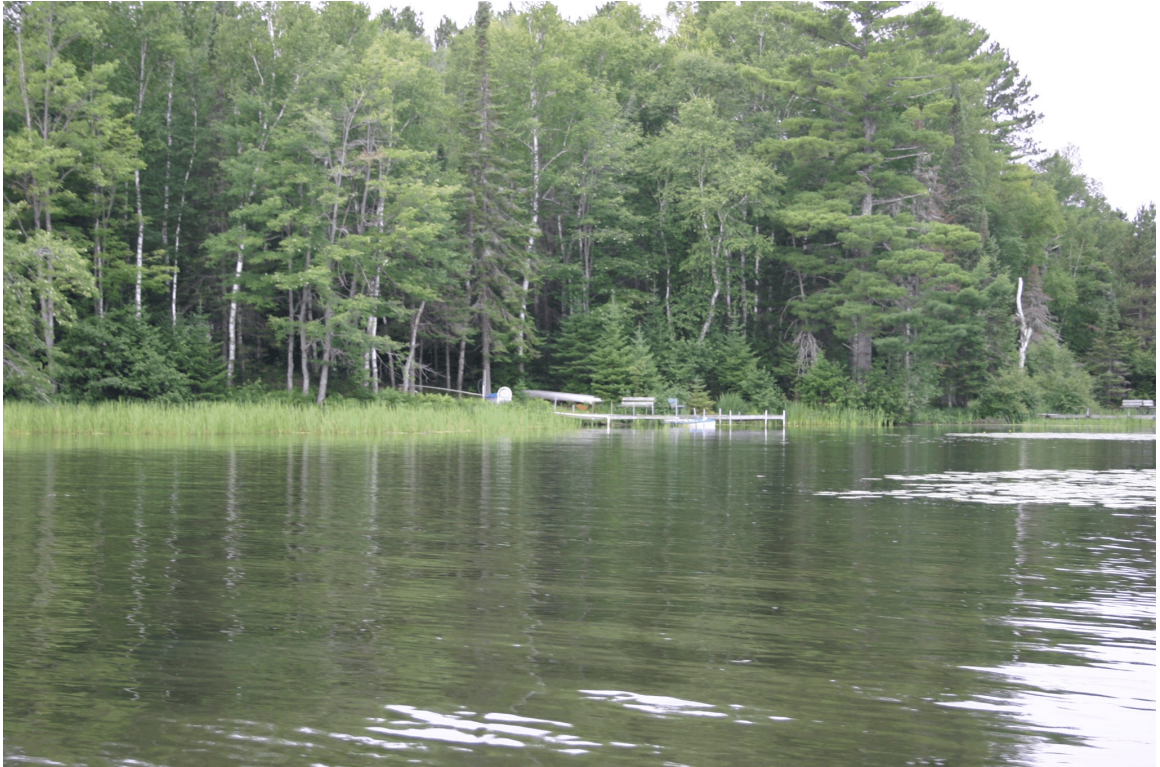
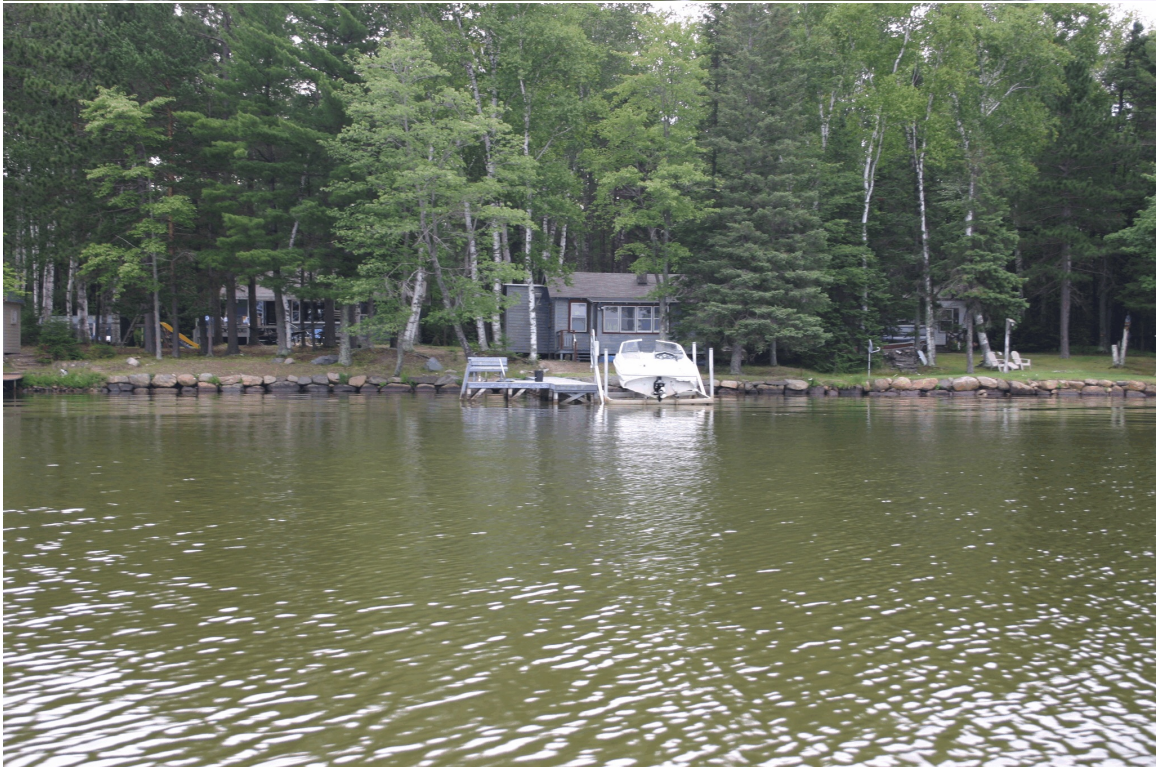
**Figure 6. [top] This parcel would rate as having a shoreline with a buffer greater than 50% of the lot width and an understory with greater than 50% natural cover. [bottom] This parcel would not qualify as having a natural shoreline buffer greater than 50% of the lot width. Also understory in the upland area would be rated as having less than 50% natural cover.**

For analysis, each photograph was evaluated by Blue Water Science staff for shoreline and upland conditions. Our criteria for natural conditions were the presence of 50% native vegetation in the understory and at least 50% natural vegetation along the shoreline in a strip at least 15 feet deep. Although the shoreline recommendations for new development is a 35-foot deep buffer, a 15-foot deep buffer is about the minimum needed to achieve some degree of runoff water quality treatment. We evaluated shorelines and uplands at the 75% natural level as well (Figure 6 illustrates the methodology).

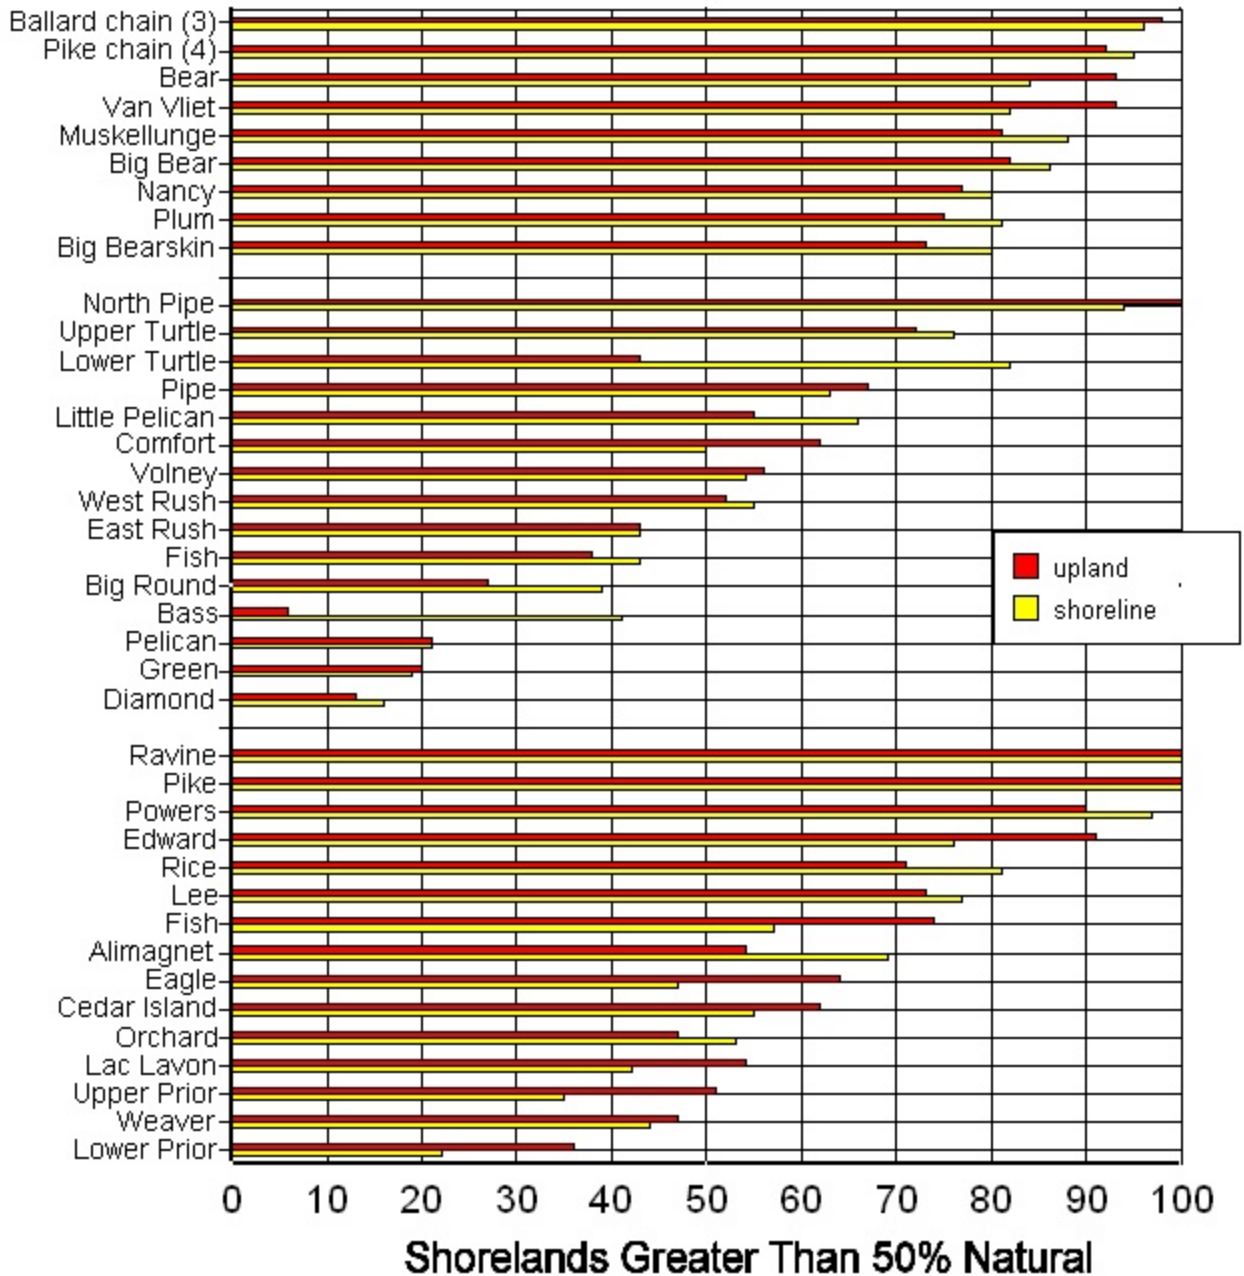
Figure 7. A summary of shoreland inventory results for lakes using an evaluation based on shoreland photographs. For each lake the percentage of shoreline and upland conditions with greater than 50% natural conditions is shown. The first tier of lakes are located in northern Wisconsin. The lower tier of lakes are in the Twin City Metropolitan area and are considered urban lakes. Although several lakes are “urban” lakes most of the shoreland is owned by the city and there is a high percentage of natural conditions. The middle tier of lakes are about an hour or two drive from the Twin Cities, and are not considered to be urban lakes, but are referred to as “country” lakes.

A comparison of Muskellunge Lake conditions to other lakes in Minnesota and Wisconsin is shown in Table 4 and in Figure 7.

Muskellunge Lake is in the northern Wisconsin tier of lakes. It’s natural shoreland conditions are about average compared to the other northern Wisconsin lakes.

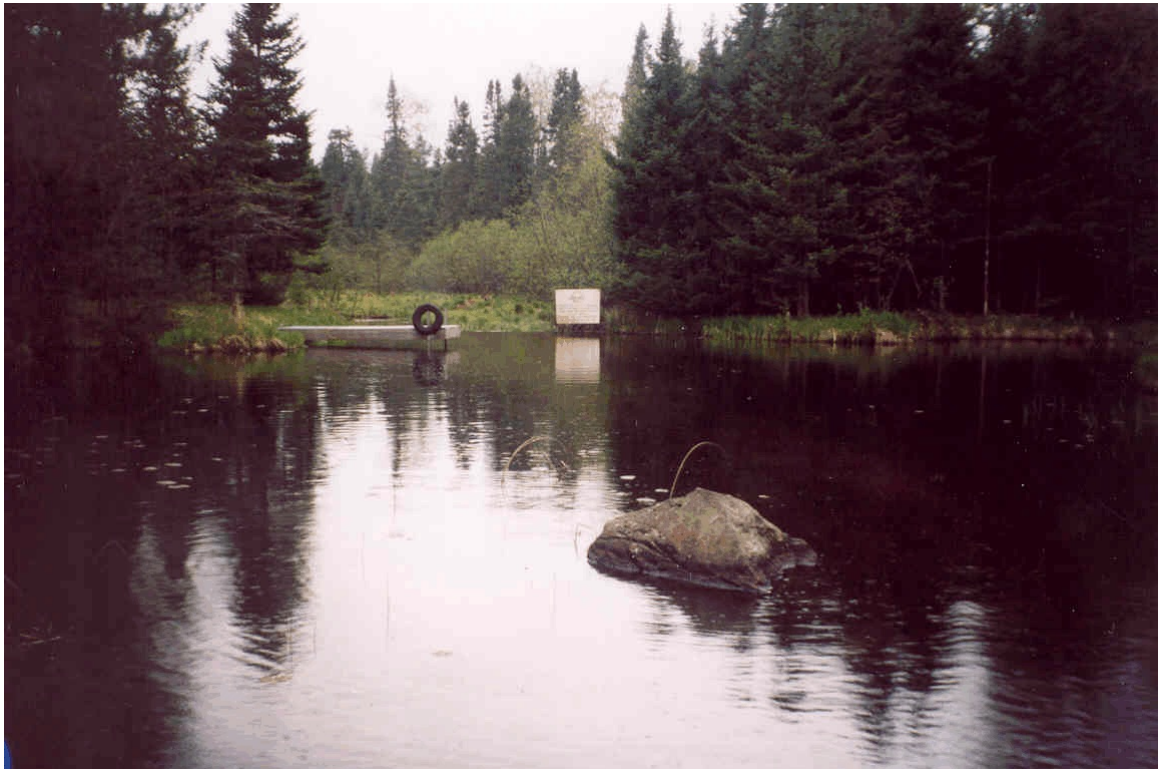
**Figure 11. Outlet area, May 2004.**

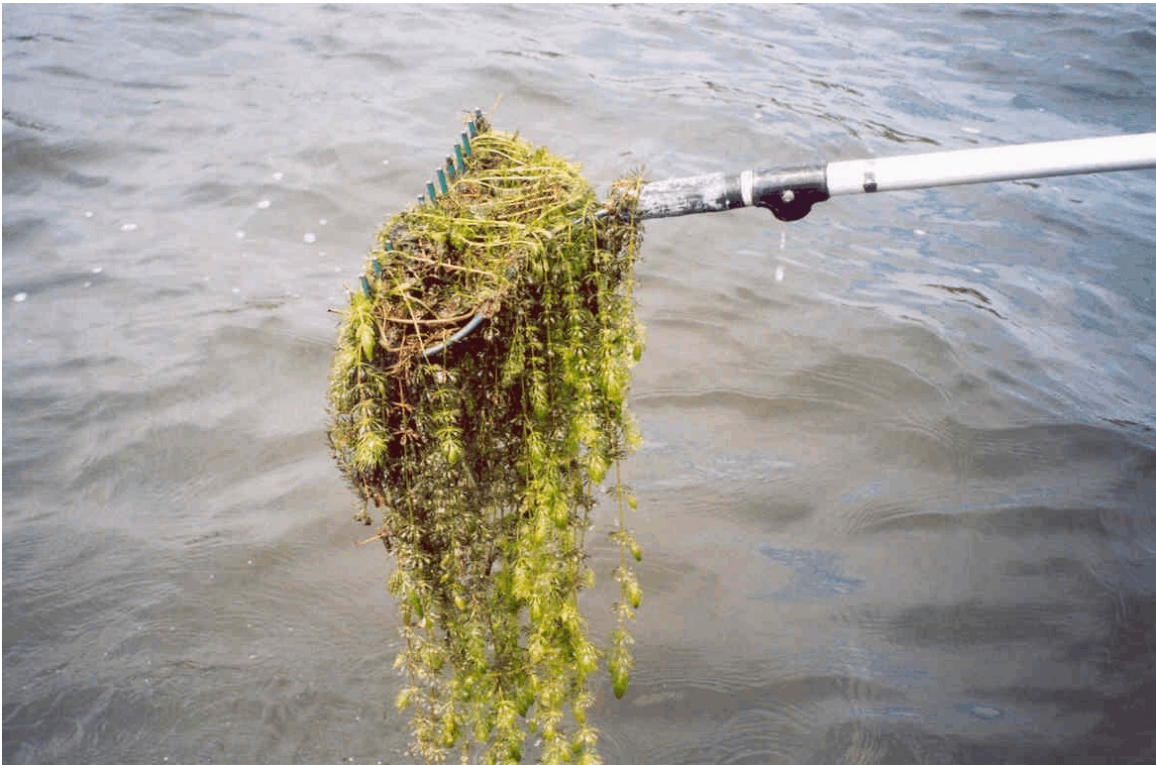
**Figure 18. Coontail is sampled on the rake at a density of 4 on Muskellunge Lake.**

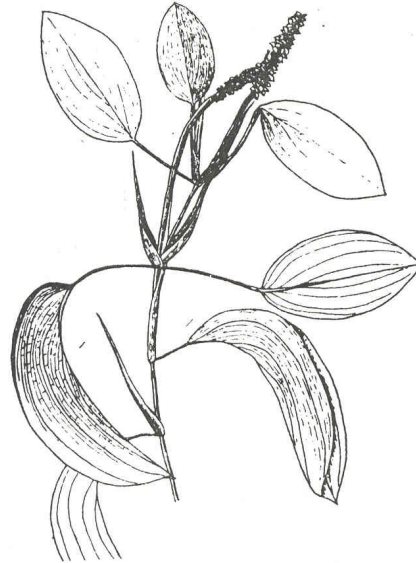
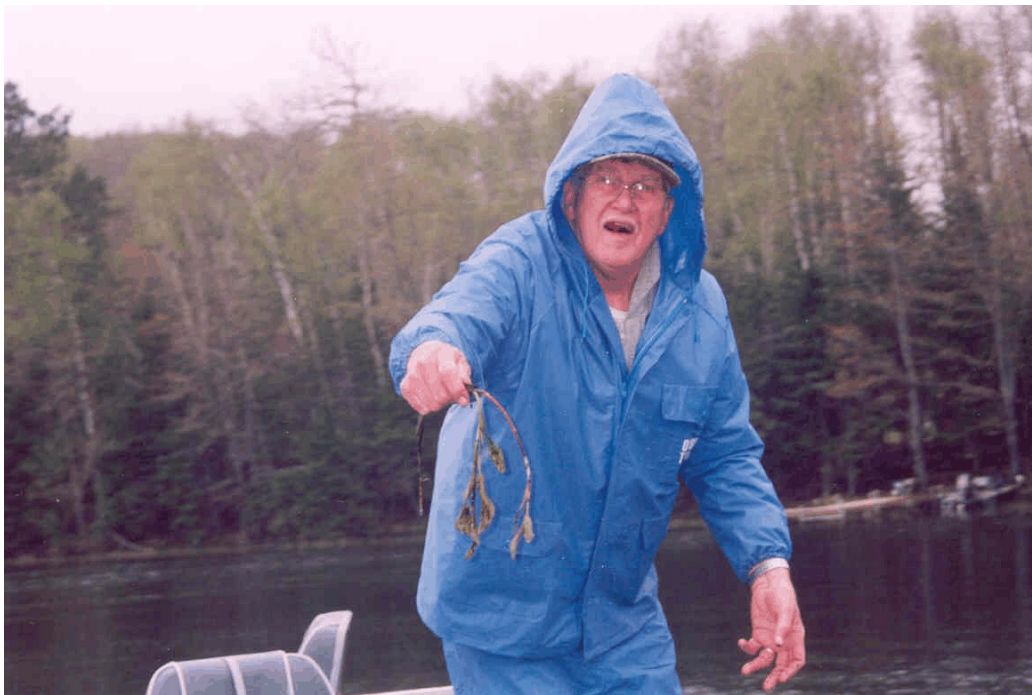
Cabbage (*Potamogeton amplifolius*) is present in all water depths.

Figure 19. [top] Two common plant species found in Muskellunge Lake in May 2004. [bottom] Here a Muskellunge Lake volunteer holds a sample of whitestem pondweed.

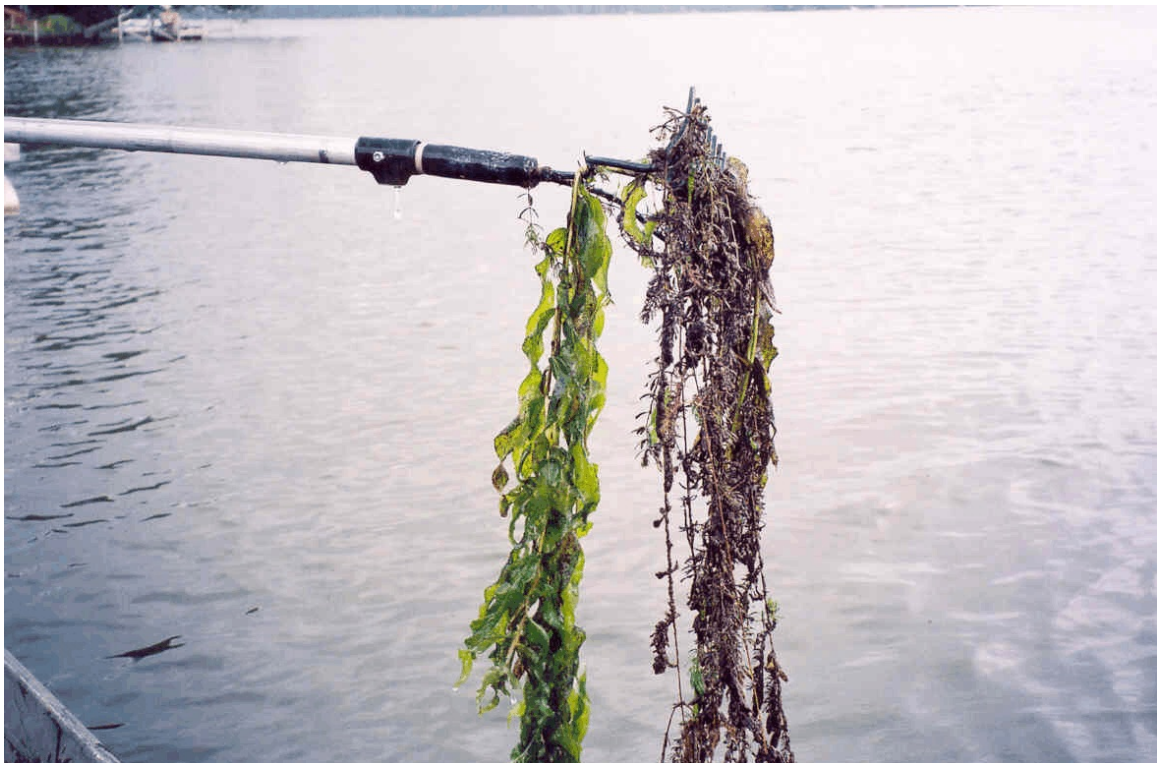
**Figure 22. Aquatic plants on a sample rake on August 25, 2004. Whitestem pondweed is shown on the left and coontail is on the right.**

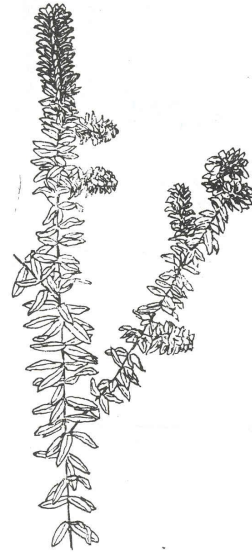
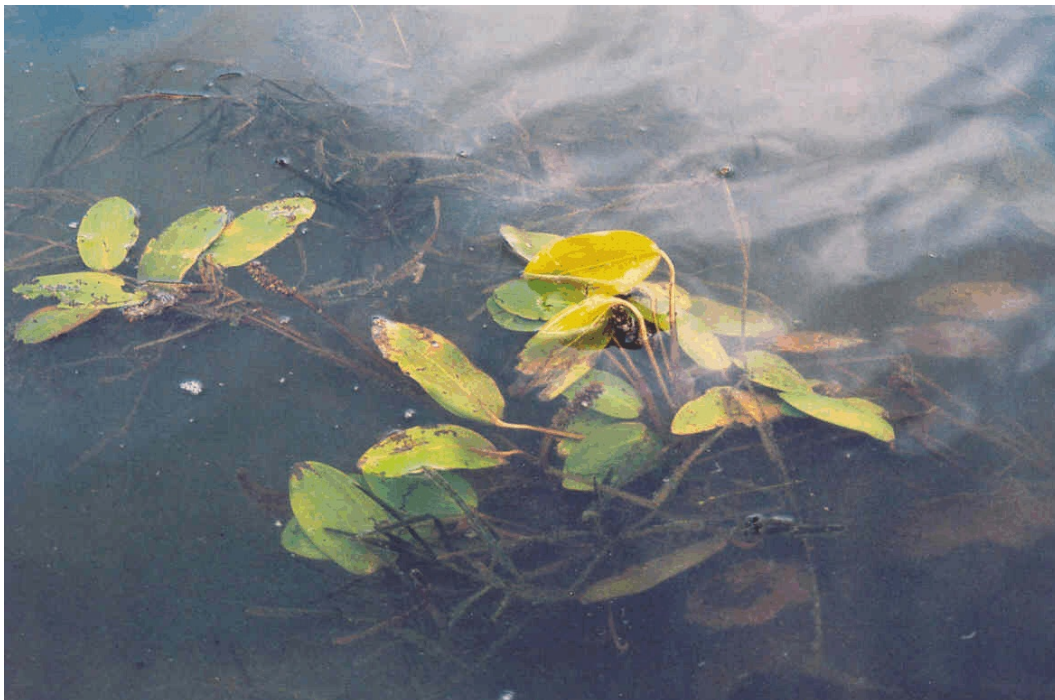
Elodea (*Elodea canadensis*) is present in all water depths.

Figure 23. [top] Two of the common plants found in Muskellunge Lake on August 25, 2004. [bottom] Fern pondweed mixed in with cabbage was common in the August 25 Muskellunge Lake aquatic plant survey.

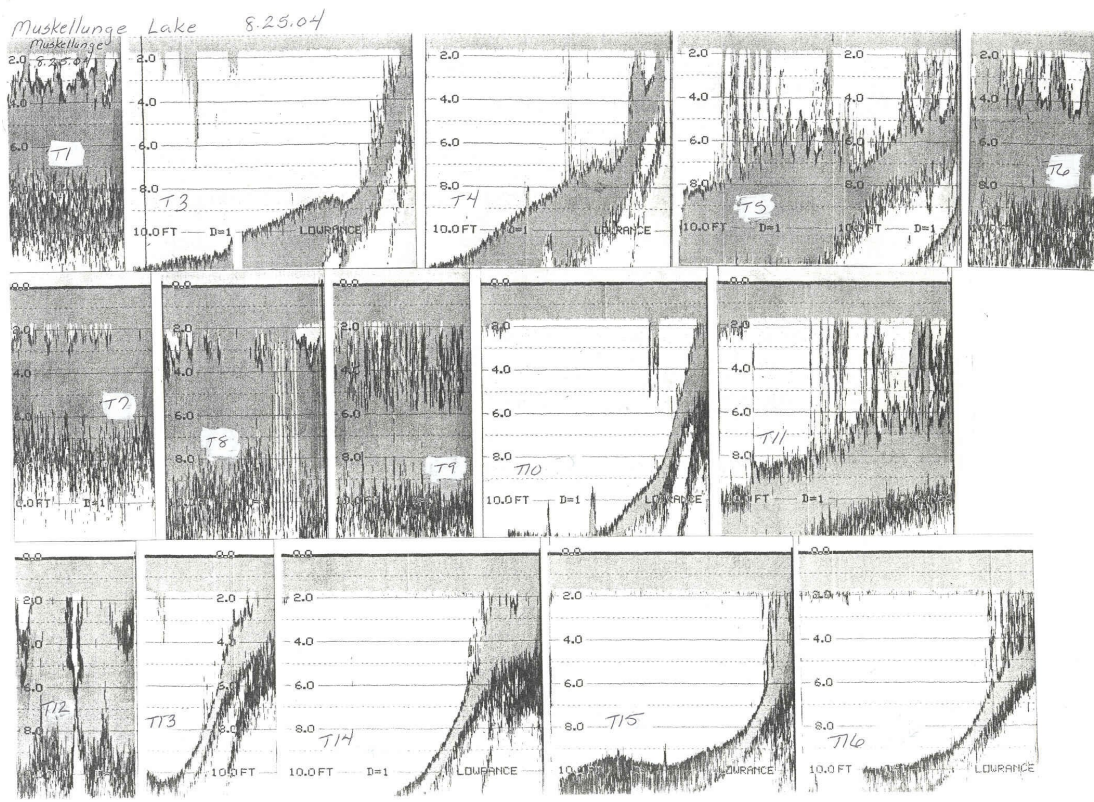
Figure 24. Sonar graphs show the aquatic plant canopy in Muskellunge Lake on August 25, 2004.

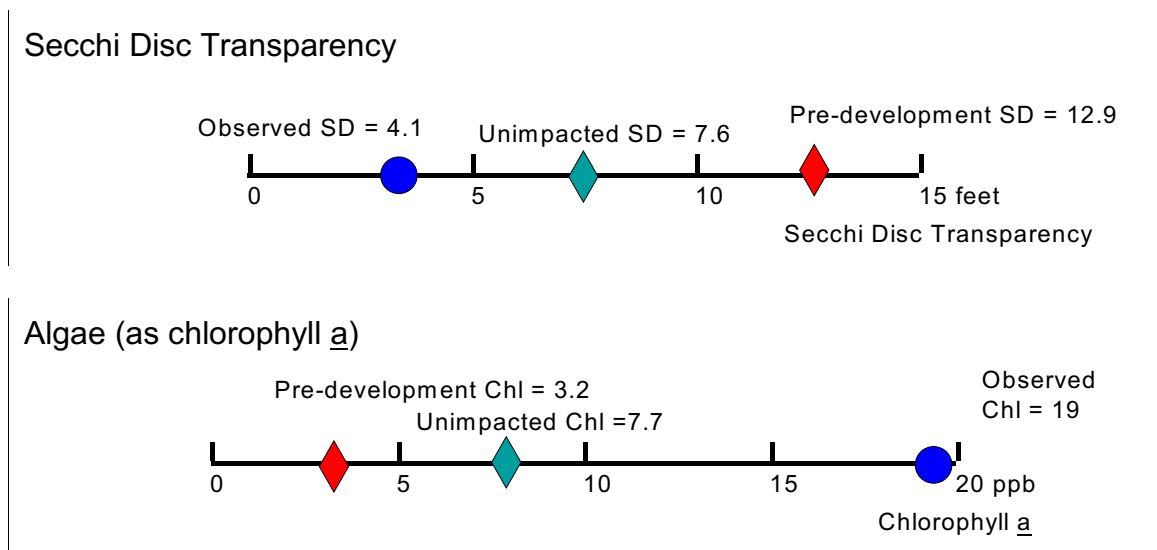
**Figure 28. Comparison of Secchi disc transparency (feet) and algae (chlorophyll a – ppb) conditions for Muskellunge Lake in 2001 (blue dots) to predicted conditions for a lake the size of Muskellunge Lake situated in the Northern Lakes and Forest (NLF) ecoregion under two runoff conditions: pre-development (red diamond) and unimpacted lake with some development (green diamond).**

The Secchi disc transparency is lower than expected and chlorophyll a is higher than expected when Muskellunge Lake is compared to other lakes in the ecoregion. The challenge to improving water quality is to address groundwater and lake sediment nutrient inputs.

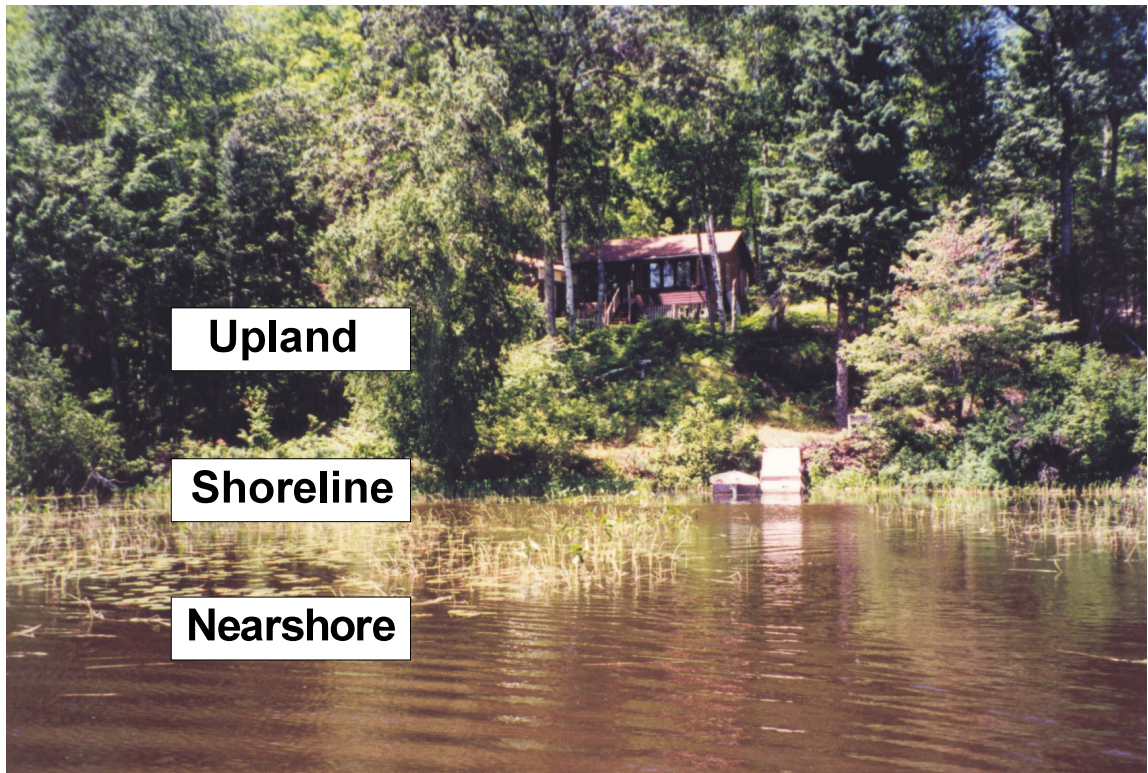
**Figure 28. Cross section of the lake shoreland habitat.**

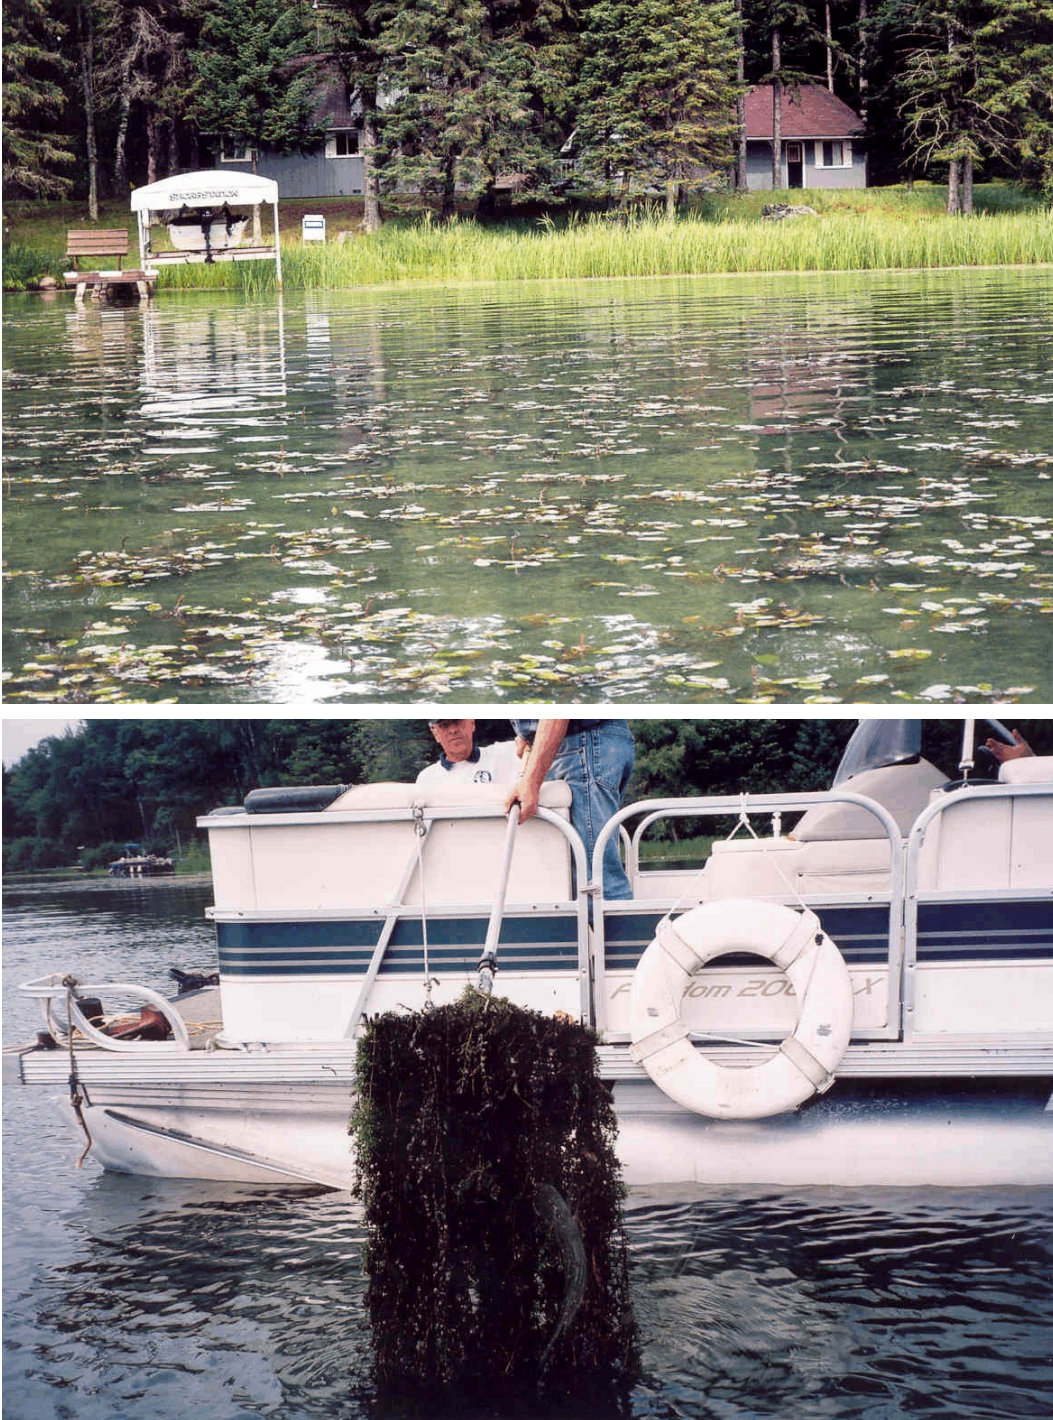
**Figure 31. [top] In the nearshore areas a variety of submerged and floatingleaf plants are present. [bottom] One of the most common plants in Muskellunge Lake is the native plant, coontail. It is difficult to control.**

Native aquatic plants flourish in the shallow, nearshore areas of Muskellunge Lake (Figure 31). They can create some navigational nuisances. Channels could be created through the plants to facilitate boating access, but it is recommended that only the minimum amount of plants be removed to reduce nuisance conditions.

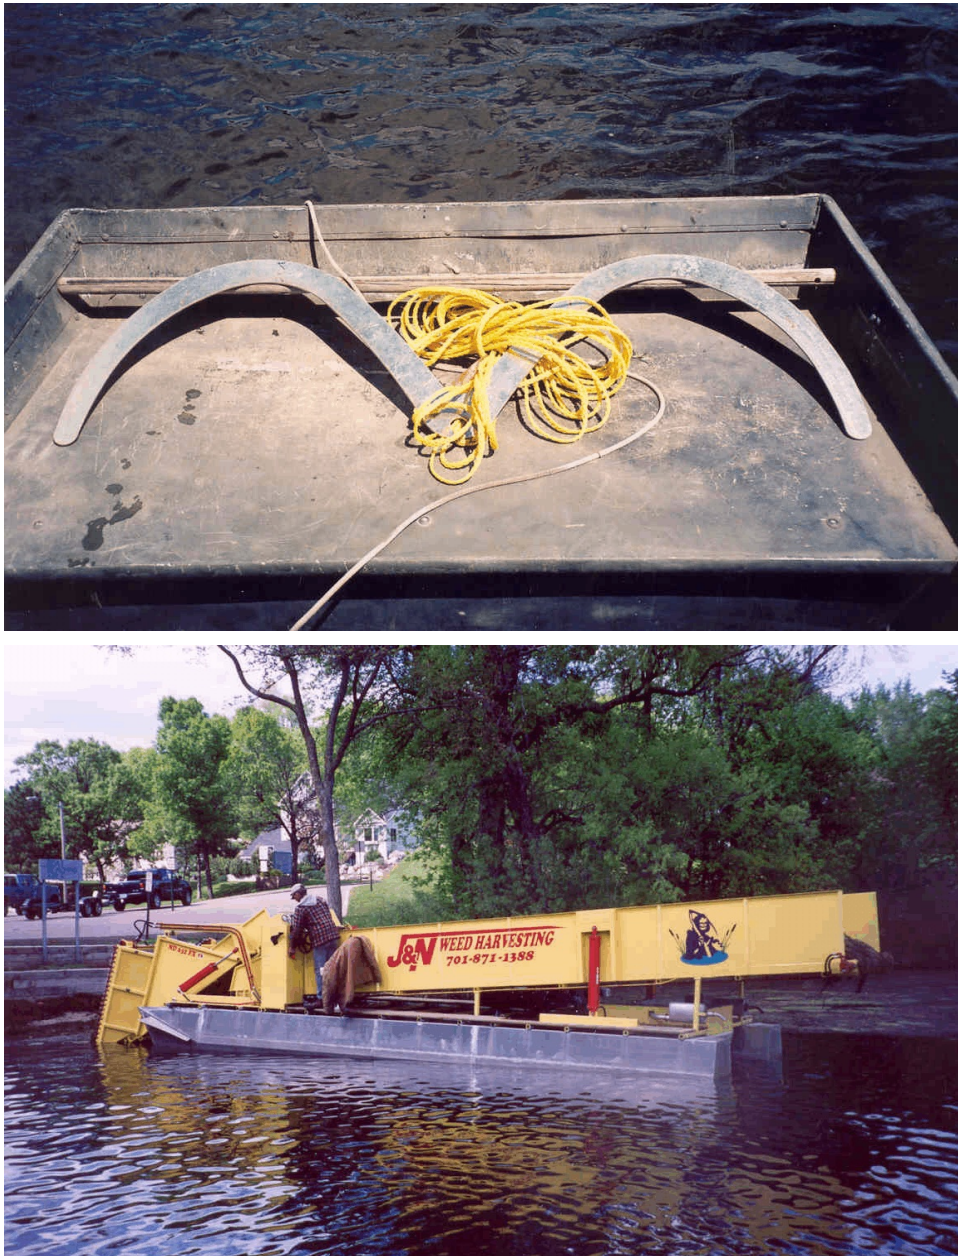
**Figure 32. A mechanical harvester is recommended for picking up coontail in the northern bays if plant management is considered.**

Another option is harvesting a channel about 20 to 30 feet wide through the surface matted growth would allow unrestricted navigation and should not harm the lake. Mechanical harvesters pick-up most of the plants that are cut (Figure 32). Hiring a mechanical harvester to cut channels or clear cut areas in the northern bays would cost about \$600 - \$800 per acre.

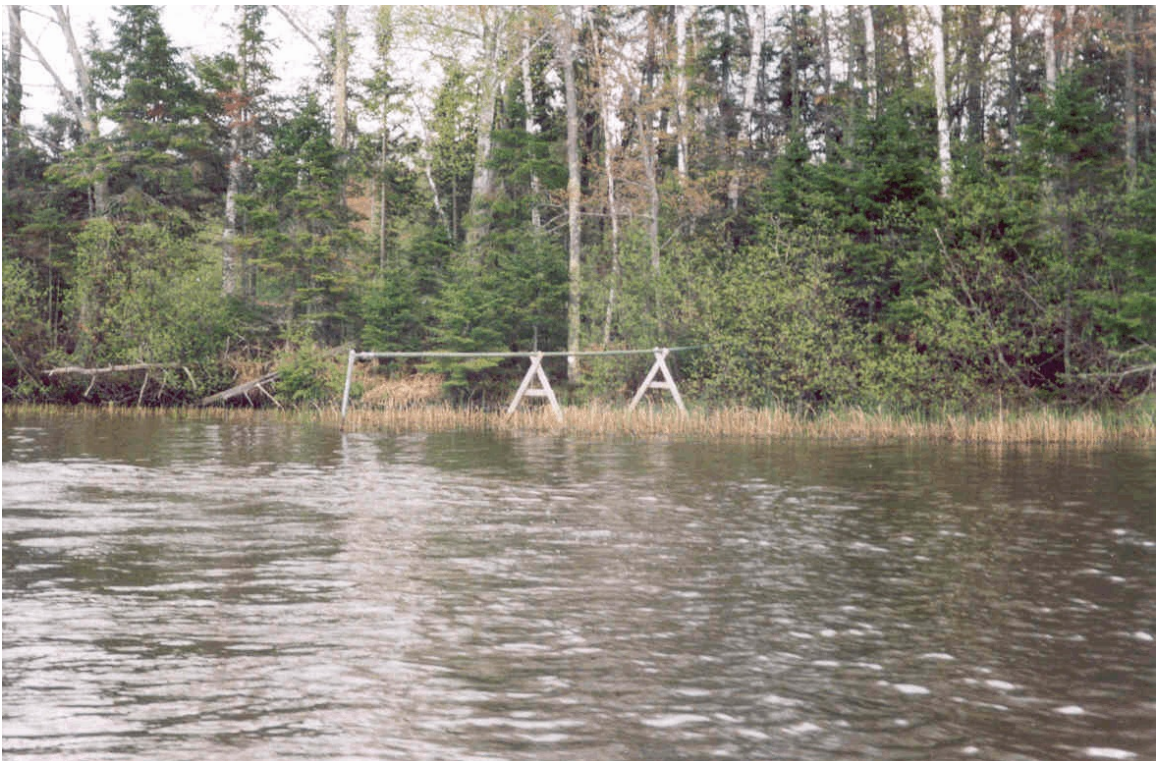
**Figure 33. The Muskellunge Lake Association operates the winter aeration system on Muskellunge Lake.**

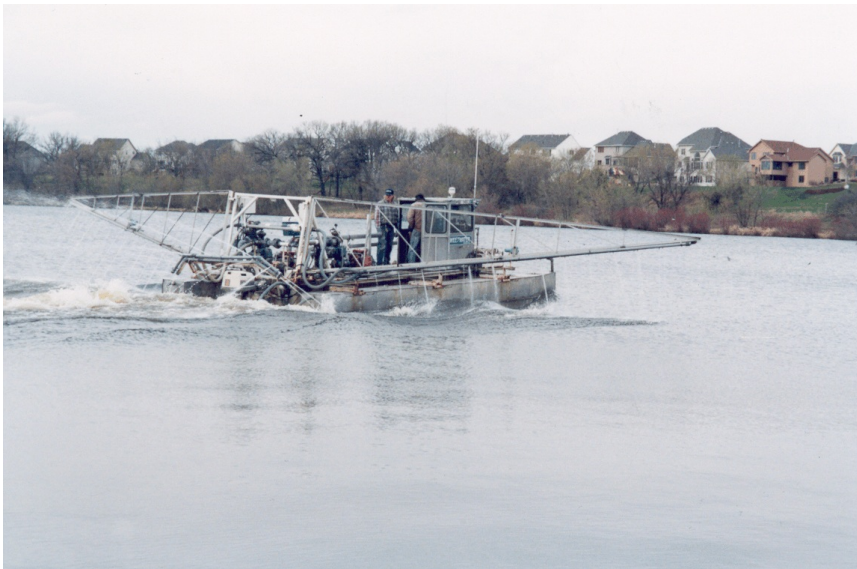
**Figure 34. An alum application is generally applied from a barge. This was a lake sediment alum application on Lake Susan in Chanhasen.**

Under existing conditions, it is estimated that groundwater and p-release account for 492 pounds of phosphorus per year, the equivalent to 2.5 mg-P/m<sup>2</sup>/day for 100 days. If the alum treatment was effective in reducing the excessive phosphorus release from lake sediments down to 1 mg-P/m<sup>2</sup>/day, the bottom loading would be reduced to 200 pounds per year. The new annual phosphorus budget for the lake would not be 380 pounds of phosphorus per year. It is predicted lake phosphorus concentrations would drop to 30 ppb or less in the lake and transparency would increase to 6.6 feet compared to the observed 4.3 feet as a seasonal average. However, there is no guarantee the effect would last longer than several years.
